ANNUAL REVIEW

1 January 2021 – 31 December 2021

Name of operation	Mt Owen Glendell Operations
Name of operator	Mt Owen, Ravensworth East and Glendell Mines
Development consent/ project approval	MGO Mining Operations Plan (Mt Owen, Glendell and Ravensworth East), DA SSD-5850 (Mt Owen and Ravensworth East) and DA 80/952 (Glendell).
Name of holder of development consent/ project approval	Mt Owen Pty Limited
Mining lease and exploration lease #	Mt Owen & Rav East – CCL715, CL383, ML1355, ML1415, ML1419, ML1453, ML1475, ML1561, ML1608, ML1629, ML1673, ML1694, ML1741, ML1802, MLA512, MLA513, EL6254, EL5824, A268, A423, A429, AL08 Glendell – ML1629, ML1673
Name of holder of mining lease	Mt Owen Pty Limited
Mining lease and Exploration Lease #	Glendell – CL358, MPL343, ML1410, ML1476, EL6594, EL8184
Name of holder of mining lease	Glendell Tenements Pty Ltd
Water licence #	Refer list provided in Table 31
Name of holder of water licences	Mt Owen Pty Limited

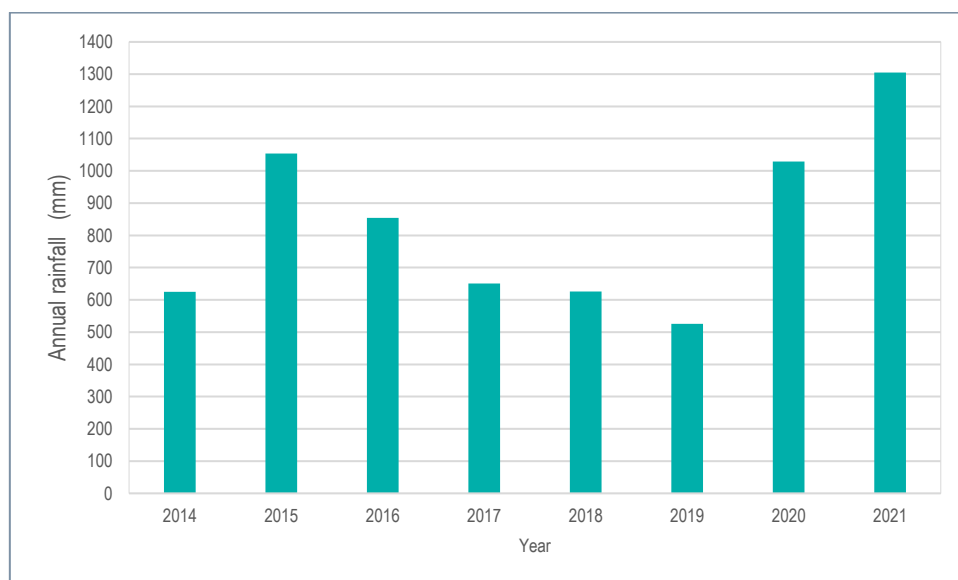
Figure 23: Regional Rainfall Data (Bowmans Creek BoM Station (0612270))

Over the last several years MGO has received highly variable rainfall. In the years prior to 2021, MGO experienced lower than average rainfall resulting in long periods of no flow conditions within MGO's creek systems. For both 2020 and 2021 above average rainfall was received, resulting in an increase in flow rates at most surface water monitoring sites. Samples collected in the 2021 reporting period were collected under variable flow conditions. MGO was unable to obtain water samples from Swamp Creek (SC3) during the reporting period due to low water levels and dry conditions (**Figure 23**).

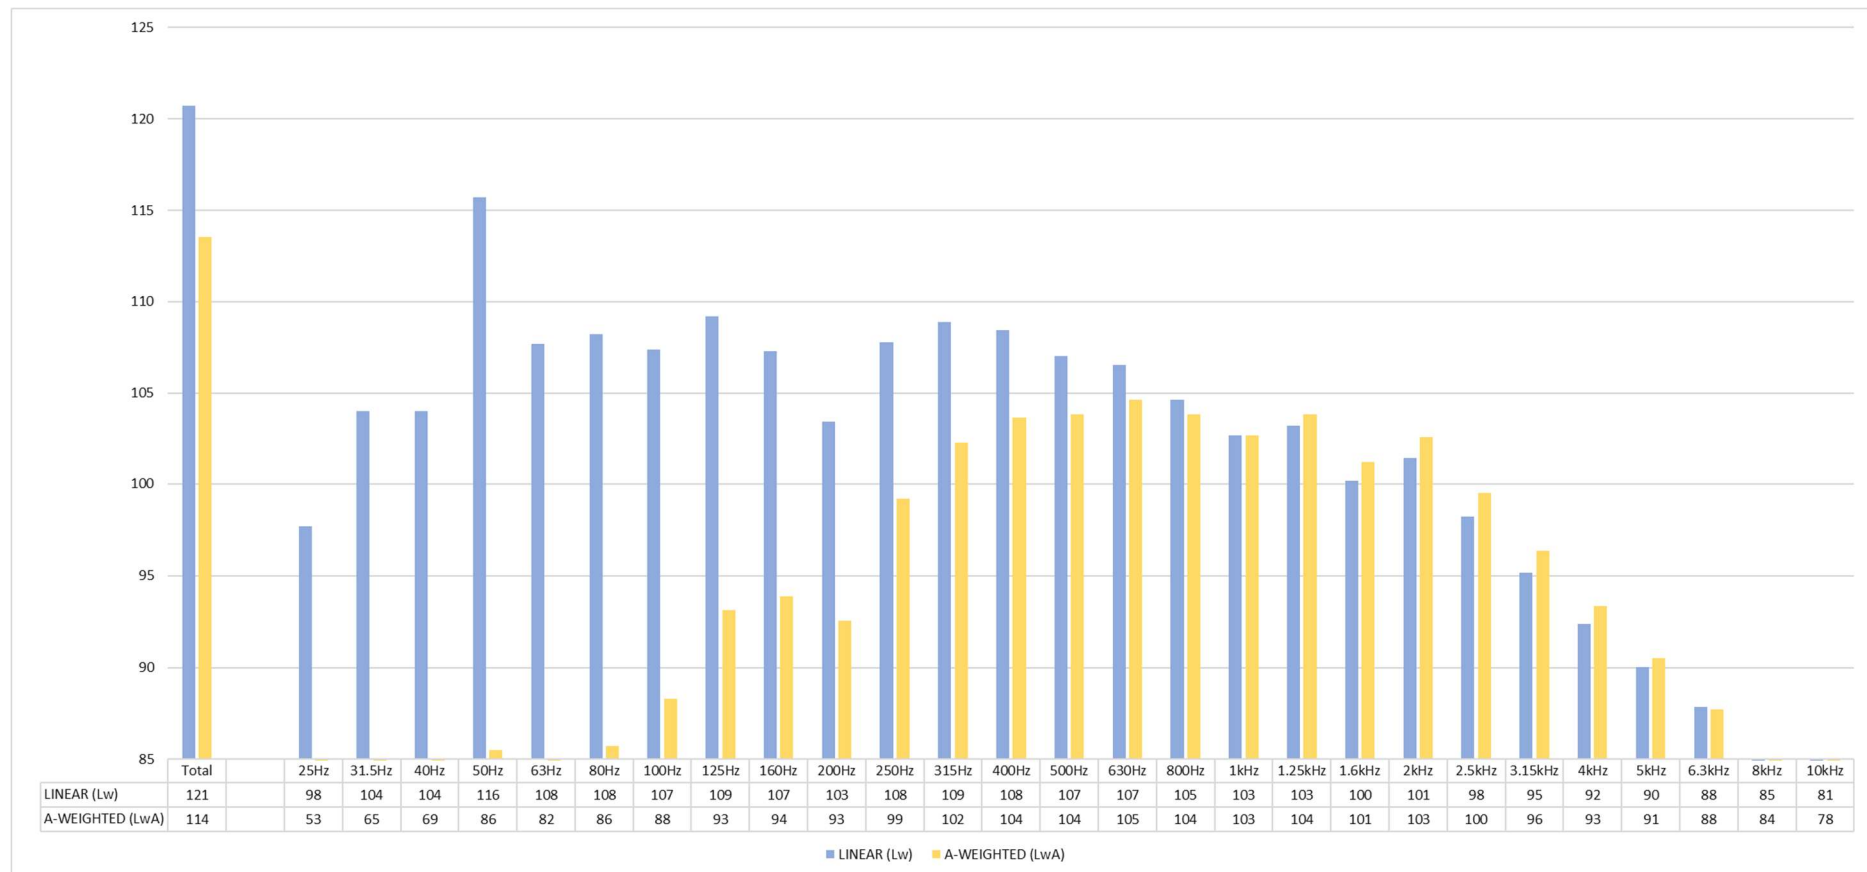
2737 Haul Truck Stationary Test

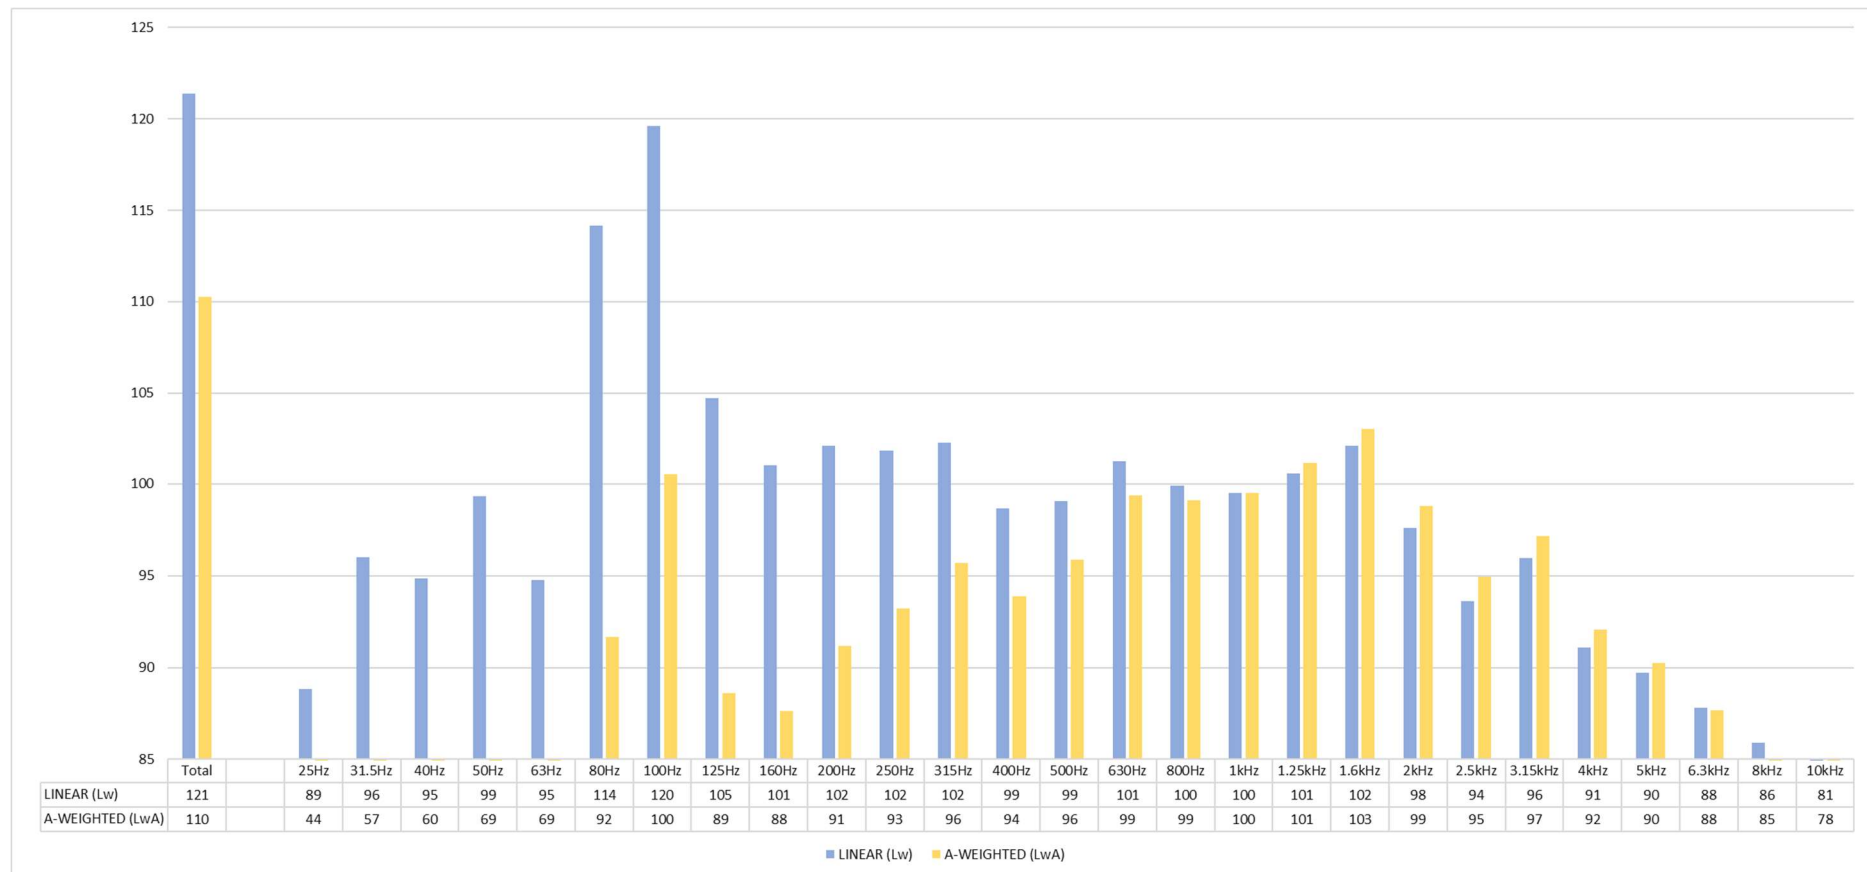
8054 Dozer Stationary Test

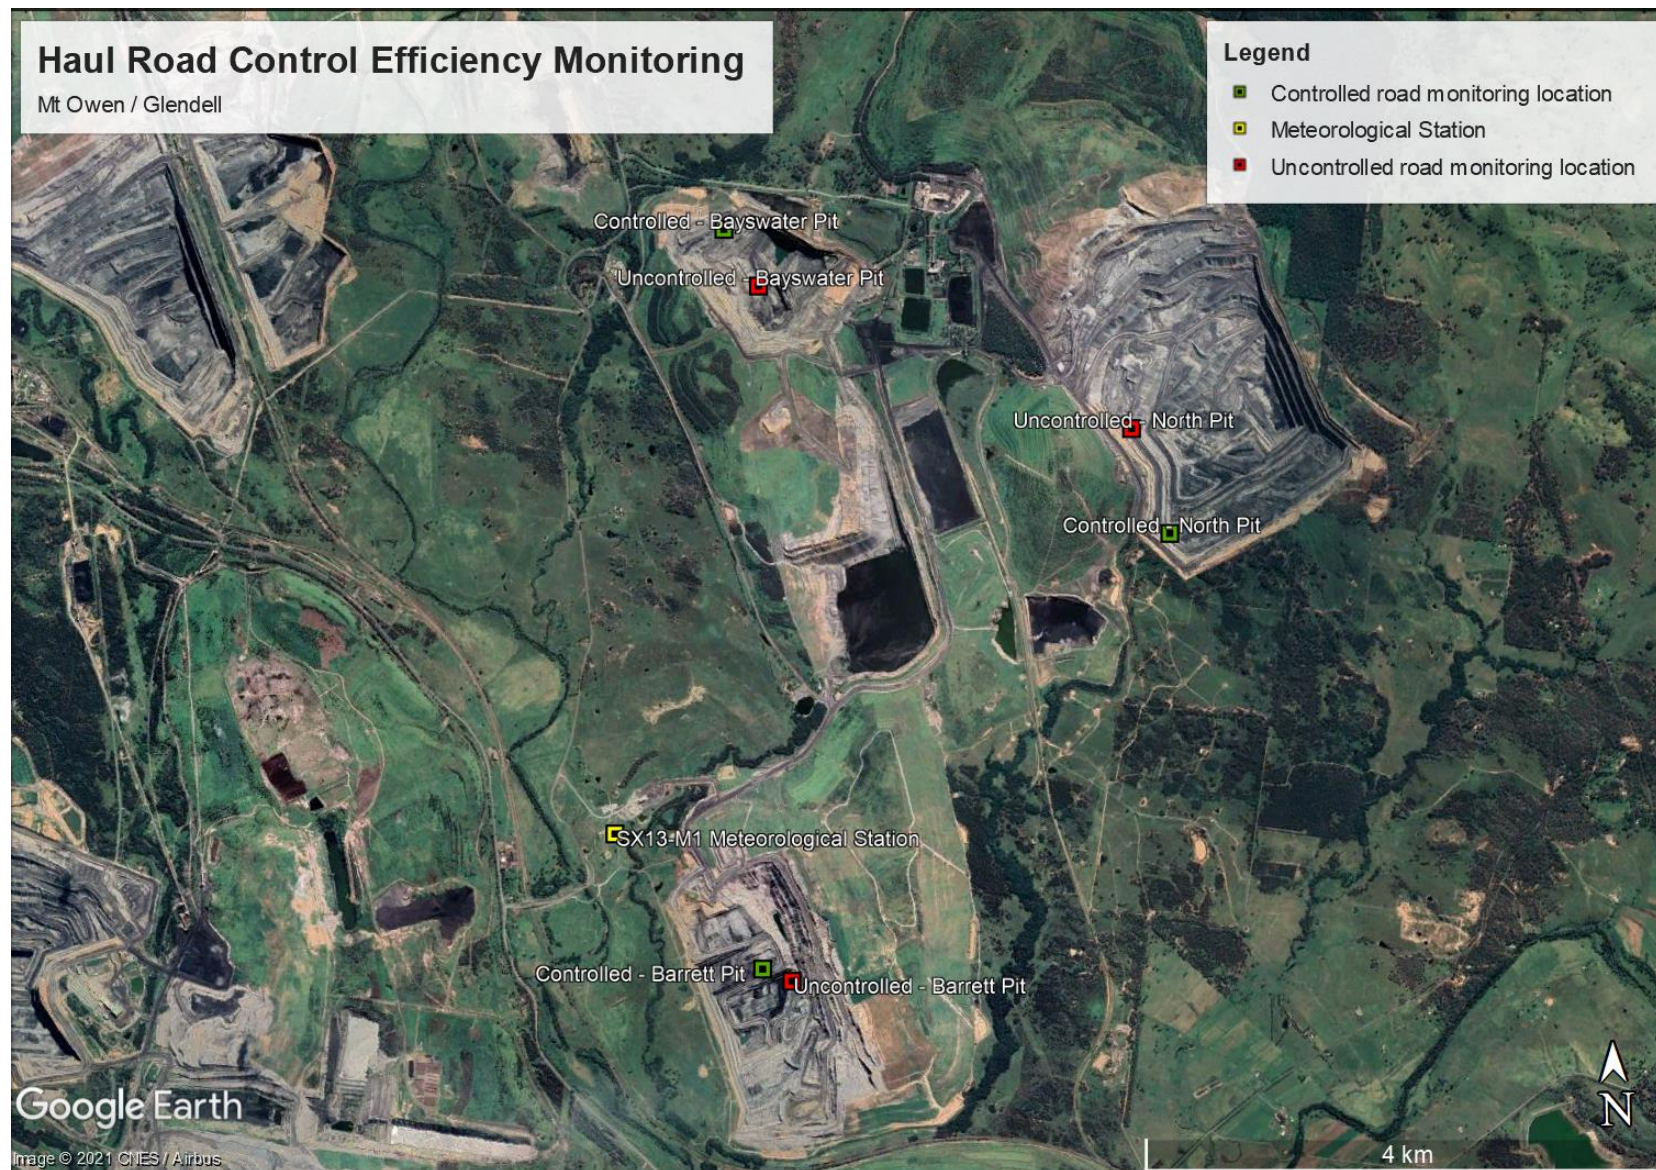
Figure 2-1: Haul road emissions monitoring locations, 3 to 4 November, 2021

Monitoring locations for controlled and uncontrolled sections are shown in Figure 2-1, along with the location of the meteorological station used to understand rainfall and wind conditions.

Site meteorological data for rainfall and wind conditions measured at SX13-M1, located to the east of the Complex between Bayswater and Barrett Pit (refer to Figure 2-1), were reviewed to understand conditions for the week prior to monitoring and during the monitoring campaign. No rain was recorded from a week prior (29 October 2021) until after the monitoring campaign was completed on 4 November 2021. Wind conditions measured on site show a prevailing south-easterly on 3 November (refer to Figure 3-1) and winds predominately from the south-east and south on 4 November (refer to Figure 3-2).

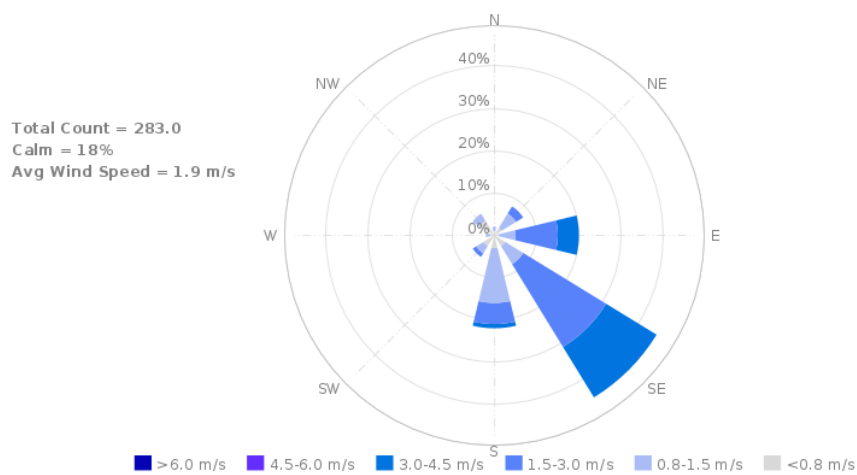
Figure 3-1: Windrose from MGO, Sentinex 13-M1, 3 November 2021

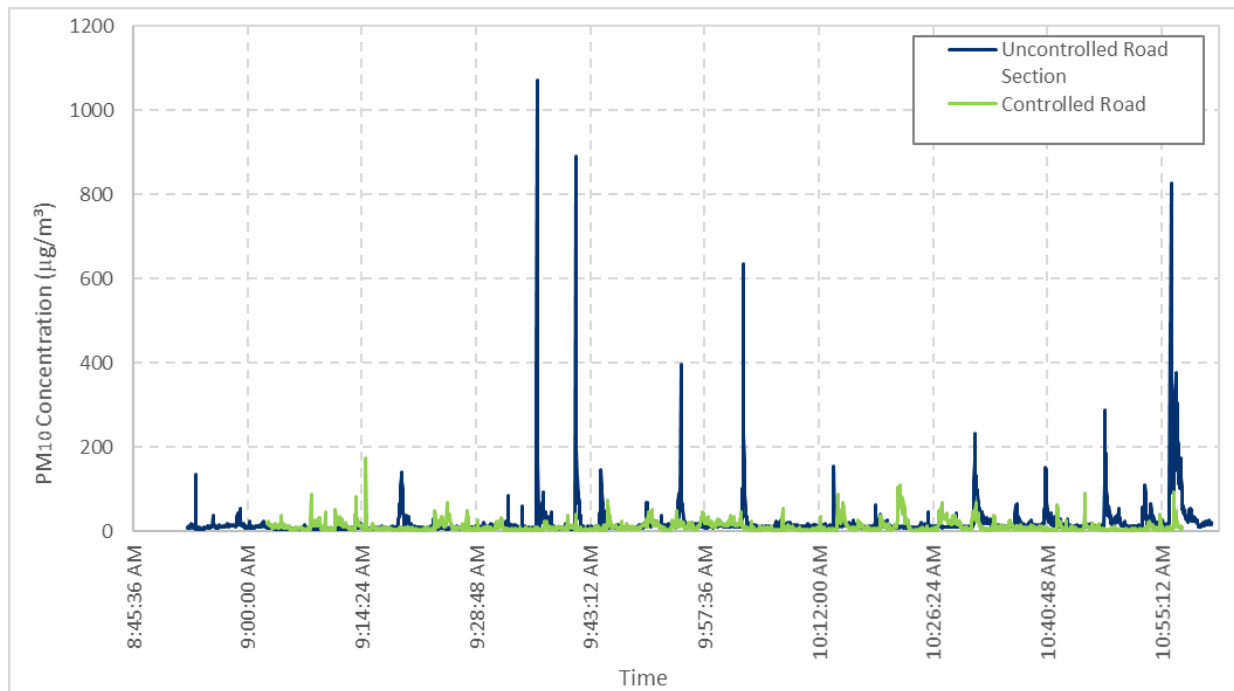
Figure 3-3: North Pit average roadside PM₁₀ concentration at controlled and uncontrolled monitoring locations, 4 November 2021

The derived control efficiency at North Pit was below the target control efficiency of 85%. A timeseries of the data, shown in Figure 3-3, shows evident peaks in the data likely as a result of trucks passing indicating the controlled road shows improved conditions compared to the uncontrolled road. The baseline emissions from both sections of road are reasonably consistent. On site inherent moisture in the road was observed in the shoulder of the road, while this is not typical of road left to dry for 12+ hours (see photo in Figure 2-2 for reference) and may not be representative of an uncontrolled road, Thiess confirmed the road was left unwatered overnight for the specified duration. The location of the monitoring point at North Pit may also be influenced by the high wall, where winds from the south and south-east during the monitoring period could be obstructed. If the controlled road section is compared to the uncontrolled sections from Barrett and Bayswater Pit, the control efficiency is much higher (92% and 98% respectively).

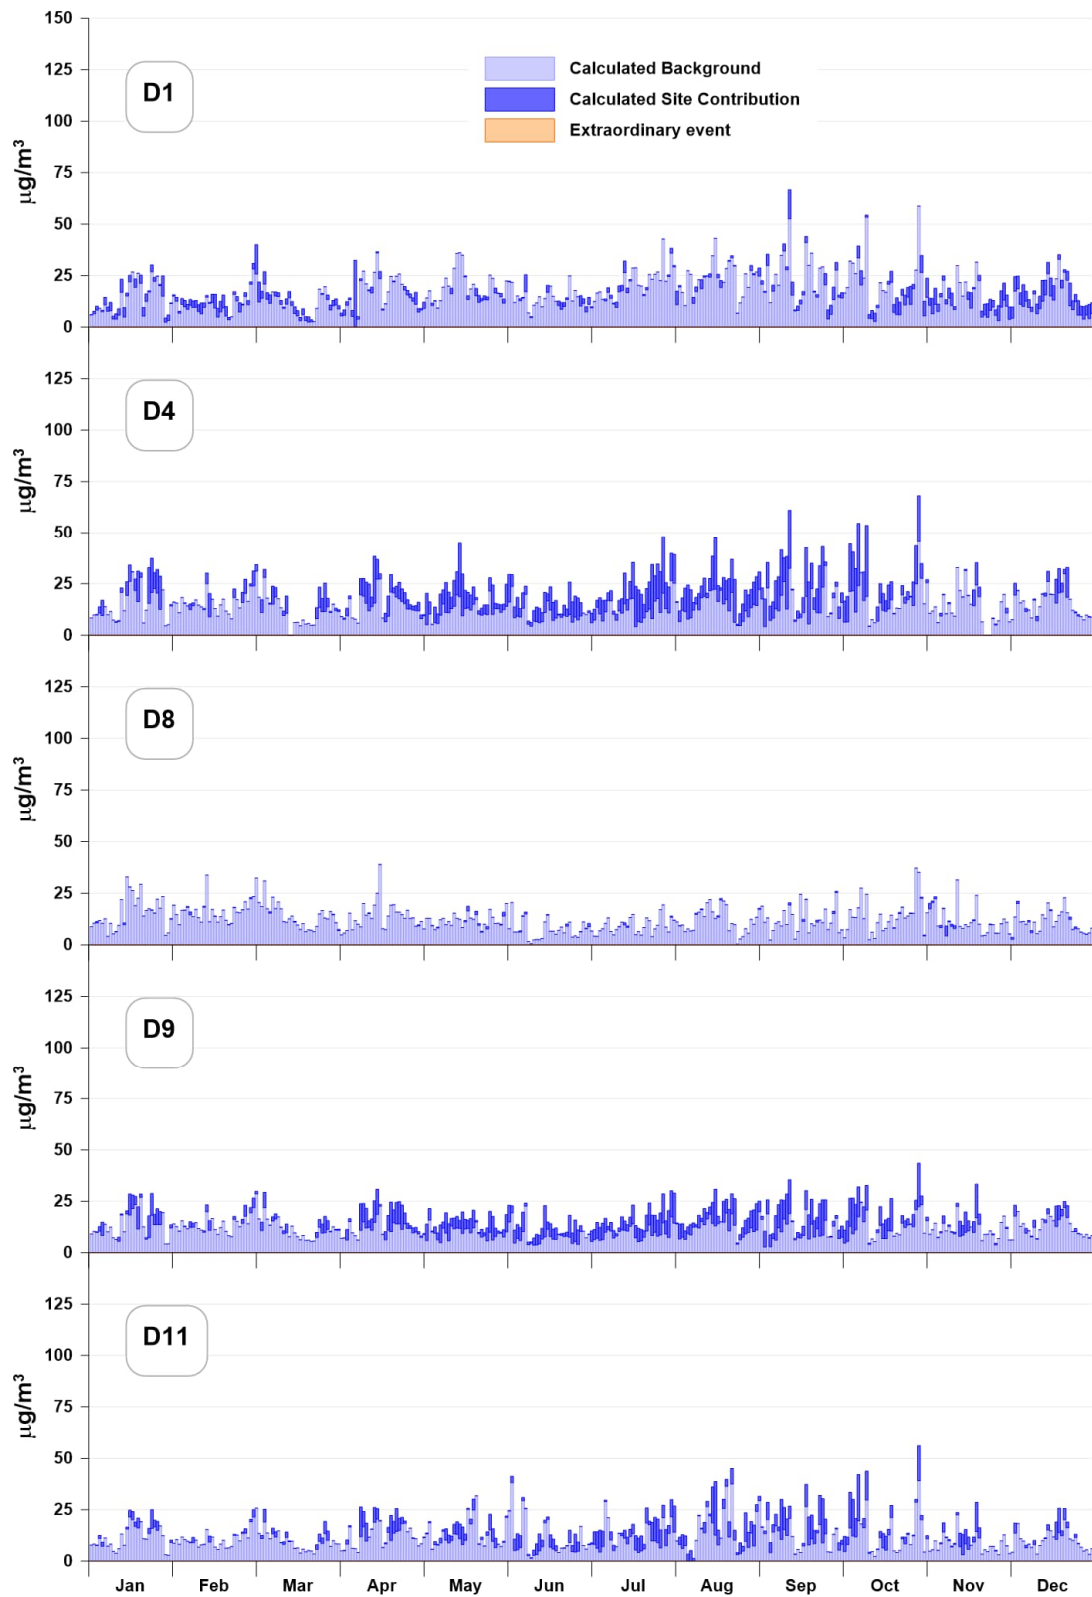
Figure 4 Measured 24-hour average PM₁₀ concentrations at MGO monitoring sites in 2021
