Harbourside Redevelopment: Stage 2 Excavation

Heritage Impact Statement and Archaeological Impact
Statement

July 2022

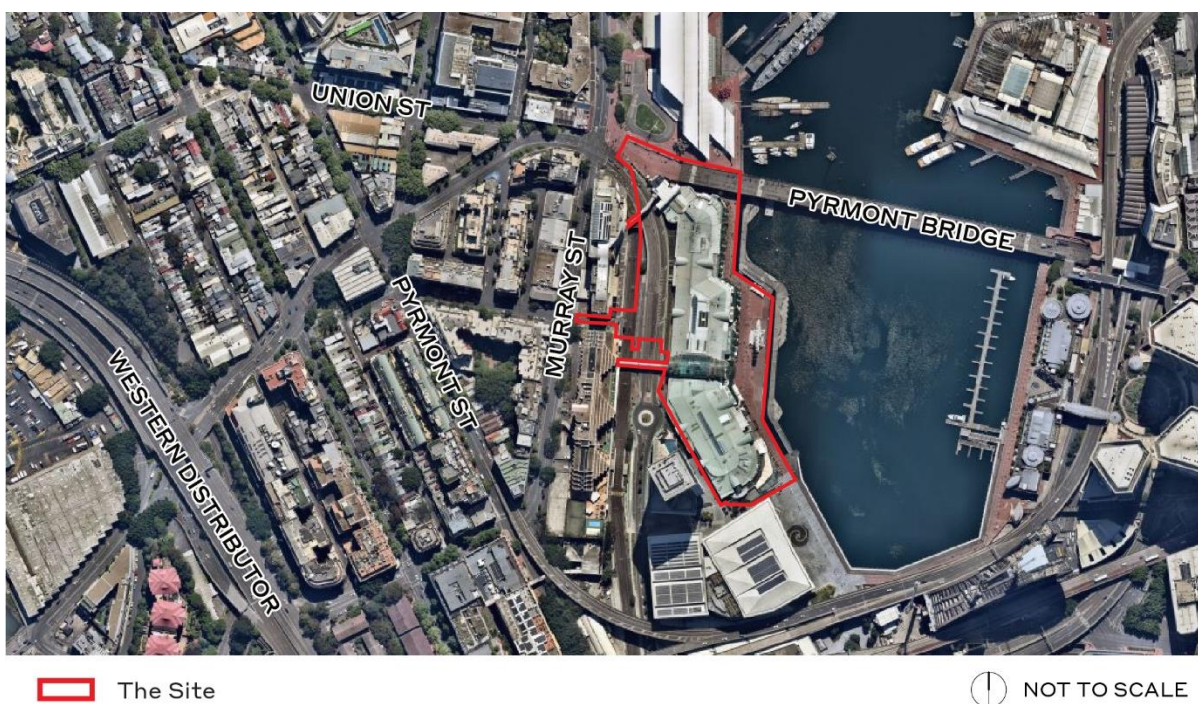
Figure 1.1. Harbourside Shopping Centre redevelopment site.

Specifically, the site occupies an area of approximately 2.05 hectares within the north western portion of Darling Harbour, in between Cockle Bay and the Pyrmont Peninsula. It is irregularly shaped and existing site improvements include the 2-3 storey Harbourside Shopping Centre – noting approval has already been granted for stage 1 demolition works. Indicative site boundaries are shown in Figure 1.1.

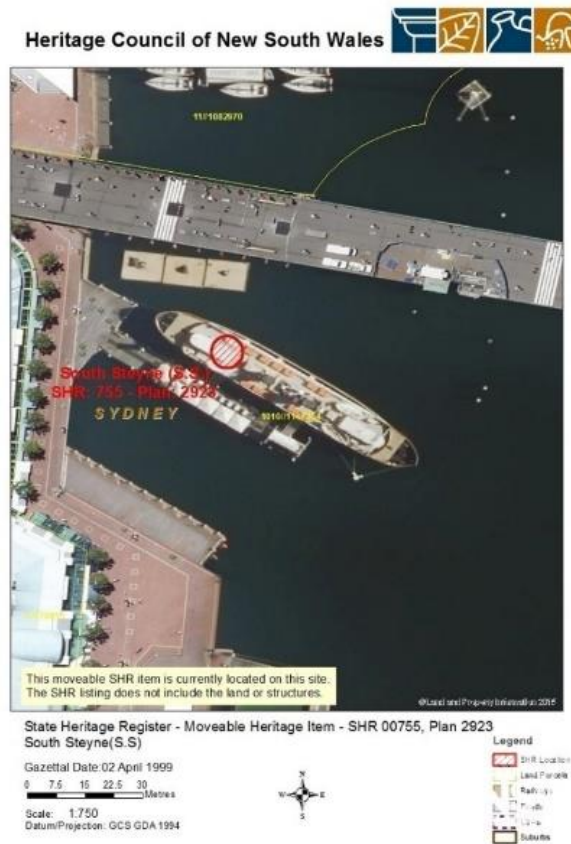
Figure 2.3. SHR curtilage map for South Steyne (S.S.). Source: Heritage NSW

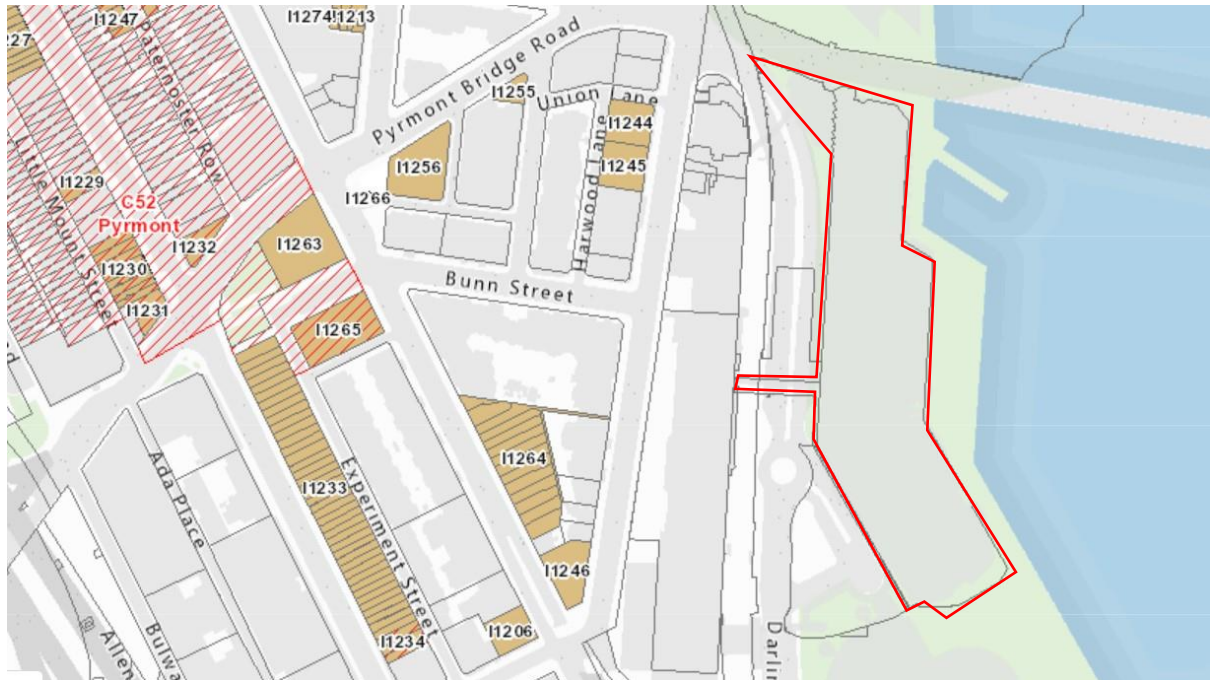
Figure 2.4 .Location of LEP listed items in relation to the study area (outlined in red). Source. City of Sydney.

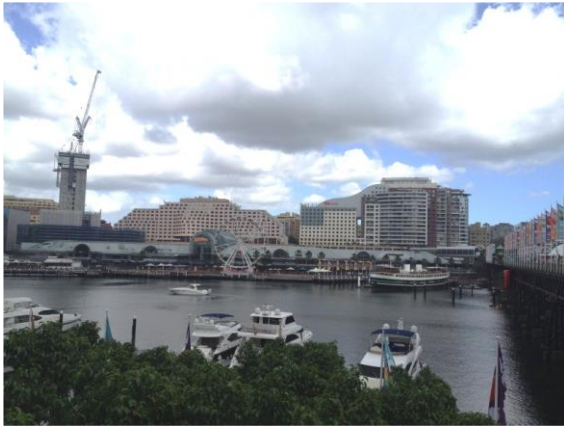
Figure 4.1: The Harbourside Shopping Centre, viewed from the eastern shore of Darling Harbour

The subject site extends from Pymont Bridge in the north to the International Convention Centre site currently under redevelopment to the south (Figure 4.1). On the west the site is bounded by Darling Drive (Figure 4.2) and extends east to the public promenade on the Darling Harbour foreshore (Figure 4.3). The northern boundary of the site abuts the south-western end of Pymont Bridge. In several locations the existing shopping centre complex has a direct physical or visual interface with Pymont Bridge (Figure 4.4 to Figure 4.7).

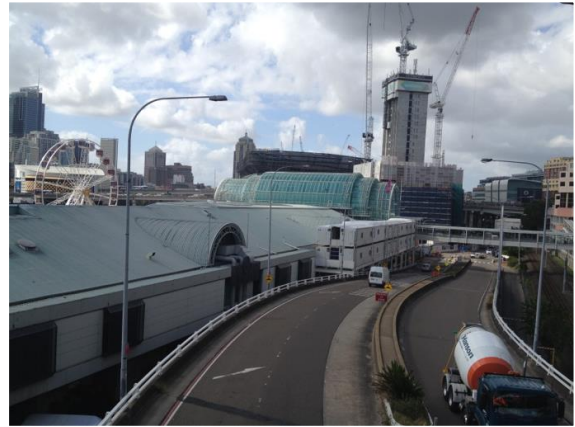
Figure 4.2: Western boundary of the subject site, view facing south. The light rail line to the west of Darling Drive follows a route of the original Darling Harbour Goods Line.

The nearby route of the light rail runs along a section of the path of the former Darling Harbour Goods Line, and is located to the west of the site. The rail line sits at a similar level to Harbourside. Darling Drive rises up from this level via a ramp (and not natural topography or an extant historical feature) to meet the higher level of Murray Street (Figure 4.9).

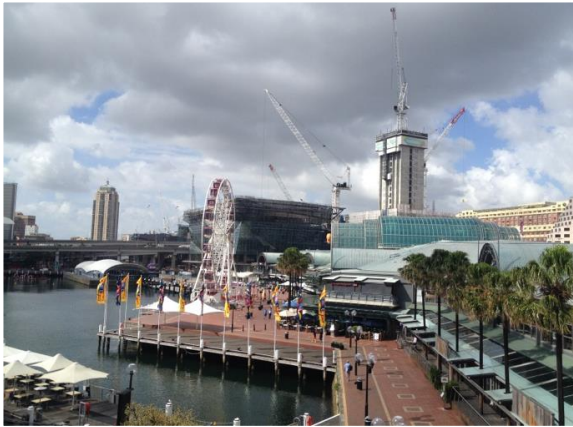
Figure 4.3: Eastern boundary of the Harbourside site, showing interface with the public promenade on the waterfront

The external areas within the subject site adjacent to the waterfront promenade are paved in red brick, and are consistent with the rest of the public promenade, western approach to Pymont Bridge, Australian National Maritime Museum forecourt (Figure 4.3, Figure 4.4 and Figure 4.7).

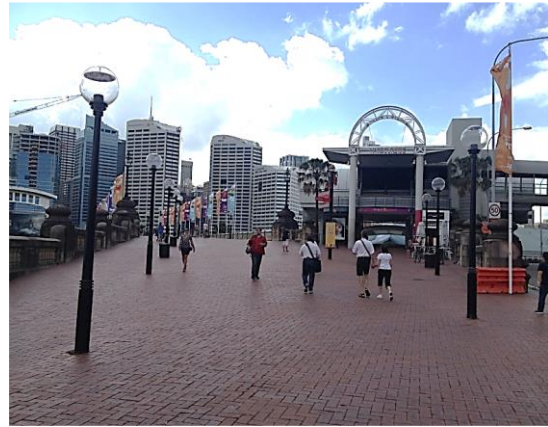
Figure 4.4: Western approach to Pyrmont Bridge, showing entrance to Harbourside

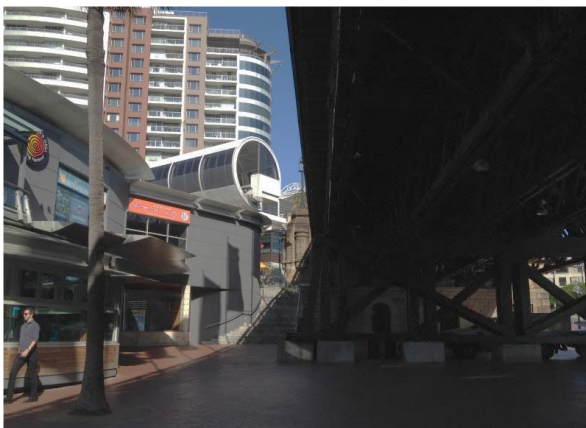
Figure 4.5: Interface between Harbourside (left) and Pyrmont Bridge (right), view facing west. the former Monorail Station is visible in the centre of the image.

The former monorail station is located above the northern end of the Harbourside Shopping Centre complex (Figure 4.5). A set of stairs provides access from Harbourside up to Pymont Bridge and the former monorail station (Figure 4.7). A pedestrian footbridge connects the former monorail station, Pymont Bridge and the northern end of Harbourside to the multistorey parking station and hotel on the western side of Darling Drive (Figure 4.7).

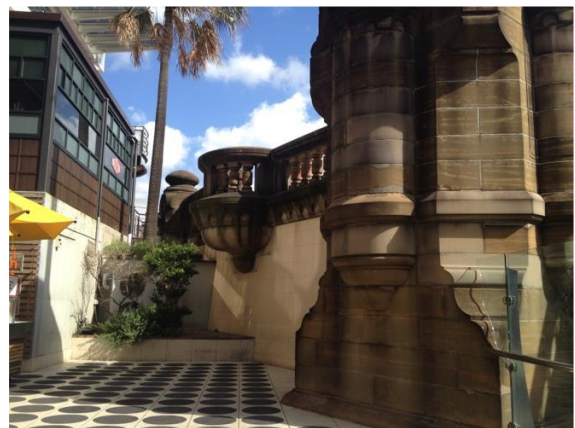
Figure 4.6: Physical interface with the Pyrmont Bridge

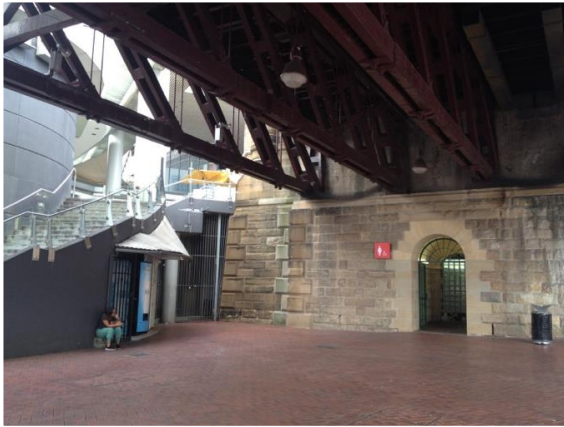
Figure 4.7: Northern boundary of Harbourside and the sandstone foundation of Pyrmont Bridge, showing gated entrance to loading dock

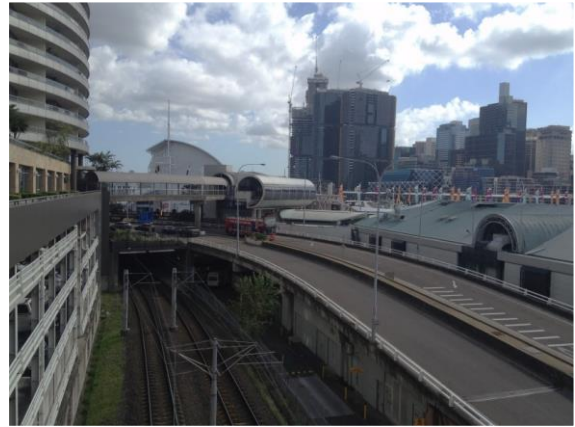
Figure 4.8: Darling Drive and pedestrian footbridge beyond the northern boundary of the subject site, showing former monorail station and Harbourside Shopping Centre.

A second pedestrian bridge connects the upper level of Harbourside to the multistorey parking station and hotel on the western side of Darling Drive (Figure 4.8).

A footpath and driveway to a loading dock provide access to the north-western side of the site. The Darling Drive ramp is located immediately west (Figure 4.8 and Figure 4.9).

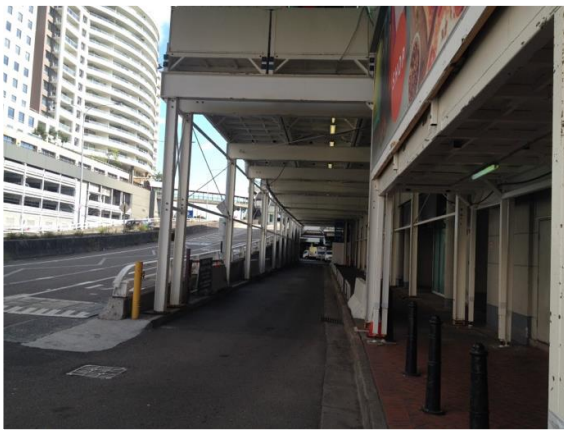
Figure 4.9: Loading dock entrance on western side of Harbourside. Darling Drive rises on the left-hand side.

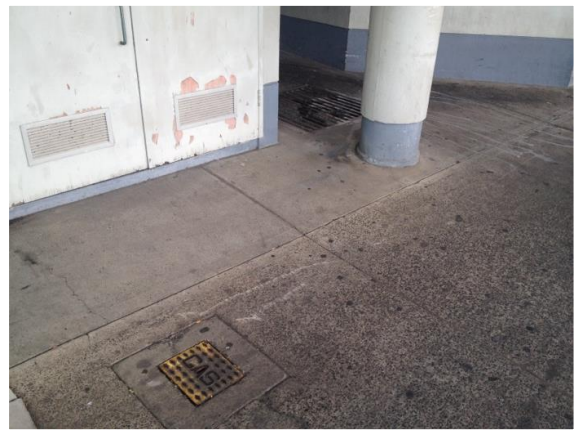
Figure 4.10: Example of subsurface services on the western side of Harbourside Shopping Centre

Evidence of subsurface services were observed across the site, including stormwater drainage (Figure 4.10).

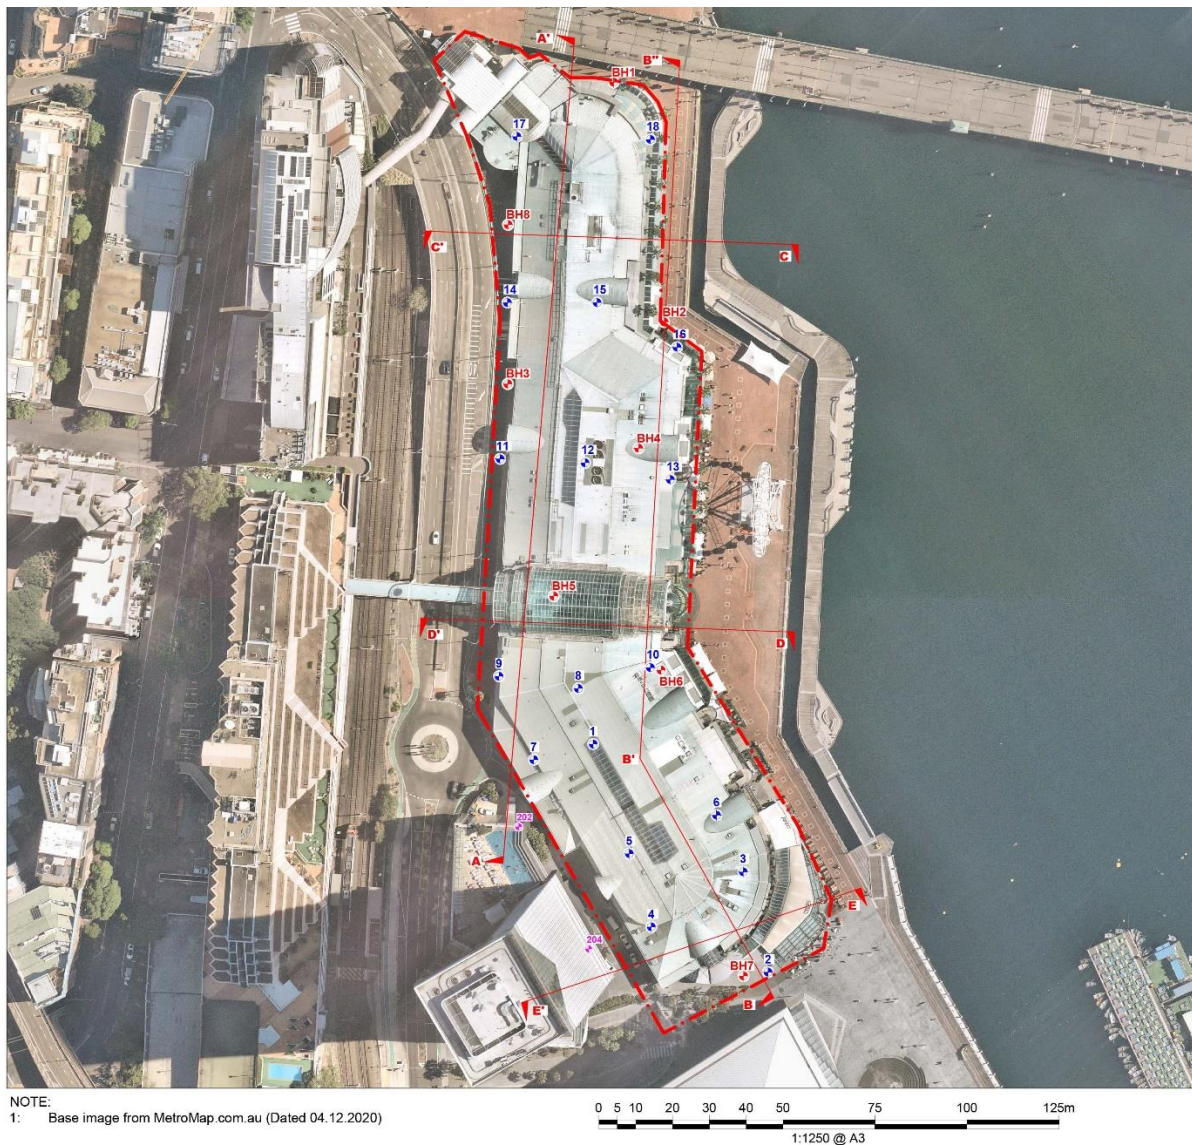
Figure 6.4. Geotechnical investigations Harbourside. The red borehole numbers correspond to the current work, the pink to the 2013 and the blue to the 1985 boreholes respectively. (Source: Douglas Partners)

*is underlain by between 2.7 m and 11.9 m of fill which appears to have been placed over either a thin layer of natural soil or bedrock. The fill is generally sandy with varying proportions of gravel, boulders and clay. The natural soils comprise soft clays and loose sands, with some organic clay encountered in BH7.*¹⁶

The presence of a former surface (i.e., concrete slab) at 1.25 m depth in BH3 is indicative of the potential survival of capped and preserved surfaces and features in these reclamation contexts. The previous examples noted above (Section 6.2.2) highlights the potential survival of complex historical strata containing significant features, deposits and artefacts from a variety of historical phases of development, from the mid nineteenth through to the twentieth century, that have archaeological research significance (see below).
