Harbourside Shopping Centre Darling Harbour

Maritime Archaeology Assessment

Darling Harbour
Sydney
NSW

July 2022

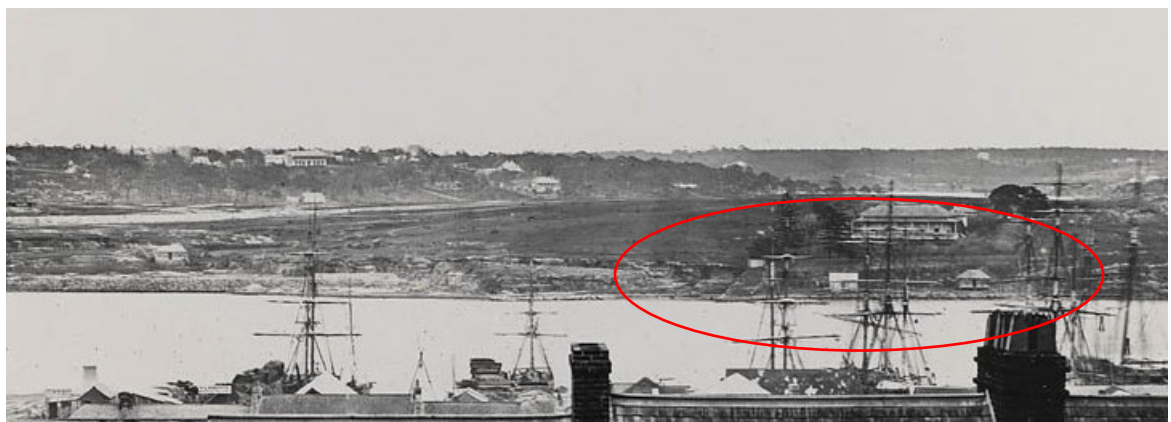
Figure 3: View of Darling Harbour's relatively undeveloped western shoreline ca. 1865. Newstead House and associated waterfront infrastructure circled in red.

Documented land usage on the western side of Darling Harbour (the current study area) didn’t commence until the 1830s. This began with the construction of a sandstone homestead at the waterfront property of Sydney merchant Captain George Bunn (Figure 3),¹⁸ known as Newstead House, or Bunn’s House. Captain George Bunn was a master mariner and successful merchant, who would have been a well-known member of Sydney society. He was the principal of the merchant firm *Buckle, Buckle, Bagster and Buchanan* as well as

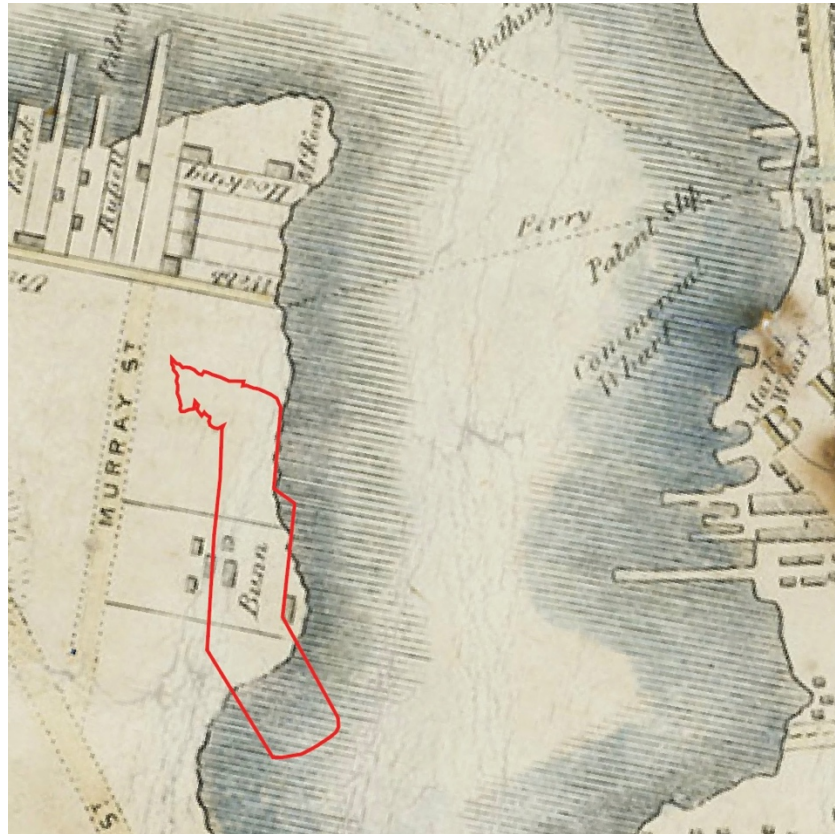
Figure 5: Map of Darling Harbour printed in 1843 showing the location of Newstead House. Approximate location of study area in red.²²

Prior to this, Captain Bunn had been living in George Street near King's Wharf and his property included extensive stores and a wharf²¹, used for his merchant dealings. It seems likely that the infrastructure being built at Newstead House would be used for the same mercantile purposes. However, less than four months later, Bunn died unexpectedly at Newstead. It is unknown if the wharf and warehouses at Newstead were completed and functioning before his death. While maps from the 1840s show some form of reclamation/slipway adjoining the property (Figure 5 and Figure 6) a photograph from 1875 depicts a jetty and slipway (Figure 4) at the shoreline.

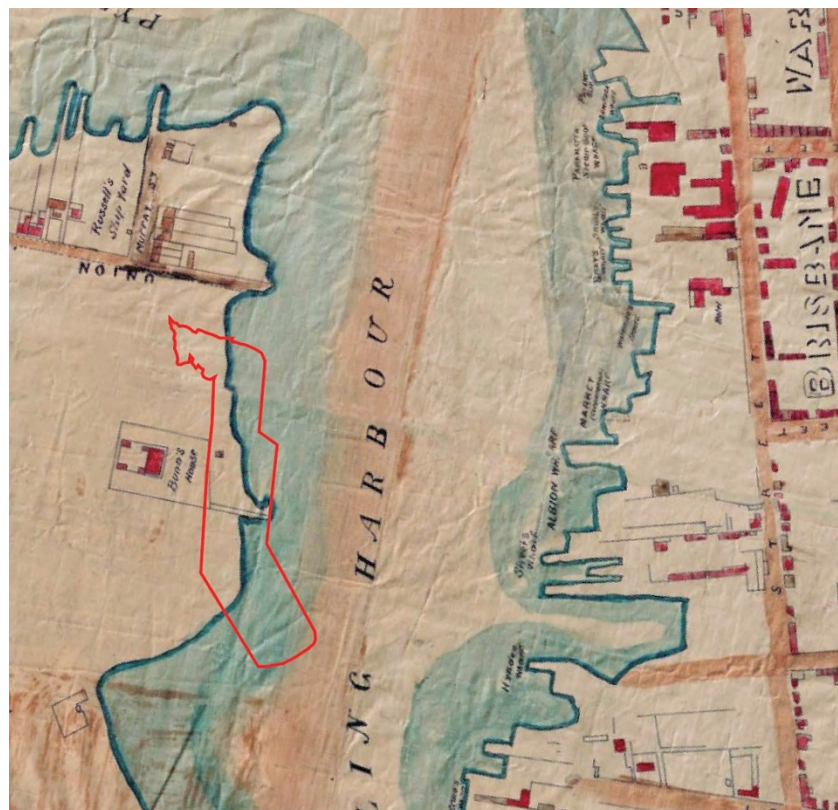
Figure 6: Map of Darling Harbour in 1845, showing the location of Newstead House with a possible slipway on the foreshore. Approximate location of study area in red.²³

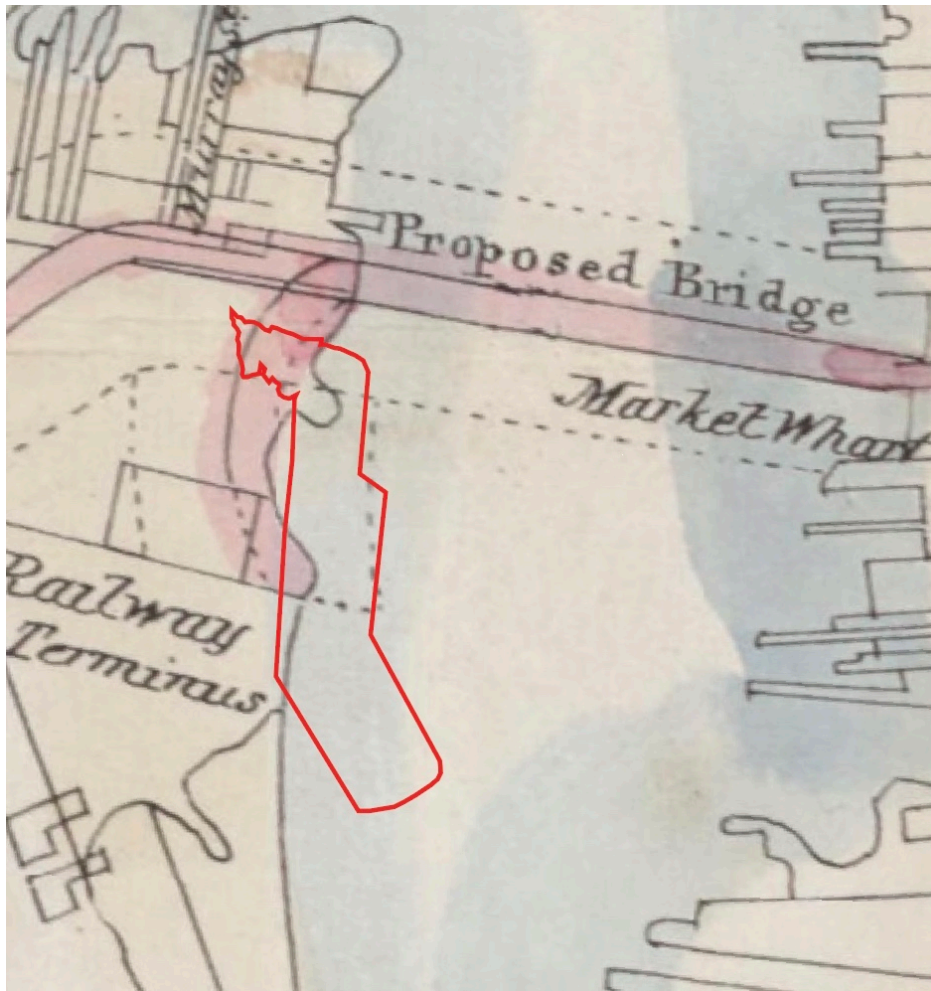
Figure 8: Excerpt from 1857 map of proposed Pymont Bridge showing railway terminus on the western side of Cockle Bay.²⁵ Note the bridge location is incorrect on this map. Approximate study area in red.

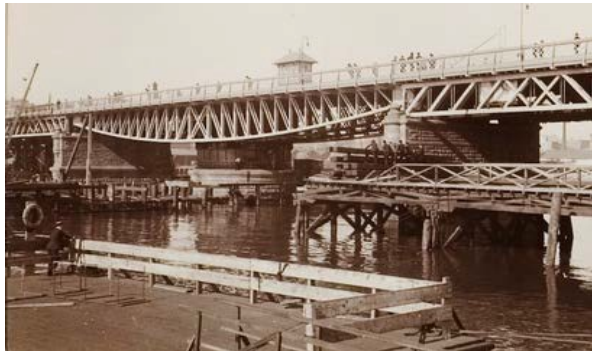
Figure 11: Pyrmont Bridge just after completion, with remnants of original bridge in foreground, 1902.³²

1891, however, in 1894, it was decided that a design for a higher-level steel bridge with bascule swing span prepared by Percy Allen, NSW Department of Public Works Engineer-in-Chief, would be adopted. Construction commenced in late 1899, with the new bridge erected just to the south of the original and completed in 1902 (Figure 11 and Figure 12).

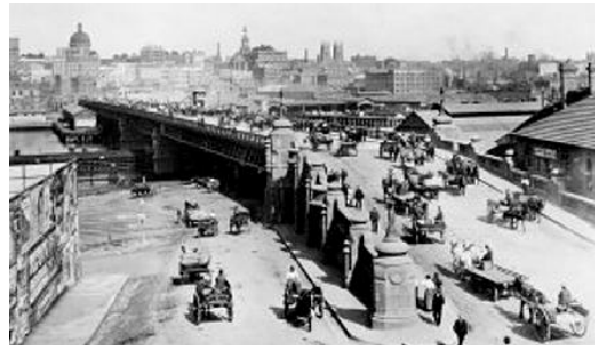
Figure 12: North side of Pyrmont Bridge, facing east, 1907.³³

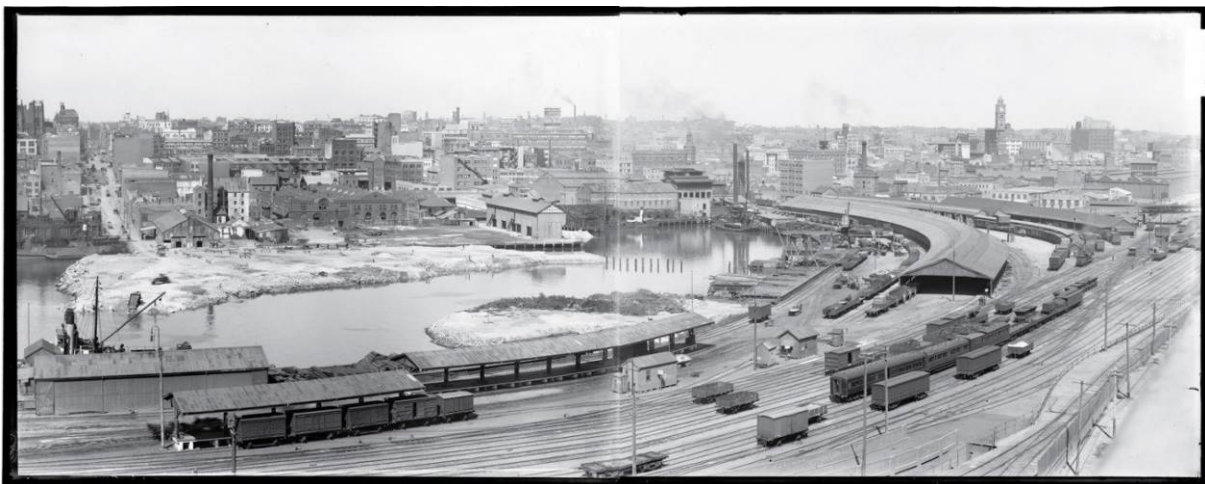
Figure 14: 1923 panorama showing commencement of reclamation works at the head of Darling Harbour. The rail yards in the foreground are the approximate location of the southern part of the study area.³⁵

Construction of the underground Sydney City Railway scheme finally commenced in 1923, allowing the reclamation of the head of Darling Harbour to be undertaken using the excavated spoil (Figure 14 and Figure 15). These works were completed in 1926 and over the course of the following two years, the Sydney Harbour Trust undertook the final stages of the Darling Harbour port improvement scheme; including the construction of cargo Wharves 37, 38 and 39 along the front of the new reclamation (Figure 16).

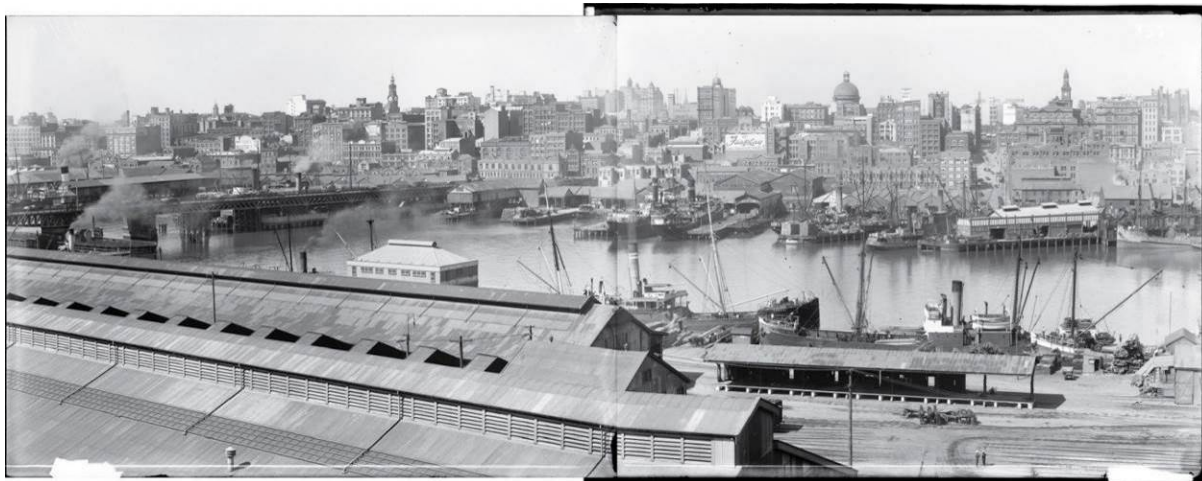
Figure 15: Continuation of 1923 panorama showing Darling Harbour railway goods yard in foreground, the site of the current study area.³⁶

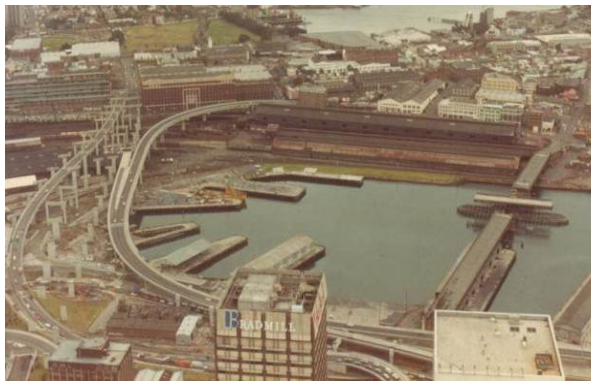
Figure 18: 1984 aerial photograph showing early stages of demolition of railway yards and wharves.³⁹

In 1982-1984, a development design plan was prepared by the NSW Department of Planning and Public Works Department, with the major components being a new exhibition centre, convention centre, market building and maritime museum on the western side of Darling Harbour, with landscaped gardens and a harbour promenade on the eastern side. A new government agency, the Darling Harbour Authority, was subsequently formed in 1984 to manage and deliver the redevelopment project. Over the course of the following four years, the Darling Harbour railway goods yards and wharves, and all wharves, warehouses and associated facilities along the southern and eastern shores of Darling Harbour south of Pyrmont Bridge, were demolished to make way for the construction of the proposed new recreational waterfront facilities. The Darling Harbour redevelopment project was completed in 1988 and officially opened during bicentenary celebrations; with the head of the harbour and associated entertainment precinct renamed “Cockle Bay”. The works continued in the 1990s as part of Stage 2 of the Darling Park Development (Figure 18 and Figure 19).

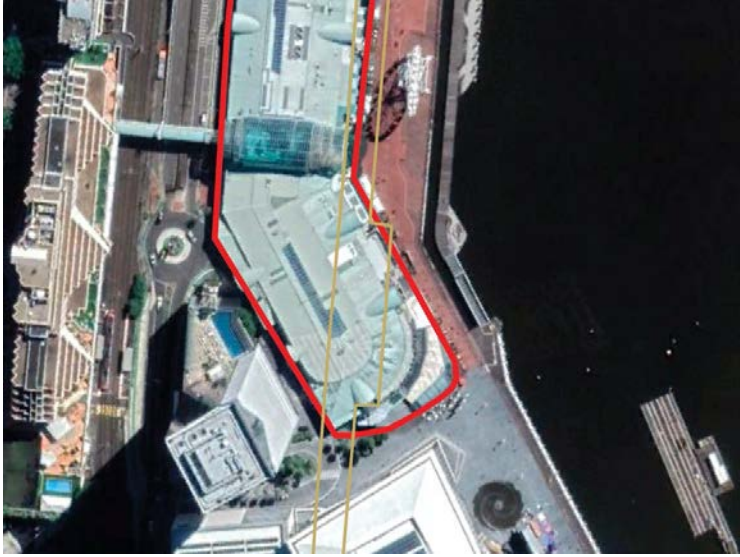
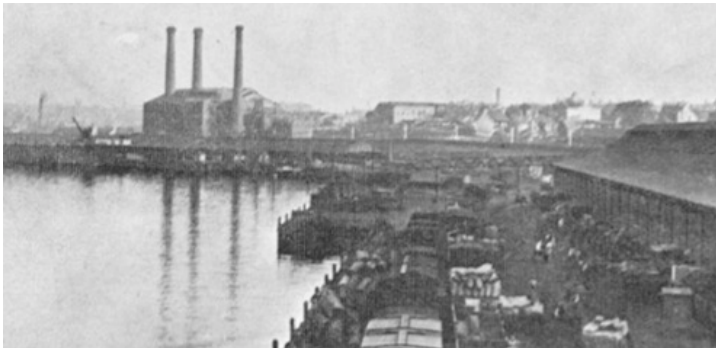
Wharf No.	History and Description	Outline Overlay and Historic Images
<p>Wharf 48 ca. early 1890s – mid/late 1920s</p>	<p>Wharf 48 was constructed in the early 1890s as part of the extension of the Darling Harbour railway to the new Government wharves in Pyrmont Bay and the associated expansion of the Darling Harbour railway goods yard. Wharf 48 was an open wharf, built of timber piles and decking, and ran parallel to the shoreline effectively forming an extension of Wharf 49 (see above).</p> <p>Wharf 48 was absorbed into the widening of Wharf 49 in ca. 1908-1911 and subsequently buried in the Railway Departments reclamation of the head of Darling Harbour during the mid to late 1920s. No previous structures have been identified within the footprint of Wharf 48.</p>

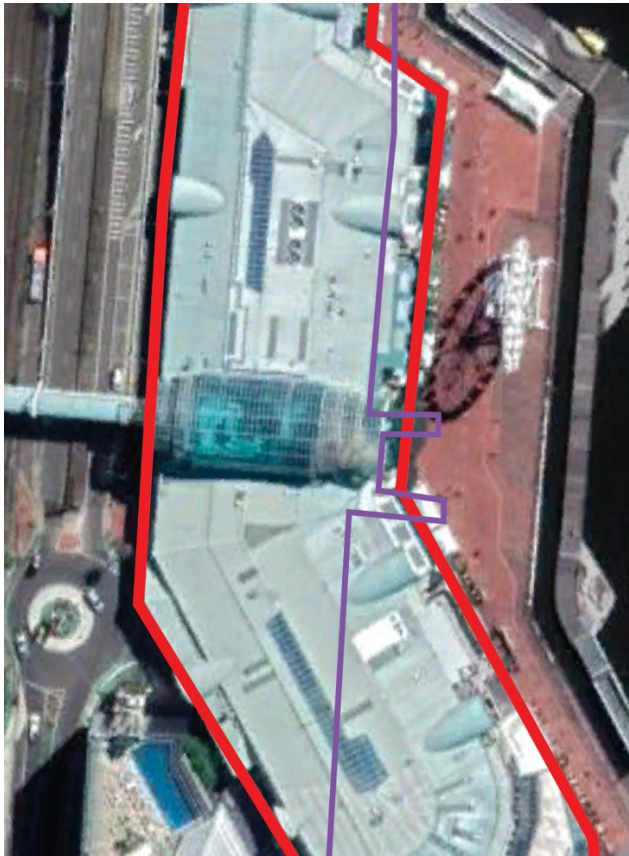
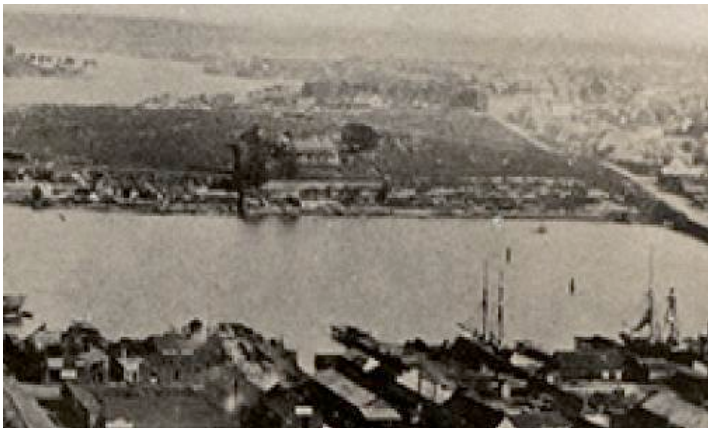
Wharf No.	History and Description	Outline Overlay and Historic Images
<p>Former Railway Wharves ca. early/mid 1870s – early 1890s</p>	<p>The former Railway Wharves were constructed ca. mid 1870s-mid 1880s on the frontage of reclamation associated with the extension of the Darling Harbour Branch Railway to just south of the Pyrmont Bridge and the establishment of adjacent railway goods yards and the construction of the Iron Wharf to the south.</p> <p>The wharves consisted of two parallel jetties, presumably constructed of timber piles and decking. In the early 1890s, these wharves were either demolished for, or incorporated into, the construction of Wharf 49. No previous structures have been identified within the footprint of the former Railway Wharves.</p>

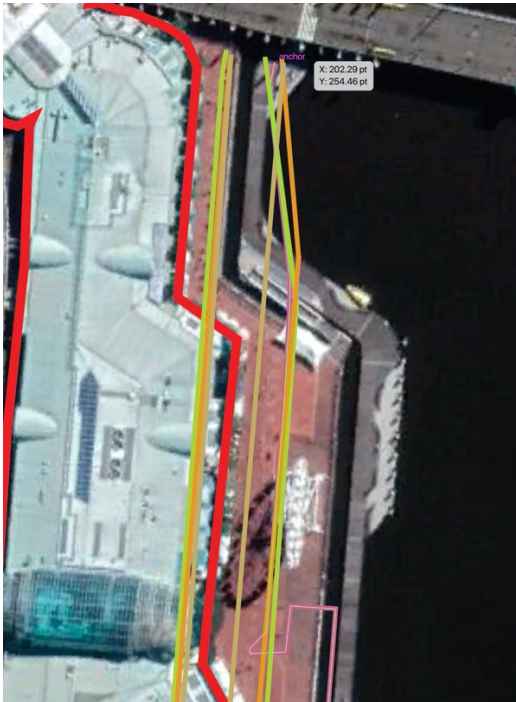
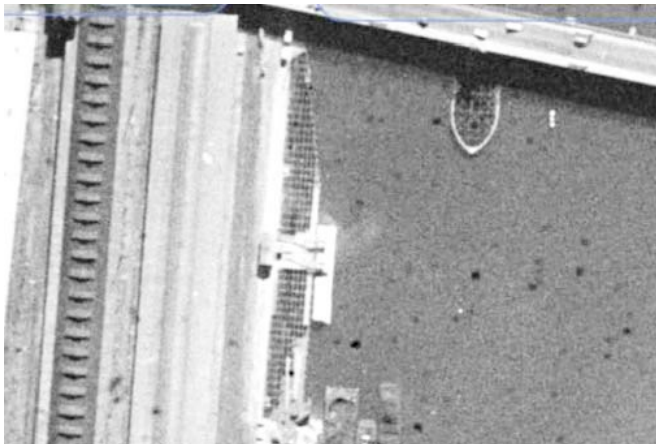
Wharf No.	History and Description	Outline Overlay and Historic Images
<p>Wharf 49 ca. early 1890s – mid 1980s</p>	<p>Wharf 49 was constructed in the early 1890s as part of the extension of the Darling Harbour railway to the new Government wharves in Pyrmont Bay and the associated expansion of the Darling Harbour railway goods yard. Wharf 49 was a long open wharf, constructed of timber piles and decking, built parallel to the shoreline on the frontage of ca. 1870s reclamation. The wharf was widened with the northern end tapered towards shore in ca. 1908-1911 as part of the Sydney Harbour Trust improvements to Darling Harbour. By the late 1920s, the southern portion of Wharf 49 was buried in the Railway Departments reclamation of the head of Darling Harbour, however, the northern portion remained in operation. Wharf 49 was demolished in the mid 1980s during the redevelopment of Cockle Bay by the Darling Harbour Authority, with the southern portion largely buried in reclamation. Previous structures within the footprint of Wharf 49 include the former Railway Wharves.</p>

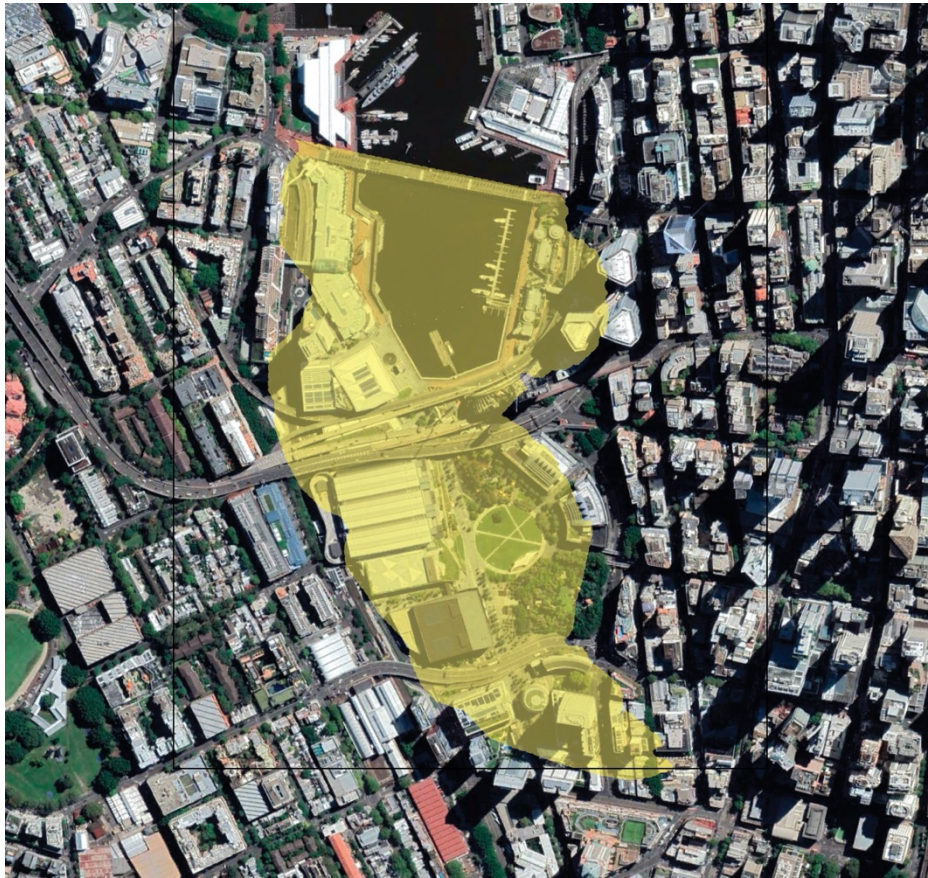
Figure 21: Indicative outline of the extent of Darling Harbour south of the Pyrmont Bridge in the 1820s. Image Source: Google Earth.

During the early years of European colonisation, the head of Darling Harbour extended as far south as Haymarket, reaching almost to Harbour Street and Sussex Street in the east and Pyrmont Street and Murray Street in the west (Figure 21).

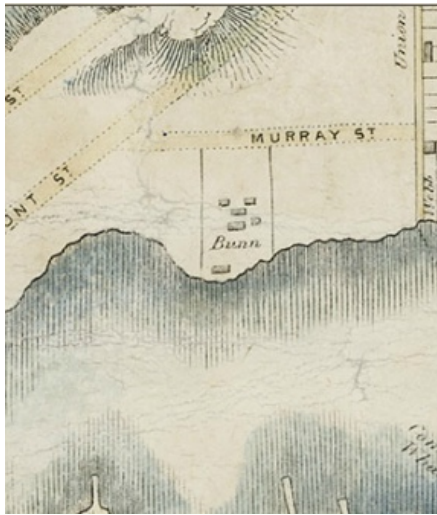
Figure 23: Bunn's property in 1843.

The earliest evidence of reclamation is linked to Captain George Bunn's property, with maps from the 1840s indicating some form of reclamation relating to an easement, which runs from Newstead House to the waterfront (Figure 23 and Figure 24). This feature may have taken the form of a slipway or simple haulage track allowing goods to be brought to the property by sea. It is unknown what materials, if any, were used in its construction. Refer to the Curio HAA for more information about structures relating to Newstead House.⁴¹

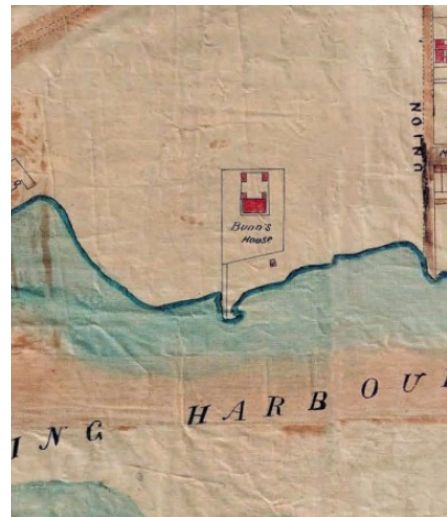
Figure 24: Bunn's property in 1845.

Note some land reclamation is apparent to accommodate the slipway or jetty.
