Client:  
Mirvac

Project:  
Kemps Creek  
Lots 54-58 DP259135 Mamre Road  
Kemps Creek NSW

Drawing Name:  
Tree Canopy Plan

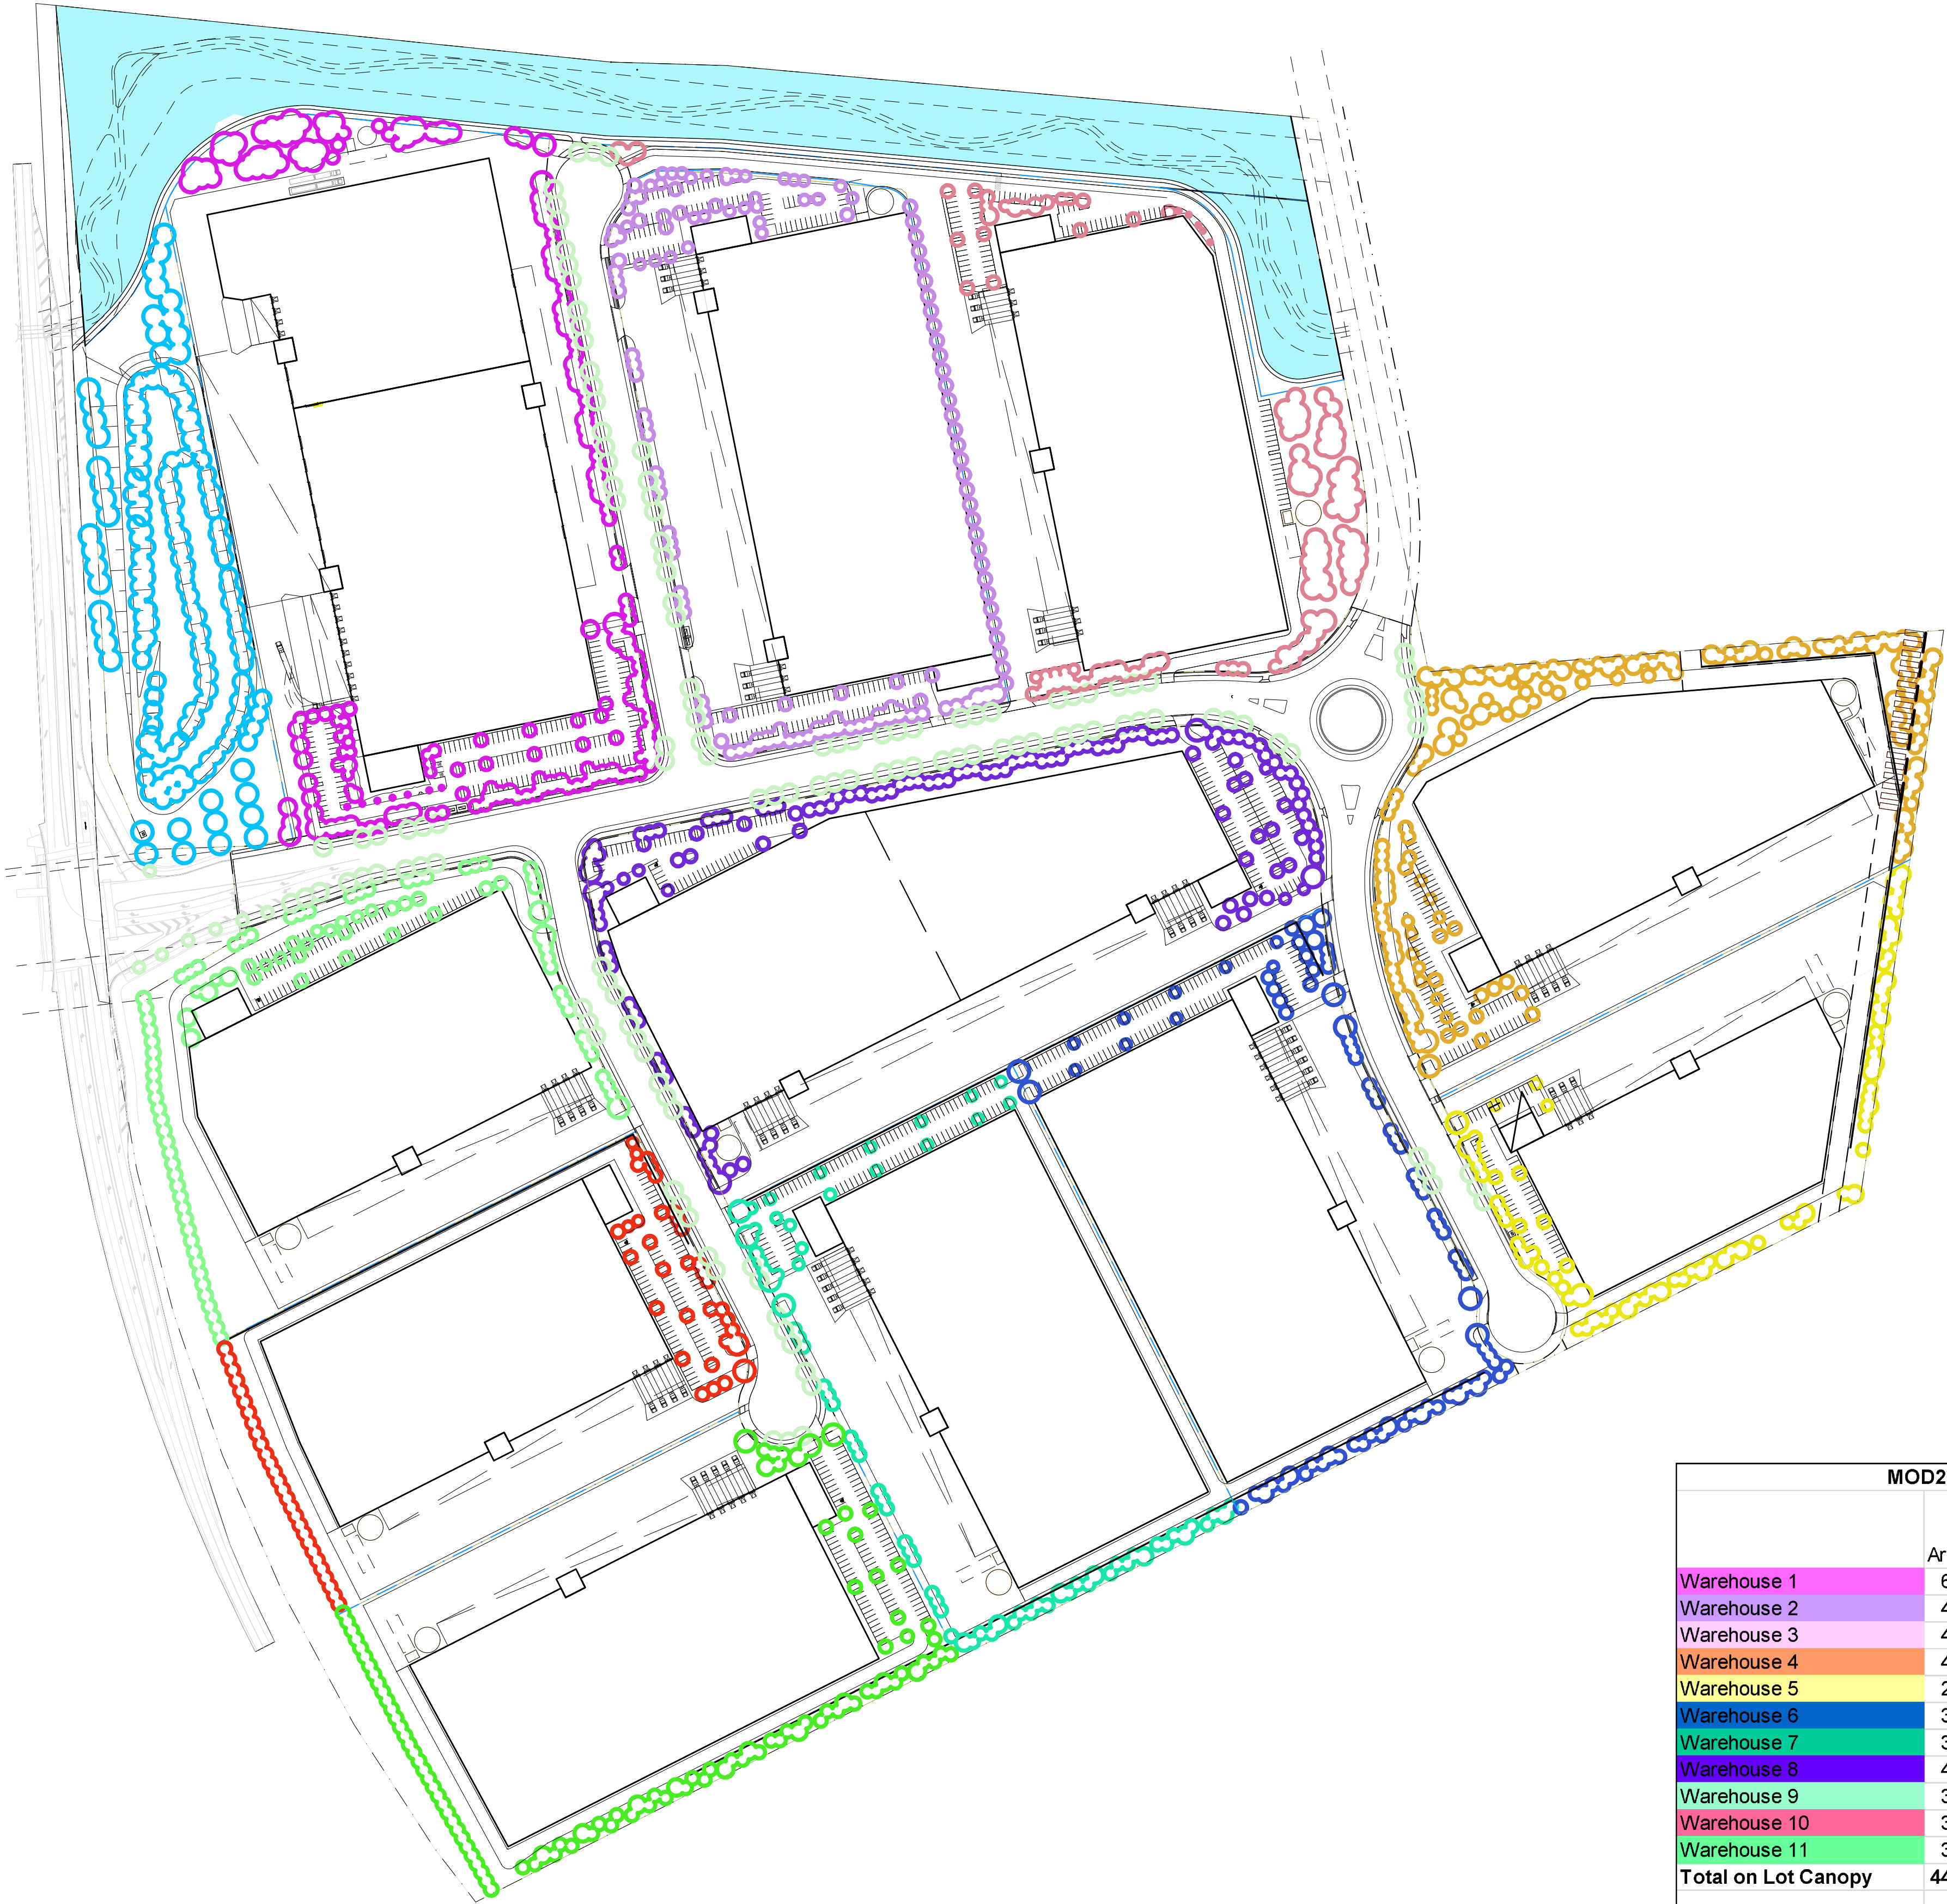
MOD2 CANOPY COVER				
	Area	Required Canopy Cover	Current Canopy Cover	
Warehouse 1	61,039	6,104	5966.4	10%
Warehouse 2	40,172	4,017	3533	9%
Warehouse 3	42,755	4,276	3710.9	9%
Warehouse 4	41,365	4,137	4820.1	12%
Warehouse 5	28,160	2,816	2449.3	9%
Warehouse 6	37,371	3,737	2547.5	7%
Warehouse 7	37,622	3,762	2107.1	6%
Warehouse 8	49,112	4,911	3286.6	7%
Warehouse 9	35,145	3,515	2841.3	8%
Warehouse 10	33,332	3,333	1791	5%
Warehouse 11	38,800	3,880	3091.4	8%
Total on Lot Canopy	444,873	44487.3	36144.6	8.12%
Riparian Zone	33760	3,376	33760	100%
Stormwater Lot	18130	1,813	8143.7	45%
Estate Roads	47523	6488	6613.6	14%
Total Site Canopy Cover	558213	55821.3	84661.9	15%
