## Memo –Management of verge works at Mamre Road, Kemps Creek

<b>Project:</b> AIE	<b>Date:</b> Wednesday, 24 August 2022
<b>Client:</b> Mirvac	<b>Authors:</b> Jonny Love (Heritage Consultant) and Dr Sandra Wallace (Director)

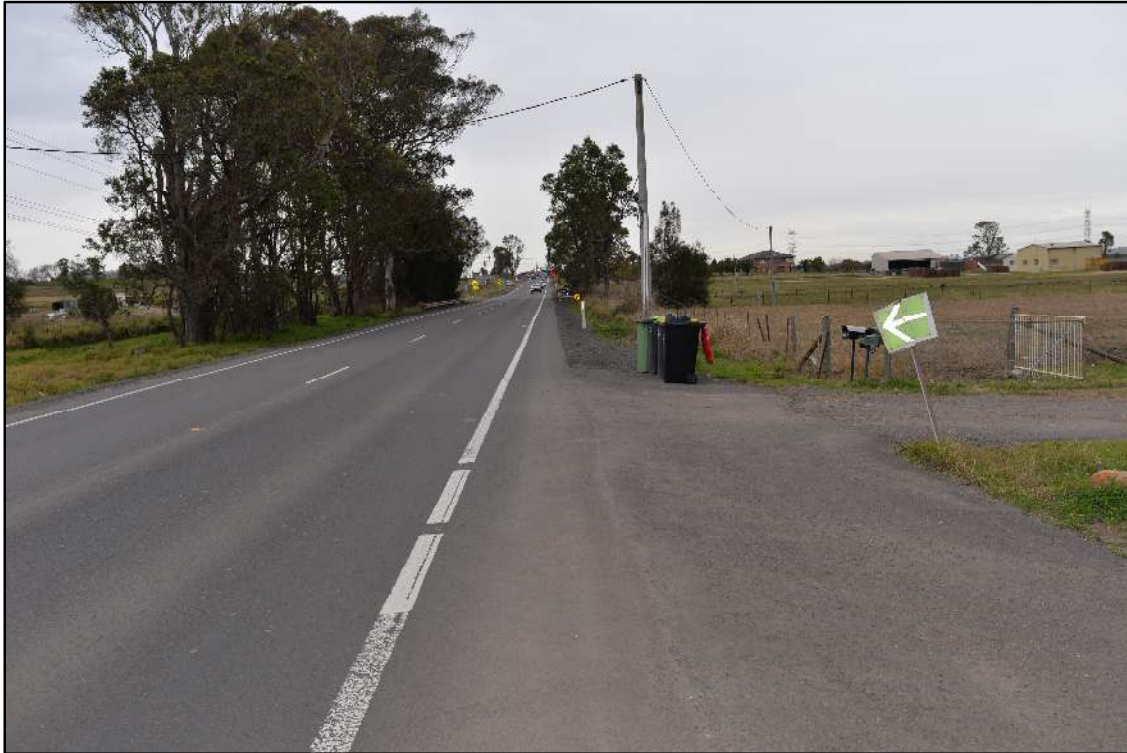
Figure 2: View of western side of Mamre Road (study area) facing south

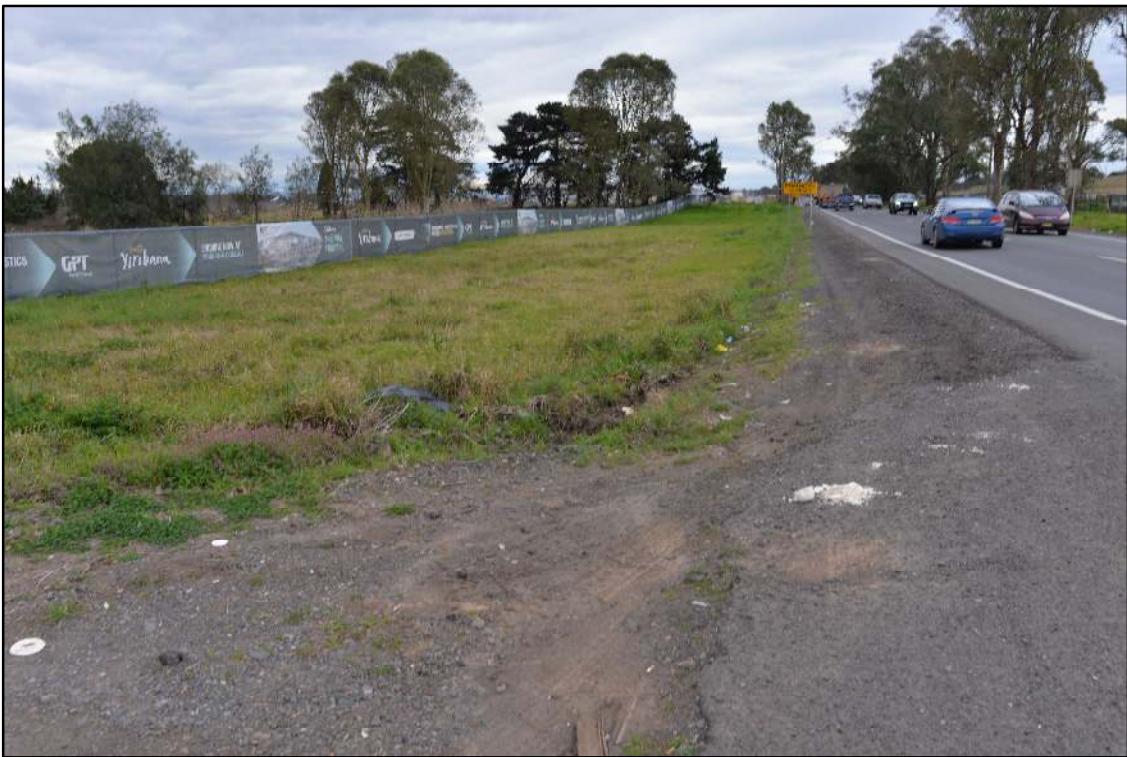
Figure 3 View of western side of Mamre Road (study area) facing north

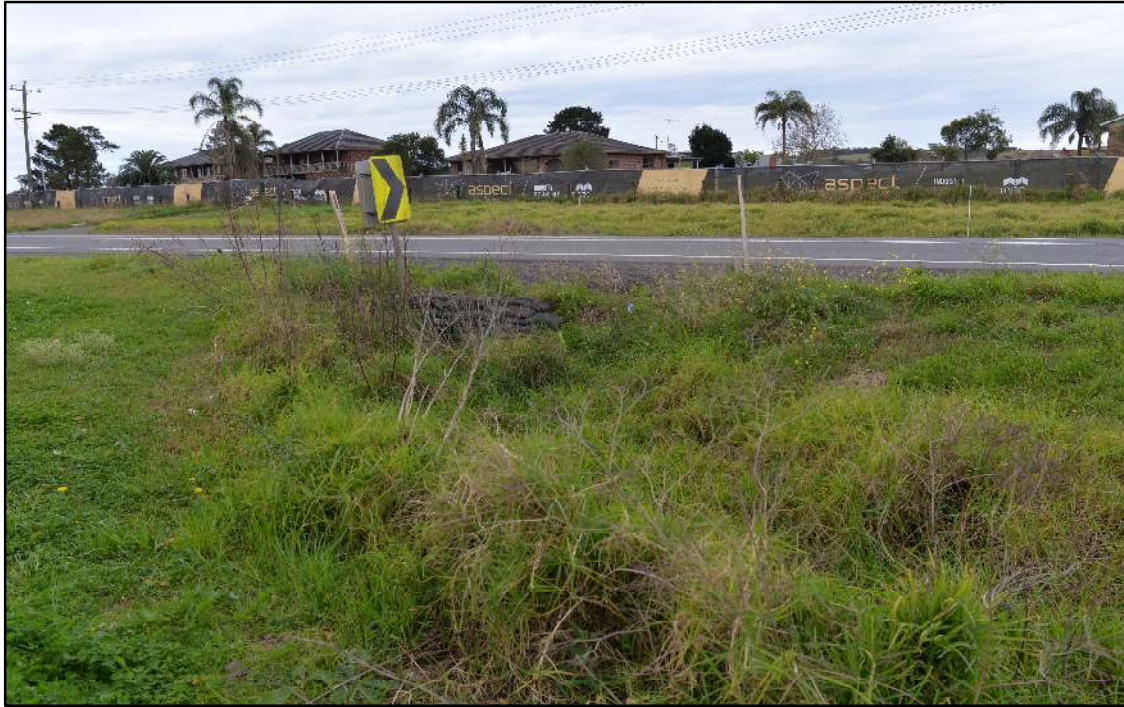
The site visit found that the study area has been subject to extensive earthwork due to road construction activities and service installation. In addition, several ground exposures were present but were found to constitute a variety of imported fill and gravel materials and no artefactual material was identified. The area has largely been cut though the slope to provide a level surface for Mamre Road (Fig. 4).

**Figure 4. View of western side of Mamre Road (study area) facing north-east. This photo provides an example for the ground works and ground exposures that were typical to the study area.**

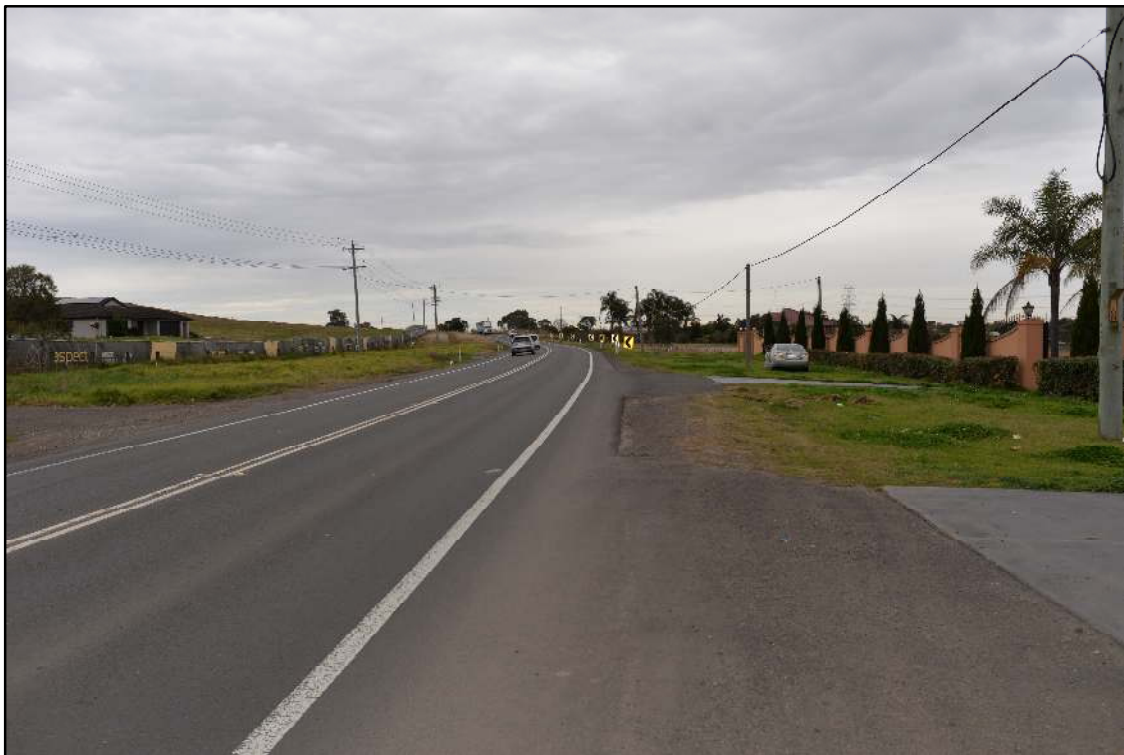
Visibility was limited due to extensive grass coverage and introduced gravels as well as cement driveways (Fig. 5). Vegetation was limited to grasses in the verge and several regrowth native trees. Of note, no evidence of cultural modification (scarring or carving) was observed on these trees. All in all, due to the high disturbance across the study area and the lack of stone artefacts or areas of sensitivity, there is low potential for archaeological deposits to be present.

**Figure 5. View of western side of Mamre Road (study area) facing south. This photo provides an example of cement driveways that were typical to the study area.**
