# Southwest Metro Corridor & BAC – Construction Heritage Management Plan

SMCSWSSJ-JHL-WEC-EM-PLN-000013

| Document Details | |
|---|---|
| Title | Construction Heritage Management Plan |

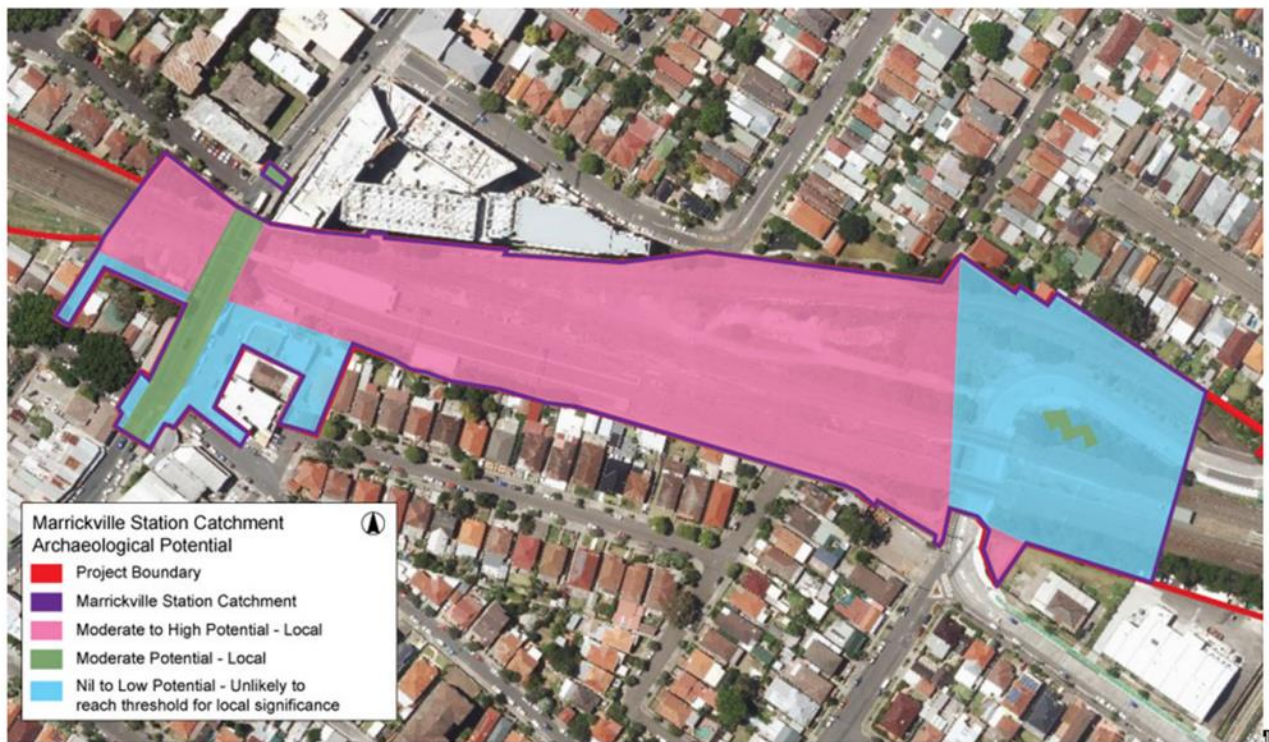
**Figure 4-16: Archaeological potential at Marrickville Station**

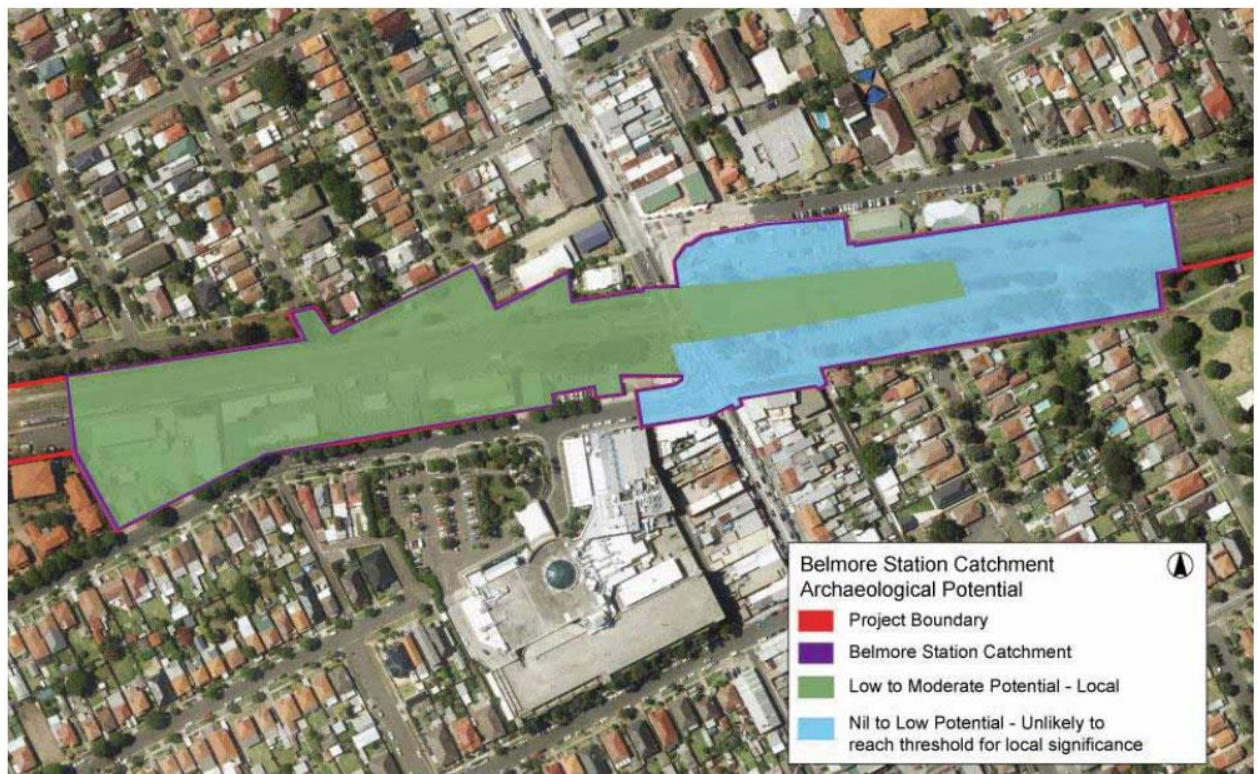
Figure 4-18: Archaeological potential at Belmore Station

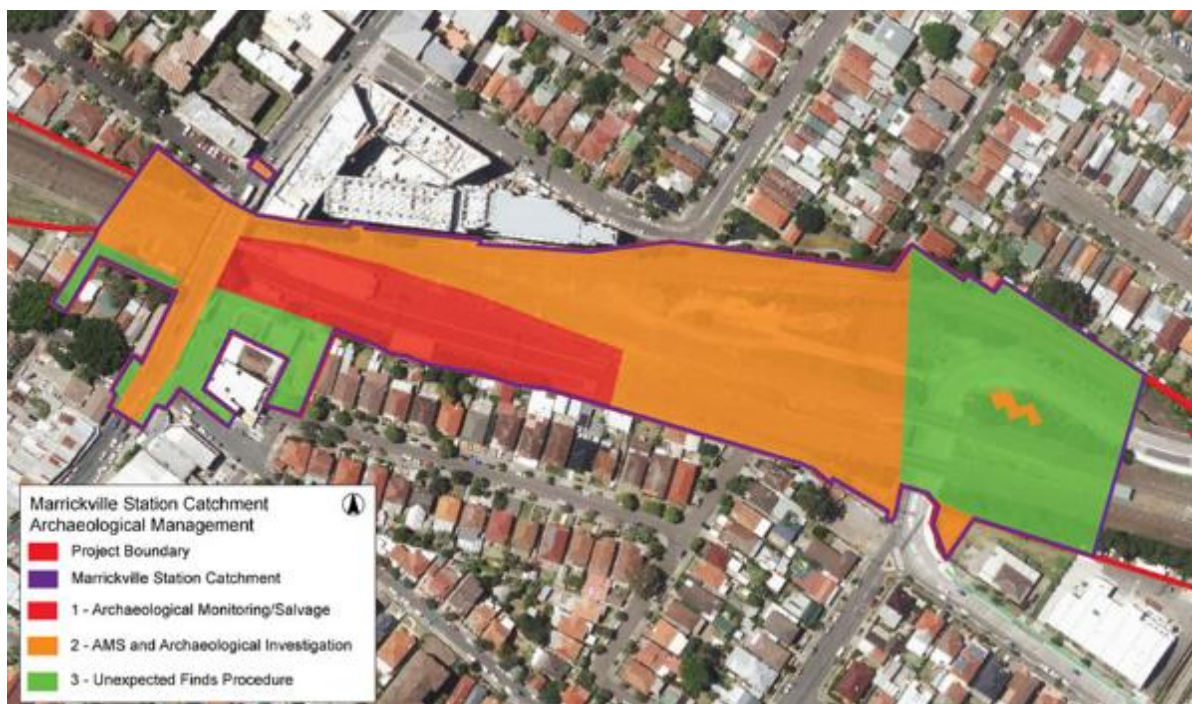
Figure 6-1 Archaeological Management zoning for Marrickville Station (Artefact Heritage 2017c)

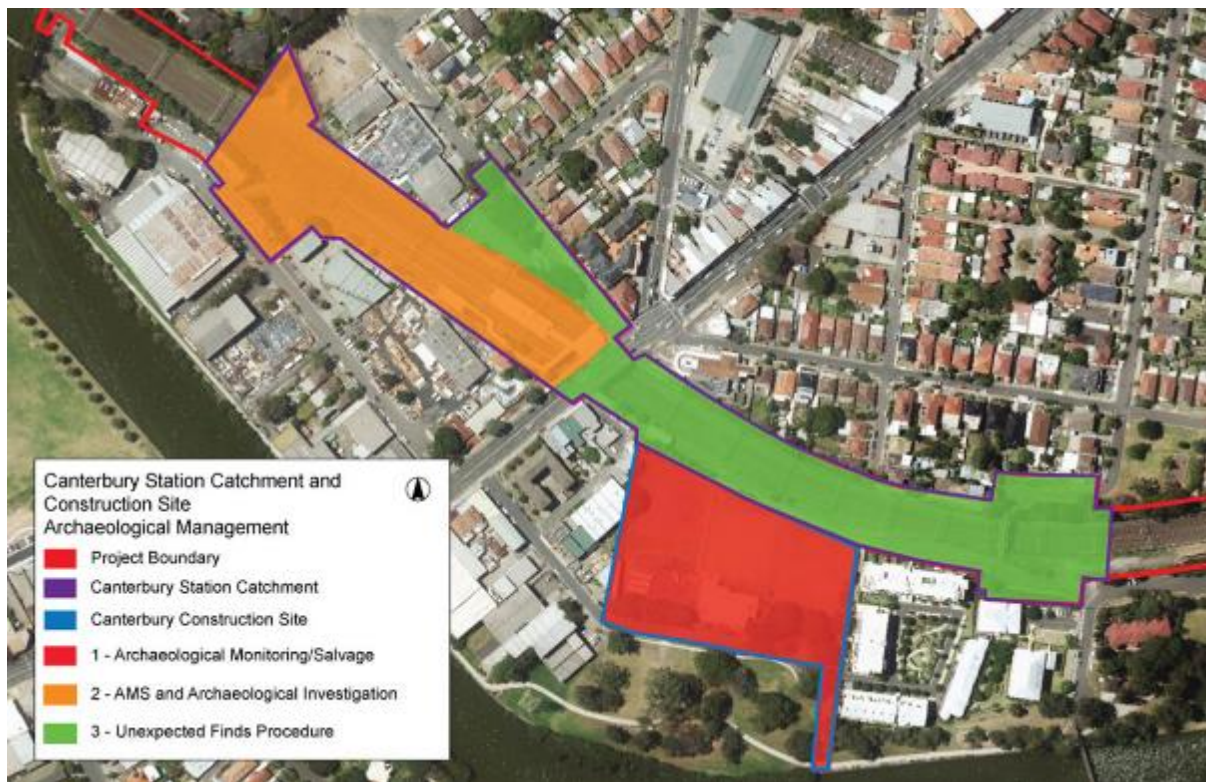
Figure 6-2 Archaeological Management zoning for Canterbury Station (Artefact Heritage 2017c)

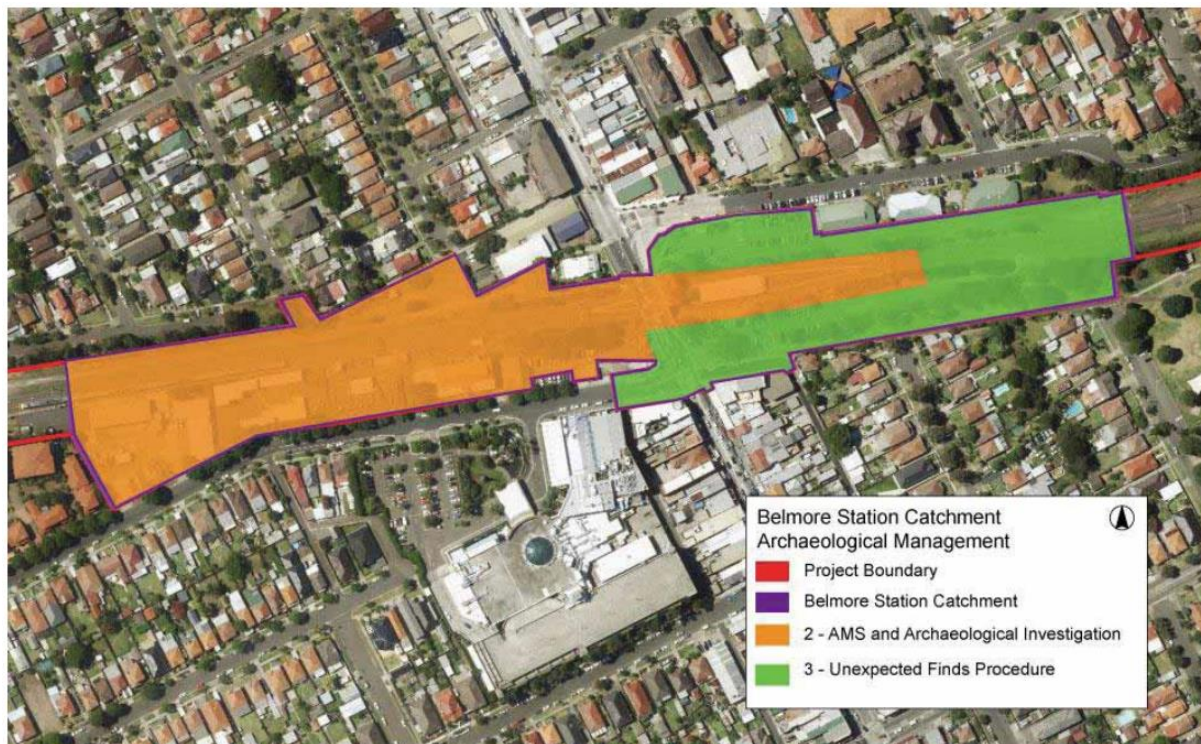
Figure 6-3 Archaeological Management zoning for Belmore Station (Artefact Heritage 2017c)

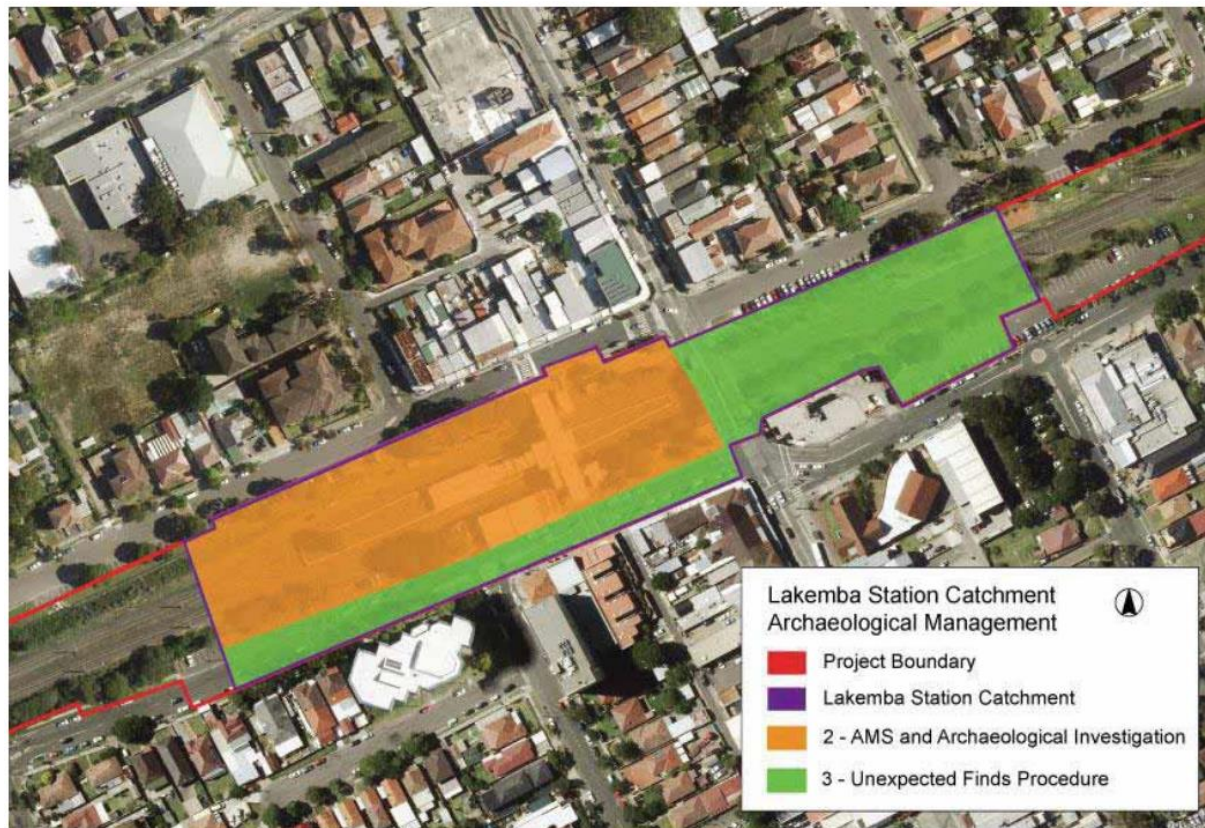
Figure 6-4 Archaeological Management zoning for Lakemba Station (Artefact Heritage 2017c)

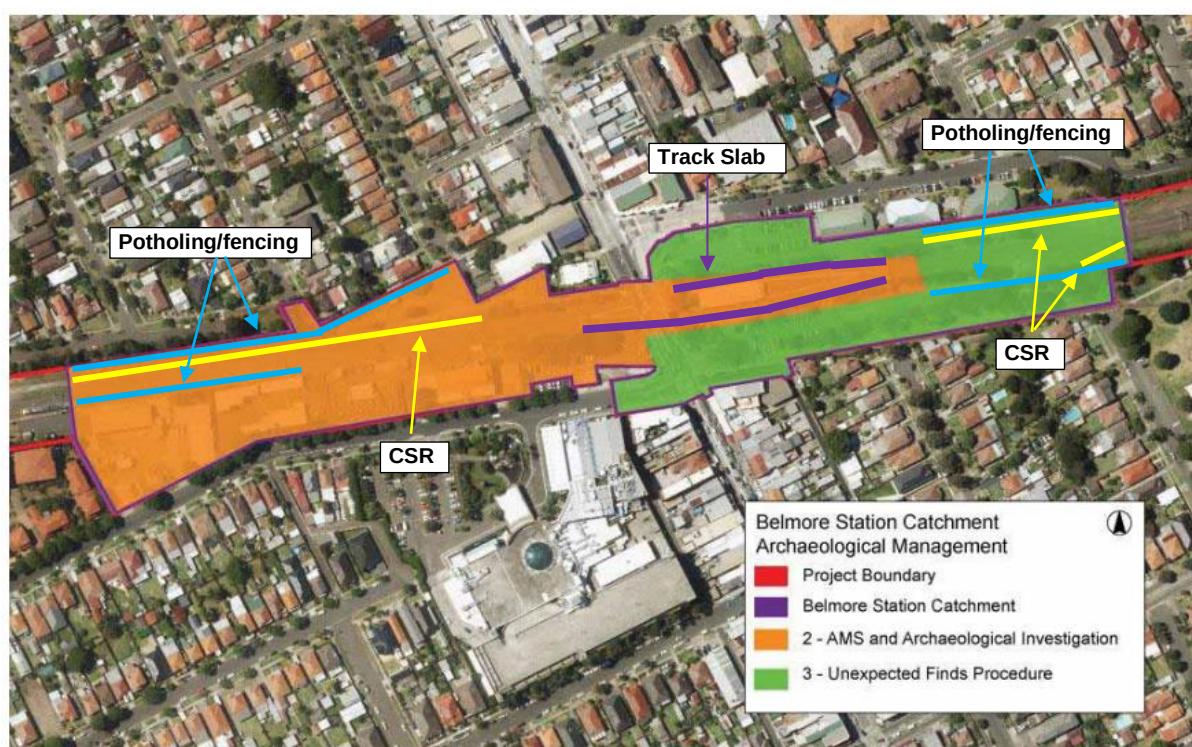
Figure 28: Primary proposed excavation works within Belmore Station

Excavation works within the Belmore Station Catchment will primarily consist of potholing for the installation of fencing, excavations for the installation of CSR along the east and west sides of the catchment, and excavations for the installation of track slabs. The location of these main excavation works proposed within Belmore Station are illustrated in Figure 28. It is noted that these may not be the only excavation works undertaken within the AMZ, however, at the time of the preparation of this HIA the exact location of other proposed excavation works is not confirmed.

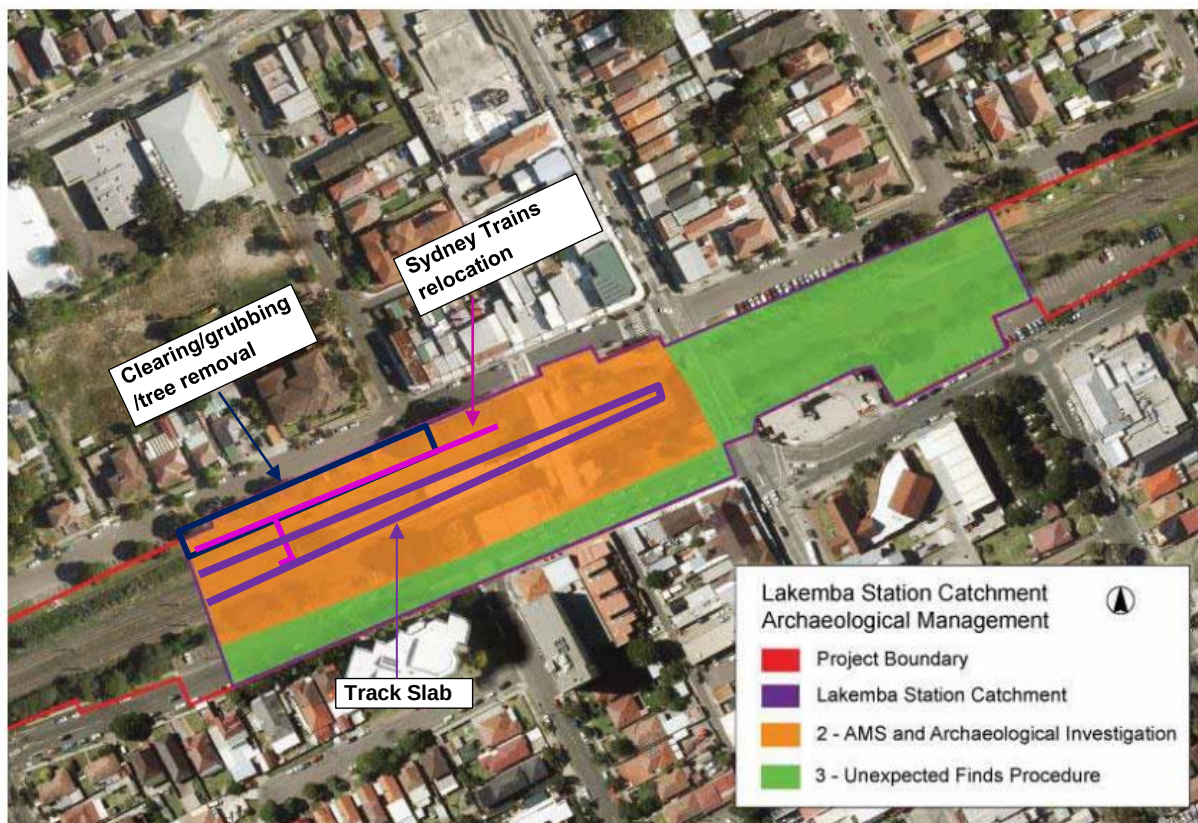
**Figure 29: Primary proposed excavation works within Lakemba Station**

Excavation works within the Lakemba Station Catchment will consist of the removal of existing underground Sydney Trains GLT, clearing and grubbing associated with the removal of trees along the north-west side of the catchment and between the tracks, and excavation works for the installation of track slabs. The location of these main excavation works proposed within Lakemba Station are illustrated in Figure 29. It is noted that these may not be the only excavation works undertaken within the AMZ, however, at the time of the preparation of this HIA the exact location of other proposed excavation works is not confirmed.
