Tomingley Gold Extension Project  
(SSD-9176045)  
Erosional Stability Assessment

FINAL REPORT

Tomingley Gold Wyoming 1 pit (August 2022)

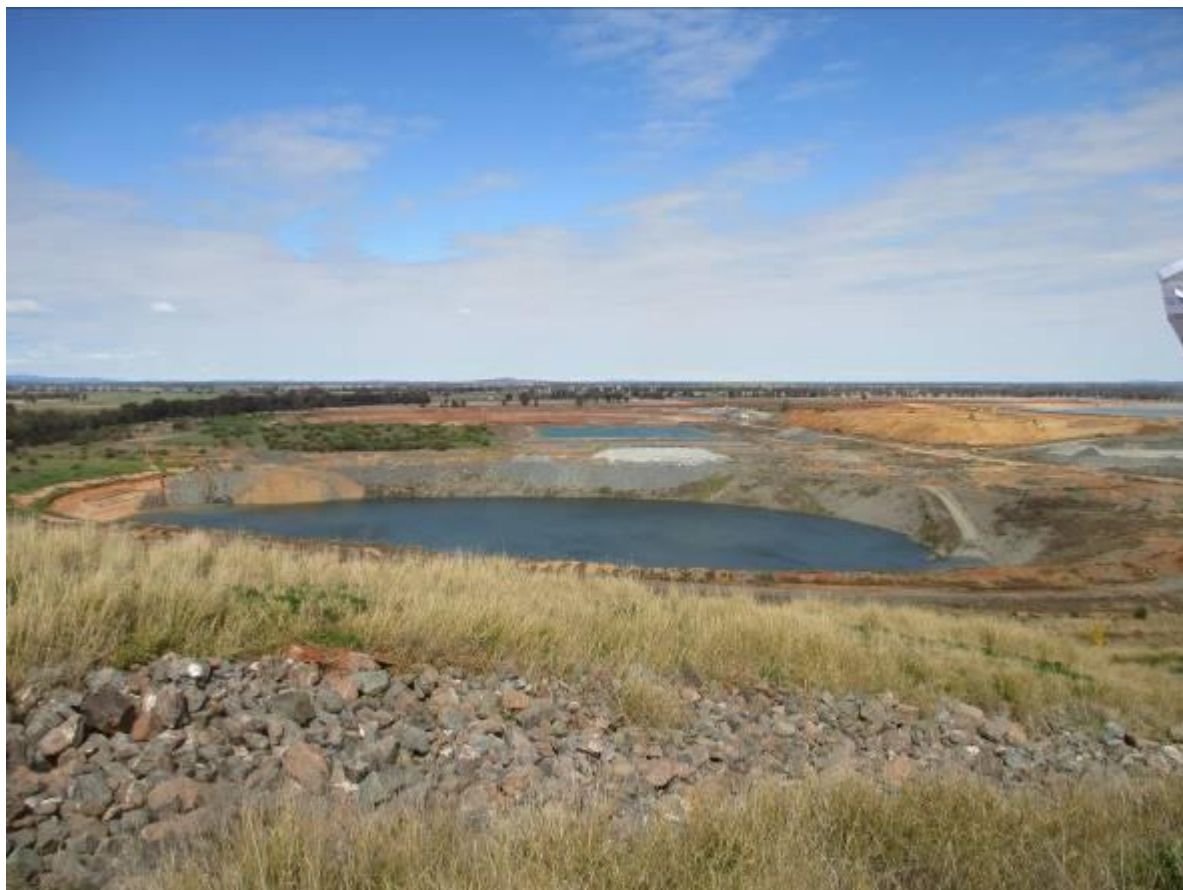
Figure 1: Wyoming 3 Open Cut as viewed from Waste Rock Emplacement 2

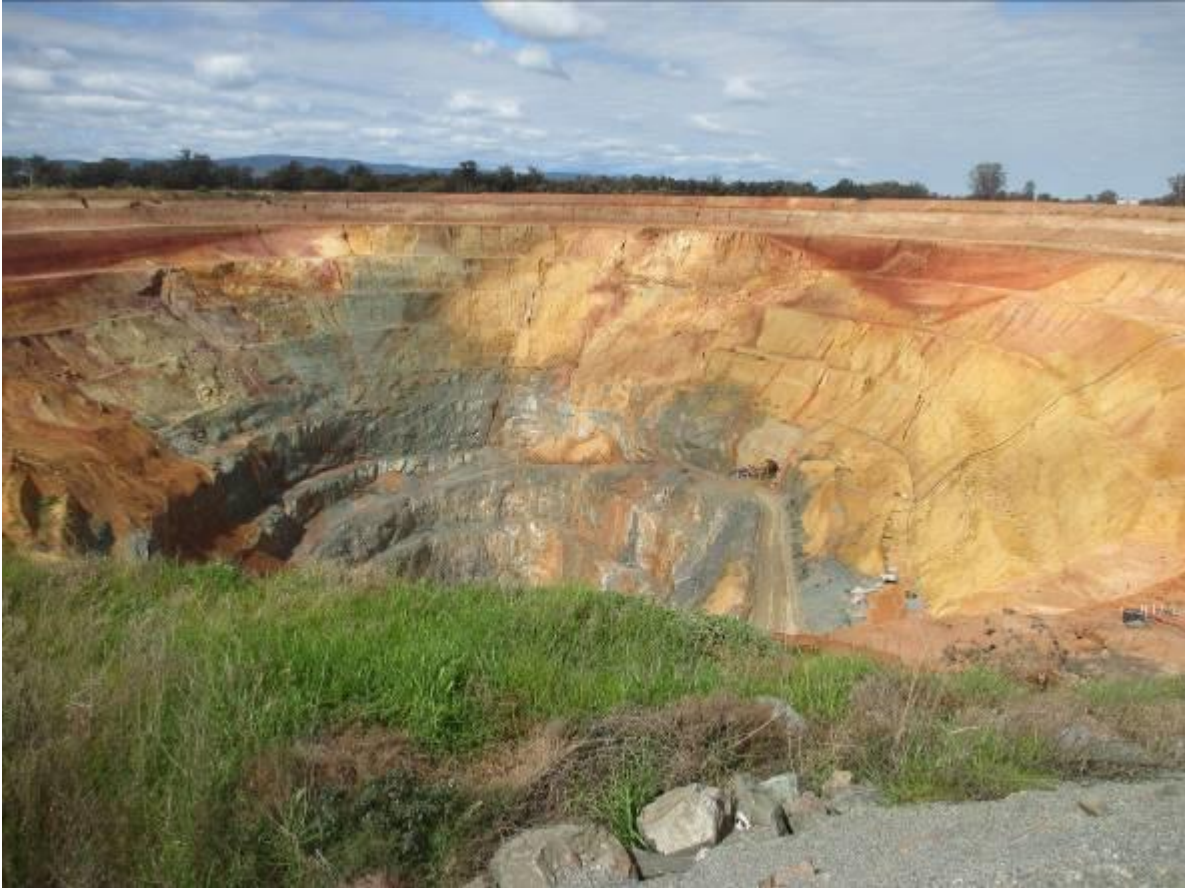
AMC (2021) report that the slopes within the saprolite and weathered rock horizon have stability concerns both at bench scale and wall scale. Aquaterra's site visit on 22-08-2022 demonstrated this (Figures 2 to 4). This was also noted and described in the document WSP Australia 2018. Localised collapse in the saprolite was typically attributed to relict geological structure (WSP, 2018). It was inferred that rainfall and surface water also played a major part in the initial collapse and ongoing slumping and erosion in some areas of the pit slopes.

Incidences of tunnel erosion were observed in the Wyoming 1 pit (Figures 2 and 3). These typically form with inlets on berms and outlets on the batter. As erosion continues these tunnels can collapse and form gullies. A feature of this site is the multiple tunnels and resultant gullies at all bench levels in both the alluvium and saprolite. Tunnels and gullies were also present on the surface (Figures 3 to 6).

Figure 2: Wyoming 1 Open Cut looking east. Underground access portal can be viewed in the middle to the right of the image. Structure and fabric of the walls can be observed with mass failures on the opposite side.

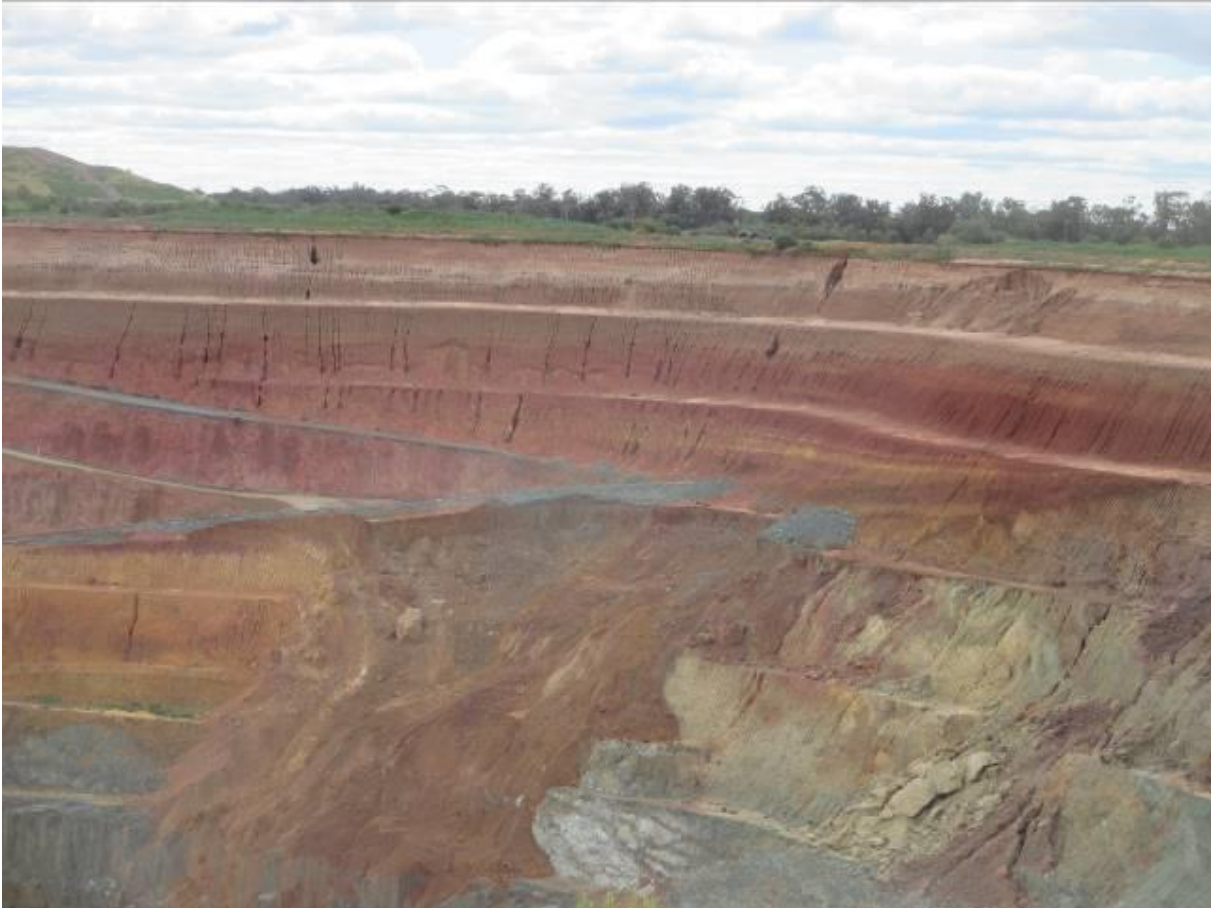
Figure 3: Wyoming 1 Open Cut looking north-west. A large mass failure (centre), and a smaller failure (right) can be observed. Tunnels from tunnel erosion and gullies can be observed in both alluvium and saprolite.

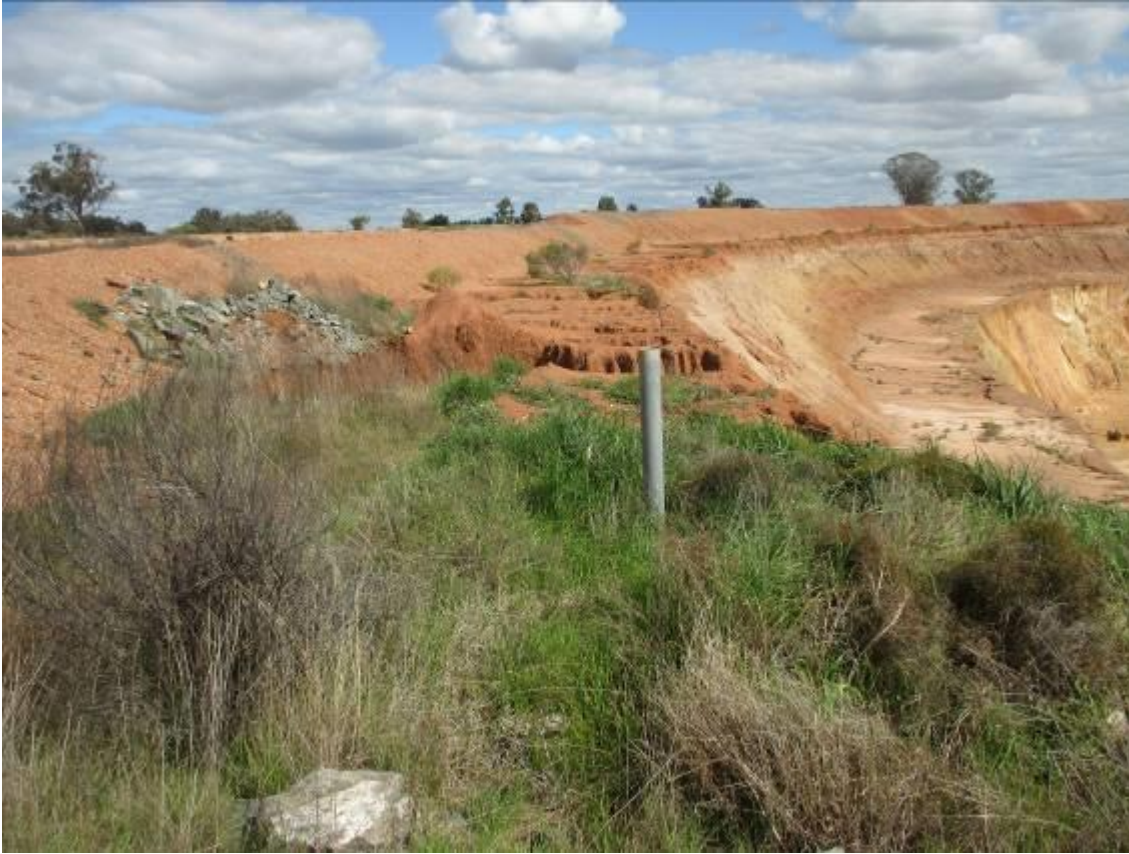
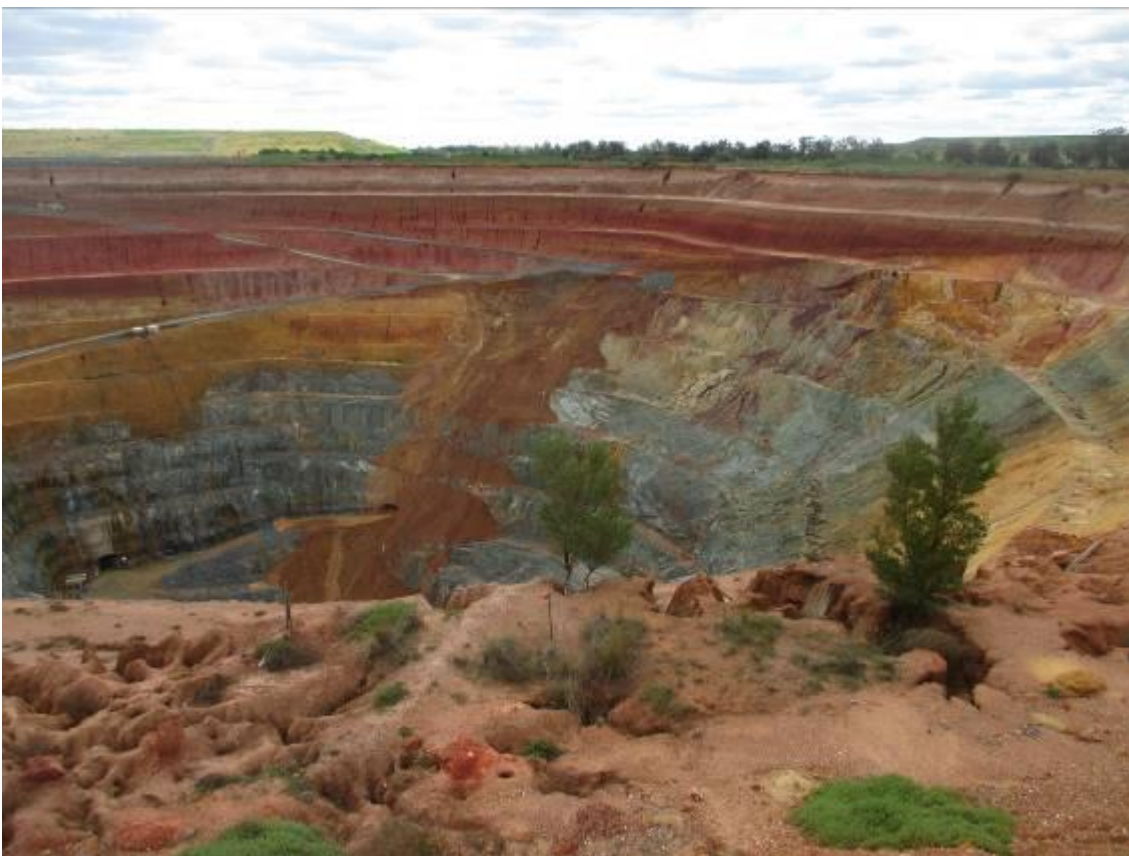
Figure 4: Wyoming 1 Open Cut looking south (top) and north-west (bottom). Gully erosion can be observed on the edge of the pit demonstrating the high erodibility of the materials

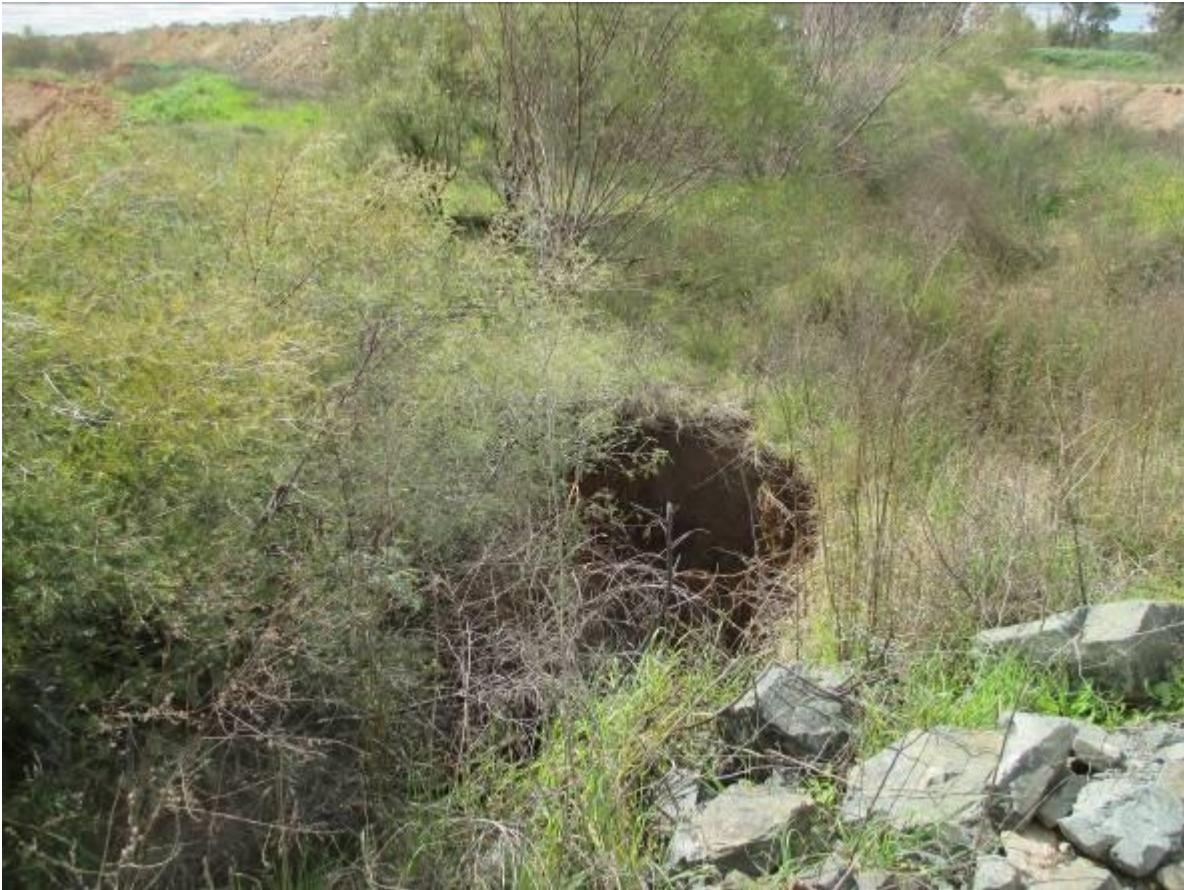
Figure 5: Wyoming 1 Open Cut looking north. Image displays a large gully with vertical sides and headcut.

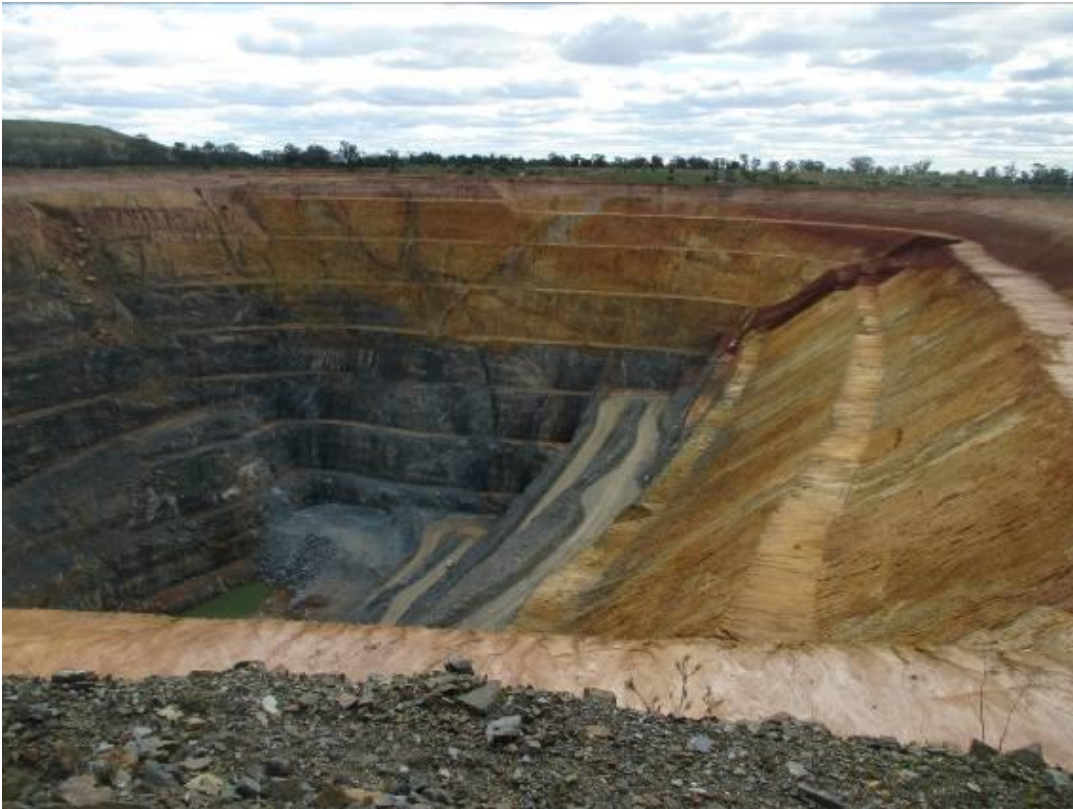
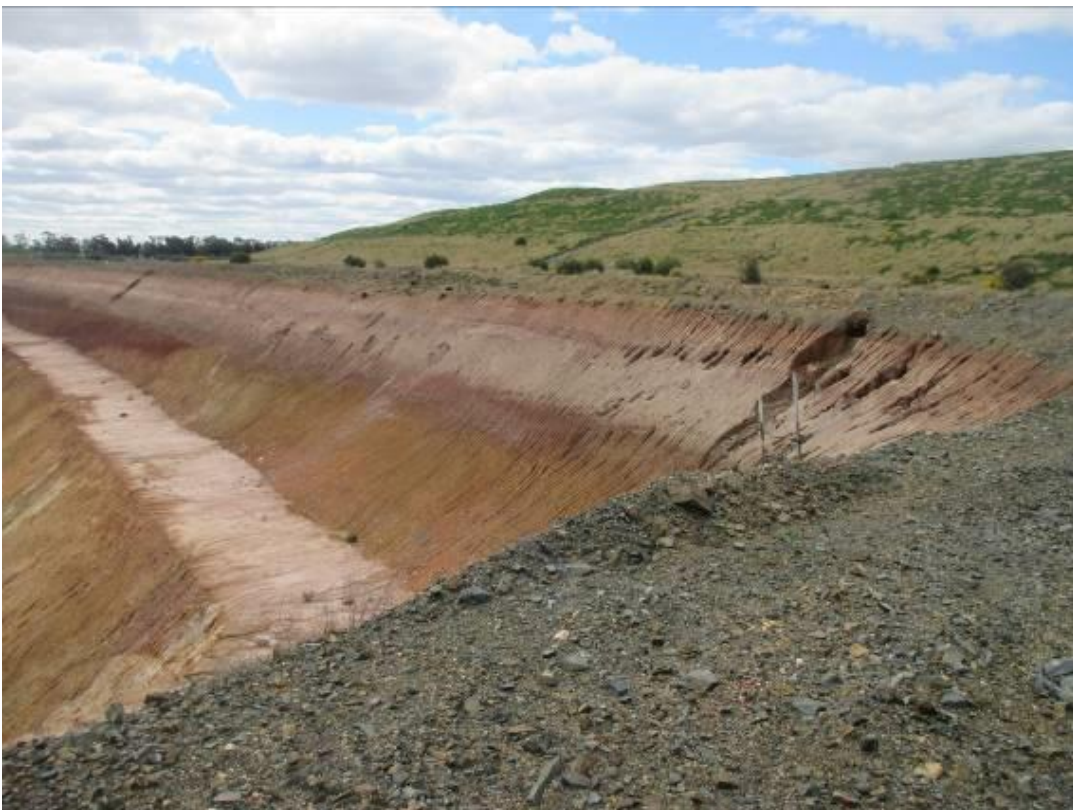
Figure 6: Caloma 1 Open Cut looking north-west (top) displaying structure and failures (top). Image displays a large gully with vertical sides and headcut. Bottom image (looking north) displays tunnel and gully erosion in the surface material. Of note is the tunnel through the bund.

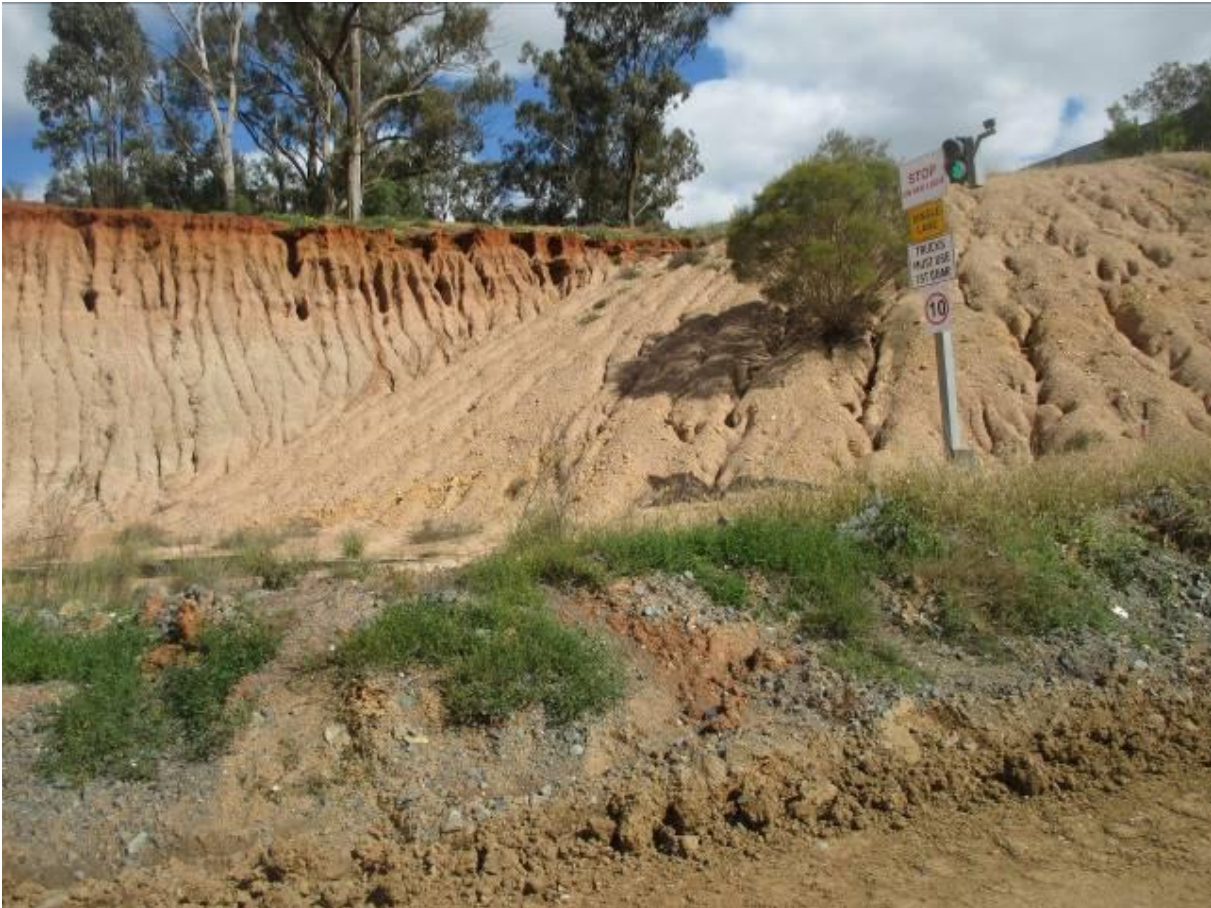
Tomingley Gold Extension Project Land and Soil Capability Assessment Major Project Application No. PA 09\_0155. Part 7a (2021) (Table 8.1) in assessing land capability found that all soils present were either moderately or highly erodible. This finding is supported by observation during the site visit (Figure 7).

Figure 7: Cutting through natural material on southern side of mine road passing under the Newell Highway. Tunnel and rill erosion can be observed in the natural material on the left while large rills can be observed on the fill material (right) used as an abutment for the bridge.
