# Cockle Bay Park Redevelopment

## Maritime Archaeology Statement of Heritage Impact

Darling Harbour  
Sydney  
NSW

March 2023

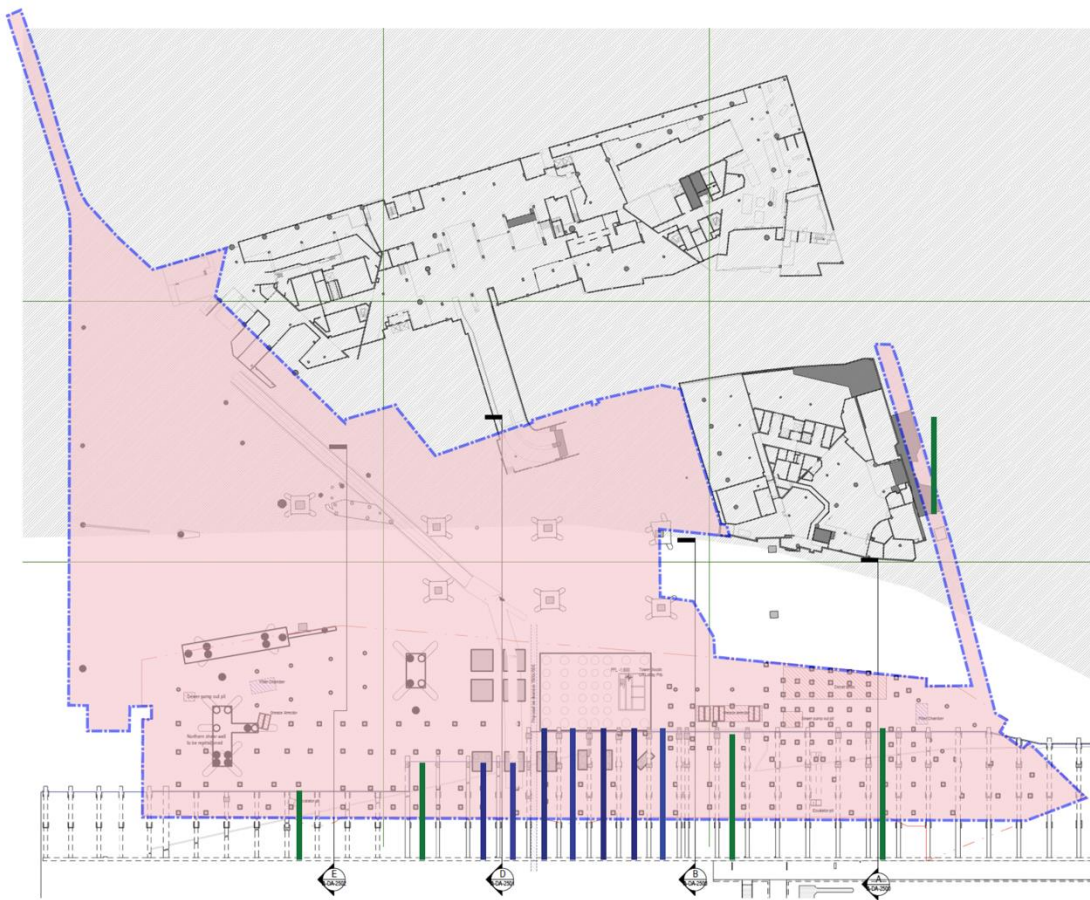
**Figure 47: Overlay of transects onto proposed piling plan.** Blue indicates transect locations in primary area of survey and green represents transects undertaken to fill in the gaps from the survey from the 2017 site inspection.

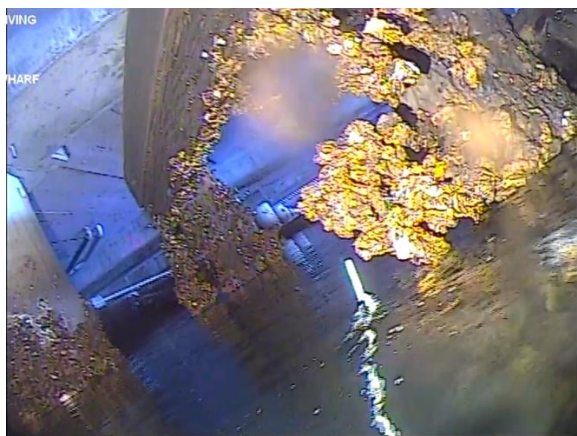
**Figure 58: Timber stormwater baffle; 'D' pile to the left of image.** Note large hole in net and missing timbers from baffle. (Image from T2 (a) Cockle Bay 210705, 03:57).

The diver started on the southern side of the bent working towards the east (Figure 56). The seabed was a relatively flat, silty bottom, and no cultural material was noted until near the 'D' pile. The rubbish net was visible in this location and just behind the net was a timber stormwater baffle (Figure 57). This structure consisted of two timber piles approximately 360 mm in diameter and 4 m tall (Figure 58). These piles were 3 m apart. Attached crossways to the piles were 8 planks measuring 100 mm thick x 300 mm wide and 3 m long (Figure 59). It appears that there were once 11 planks. This structure is in line with the stormwater drain at the eastern end of the bay. The drain appears to be held up by a concrete plinth that sits in the rock batter. There was a build-up of timber and sediment underneath the rubbish net and surrounding the timber baffle (Figure 60).

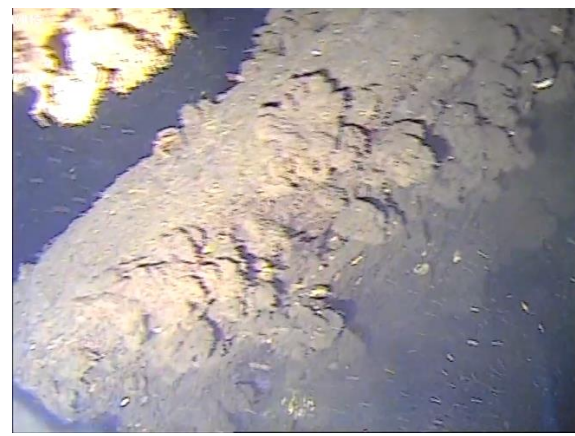
**Figure 59: Example of timber planking for stormwater baffle.** (Image from T2 (a) Cockle Bay 210705), 04:37).

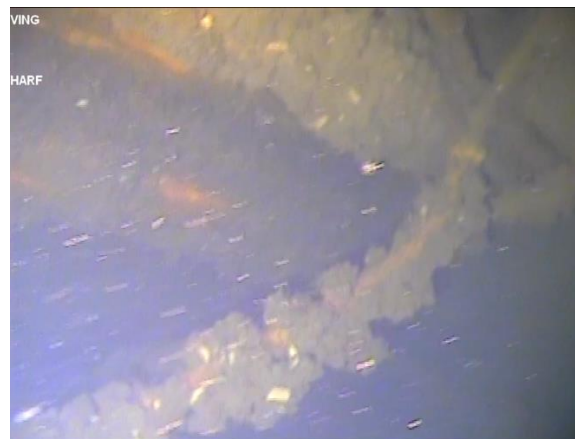
**Figure 69: Sheet piling in background with loose ferrous piping in the foreground.** (Image from T3 (a) Cockle Bay 210705, 07:38).

The rubbish net angled behind the northern 'D' pile and ended at the seawall in the next bent (Figure 67). Sheet piling began in the centre of this bent (Figure 68). At the base of the sheet pile and as the diver moved to the northern 'D' pile, there were pieces of scattered ferrous piping lying loose on top of the rock batter.

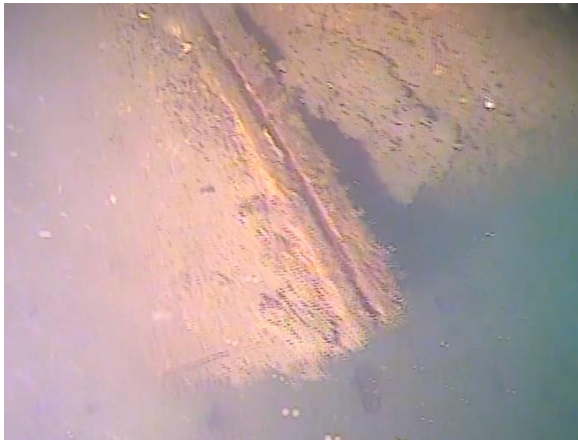
**Figure 80: Sandwich or menu board resting against southern 'A' pile.** (Image from T6 (a) Cockle Bay 210705; 00:36).

The diver started on the southern side of the bent working towards the east. Again, the seabed was silty and relatively flat. Leaning against the southern 'A' pile was what appeared to be a sandwich board or restaurant sign made of aluminium and ply, potentially from one of the restaurants in Cockle Bay (Figure 80). Immediately to the north of the sandwich board was a degraded timber. The timber stood upright 500 mm and was 120 mm in diameter (Figure 81). It did not appear to be a driven pile as the diver was able to push the timber over.

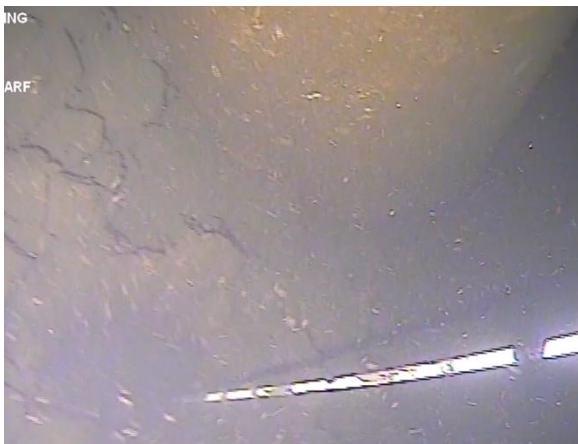
**Figure 82: The rock batter is exposed at the 'C' pile.** (Image from T6 (a) Cockle Bay 210705; 04:10).

Approximately 1 m west of the southern 'C' pile, the seabed began to rise at an angle, before the rock batter started at the base of the 'C' pile (Figure 82). In the centre of the bent, adjacent to the 'C' pile, there was a 3 m section of 150 mm diameter PVC pipe running east to west. Underneath the pipe there was a 5 m section of encrusted ferrous pipe, like that seen in the previous transects. There was a large bend at one end of the pipe, both pipes were sitting loose on top of the rock batter (Figure 83).

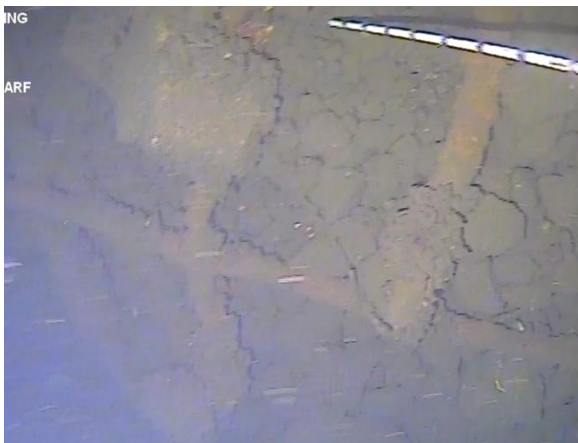
**Figure 84: Near the sheet piling there was a number of loose ferrous pipes lying on top of the rock batter.** (Image from T6 (a) Cockle Bay 210705; 05:57).

At the base of the sheet pile wall, the steep rock batter consisted of 100 – 200 mm rocks with construction debris lying loose on top (Figure 84). Both the northern and southern 'D' piles were out of the water behind the sheet pile wall.

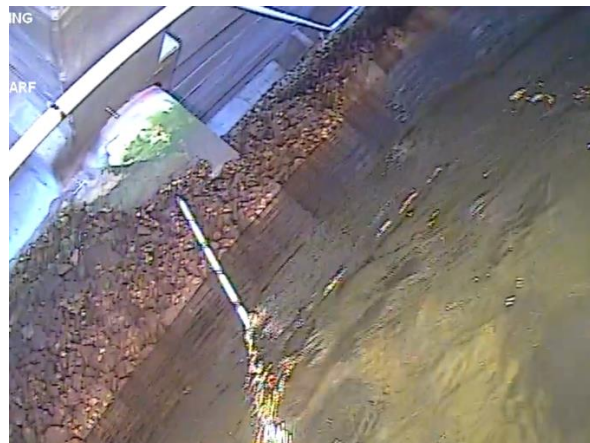
**Figure 85: Southern 'D' pile is out of the water behind the sheet piling wall.** (Image from T6 (a) Cockle Bay 210705).

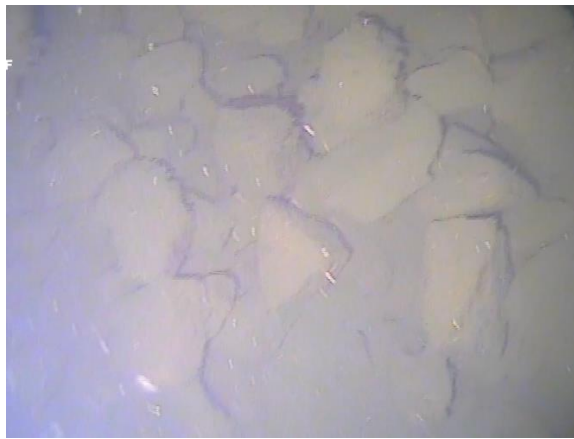
**Figure 86: Rock batter emerging from the sediment to the east of the 'B' pile.** (Image from T7 (b) Cockle Bay 210705; 01:12).

The diver started on the southern side of the bent working towards the east. Again, the seabed was silty and relatively flat. The seabed starts to rise just to the east of 'B' pile and the rock batter starts to emerge from the silty sediment (Figure 86). There were some larger rocks within this batter up to 800 mm and the batter itself was less than 45°. No cultural material was noted other than modern rubbish.

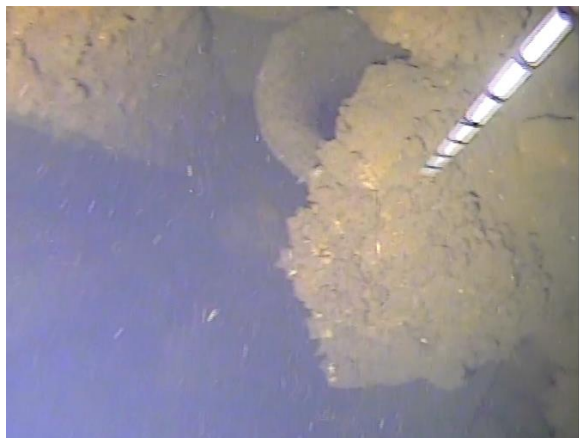
**Figure 90: Degraded and hollowed out timber pile northeast end of transect 7.** (Image from T7 (b) Cockle Bay 210705; 03:56).

Just behind the northern 'C' pile, immediately in front of the sheet pile wall, a horizontal and a vertical timber pile were located underneath a section of concrete and other construction debris such as ferrous pipes. The diver could not get underneath the concrete section as it was not stable, so measurements of the piles are approximate. The vertical timber pile is resting directly in front (west) of the upright pile. It is heavily degraded, 700 mm diameter and 4 m long (Figure 89). The upright pile is heavily degraded, hollow in the centre and has a slightly smaller diameter of 500 mm and is standing out of the rock batter 2 m (Figure 90).

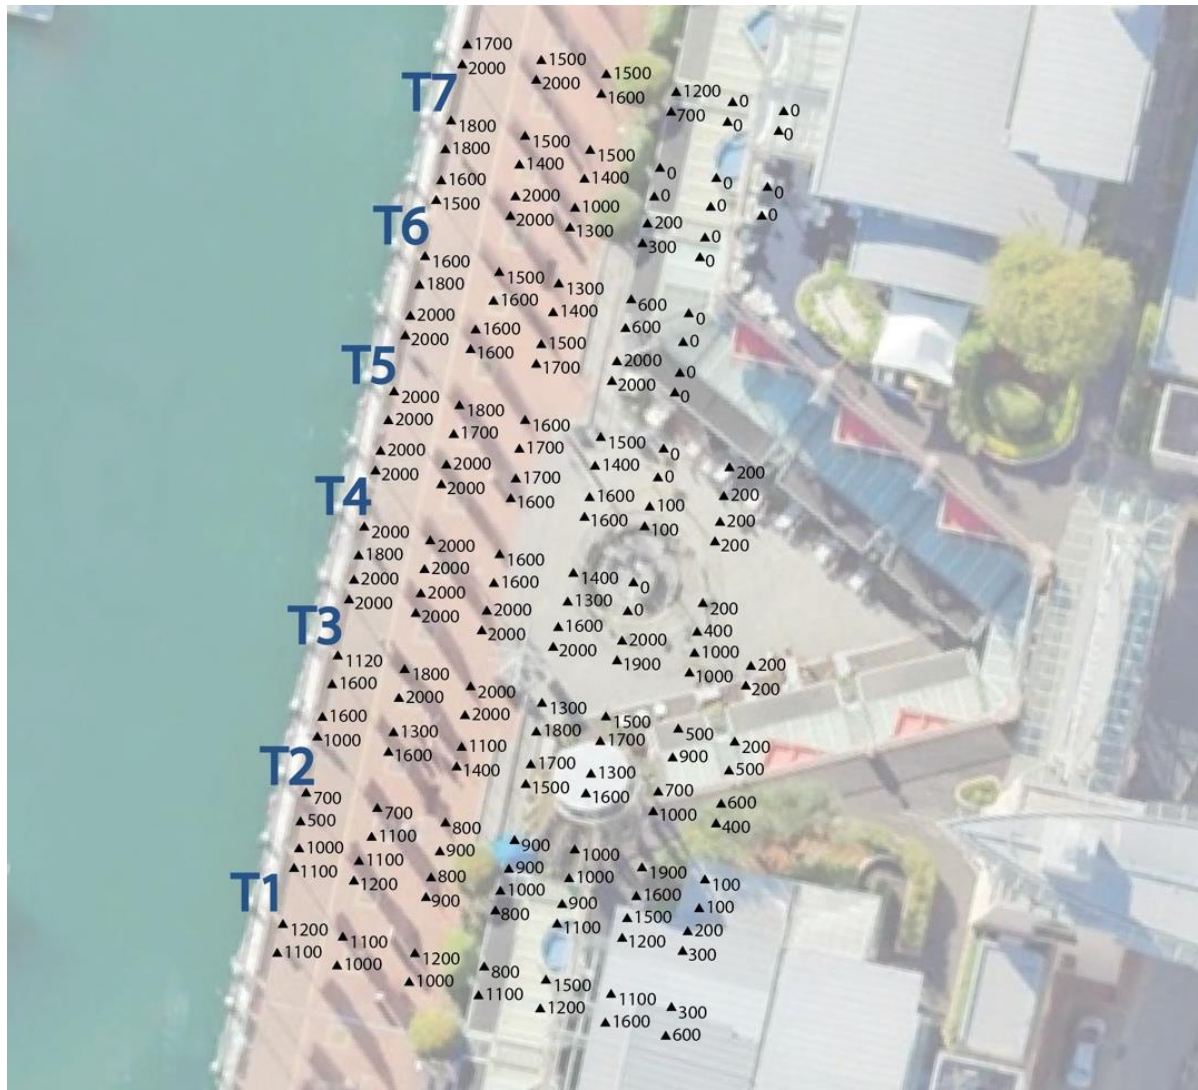
**Figure 91: Overlay of probe results along transects in primary survey area.** All depths are in mm.

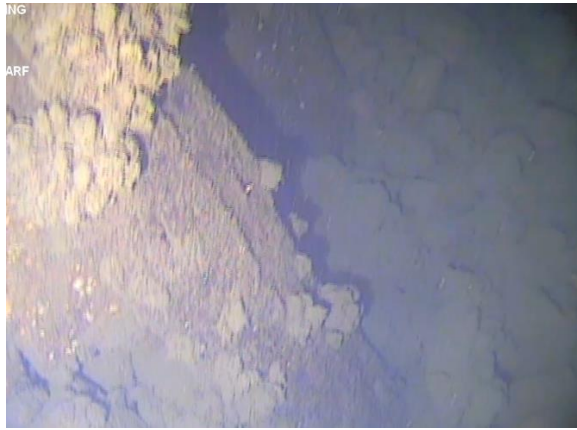
**Figure 100: Two of the cut off timber piles near the southern 'E' steel pile.** (Image from T10 (a) Cockle Bay 210705; 07:39).

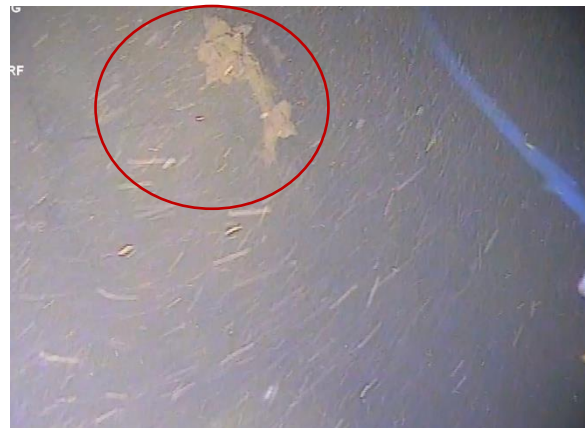
**Figure 103: Top of the northern cut off timber pile closest to the northern 'E' steel pile.** Note heavy deterioration. (Image from T10 (b) Cockle Bay 210705; 02:52).

The diver then moved along the rock batter to the northern 'E' pile and continued the transect to the west. Adjacent to the northern 'E' pile there was another two cut off timber piles. The first was heavily degraded with only the outside still present. The pile was 1.5 m high with an estimated diameter of 300 mm. The next pile was 1.5 m to the south of the first and measured 2 m high out of the rock batter and was also heavily degraded (Figure 103 and Figure 104). Immediately next to the second pile there was another short pile that was 600 mm high out of the rock batter and heavily degraded.

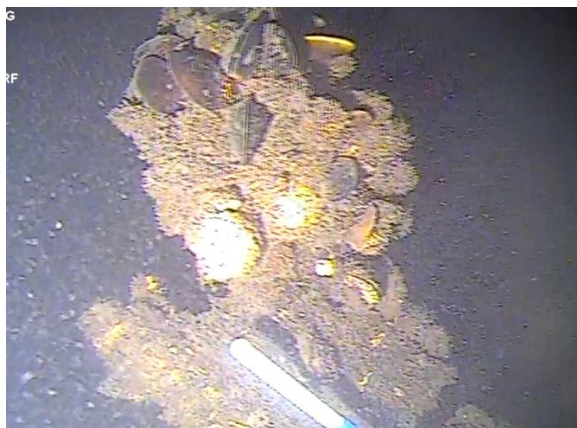
**Figure 104: Heavily deteriorated cut off timber pile 1500 mm to the south of the northern 'E' pile.** (Image from T10 (b) Cockle Bay 210705; 05:00).
