# **BURROWS INDUSTRIAL ESTATE 1-3 BURROWS ROAD, ALEXANDRIA**

## **Geotechnical Report**

PSM2808-005R REV4      16 December 2024

Goodman Property Services (Aust) Pty Ltd

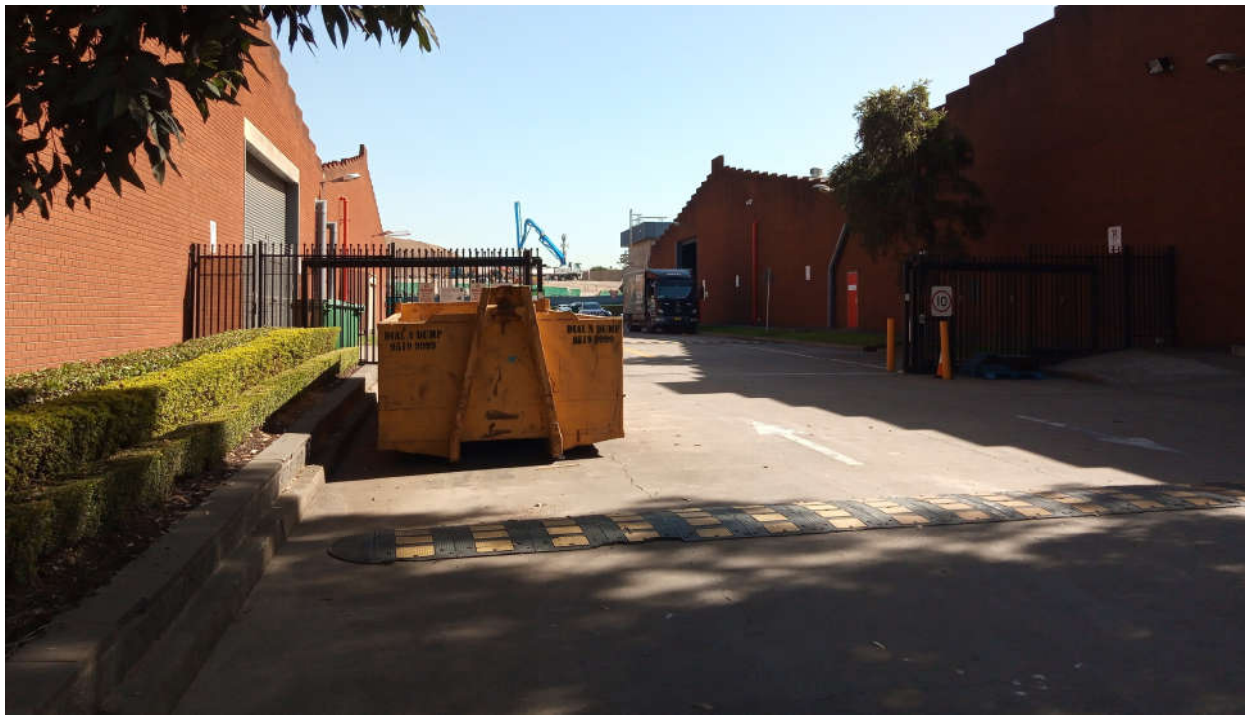
Photo 1 - General Site Conditions - Site Entrance

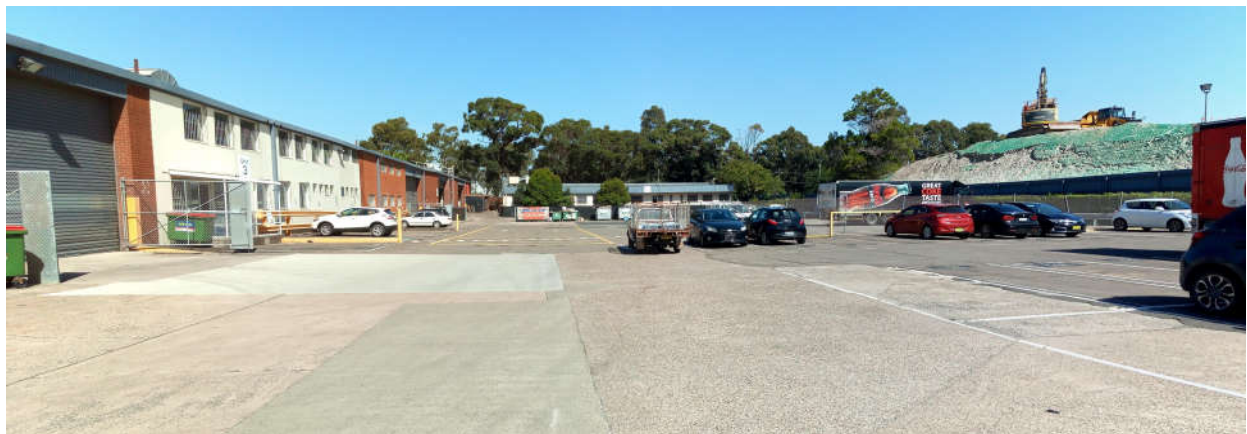
Photo 2 - General Site Conditions - View to the South from entrance

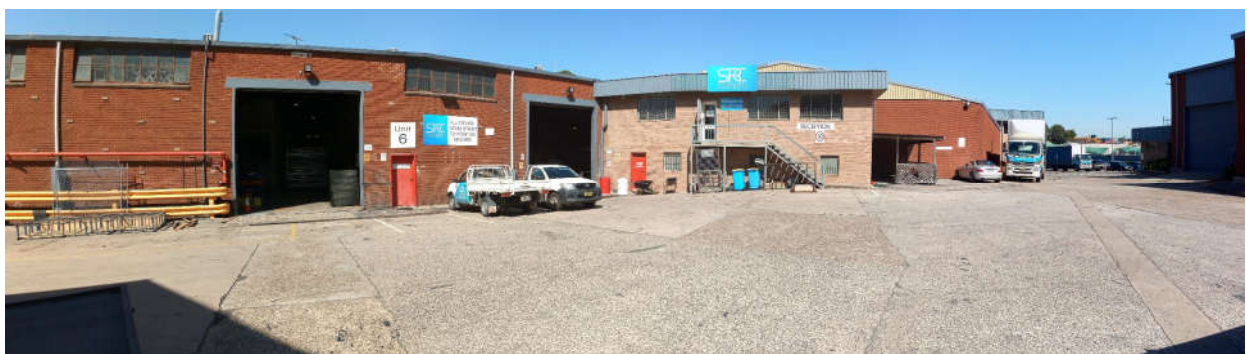
Photo 3 - General Site Conditions - North part of the site looking South

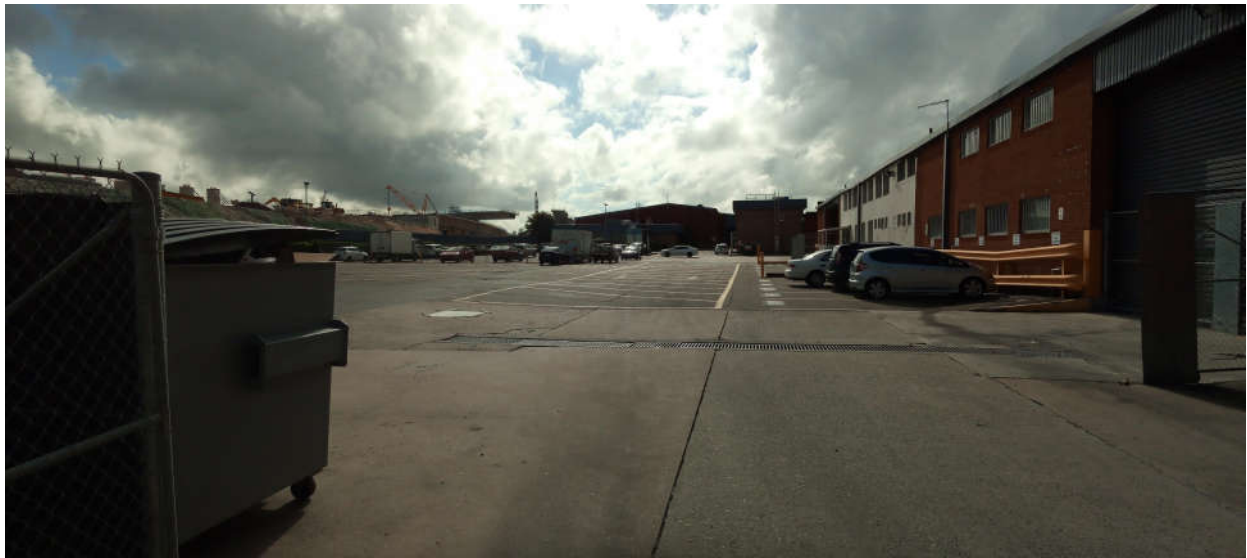
Photo 4 - General Site Conditions - View to the North from the South

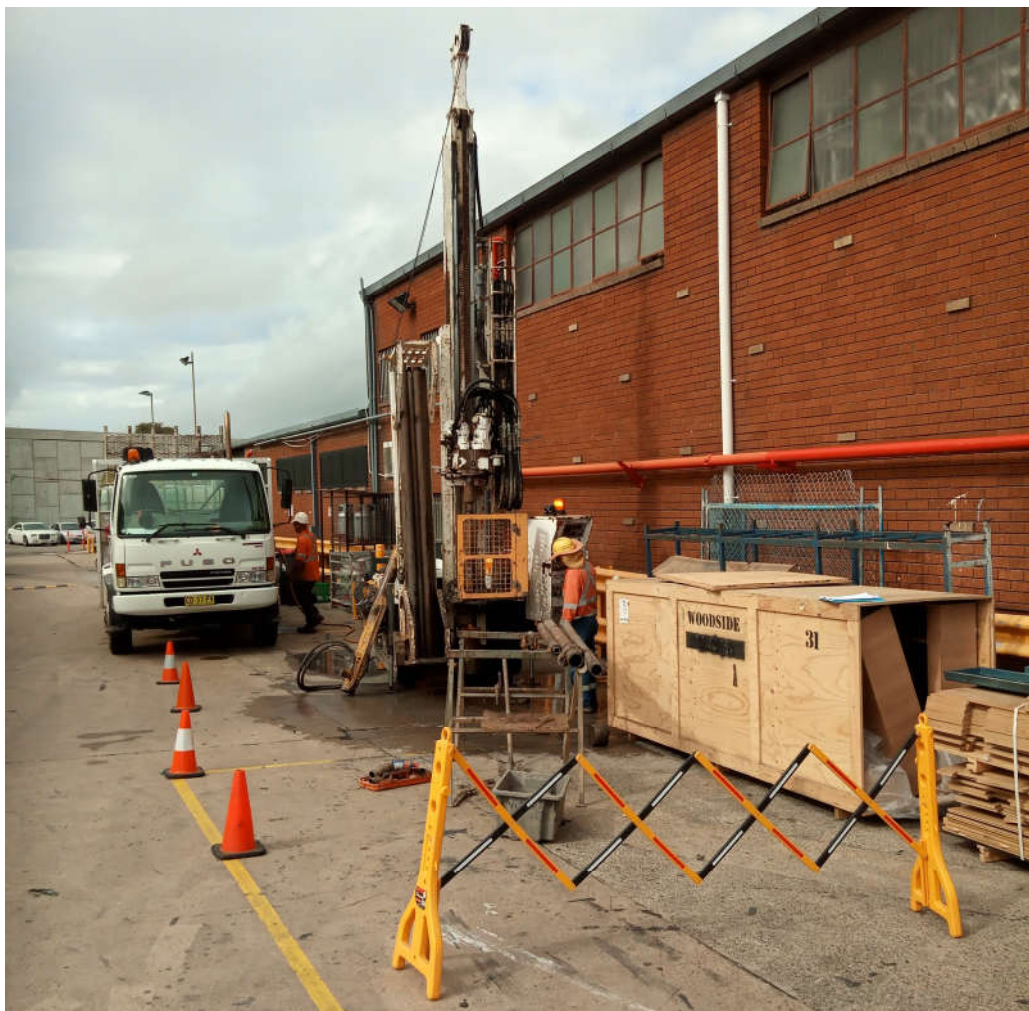
Photo 5 - Drilling rig and exclusion zone

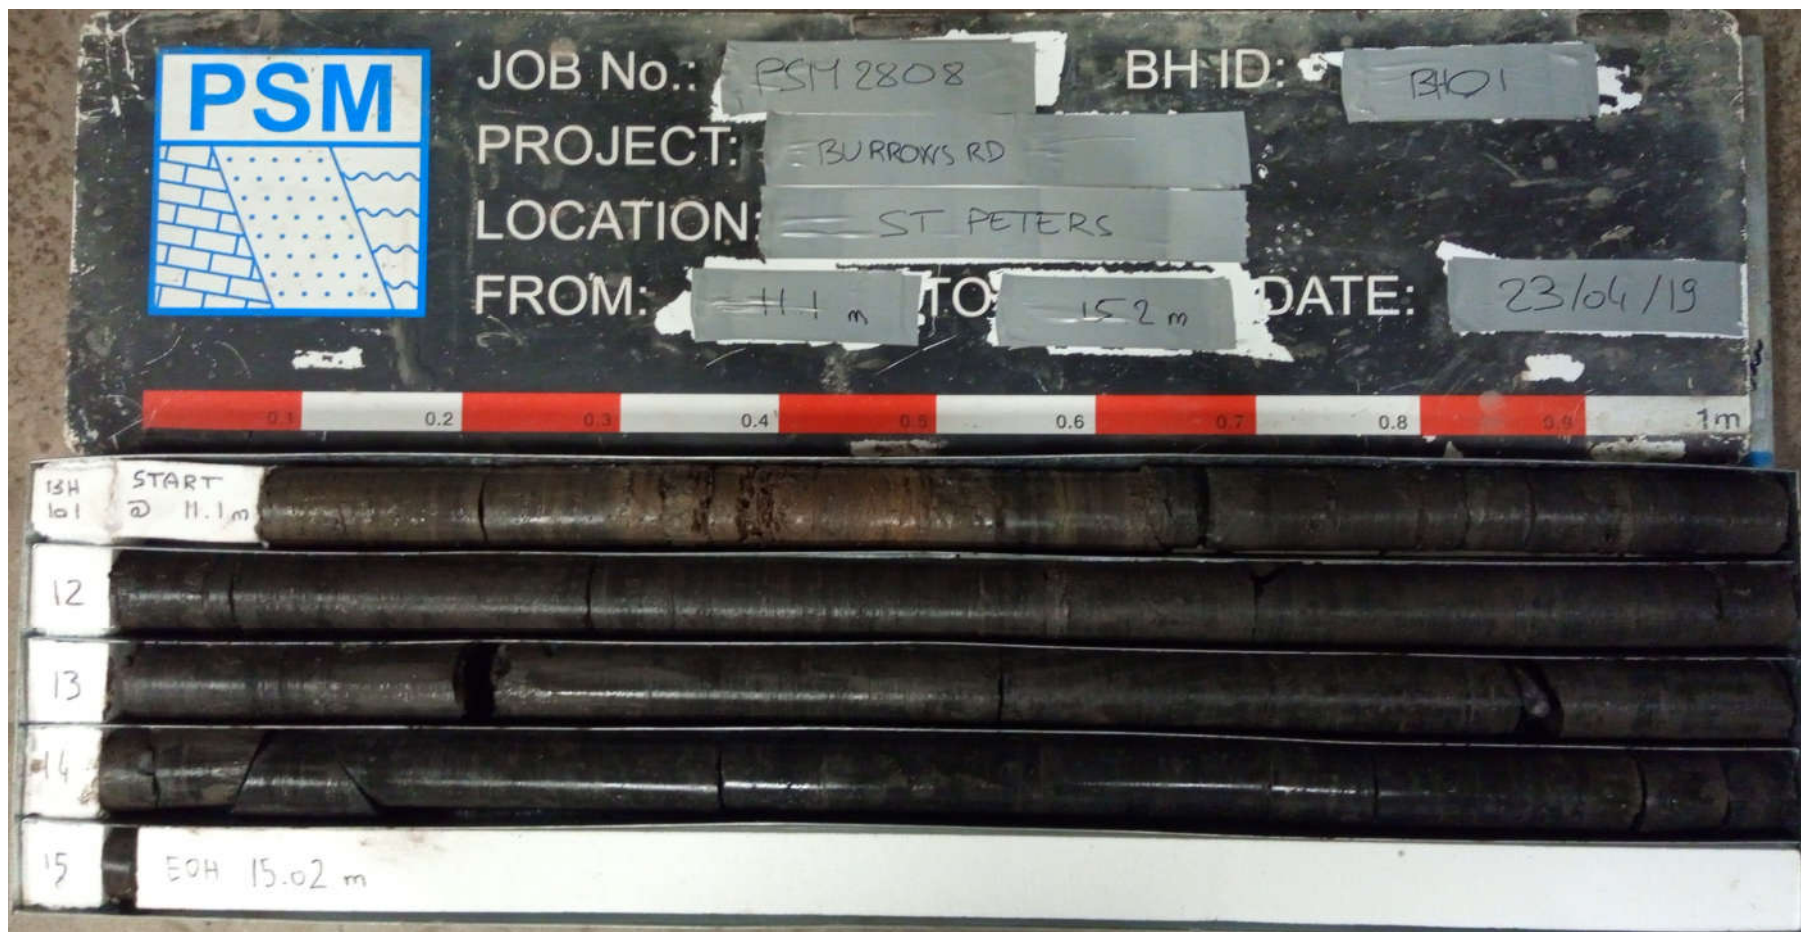
Goodman Limited  
 1 - 3 Burrows Road, St Peters  
 Geotechnical Investigation  
 BOREHOLES CORE PHOTO  
 BH01 From 11.1 m to 15.02 m

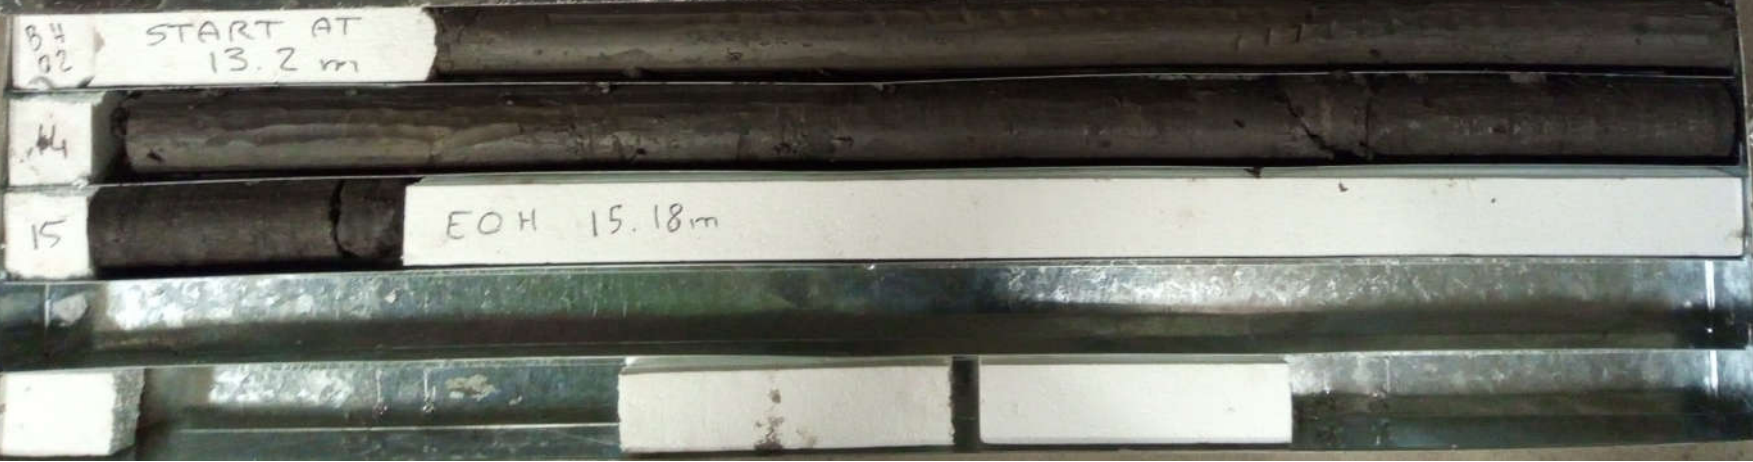
Goodman Limited  
1 - 3 Burrows Road, St Peters  
Geotechnical Investigation  
BOREHOLES CORE PHOTO  
BH02 From 13.2 m to 15.18 m

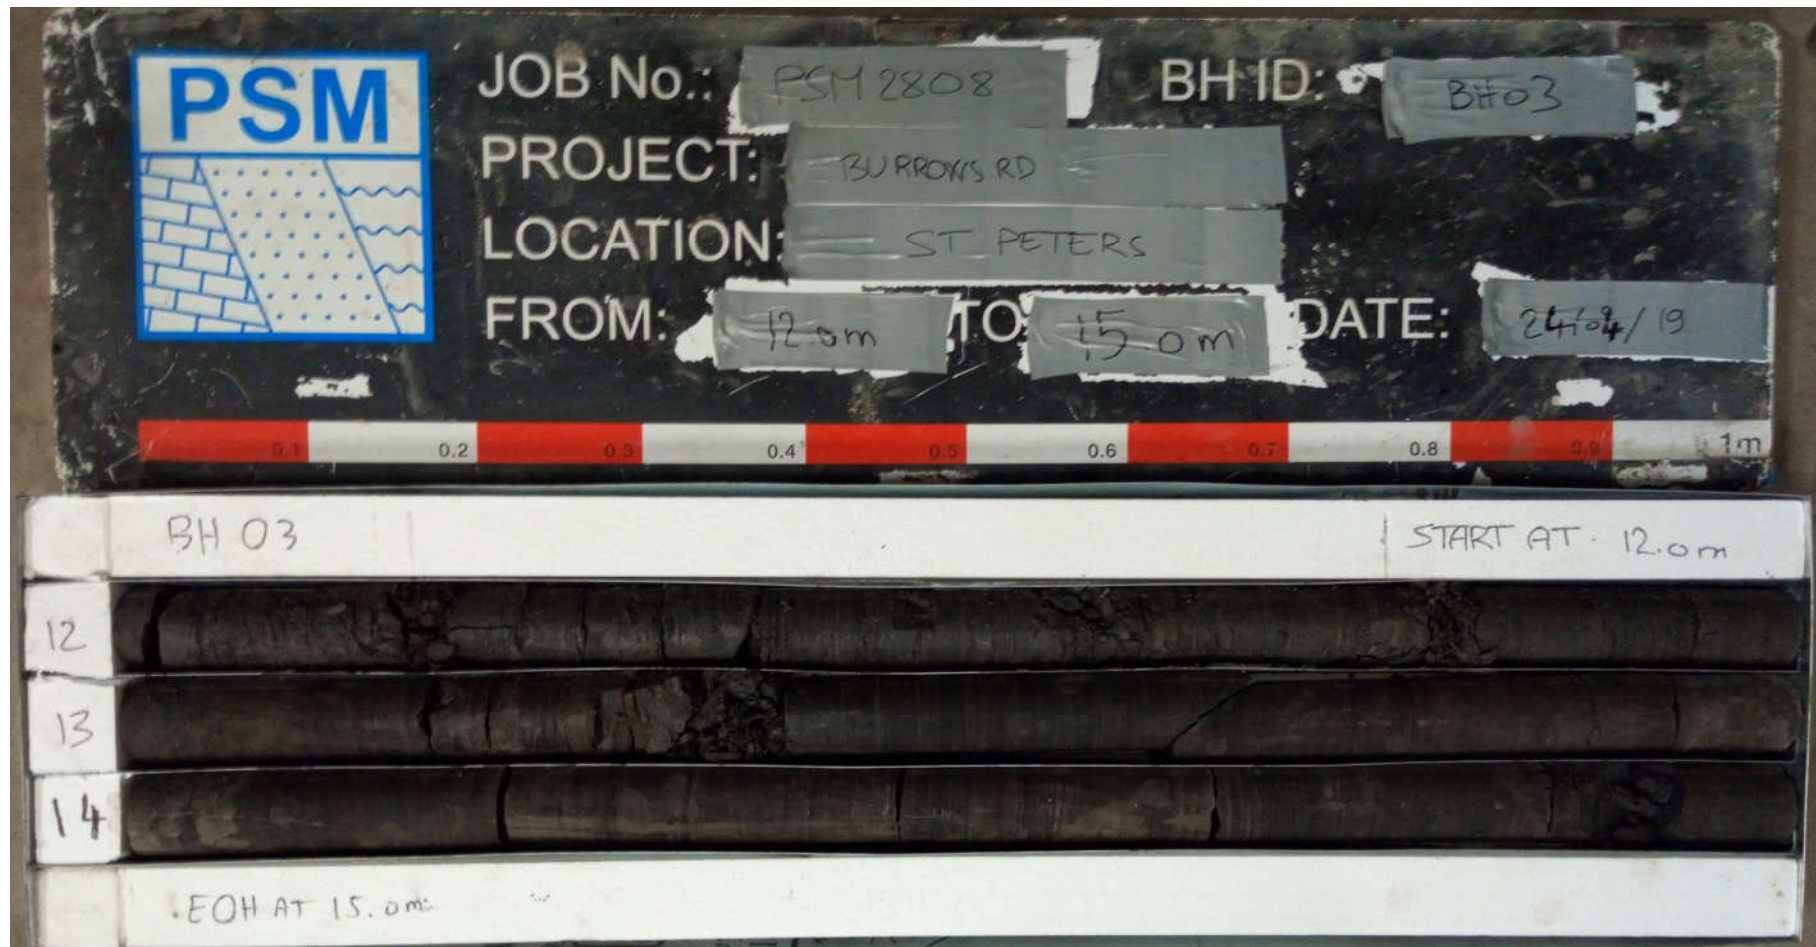
Goodman Limited  
 1 - 3 Burrows Road, St Peters  
 Geotechnical Investigation  
 BOREHOLES CORE PHOTO  
 BH03 From 12.0 m to 15.0 m
