**ROAD CONDITION ASSESSMENT  
(BEFORE CONSTRUCTION)**

NEOEN CULCAIRN SOLAR FARM

**10 AUGUST 2023**

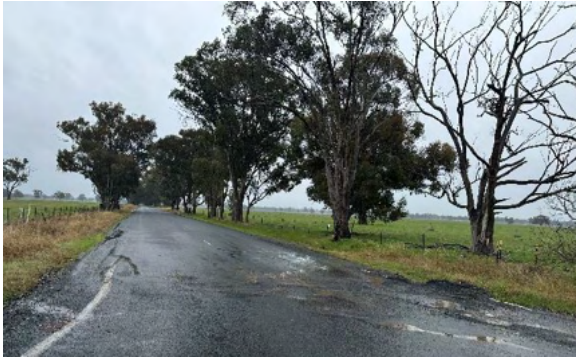
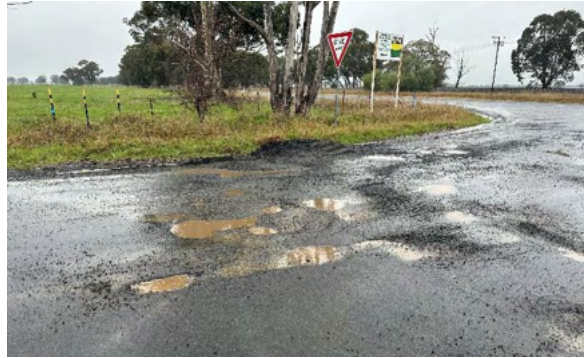
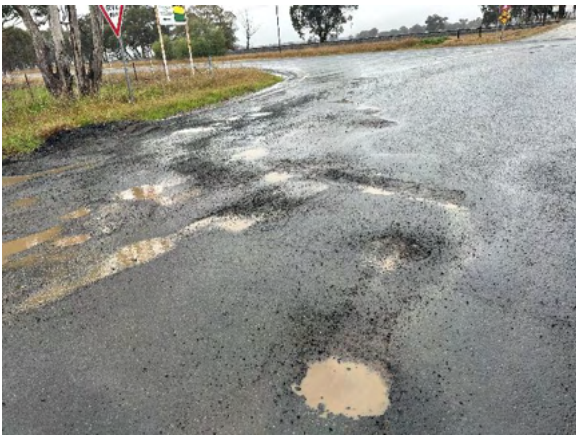
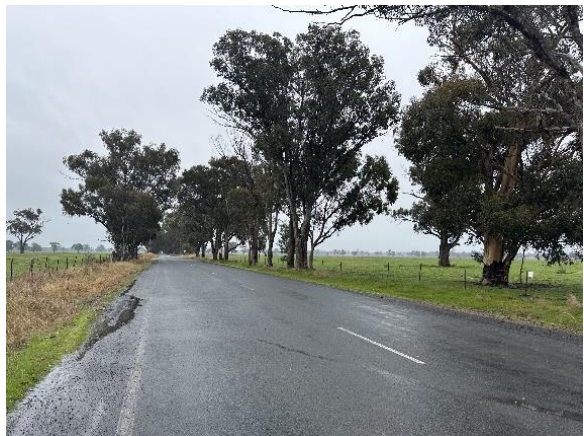
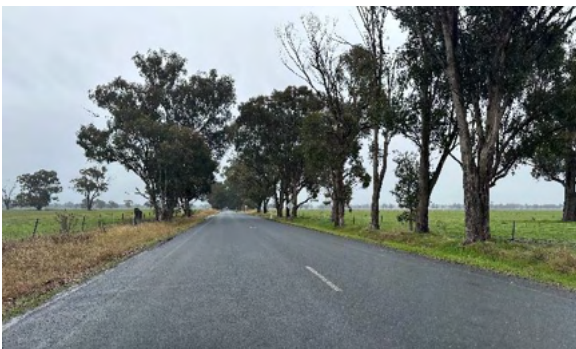
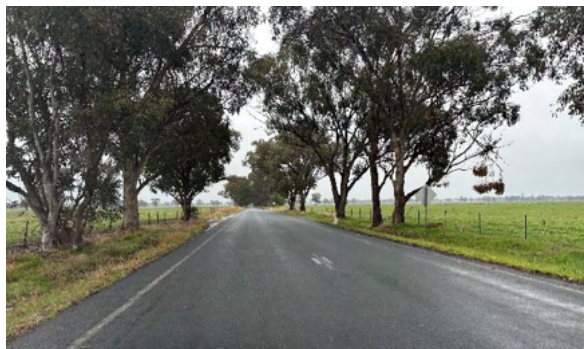
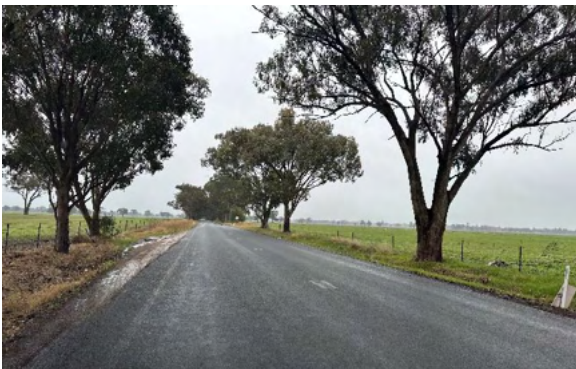
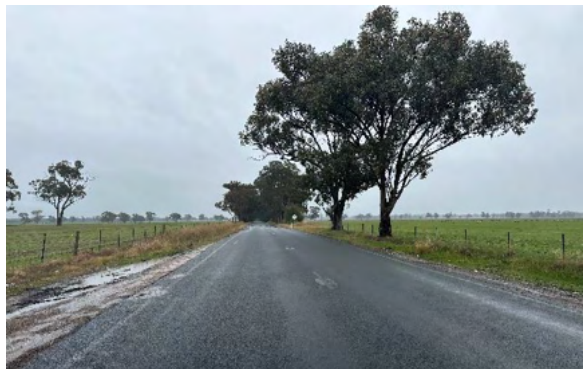
**Benambra Road, commencing just west of Olympic Hwy**

Benambra Road generally has a sealed pavement width of 7 metres with grass / gravel shoulders. The road pavement is generally in good condition, with isolated sections of failure, mainly pot holing.

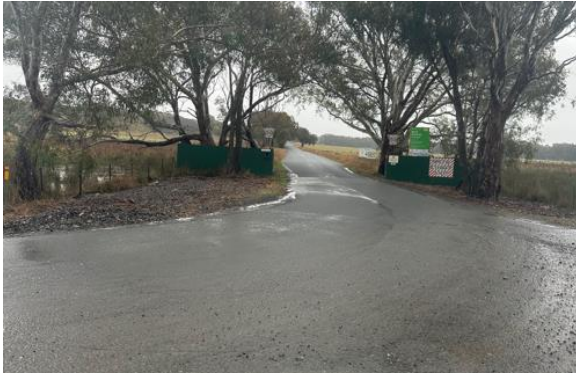
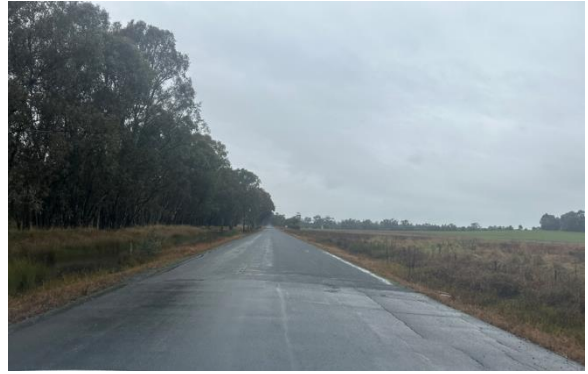
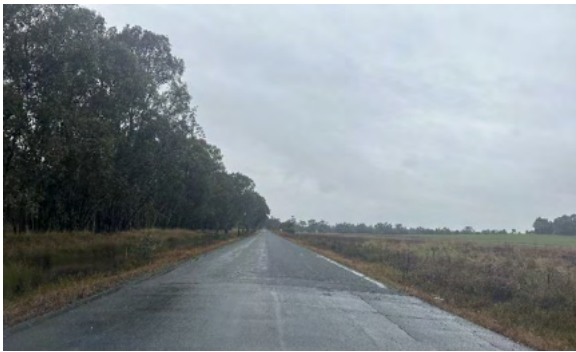
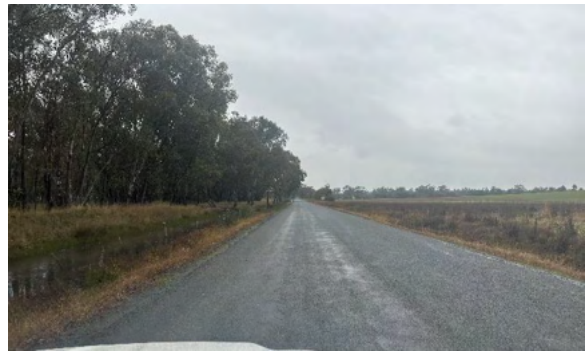
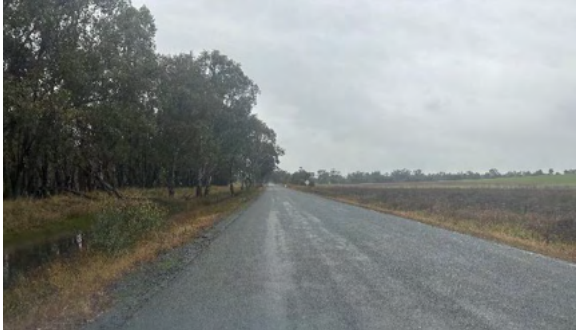
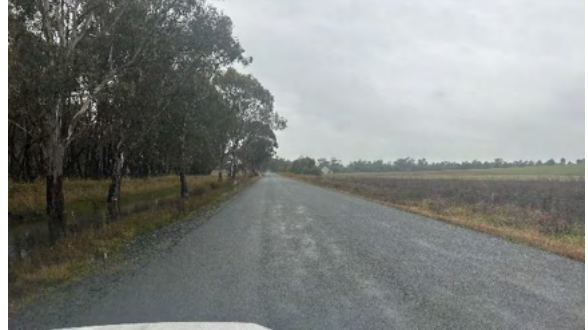
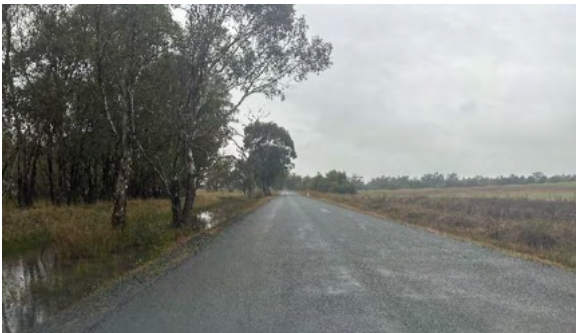
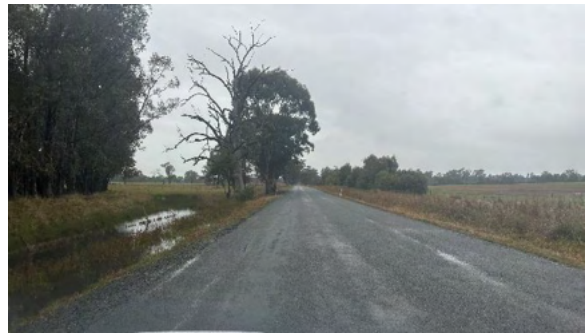
**Travelling south on Weeamera Road from Boral site**

This section has regular corrugations and rutting.
