# Snowy 2.0 – Tantangara Surface Depression Rehabilitation Plan

| <b>Title</b> | Tantangara Surface Depression - Site Specific Rehabilitation Plan | | |
| <b>Document Number</b> | S2-SHL-ENV-PLN-0004 | | |

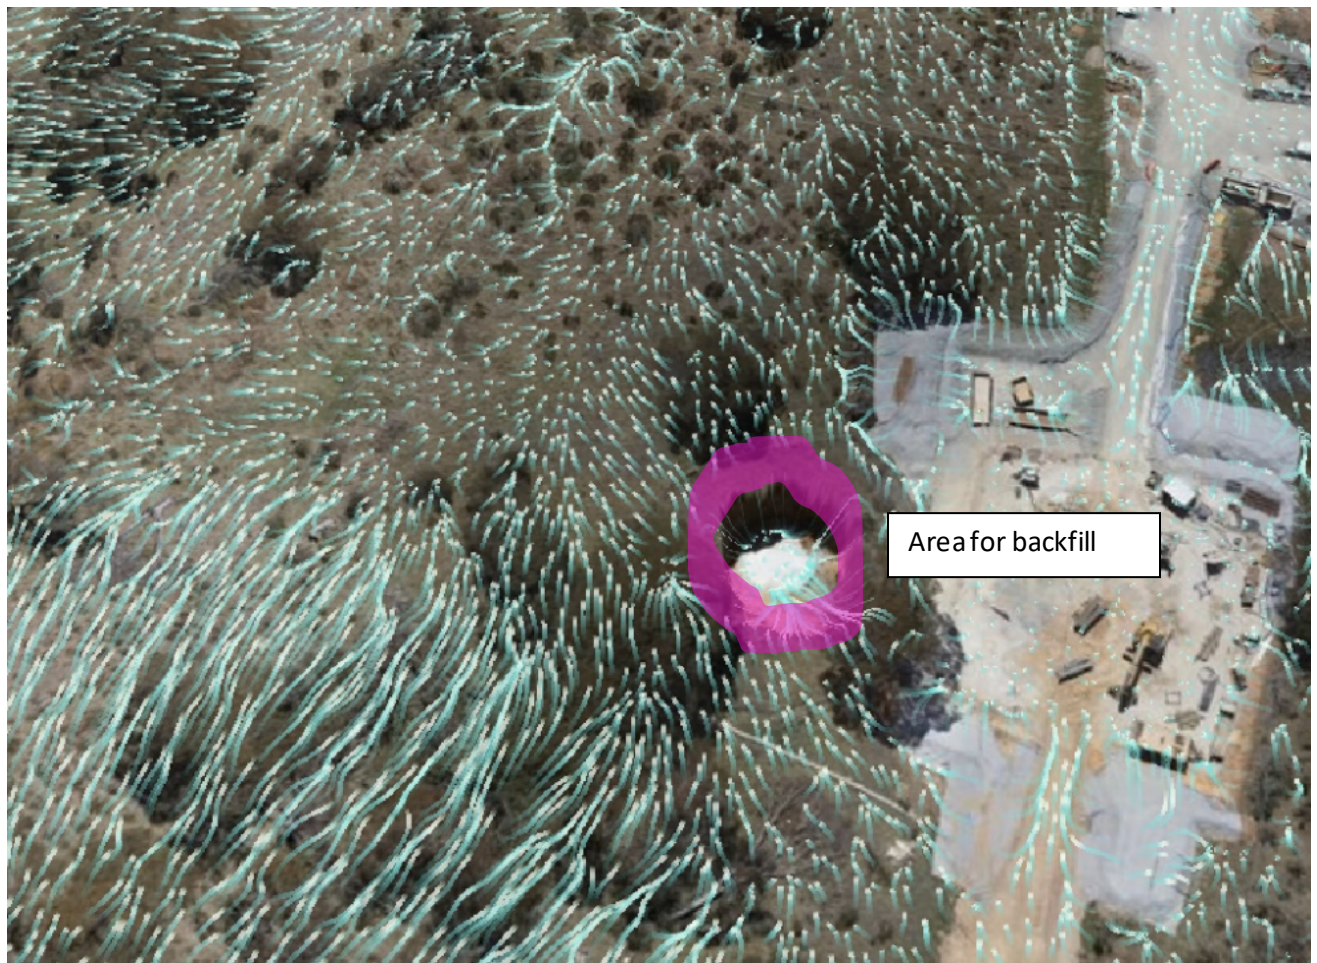
Figure 6: Local surface water flow path and area to be backfilled

On the north-western corner of the proposed disturbance footprint there is first order stream that will not be directly impacted by remediation activities, any flow directed to the drainage line will be managed in accordance with the ESCP as shown in Figure 5 (above). Figure 6 (below) also shows the existing natural flow paths to be reinstated following backfilling of the depression.

The natural surface water flow of the area highlighted in Figure 6 (above) is to be restored to pre subsidence conditions by completing the following process outlined in MOD 2:

Following backfill activities the natural contours will be re-established across the disturbance area as shown below in Figure 7. Figure 6 further illustrates the natural surface flow through the disturbance area and how this ties into the backfilled area shown in figure 7. If for any reason disturbance of the first order drainage line is required, it will have jute mesh applied after topsoiling and be planted out at a rate of 4 plants per metre. Slope breaks in the form of coir logs will also be installed. The drainage line is not in the planned disturbance area.
