# UNITED WAMBO

## 2023 Annual Review

| Name of Operation | United Wambo Open Cut Coal Mine |
| Development consent / project approval # | SSD 7142 |

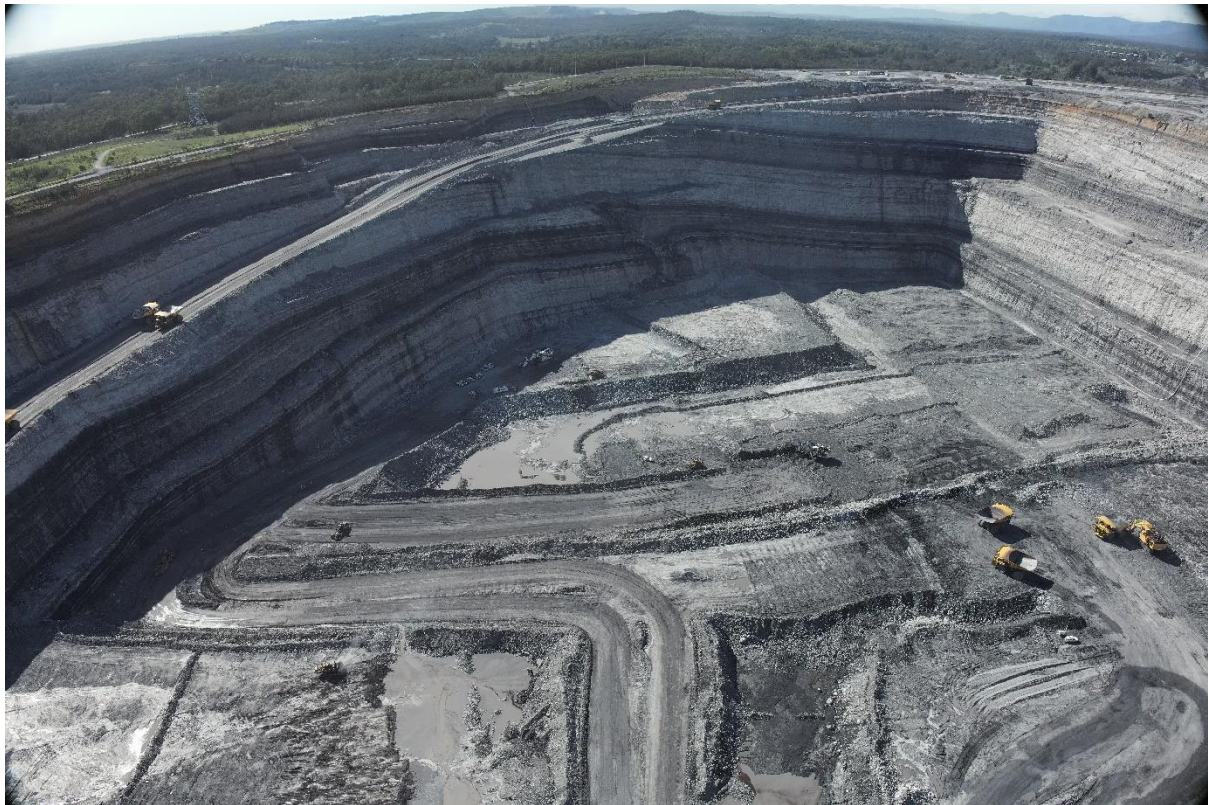
Figure 4-1 United Open Cut operations in December 2023

During 2023, mining operations continued within the United Open Cut (United OC), focusing on moving waste and coal from the eastern side of the pit to reach pit floor see Figure 4-1. Development of the overburden emplacement areas continued, with dumps progressing west toward Montrose. The out-of-pit emplacement areas were mostly over areas previously mined and previously rehabilitated by Wambo. Mining also continued within the Wambo Open Cut's Montrose Pit, including the Montrose Ridge area. Overburden from Wambo Open Cut is emplaced in the in-pit emplacement areas. Coal mined from both the United and Wambo open cuts was transported to the ROM hopper or stockpile area.

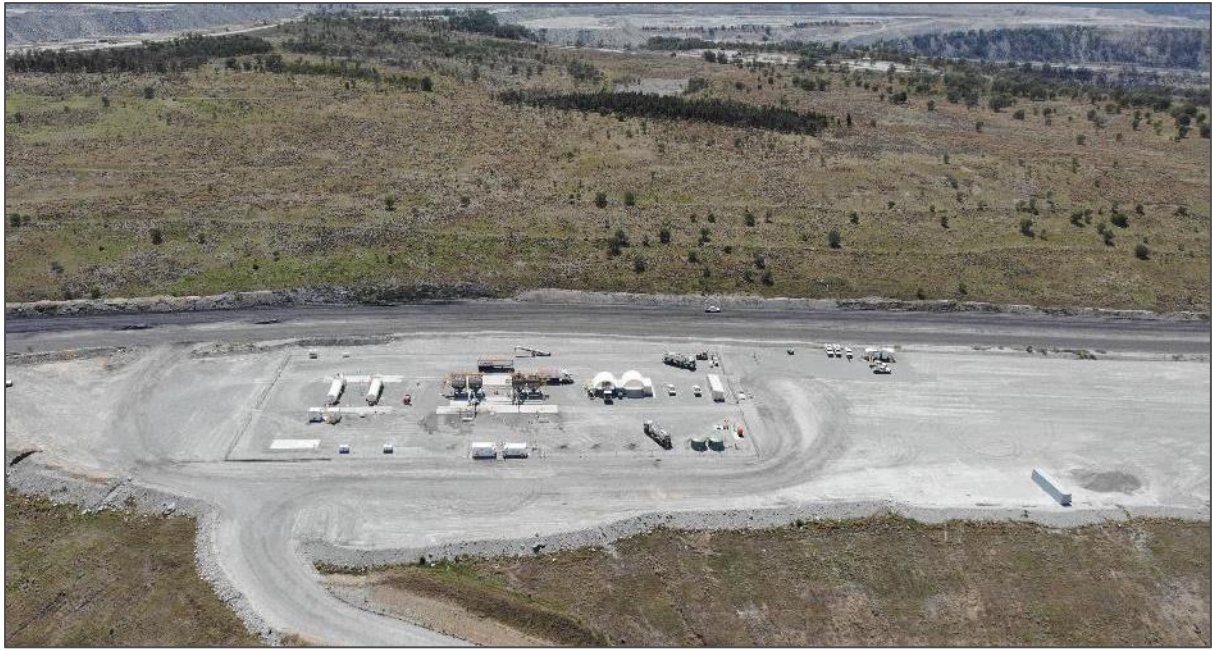
*Figure 4-2 Reload and magazine area constructed*

| Item No | Construction Activity | Description |
|---|---|---|
| 1. | Explosives Reload and Magazine Area | A new overburden pad was constructed in a pasture area rehabilitated in the 2000s, near the South Mine Infrastructure Area (SMIA). Topsoil resources were salvaged and stockpiled for reuse. The pad was constructed using mining equipment and overburden from United OC. Explosives reload and magazine infrastructure was installed by local Hunter Valley contractors. The relocation was to make way for planned overburden dump progression at the Homestead domain see Figure 4-2. |

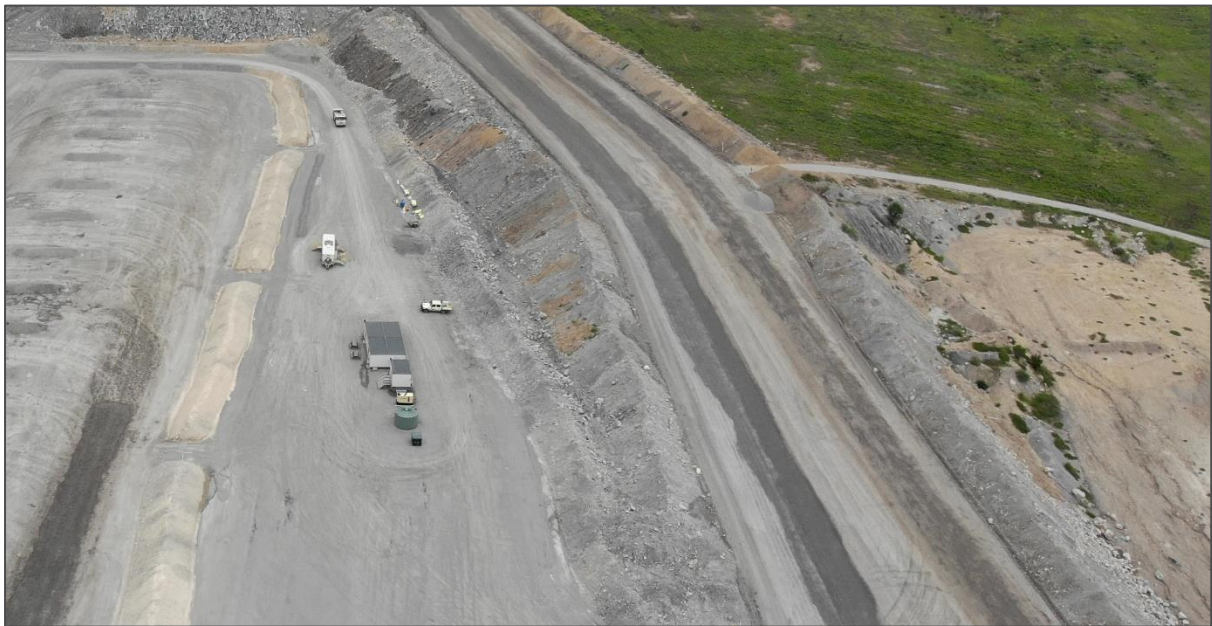
*Figure 4-3 Montrose crib hut constructed*

| Item No | Construction Activity | Description |
|---|---|---|
| 2. | Montrose Crib Hut | A primary, semi-permanent crib hut building was installed in Montrose Pit. The original crib hut was decommissioned, and the location relocated from a lower dump system to a higher location (approximately RL160) to the north of the pit. The relocation was to make way for planned overburden dump progression see Figure 4-3. |

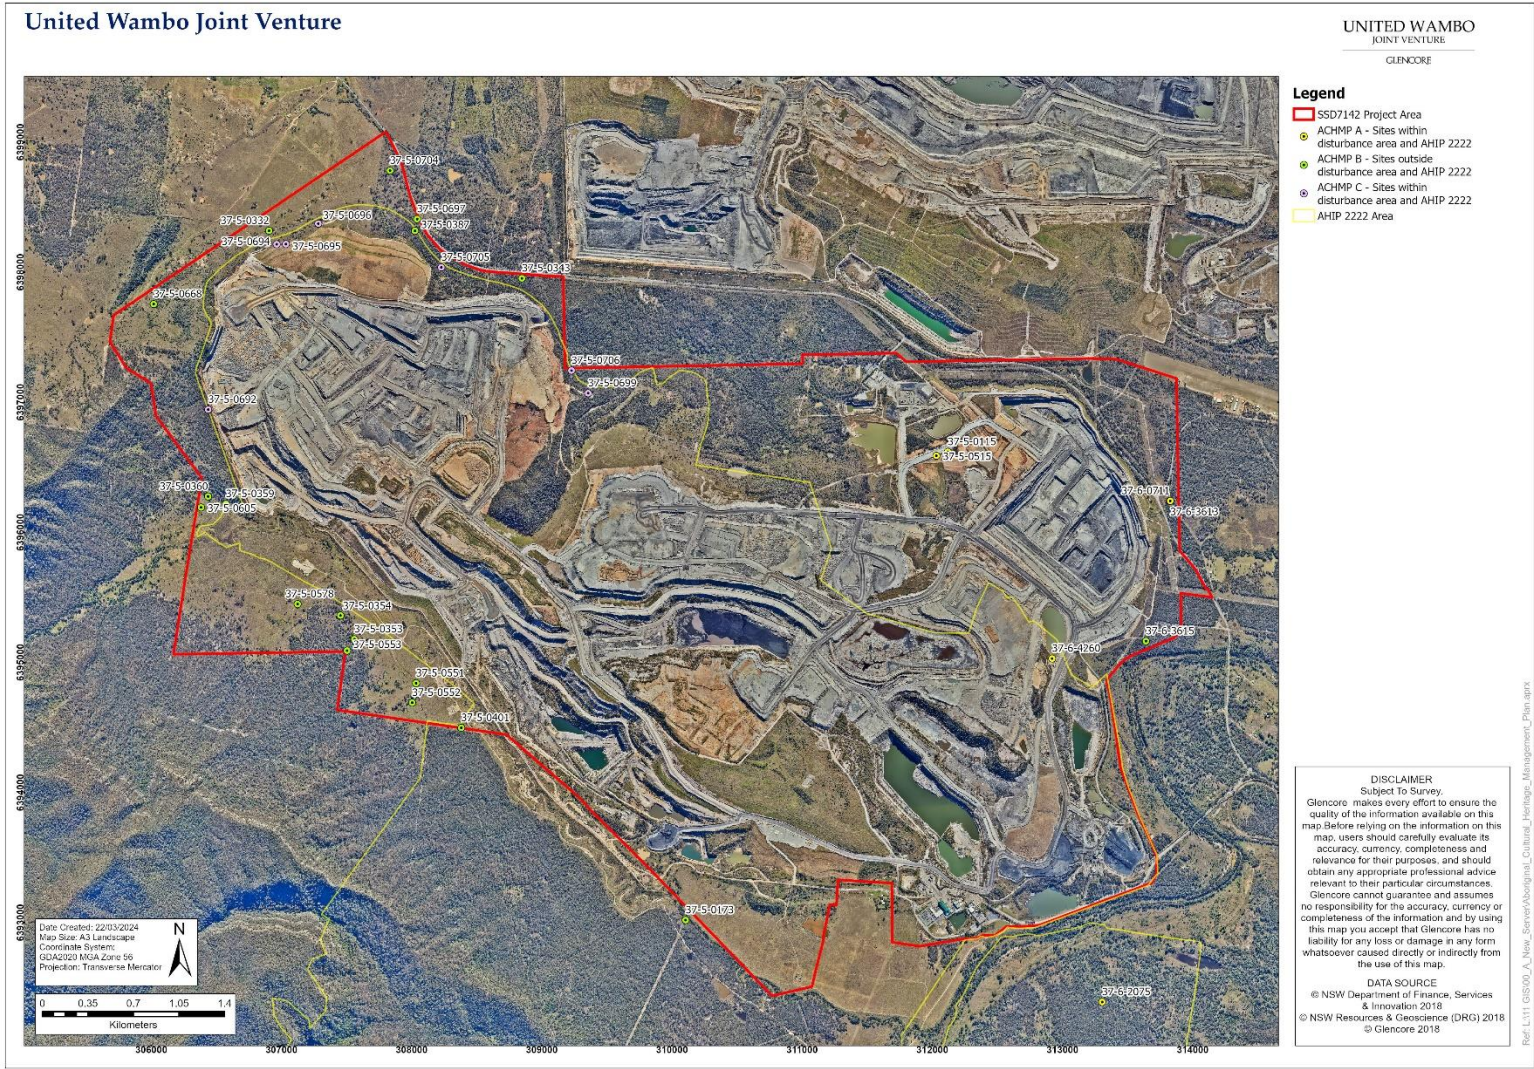
Figure 6-3 Aboriginal Heritage Sites

There was one salvage of Aboriginal artefacts in 2023, these artefacts were additional to those collected from a previously identified site. **Figure 6-3** illustrates the current status of heritage sites in the United Wambo area.

The recommended measures for the Aboriginal heritage sites remaining within the United Wambo area have been implemented, which includes, but not limited to, the fencing and signposting of in situ sites. United Wambo continue to ensure cultural heritage sites are not impacted through the implementation of the Ground Disturbance Permit process onsite.
