## DETAILED SITE INVESTIGATION

### 97-123 & 125-151 WALLGROVE ROAD, CECIL PARK NSW

Cecil Park Business Hub Development

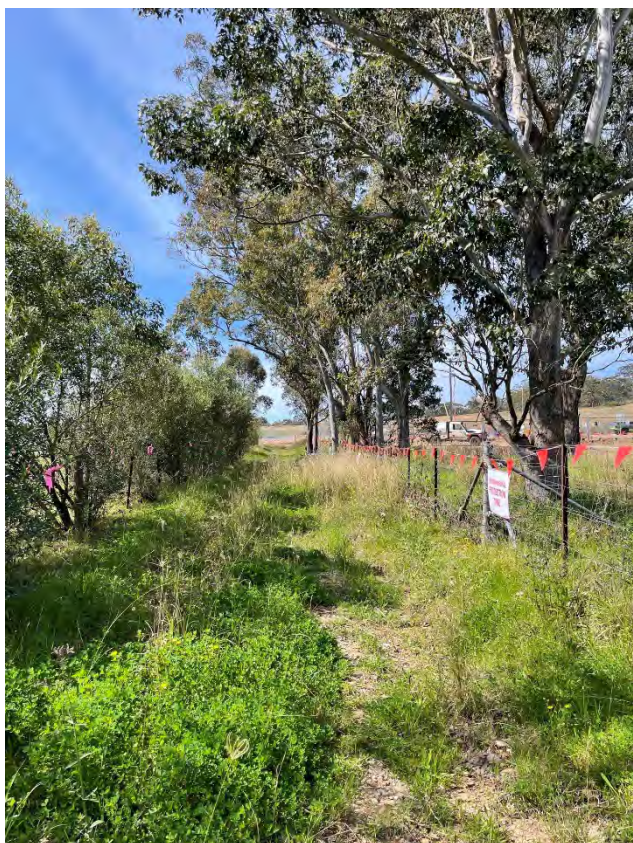
Image 1: Unsealed Driveway located in the south-eastern portion of the site (location of borehole BH16).

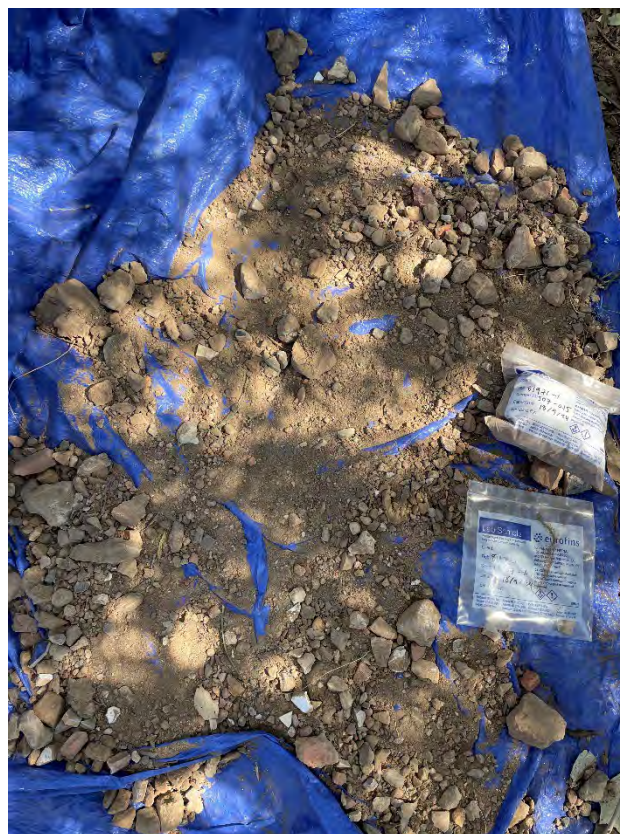
ACM including a loose fibre bundle was identified within shallow fill soils at four out of the 10 sample locations (BH16, S06, S07 and S09) along the unsealed driveway in the southeastern portion of the site.

Image 2: Fill Material from Unsealed Driveway located in the south-eastern portion of the site (location of surface soil sample S07 and identified ACM).

Fyfe recommends that appropriately qualified contractors be engaged to undertake a pre-demolition asbestos audit of the dwelling on the site, and to remove the discarded ACM sheet and the asbestos containing shallow soils used to construct the unsealed driveway.

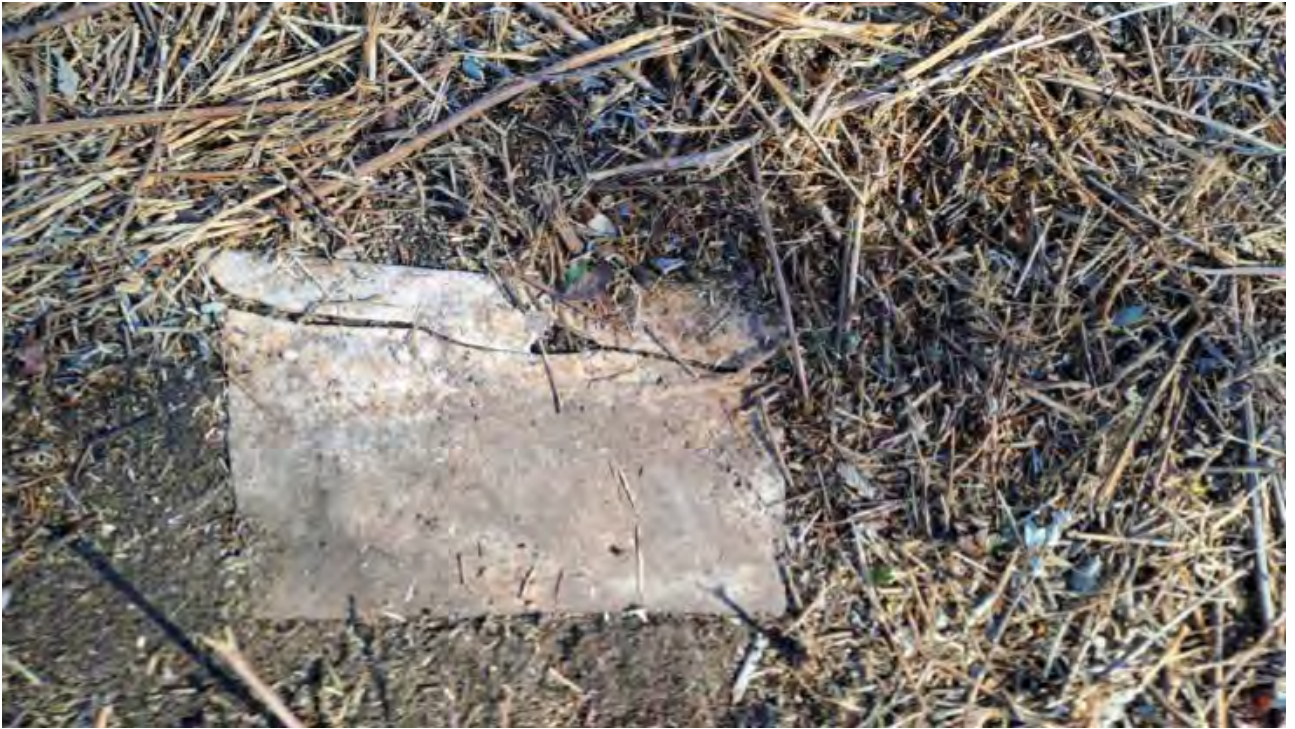
Contamination at the site has been identified in the form of a discarded piece of ACM sheeting. This sheeting was likely derived from sheeting that had been used elsewhere on the site. ACM contamination was also found in the fill material used to construct the unsealed driveway into the property. A loose fibre bundle was detected in one of the samples from the roadway.

The ACM sheeting is present in a bonded form within the matrix of the building material and so does not present a risk to human health in its current undisturbed condition whilst the site remains vacant. However, the presence of a loose fibre bundle indicates that the roadway fill material may present a potential risk to human health. The fibre bundle has almost certainly been generated from the movement of vehicles over the bulk ACM fragments present in the material used to construct the driveway.

ACM sheet, located to the immediate north of the Residential Dwelling.

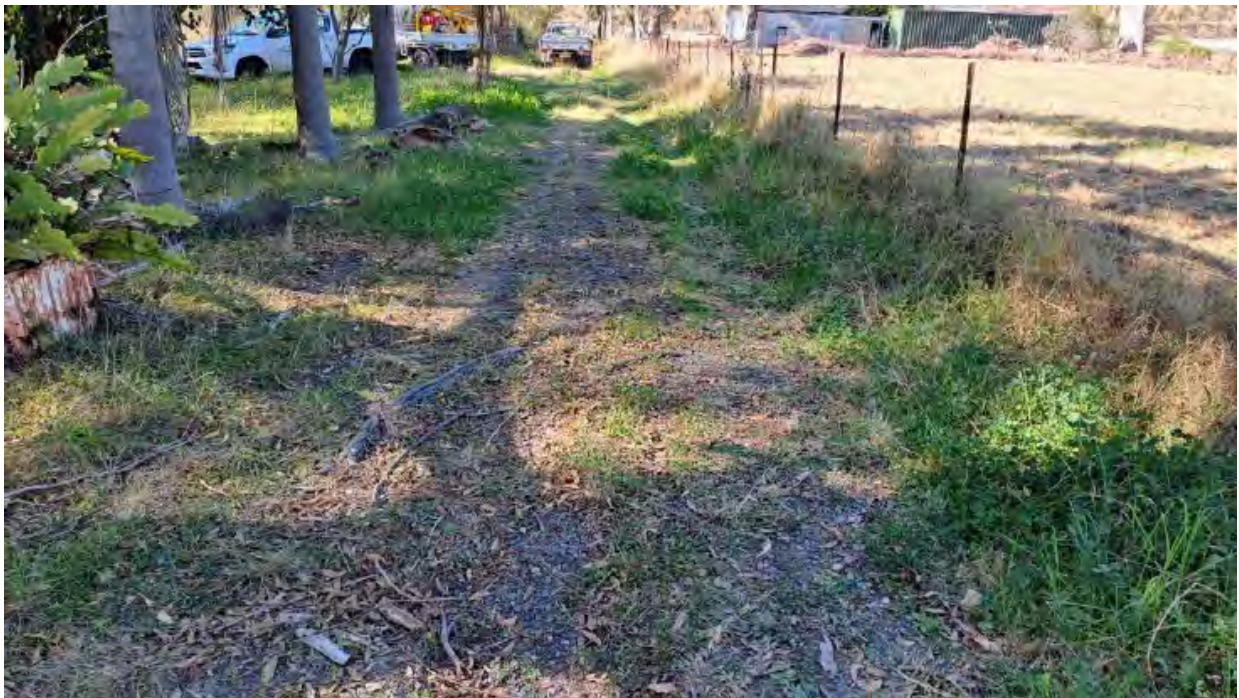
ACM including a loose fibre bundle was identified in shallow soils that had been used to construct the unsealed entrance driveway. Fyfe undertook a comprehensive site walkover to determine if there may be more discarded ACM present than that identified in the PSI. The walkover confirmed that the ACM reported in the PSI was still present. It did not identify any other ACM except for that in the entrance driveway.

View of Unpaved Driveway with shallow filling, facing east.

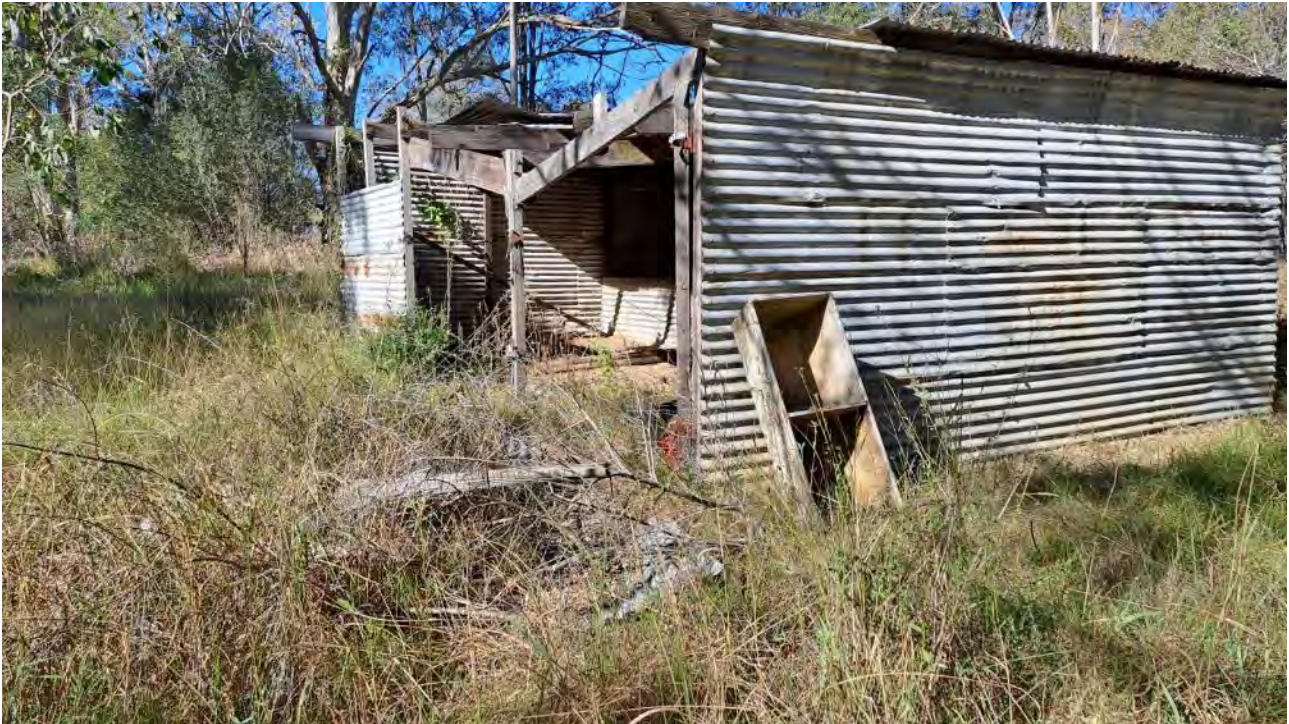
**Image 6.2.3 View of metal shed (shed 2) with damaged roofing, facing west**

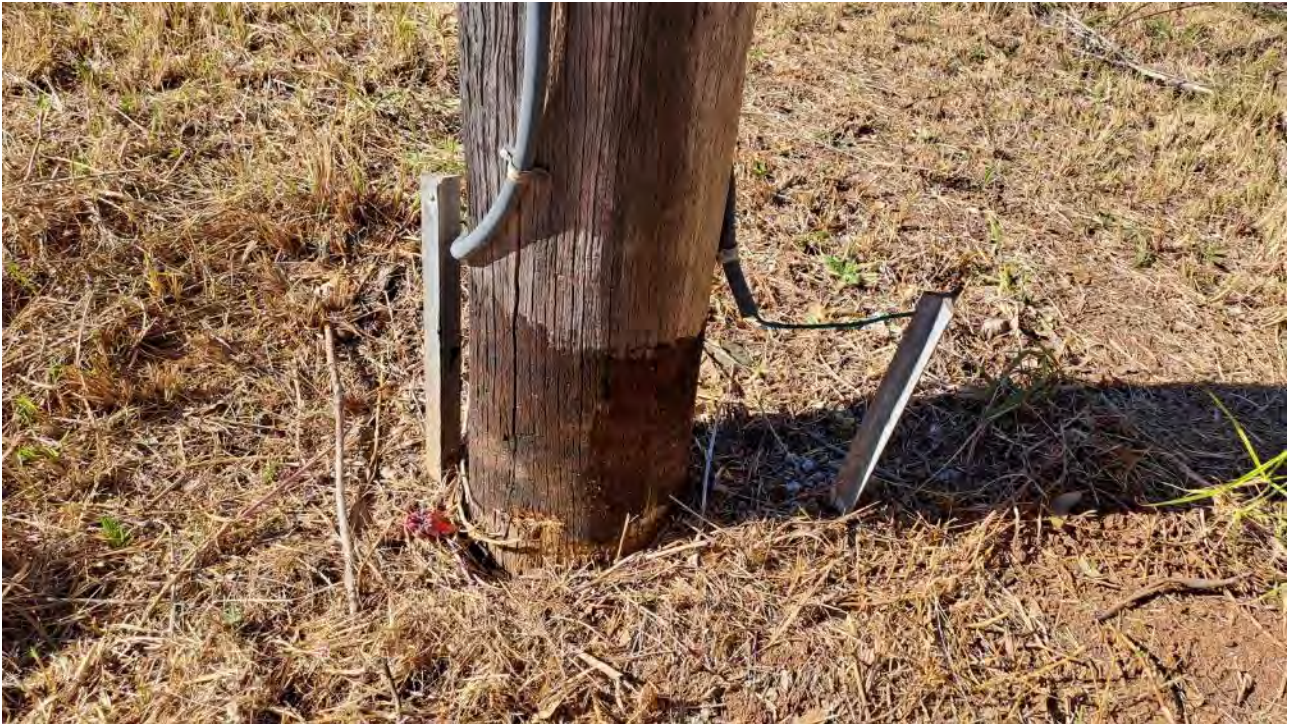
**Image 6.2.5 View of potentially termite treated power pole within the southeast portion of the site**

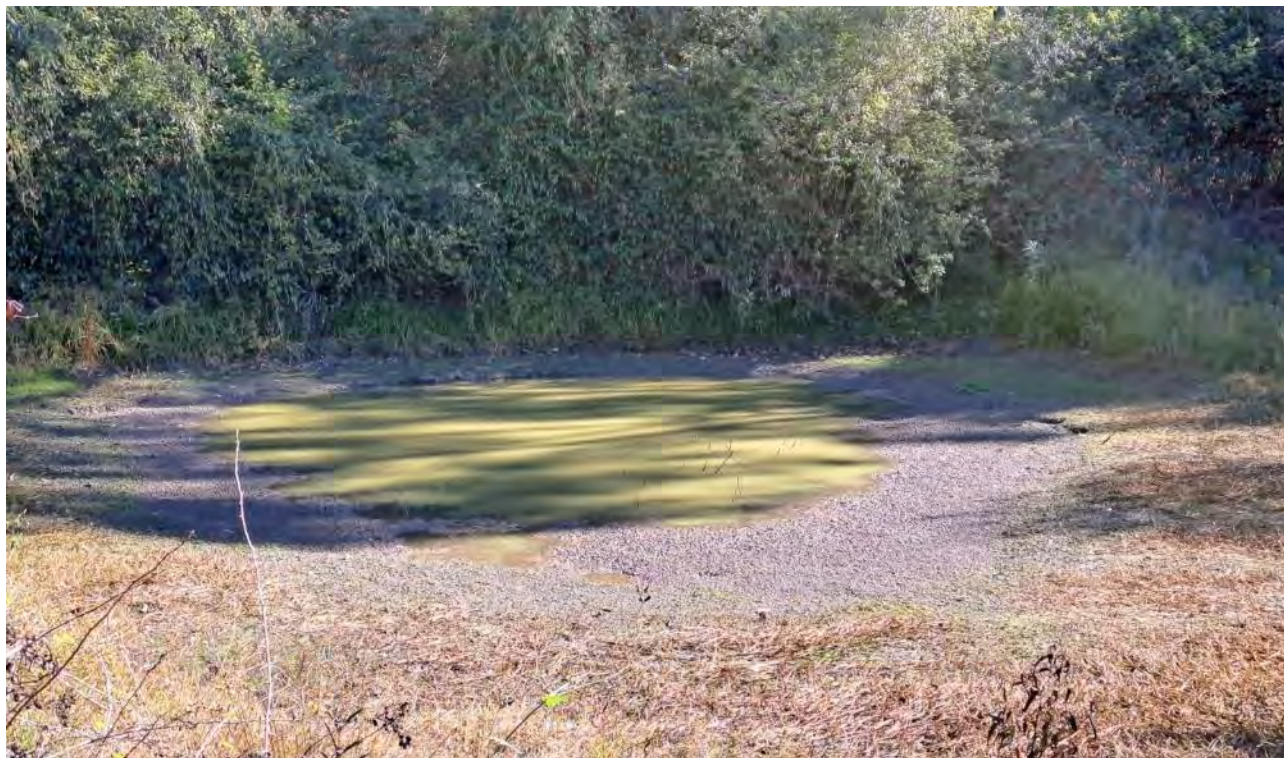
There was a dam located in the southern portion of the site. The dam water appeared to be turbid and presented a discernible green colouration. A wetland consisting of tall grass was observed in the north-western portion of the site, adjacent to the western boundary of the site.

**Image 6.4.1 View of the dam showing green colouration, present within the southern portion of the site**

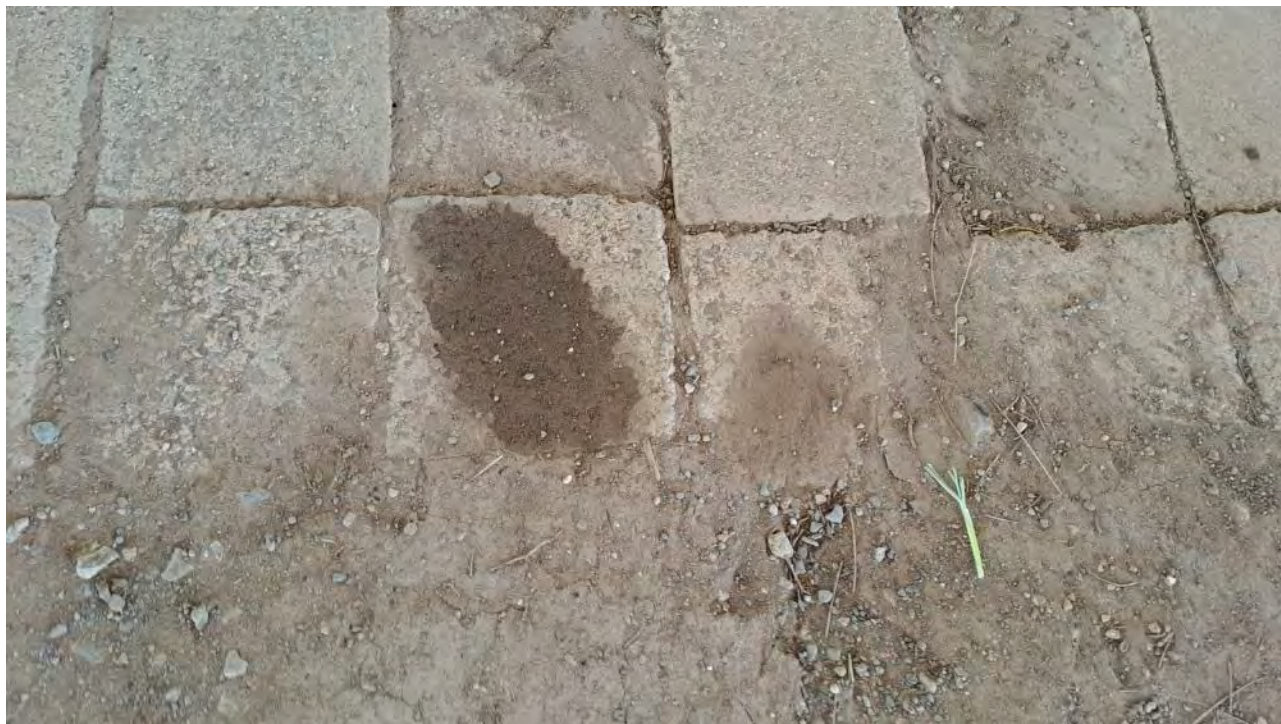
There was no visual evidence observed of significant or widespread staining on the surface of the site. There was evidence of a localised area of oil staining (<1m<sup>3</sup>) on the concrete tile in the carpark attached to the residential house.

**Image 6.5.1 View of localised area of oil staining on brick surface in carpark attached to the dwelling**

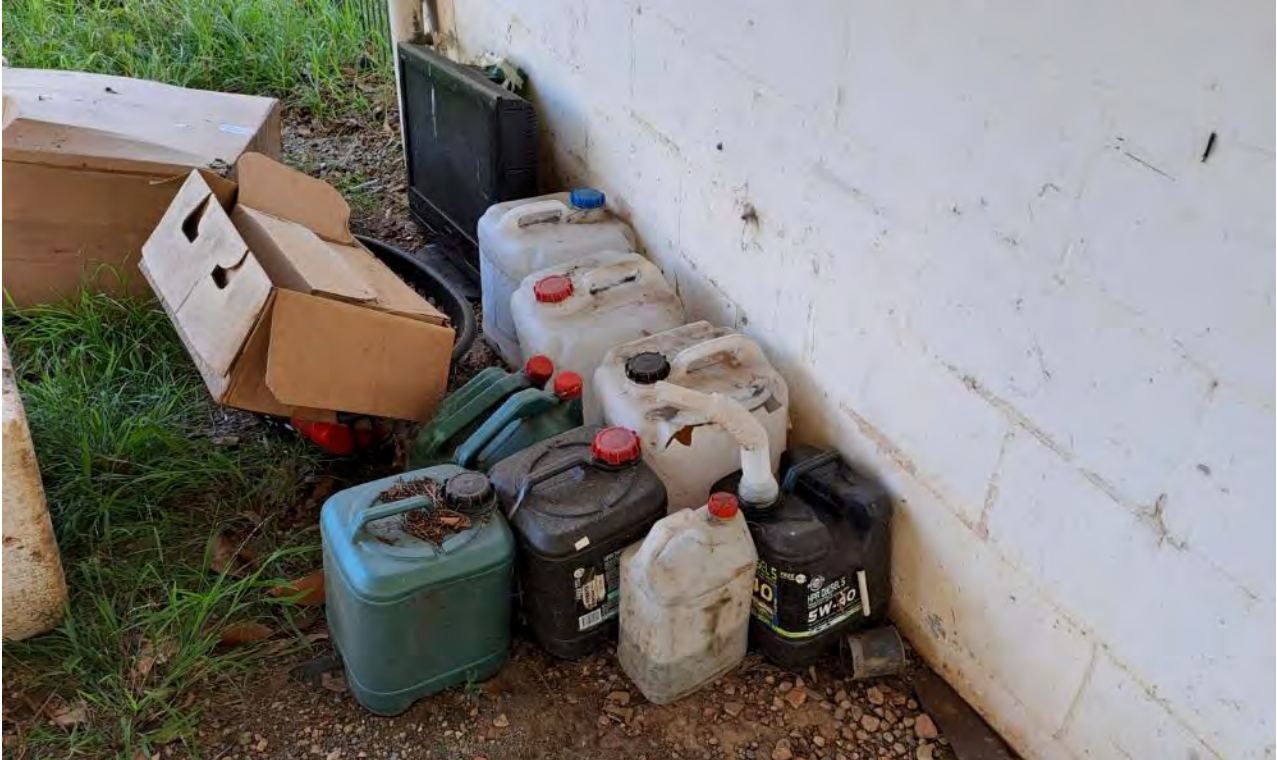
The following chemicals, and indicative volumes, were observed stored in the garden bed area, located along the southern side of the house:

**Image 6.6.1 View of chemicals stored on an unsealed surface within the carpark shed attached to the house**

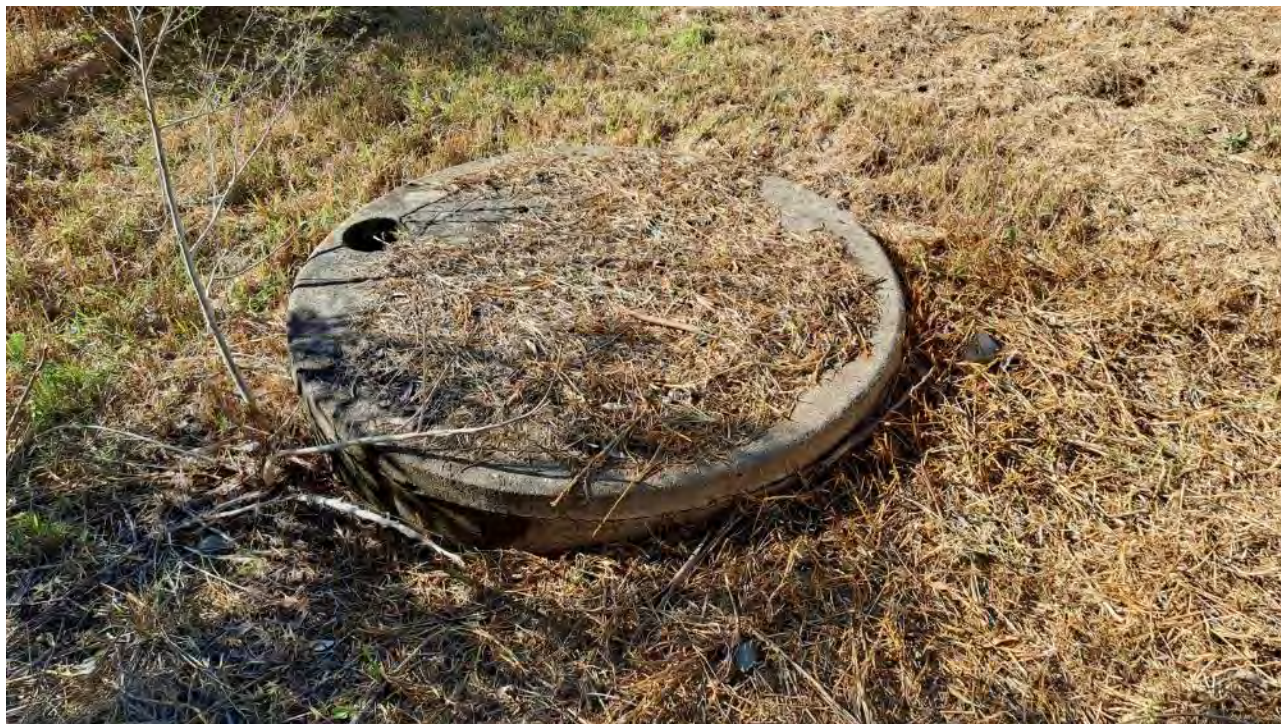
**Image 6.8.1 View of septic system located to the north of the house**

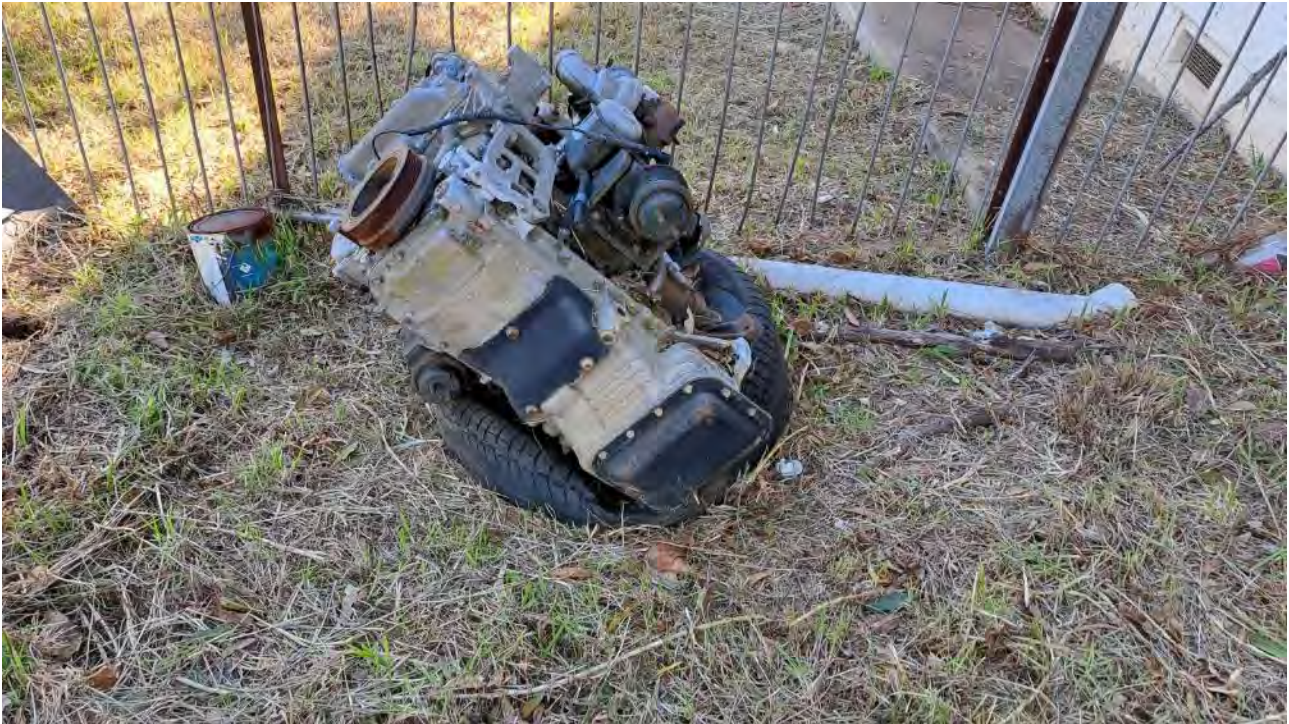
There was visual evidence observed during the walkover to indicate the storage of wastes on the site, specifically boat and vehicle parts. A boat motor, six car/boat batteries, an exhaust pipe and several other vehicle parts were observed to be placed on an unsealed surface adjacent to the house, located in the southeast section of the site.

**Image 6.8.1 View of boat motor resting on a tyre, located adjacent to the dwelling**

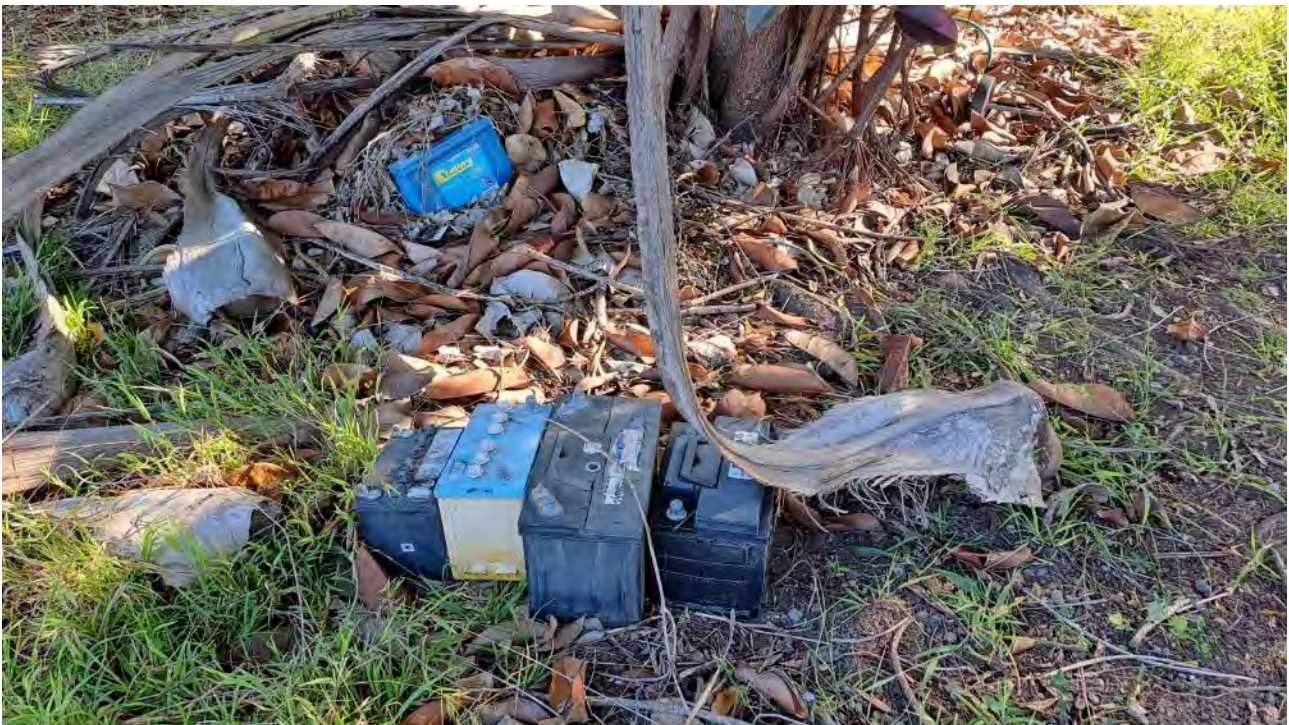
**Image 6.8.2 View of vehicle batteries sitting on an unsealed surface, adjacent to the house**

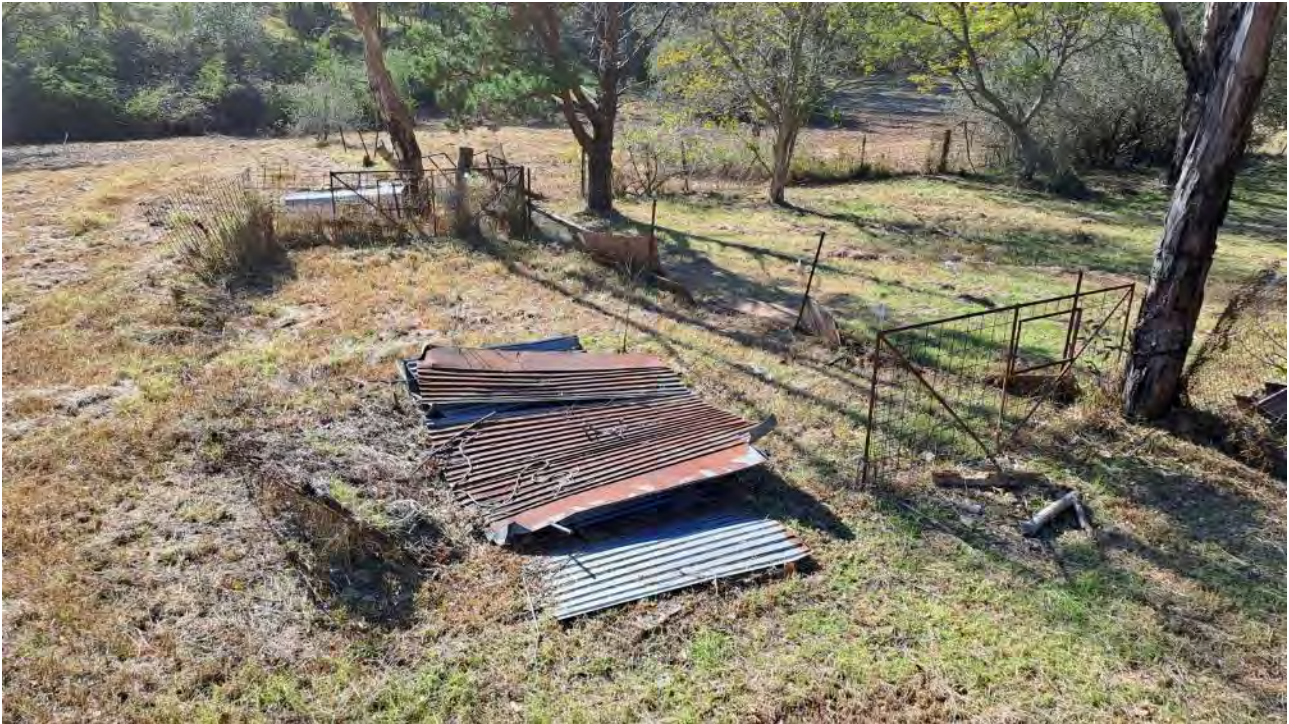
**Image 6.8.3 View of presumed chicken pen on an unsealed surface, with corrugated metal roofing sheets**

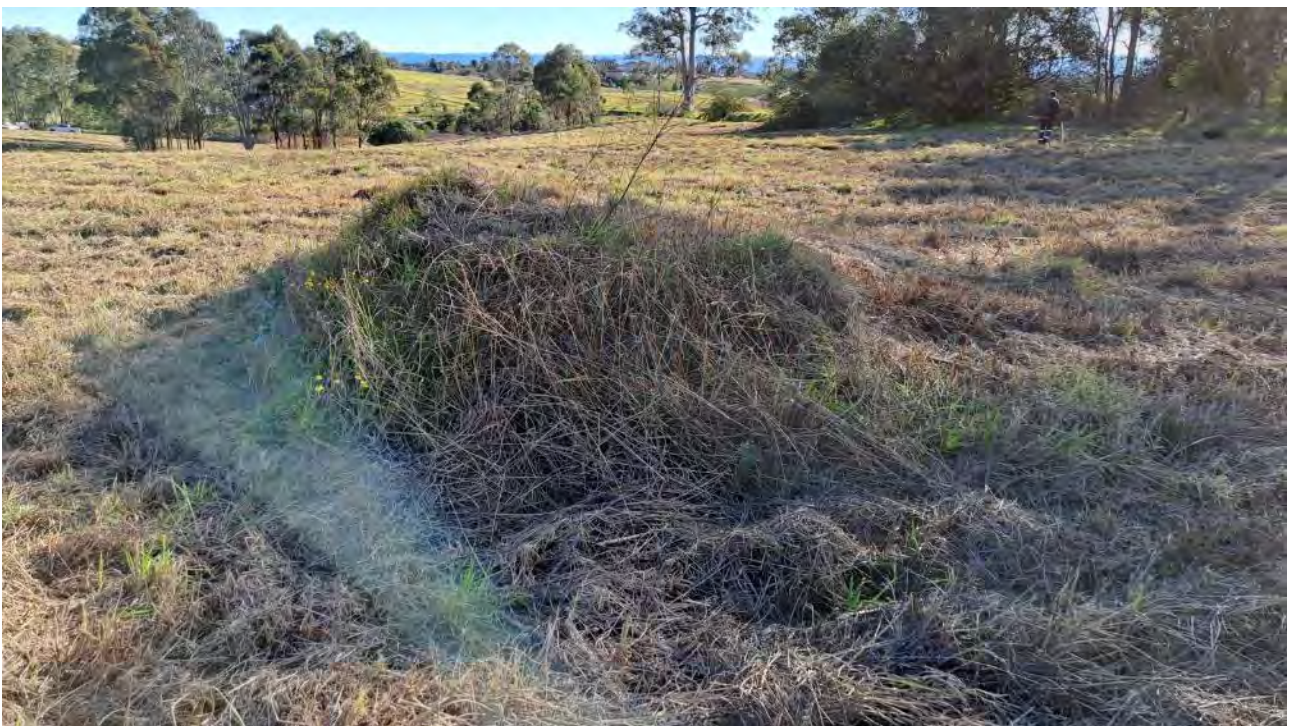
Three soil stockpiles were observed at the site, referred to as stockpile 1, stockpile 2 and stockpile 3 herein.

**Image 6.8.2 View of stockpile 1 within the northern portion of the site, facing west**

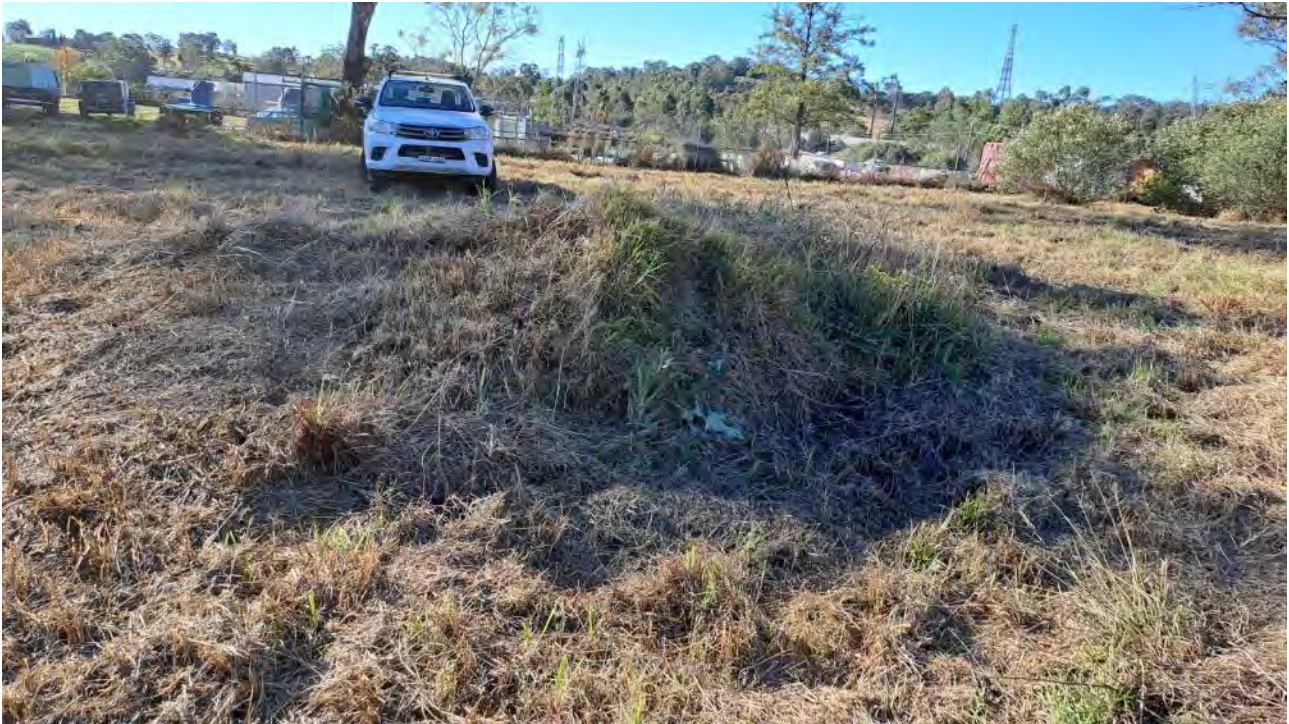
**Image 6.8.3 View of stockpile 2 within the northern portion of the site, facing north**

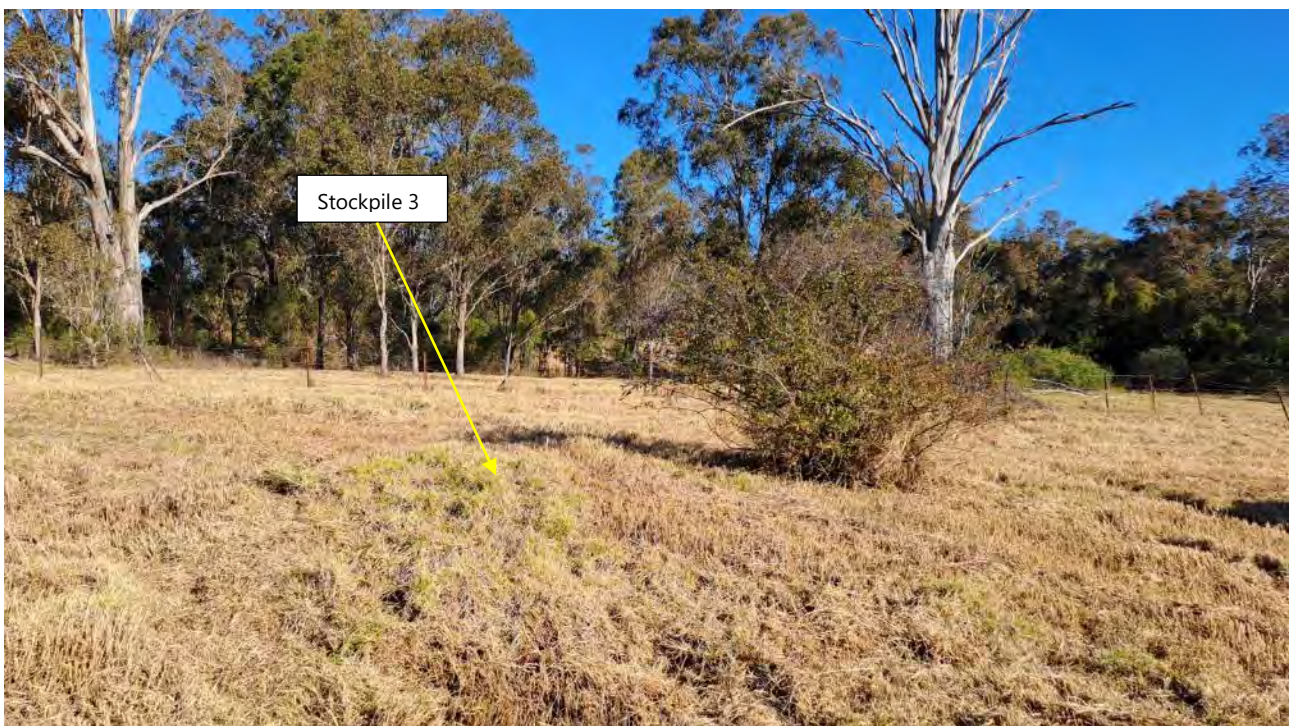
Stockpile 3 was located in the central portion of the site and was estimated to be approximately 10m<sup>3</sup> in volume. The surface of the stockpile was generally covered with grass.

**Image 6.8.4 View of stockpile 3 within the northern portion of the site, facing south**

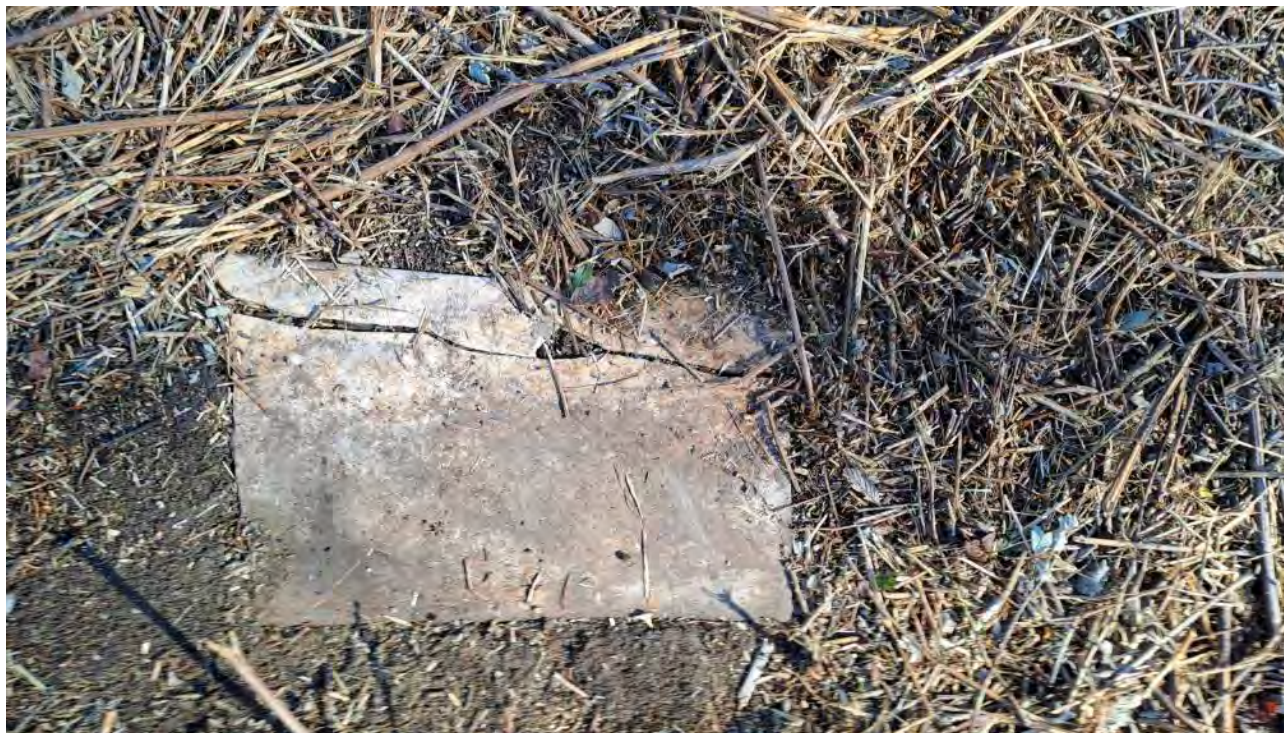
### Image 6.10.1 View of broken ACM sheet, located to the immediate north of the dwelling

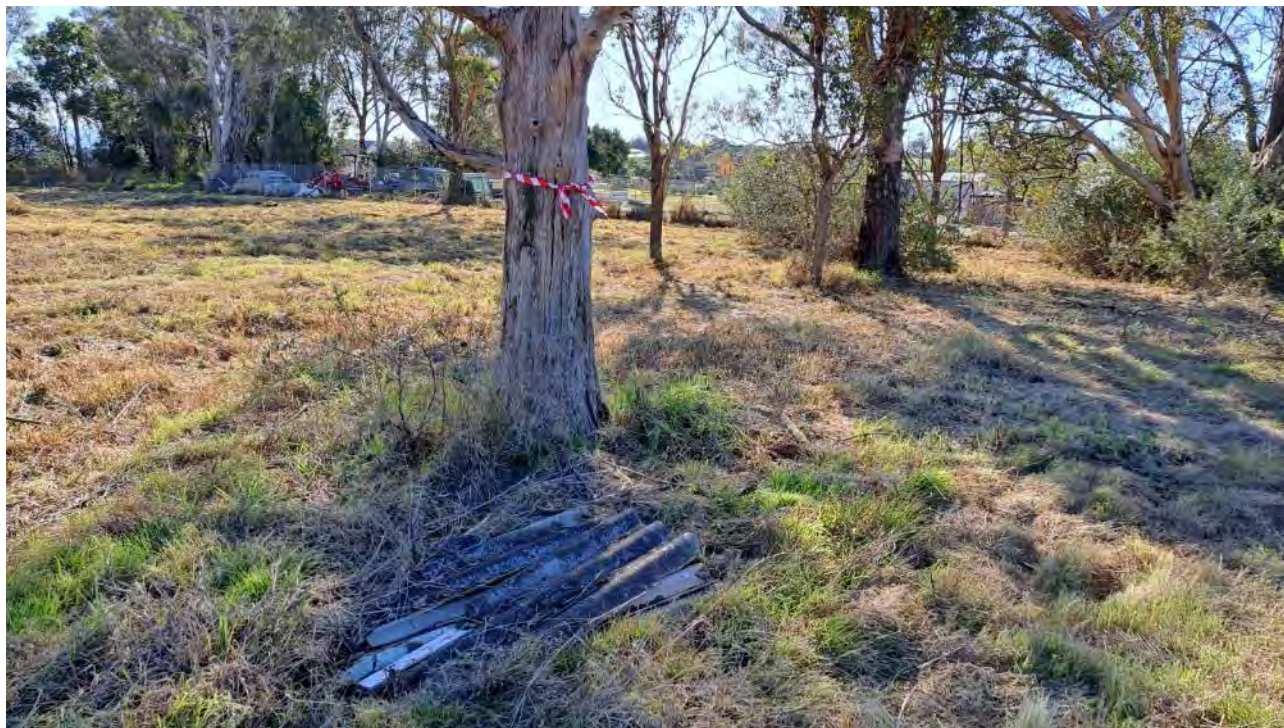
**Image 6.10.2 View of corrugated ACM roofing sheets, in the northeast portion of the site**

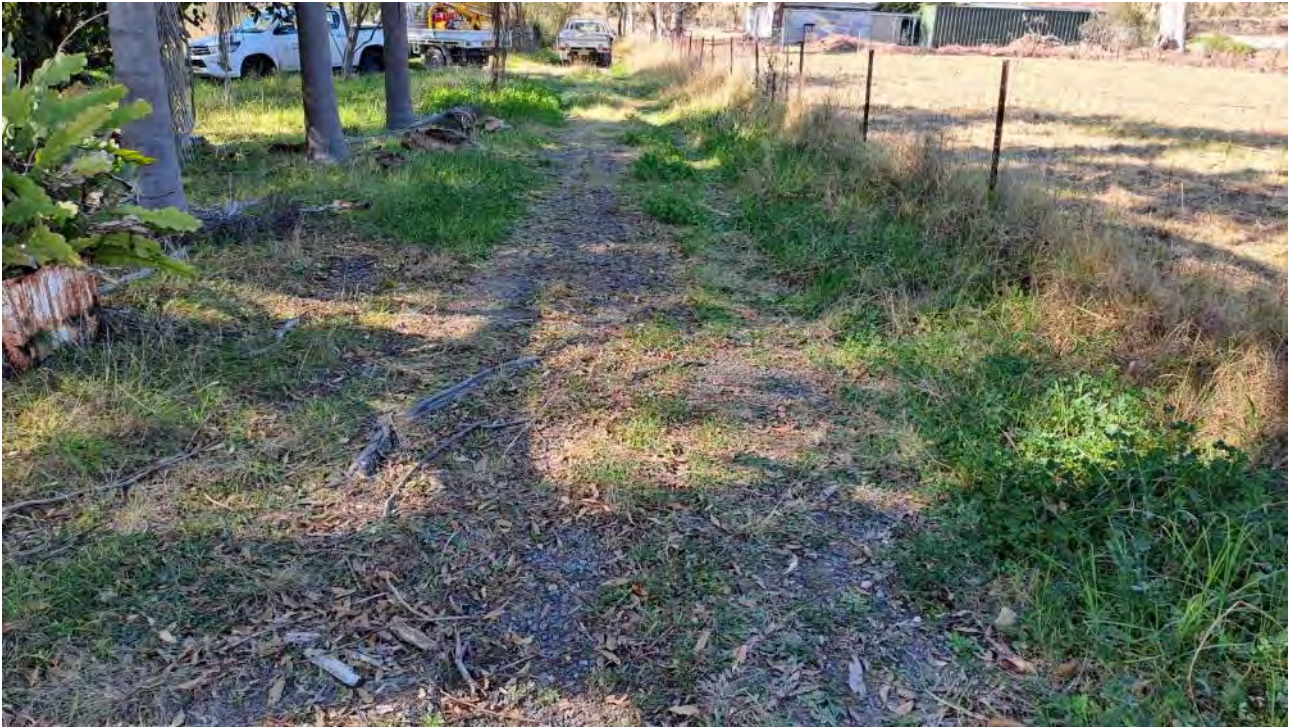
There was no visual evidence observed to suggest widespread filling observed at the site. However, there was visual evidence of potential shallow filling in the driveway, located in the southeast portion of the site.

**Image 6.11.1 View of unpaved driveway with potential shallow filling, facing east**

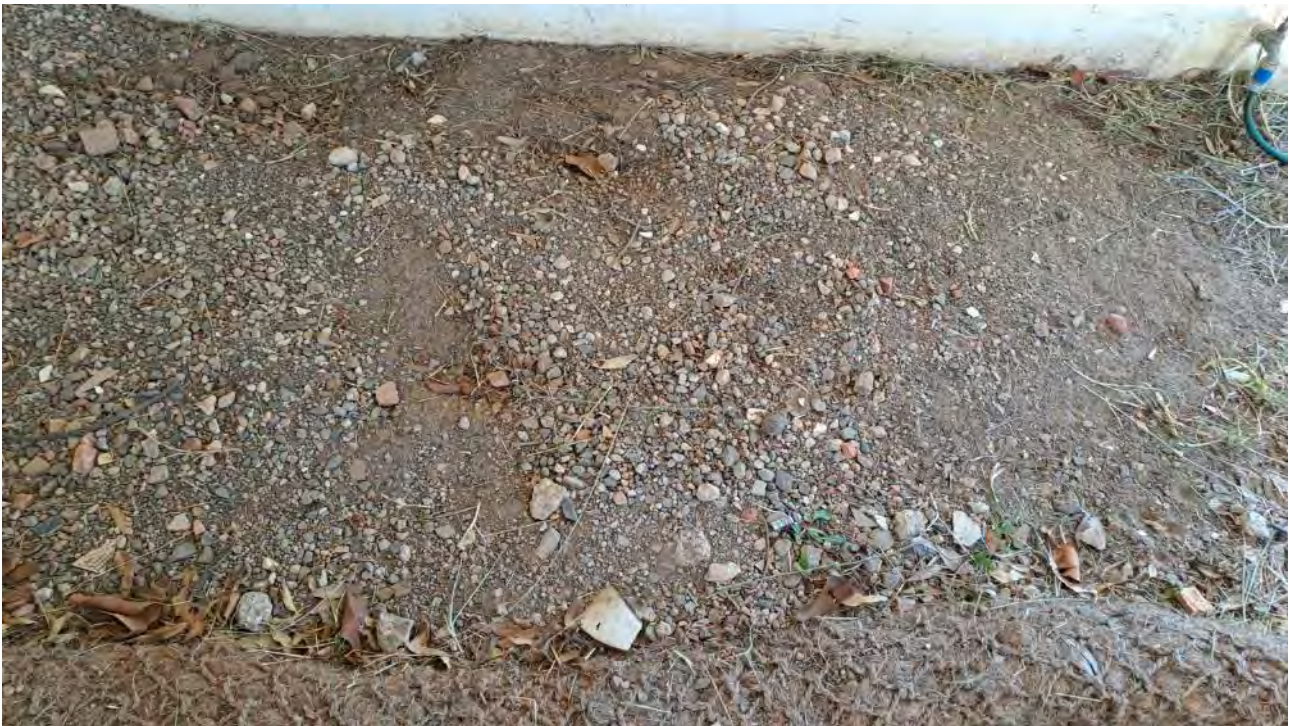
**Image 6.11.2 View of shallow filling observed in garden bed, along the southern wall of the house**

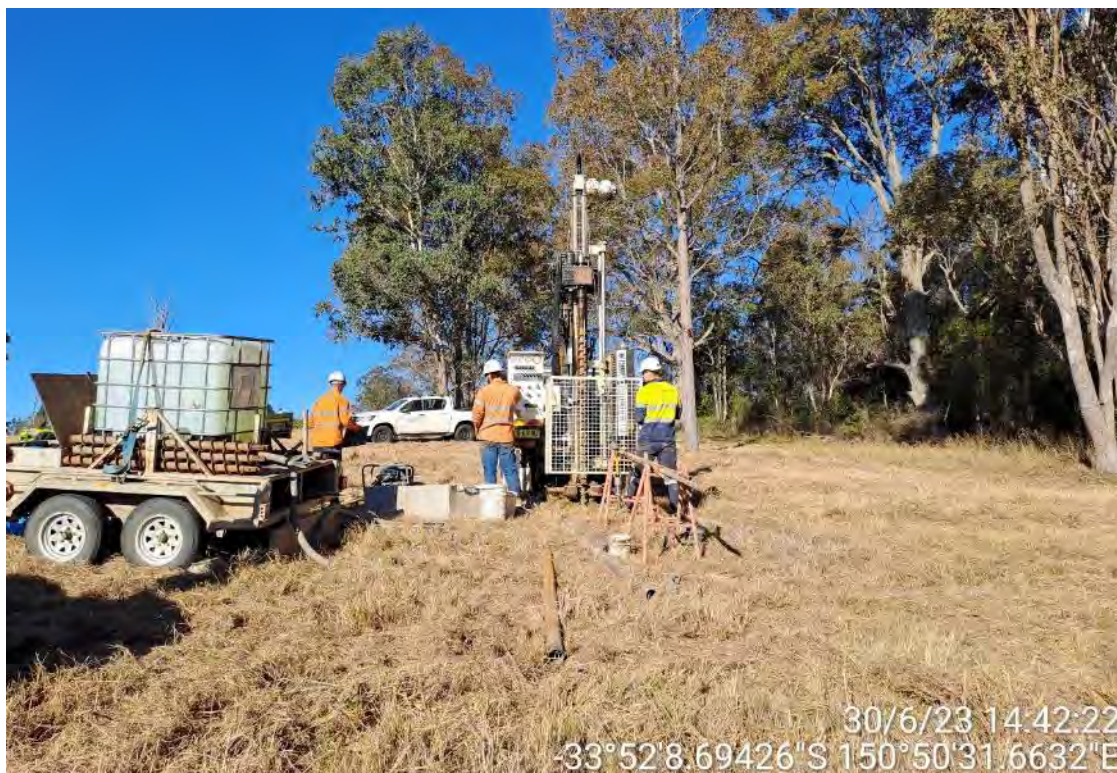
CS undertook a preliminary field investigation to understand the risk of subsoil contamination at the site at the request of the client. This investigation was undertaken opportunistically alongside a geotechnical investigation of the site (CS, 2023). CS notes that the sampling strategy and frequency adopted here is insufficient for a comprehensive assessment of site suitability in reference to NSW EPA sampling guidelines (NSW EPA, 2022) and that the data obtained is indicative of general site conditions only.

**Image 8.1.1 View of sampling work at BH05, facing east**
