# METROPOLITAN COAL    LONGWALLS 311-316

## BIODIVERSITY MANAGEMENT PLAN

May 2025

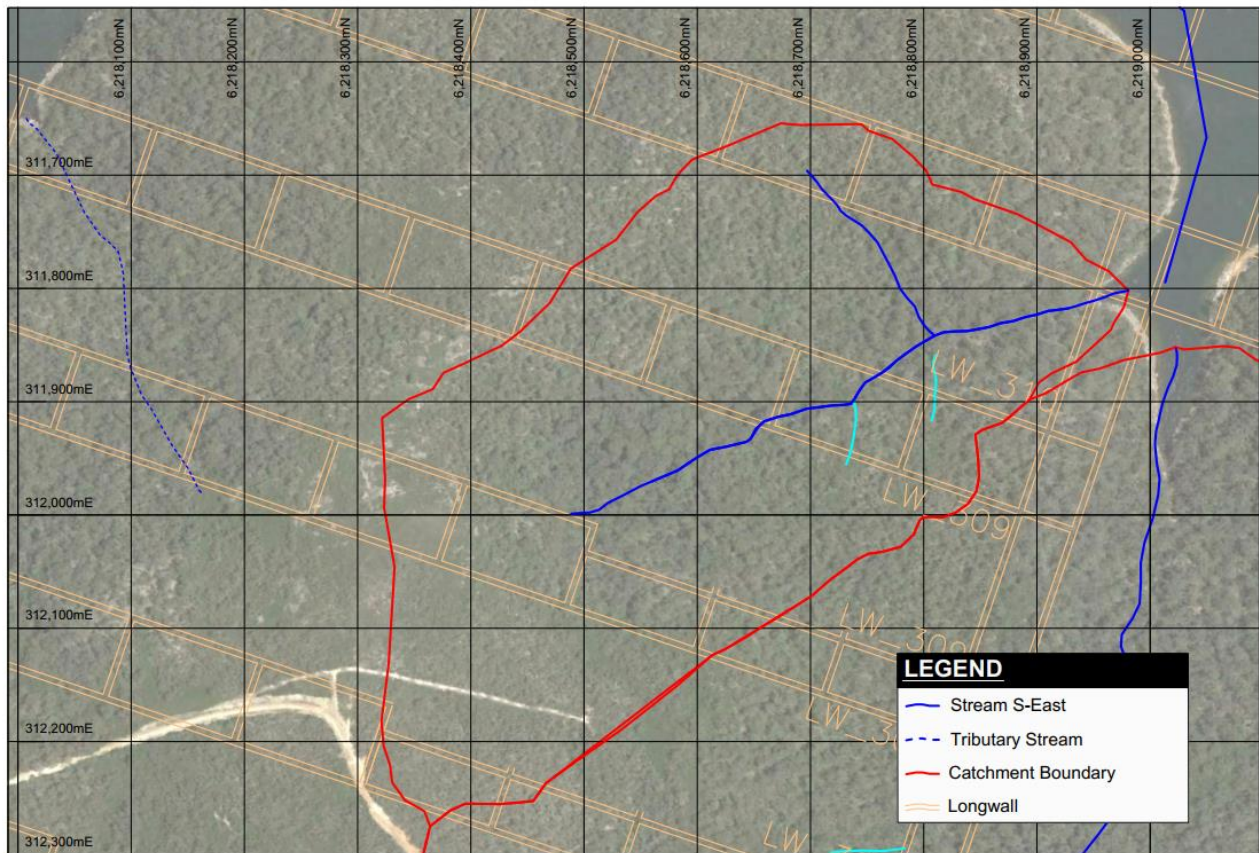
**Figure 15 Stream S-East Catchment**

Stream S-East is joined by a small stream which flowed through a confined valley – refer Figure 15. The upper sections comprised a steep, gully form with ill-defined drainage channels and boulder cascades. Several pools were observed in the lower reaches with two medium pools near the confluence of the two arms of the stream. There was no significant flow observed and no visible flow at either the stream confluence or at the outflow to the Woronora Reservoir.

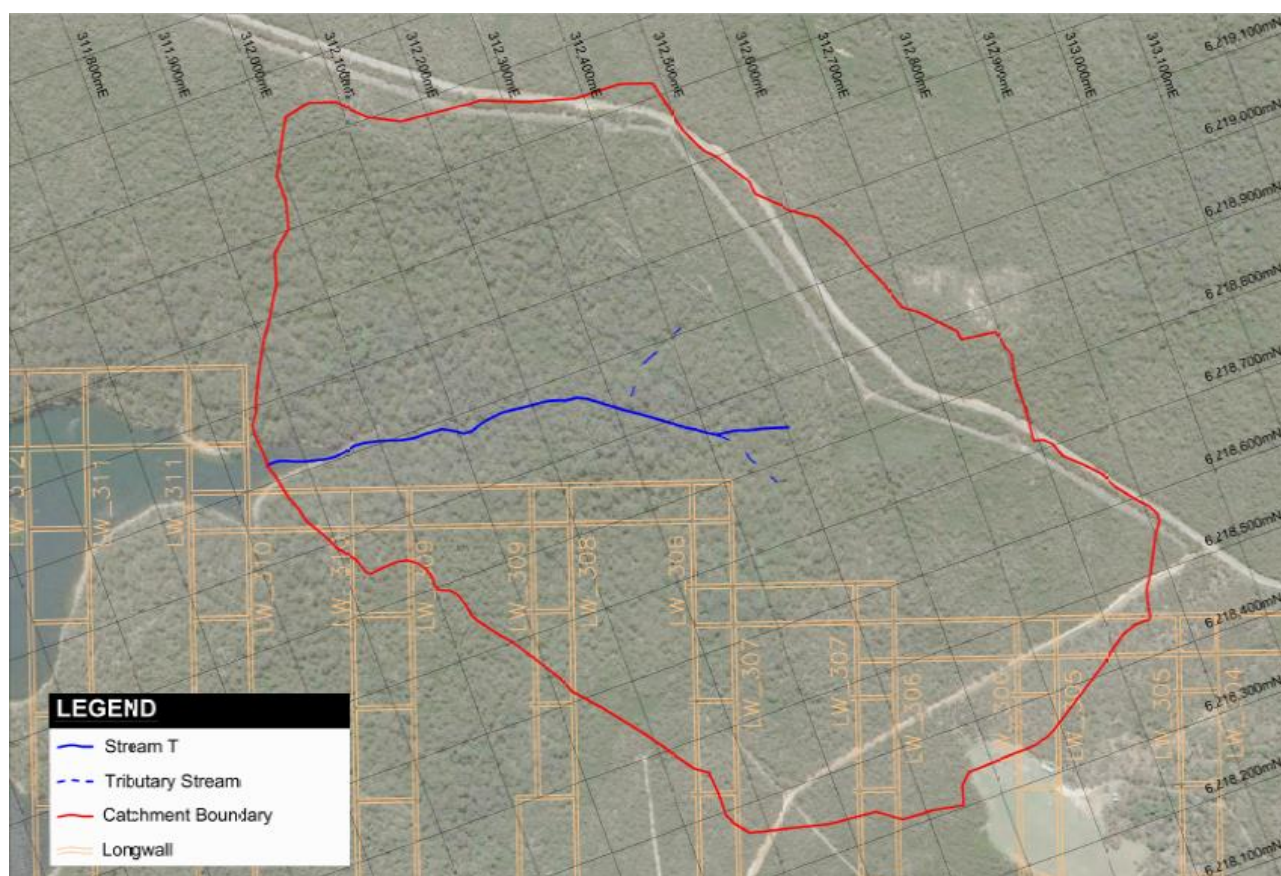
**Figure 17 Stream T Catchment**

Stream T is a small second order stream – refer Figure 17. The stream morphology is similar to Stream S-East. There was a small continuous flow in the lower reaches of the stream which carried through to the Woronora Reservoir. The medium and larger pools mapped were larger than those observed in Stream S-East.

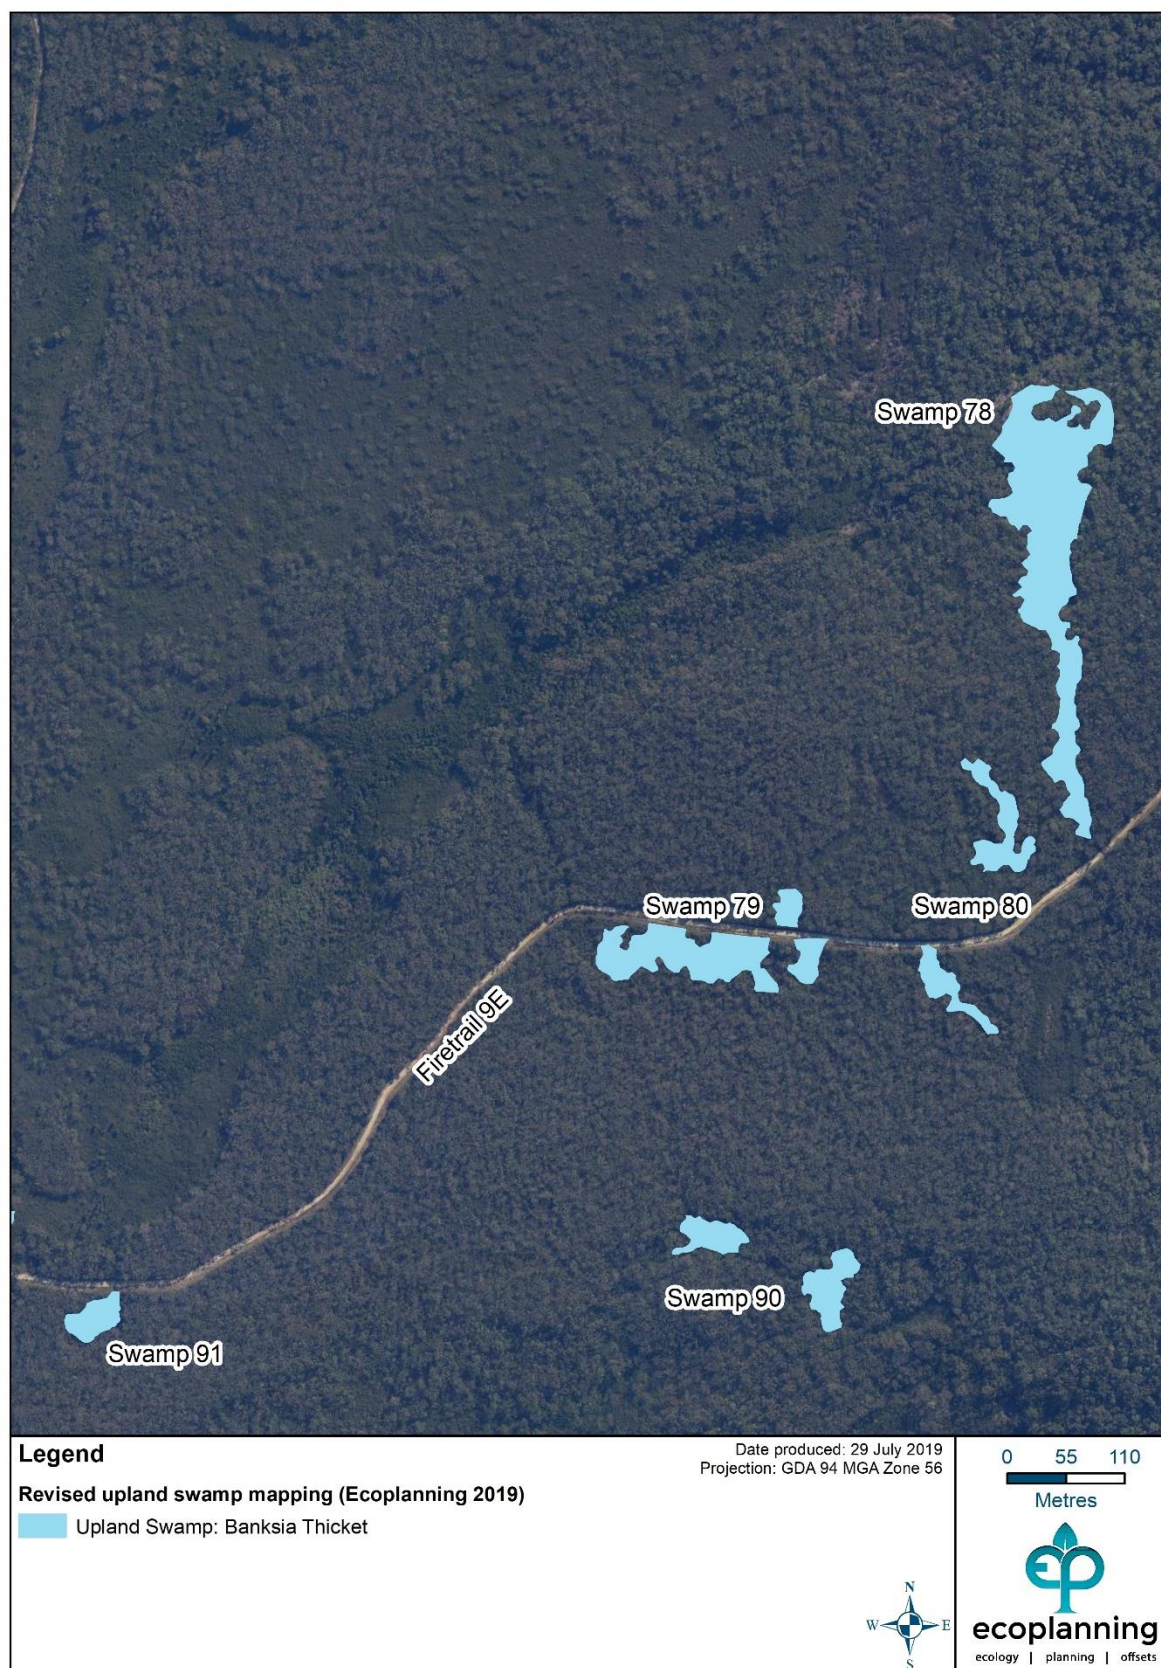
Figure 3.1: Revised upland swamp vegetation mapping extent (Ecoplanning 2019)

Profiles for each of the swamps including the specific vegetation community confirmed as occurring, updated boundaries, photos and key characteristics of each swamp are also provided in **Appendix A**. The revised vegetation community mapping (as a result of the revised upland swamp boundaries and vegetation community classification within 600 m of Longwalls 311-315 secondary extraction) by Ecoplanning (2019) is shown on **Figure 3.1** and **Figure 3.2**.
