# YANCO CREEK MODERNISATION PROJECT: PART 2 – BILLABONG CREEK REGULATORS NEW SOUTH WALES

ABORIGINAL CULTURAL HERITAGE ASSESSMENT

FINAL REPORT

31 July 2025

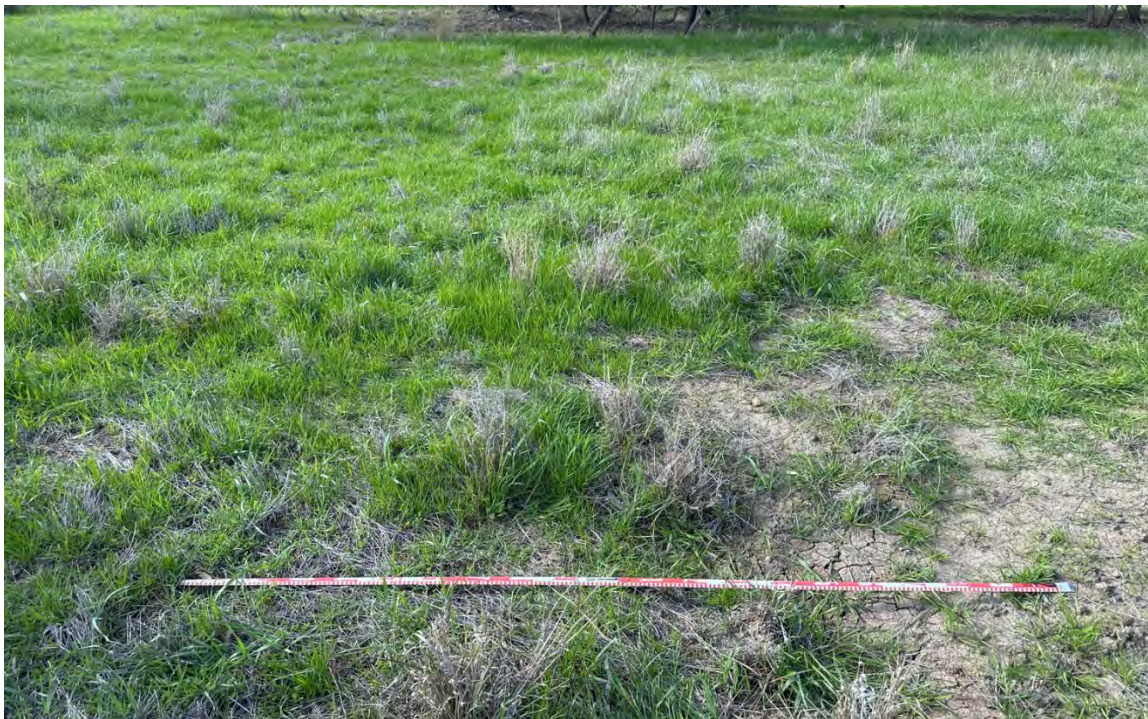
**Figure 7.15** North-east facing view of potential hearth with clay ball and heat retaining material at Hartwood Weir study area.  
*Photograph taken on 13 July 2023 by Nicole Monk.*

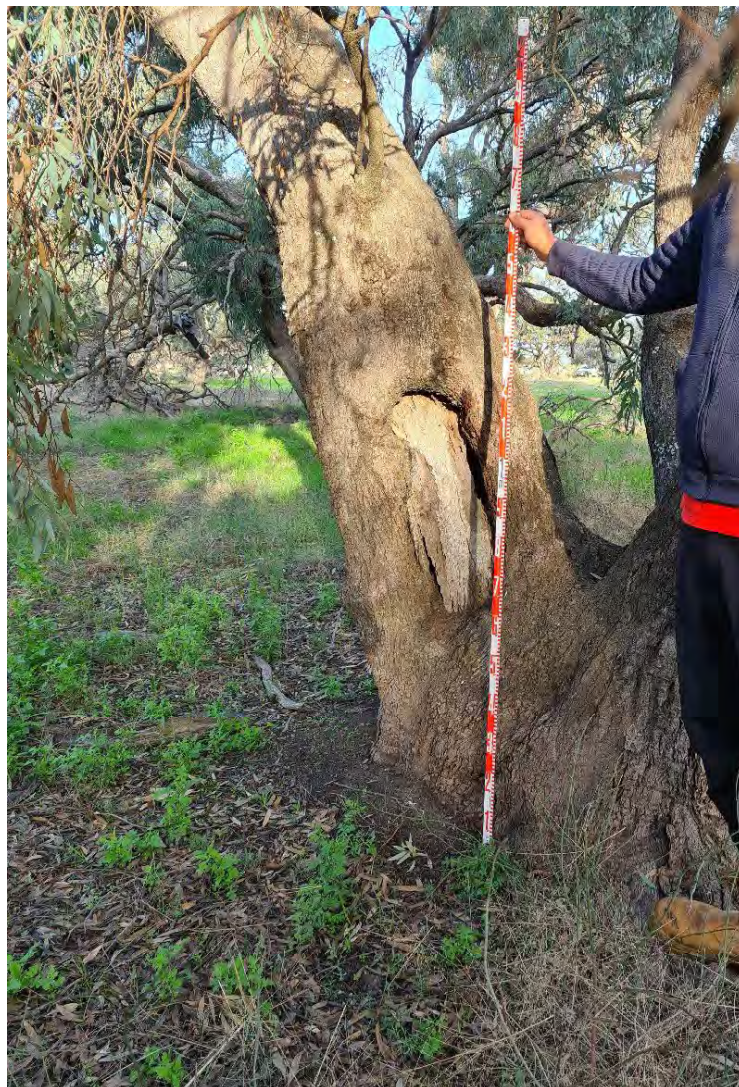
**Figure 7.62** South-facing-view of Forest Creek Block Bank Scarred Tree 2 (AHIMS # 54-3-0031), re-identified during the pedestrian survey of Forest Creek Block Bank.

| Site / AHIMS | Aboriginal cultural heritage values | Significance | Impact |
|---|---|---|---|
| <b>Forest Creek Block Bank Scarred Tree 2 / AHIMS # 54-3-0031</b> | Forest Creek Block Bank Scarred Tree 2 (AHIMS # 54-3-0031) is a scar tree in good condition and is not associated with any other sites. This form of scar tree is common within the surrounding region; however, scar trees are a declining cultural site since they are dependent on the life of the tree. It offers very little educational or research potential. Therefore, Forest Creek Block Bank Scarred Tree 2 (AHIMS # 54-3-0031) has a moderate scientific value at a local level. | Moderate | This site will be partially harmed through trimming and removal of branches.<br>The impact is considered minimal.<br>The site is to be managed through the preparation of an Aboriginal Cultural Heritage Management Plan. |

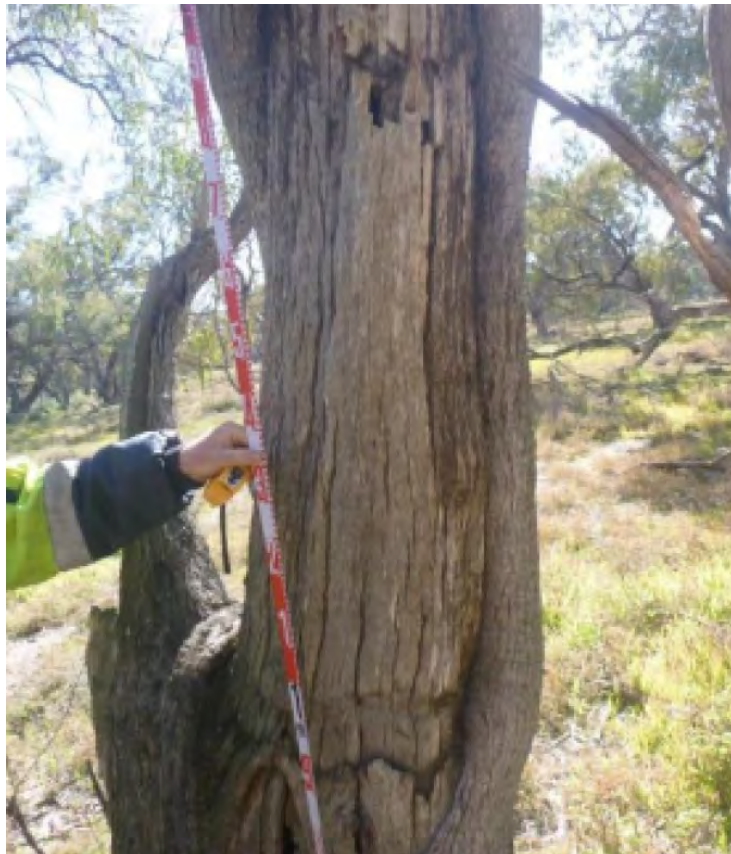
**Figure 7.63** South-facing-view of Forest Creek Block Bank Scarred Tree 3 (AHIMS # 54-3-0034), re-identified during the pedestrian survey of Forest Creek Block Bank.

| Site / AHIMS | Aboriginal cultural heritage values | Significance | Impact |
|---|---|---|---|
| <b>Forest Creek Block Bank Scarred Tree 3 / AHIMS # 54-3-0034</b> | Forest Creek Block Bank Scarred Tree 3 (AHIMS # 54-3-0034) is a scarred tree in good condition and is not associated with any other sites. This form of scarred tree is common within the surrounding region; however, scarred trees are a declining cultural site since they are dependent on the life of the tree. It offers very little educational or research potential. Therefore, Forest Creek Block Bank Scarred Tree 3 (AHIMS # 54-3-0034) has a moderate scientific value at a local level. | Moderate | This site was unable to be relocated during Austral's survey. If it is relocated the recommendation is to, avoid the site. The drip line of the tree using site extents from the site card should be the buffer zone. |

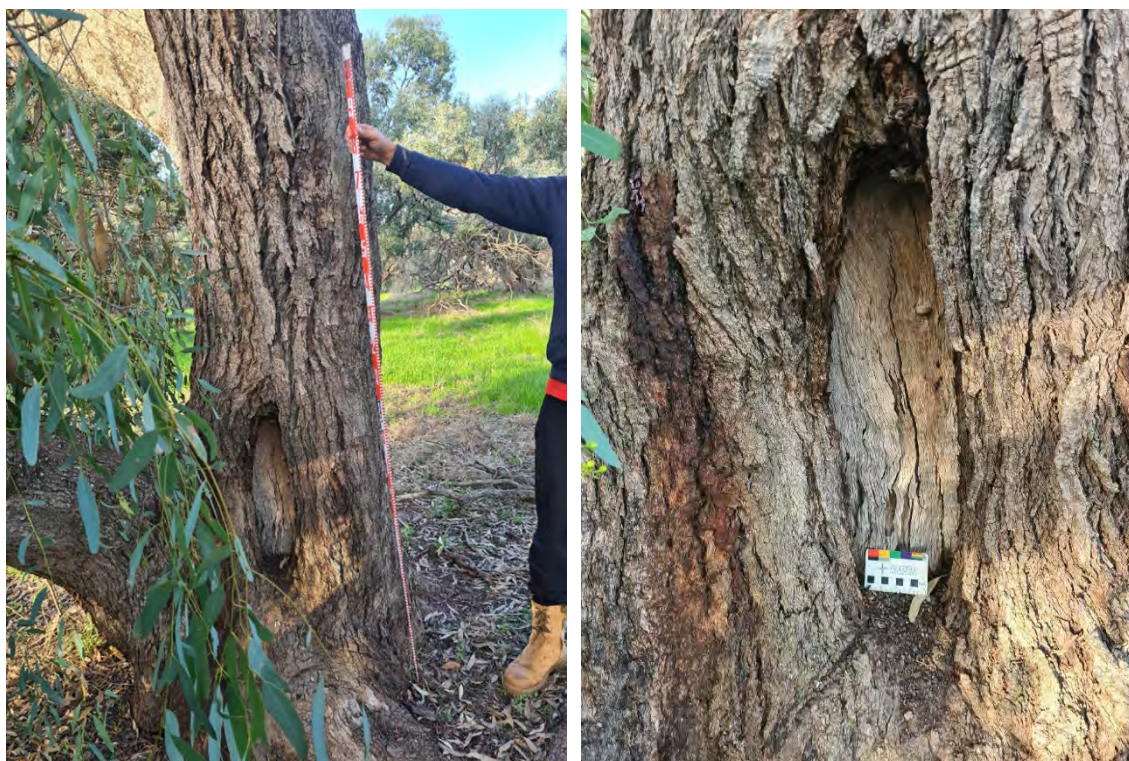
**Figure 7.64** East-facing view of Forest Creek Block Bank Scarred Tree 4 (AHIMS # 54-3-0057).

| Site / AHIMS | Aboriginal cultural heritage values | Significance | Impact |
|---|---|---|---|
| <b>Forest Creek Block Bank Scarred Tree 4 / AHIMS # 54-3-0057</b> | Forest Creek Block Bank Scarred Tree 4 (AHIMS # 54-3-0057) is a scar tree in good condition and is not associated with any other sites. This form of scar tree is common within the surrounding region; however, scar trees are a declining cultural site since they are dependent on the life of the tree. It offers very little educational or research potential. Therefore, Forest Creek Block Bank Scarred Tree 4 (AHIMS # 54-3-0057) has a moderate scientific value at a local level. | Moderate | This site will be partially harmed through trimming and removal of branches. The impact is considered minimal. The site is to be managed through the preparation of an ACHMP. |

- Forest Creek Block Bank Scarred Tree 4 (AHIMS # 54-3-0057): trimming to be conducted by qualified arborist and under supervision of RAPs, and
  - Wanganella Weir Scarred Tree 3 (AHIMS # 54-2-0264) digital recording of the tree using LIDAR scanning and casting of the scar; followed by careful removal of the tree avoiding damage to the cultural modification of the tree.

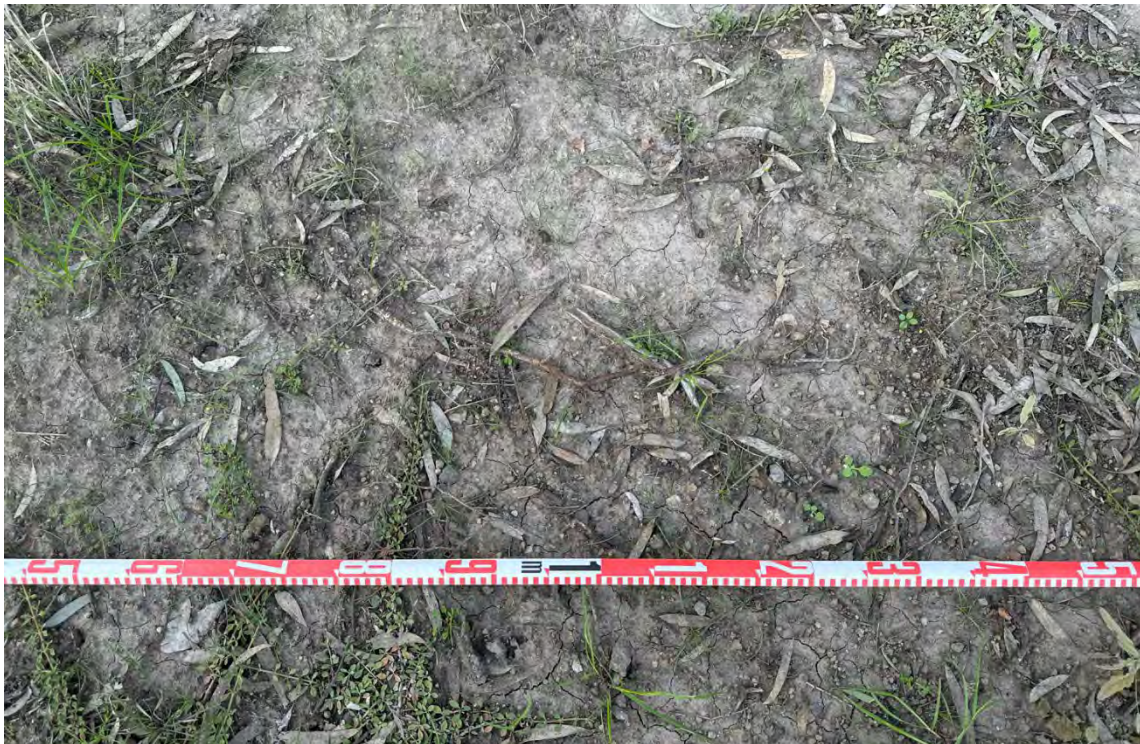
**Figure 7.66** Exposed clay balls within the identified earth mound site.  
*Photograph taken on 13 July 2023 by Madelaine Firth.*

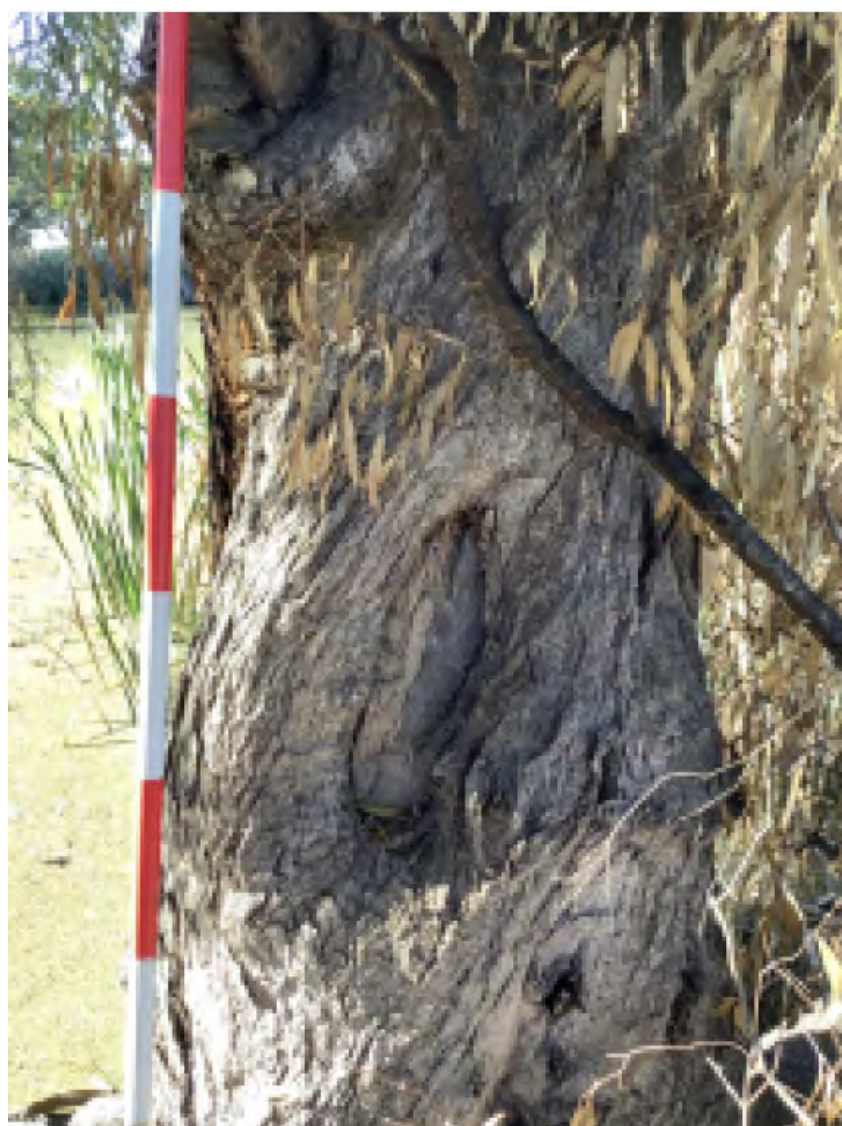
**Figure 7.67** Close up of Hartwood Weir Scarred Tree 1 (AHIMS # 54-3-0026)

| Site / AHIMS | Aboriginal cultural heritage values | Significance | Impact |
|---|---|---|---|
| <b>Hartwood Weir Scarred Tree 1 (AHIMS # 54-3-0026)</b> | Hartwood Weir Scarred Tree 1 (AHIMS # 54-3-0026) is scarred in good condition and is not associated with any other sites. This form of scarred tree is common within the surrounding region; however, scarred trees are a declining cultural site since they are dependent on the life of the tree. It offers very little educational or research potential. Therefore, Hartwood Weir Scarred Tree 1 (AHIMS # 54-3-0026) has a moderate scientific value at a local level. | Moderate | There will be no impact from the proposed works as the sites are adjacent to an existing access track that will not be widened/alterd during the proposed development. |

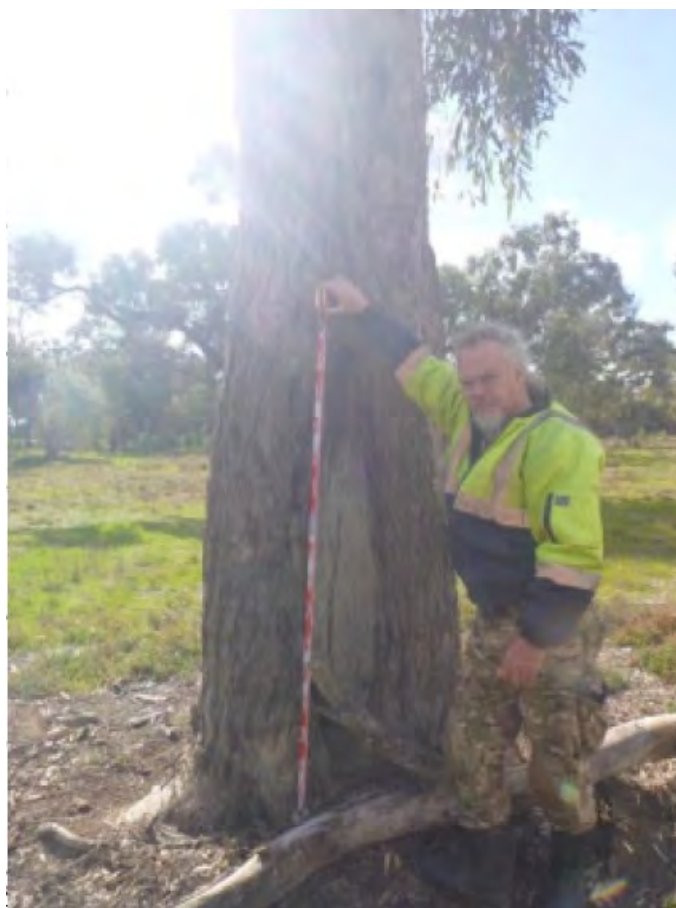
**Figure 7.68** North-west facing view of Hartwood Weir Scarred Tree 3 (AHIMS # 54-3-0029).

| Site / AHIMS | Aboriginal cultural heritage values | Significance | Impact |
|---|---|---|---|
| <b>Hartwood Weir Scarred Tree 3 (AHIMS # 54-3-0029)</b> | Hartwood Weir Scarred Tree 3 (AHIMS # 54-3-0029) is scarred in good condition and is not associated with any other sites. This form of scarred tree is common within the surrounding region; however, scarred trees are a declining cultural site since they are dependent on the life of the tree. It offers very little educational or research potential. Therefore, Hartwood Weir Scarred Tree 3 (AHIMS # 54-3-0029) has a moderate scientific value at a local level. | Moderate | There will be no impact from the proposed works as the sites are adjacent to an existing access track that will not be widened/alterd during the proposed development. |

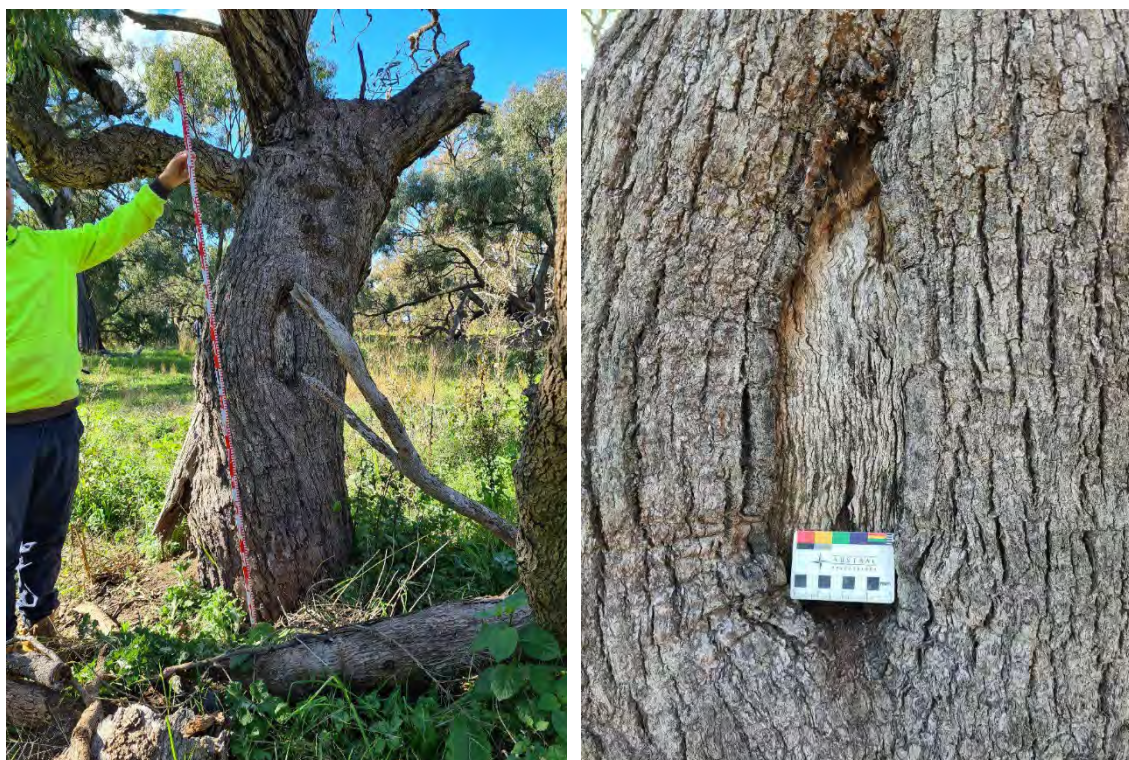
**Figure 7.69** East-facing view of Hartwood Weir Scarred Tree 4 (AHIMS # 54-3-0059).

| Site / AHIMS | Aboriginal cultural heritage values | Significance | Impact |
|---|---|---|---|
| <b>Hartwood Weir Scarred Tree 4 / AHIMS # 54-3-0059</b> | Hartwood Weir Scarred Tree 4 (AHIMS # 54-3-0059) is a scarred tree in good condition and is not associated with any other sites. This form of scarred tree is common within the surrounding region; however, scarred trees are a declining cultural site since they are dependent on the life of the tree. It offers very little educational or research potential. Therefore, Hartwood Weir Scarred Tree 4 (AHIMS # 54-3-0059) has a moderate scientific value at a local level. | Moderate | The site cannot be avoided and will be destroyed. Managed through the preparation of an ACHMP. |

- Hartwood Weir Scarred Tree 4 (AHIMS # 54-3-0059): digital recording of the tree using LIDAR scanning and casting of the scar; followed by careful removal of the tree avoiding damage to the cultural modification of the tree,

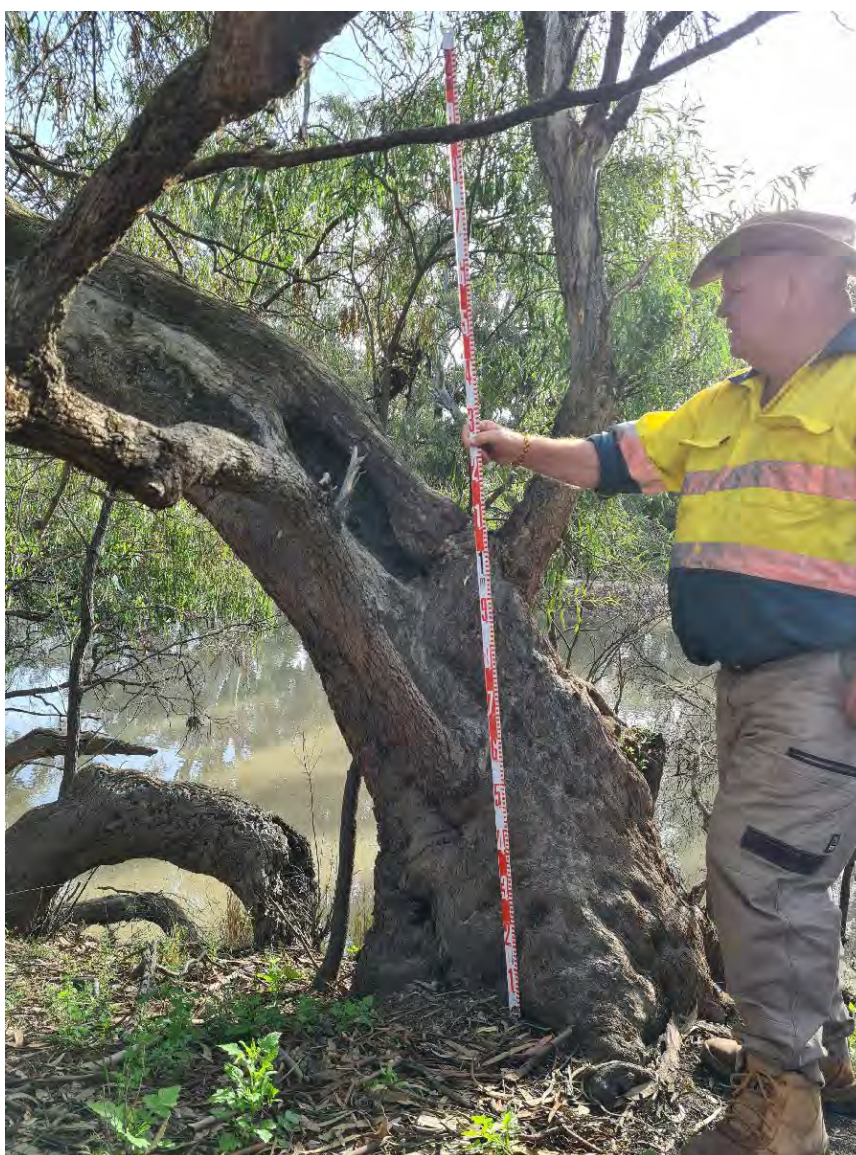
**Figure 7.76** North-facing view of Wanganella Weir Scarred Tree 1 (AHIMS # 54-2-0263).  
*Photograph taken on 13 July 2023 by Madelaine Firth.*

| Site / AHIMS | Aboriginal cultural heritage values | Significance | Impact |
|---|---|---|---|
| <b>Wanganella Weir Scarred Tree 1 / AHIMS # 54-2-0263</b> | Wanganella Weir Scarred Tree 1 (AHIMS # 54-2-0263) is a scarred tree in good condition and is not associated with any other sites. This site was initially recorded during a survey undertaken by Jacobs and was registered as W scar tree 1 (AHIMS #54-2-0252). It has since been reclassified as Wanganella Weir Scarred Tree 1 (AHIMS #54-2-0263). This form of scarred tree is common within the surrounding region; however, scarred trees are a declining cultural site since they are dependent on the life of the tree. It offers very little educational or research potential. Therefore, Wanganella Weir Scarred Tree 1 (AHIMS # 54-2-0263) has a moderate scientific value at a local level. | Moderate | No impact, the site can be avoided. The drip line of the tree should be the buffer zone. |

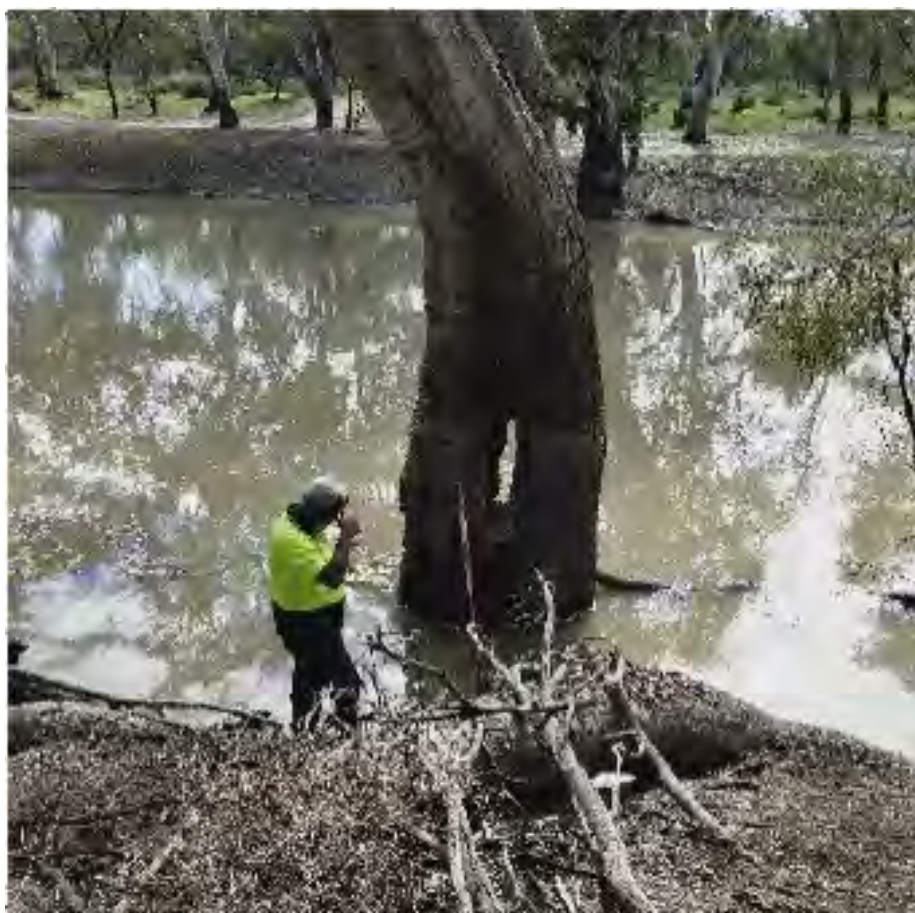
**Figure 7.77 View of W scar tree 2 (AHIMS # 54-2-0251) in the water.**

| Site / AHIMS | Aboriginal cultural heritage values | Significance | Impact |
|---|---|---|---|
| <b>W scar tree 2 (AHIMS # 54-2-0261)</b> | W scar tree 2 (AHIMS # 54-2-0251) is scarred in a disturbed condition and is not associated with any other sites. This form of scarred tree is common within the surrounding region; however, scarred trees are a declining cultural site since they are dependent on the life of the tree. It offers very little educational or research potential. Therefore, W scar tree 2 (AHIMS # 54-2-0251) has a moderate scientific value at a local level. | Moderate | There will be no impact from the proposed works as the sites are adjacent to an existing access track that will not be widened/alterd during the proposed development. |

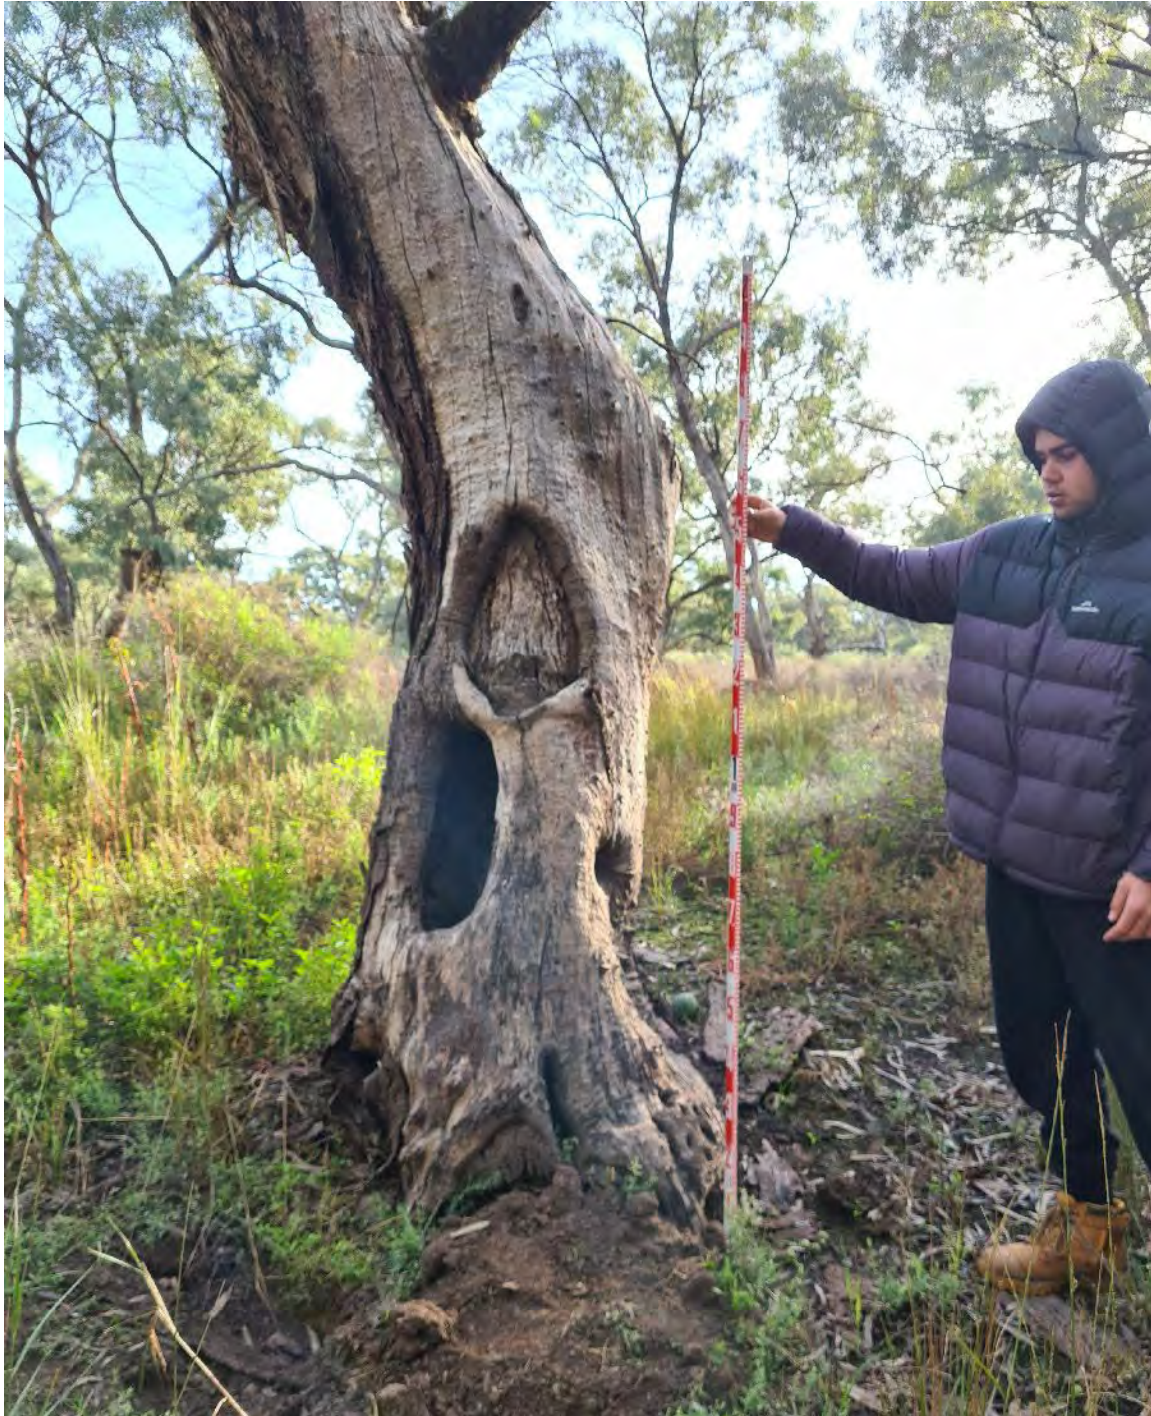
**Figure 7.78** North-facing view of Wanganella Weir Scarred Tree 3 (AHIMS # 54-2-0264).

| Site / AHIMS | Aboriginal cultural heritage values | Significance | Impact |
|---|---|---|---|
| <b>Wanganella Weir Scarred Tree 3 / AHIMS # 54-2-0264</b> | Wanganella Weir Scarred Tree 3 (AHIMS # 54-2-0264) is a scarred tree in good condition and is not associated with any other sites. This site was initially recorded during a survey undertaken by Jacobs and was registered as W scar tree 3 (AHIMS #54-2-0259). It has since been reclassified as Wanganella Weir Scarred Tree 3 (AHIMS #54-2-0264) This form of scarred tree is common within the surrounding region; however, scarred trees are a declining cultural site since they are dependent on the life of the tree. It offers very little educational or research potential. Therefore, Wanganella Weir Scarred Tree 3 (AHIMS # 54-2-0264) has a moderate scientific value at a local level. | Moderate | The site cannot be avoided and will be destroyed. Managed through the preparation of an ACHMP. |
