## L03 Chatswood Dive Site Summary\_Rev 2

### Summary of Site Contamination to Support SSDA and Concurrent Rezoning Proposal – Former Chatswood ‘Dive Site’, Corner of Pacific Highway and Mowbray Road, Chatswood NSW

Nation Partners Pty Ltd (Nation Partners) has been engaged by Sydney Metro to prepare a remediation action plan (RAP) for the property known as the Chatswood Metro site, located at the north-east corner of the Pacific Highway and Mowbray Road, Chatswood, New South Wales (NSW) (the site). The location and boundary of the site are shown on the below **Figure 1**. Nation Partners understands Sydney Metro intends to divest the site following completion of the Sydney Metro – City and Southwest (SMCS) project. Nation Partners completed a Data Gap Investigation (Nation Partners, 2021) which has been utilised to prepare this RAP. This RAP has been prepared to inform and guide the remediation and validation required for the potential redevelopment of the Chatswood Metro site.

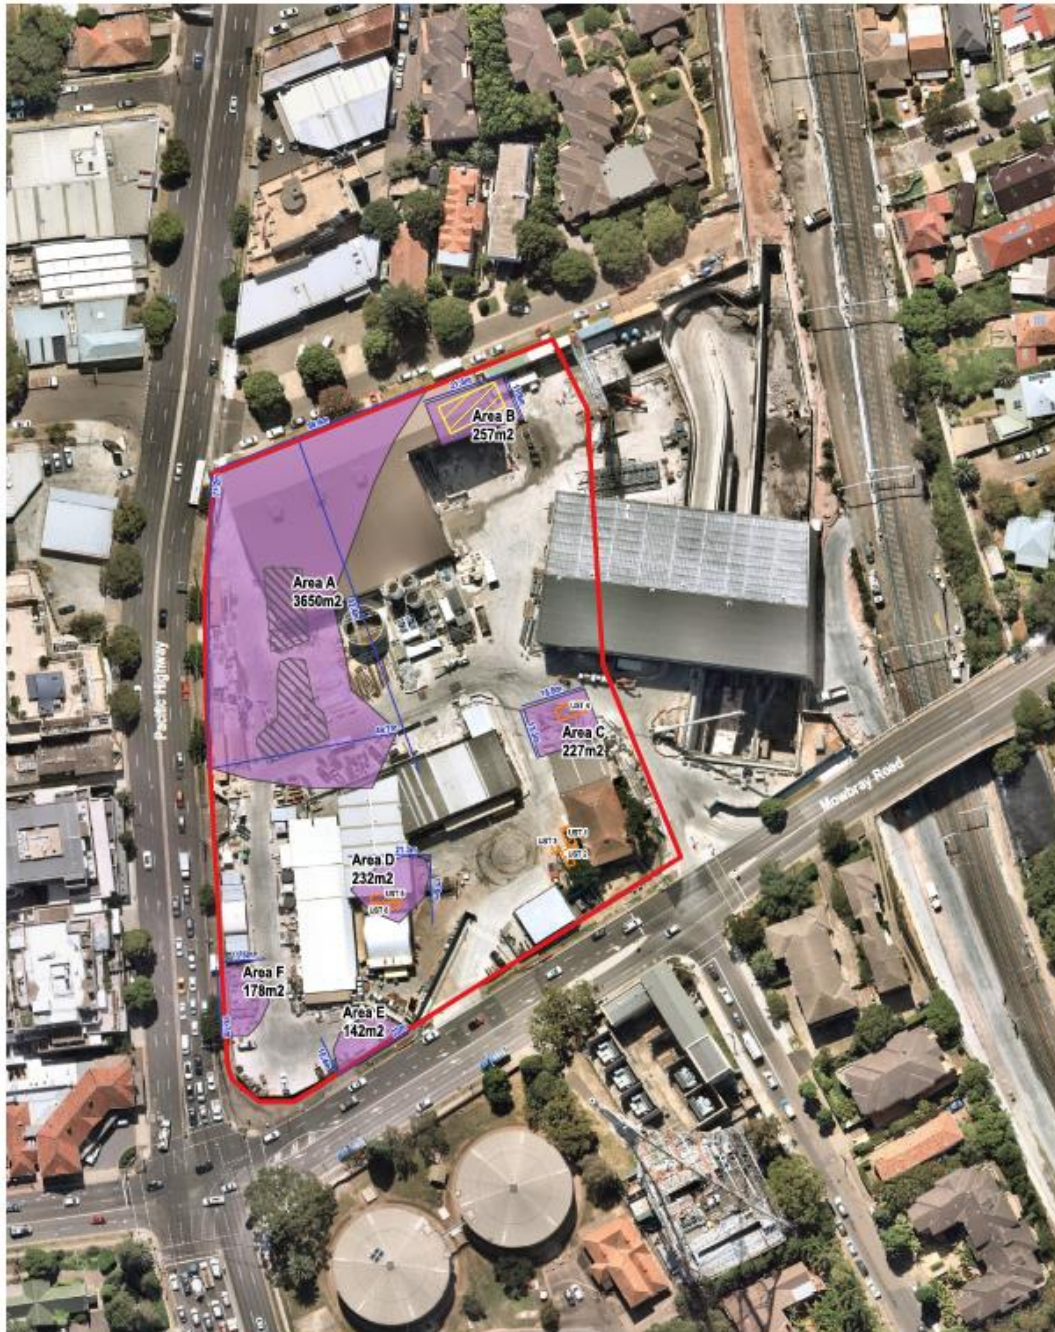
#### Appendix C-1: Indicative Extent of Remediation

| <b>Remediation Extent</b> | <p>The indicative extent of remediation, prior to refinement following the additional sampling, is defined as:</p> <ul style="list-style-type: none"> <li>» Remediation Area A – former asbestos burial pits, and chemical impacts associated with a former service station.</li> <li>» Remediation Area B – a former asbestos slab.</li> <li>» Remediation Area C – a former underground storage tank associated with a former energy depot.</li> <li>» Remediation Area D – two former USTs, also associated with the former energy depot.</li> <li>» Remediation Areas E and F – exceedances in shallow soils.</li> </ul> <p>The above indicative extents are shown on the below <b>Figure C-1</b>.</p> |

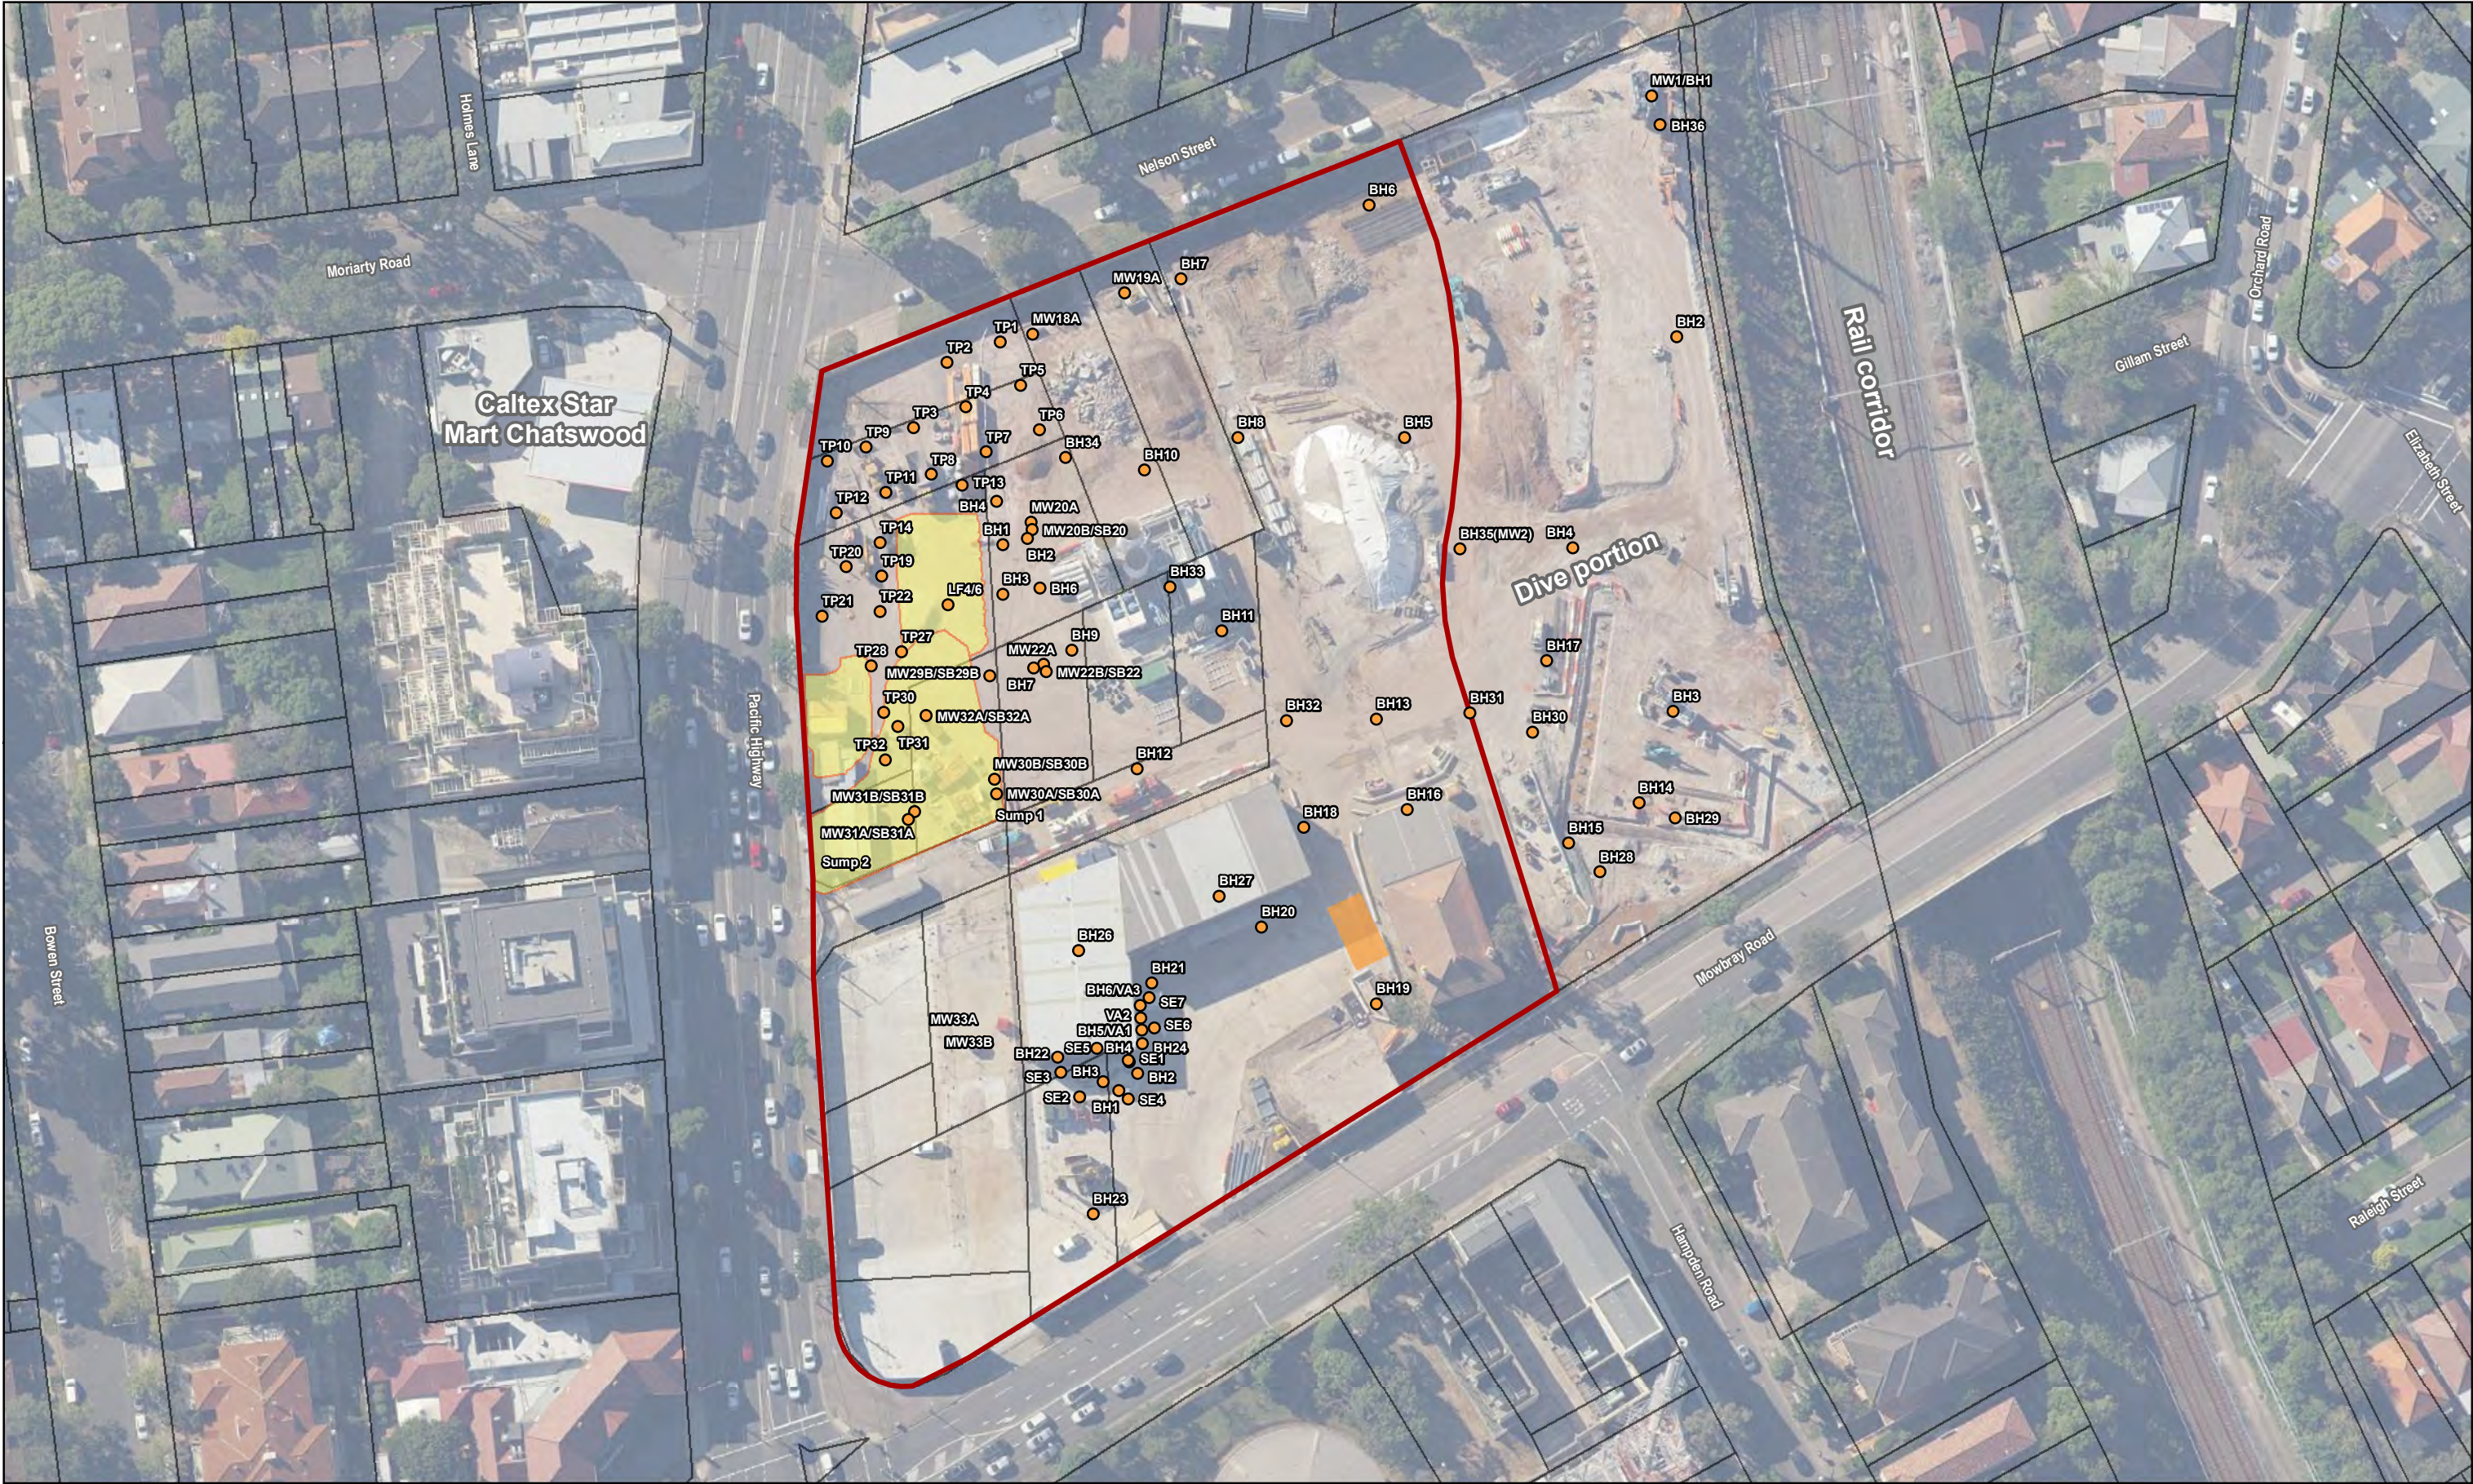
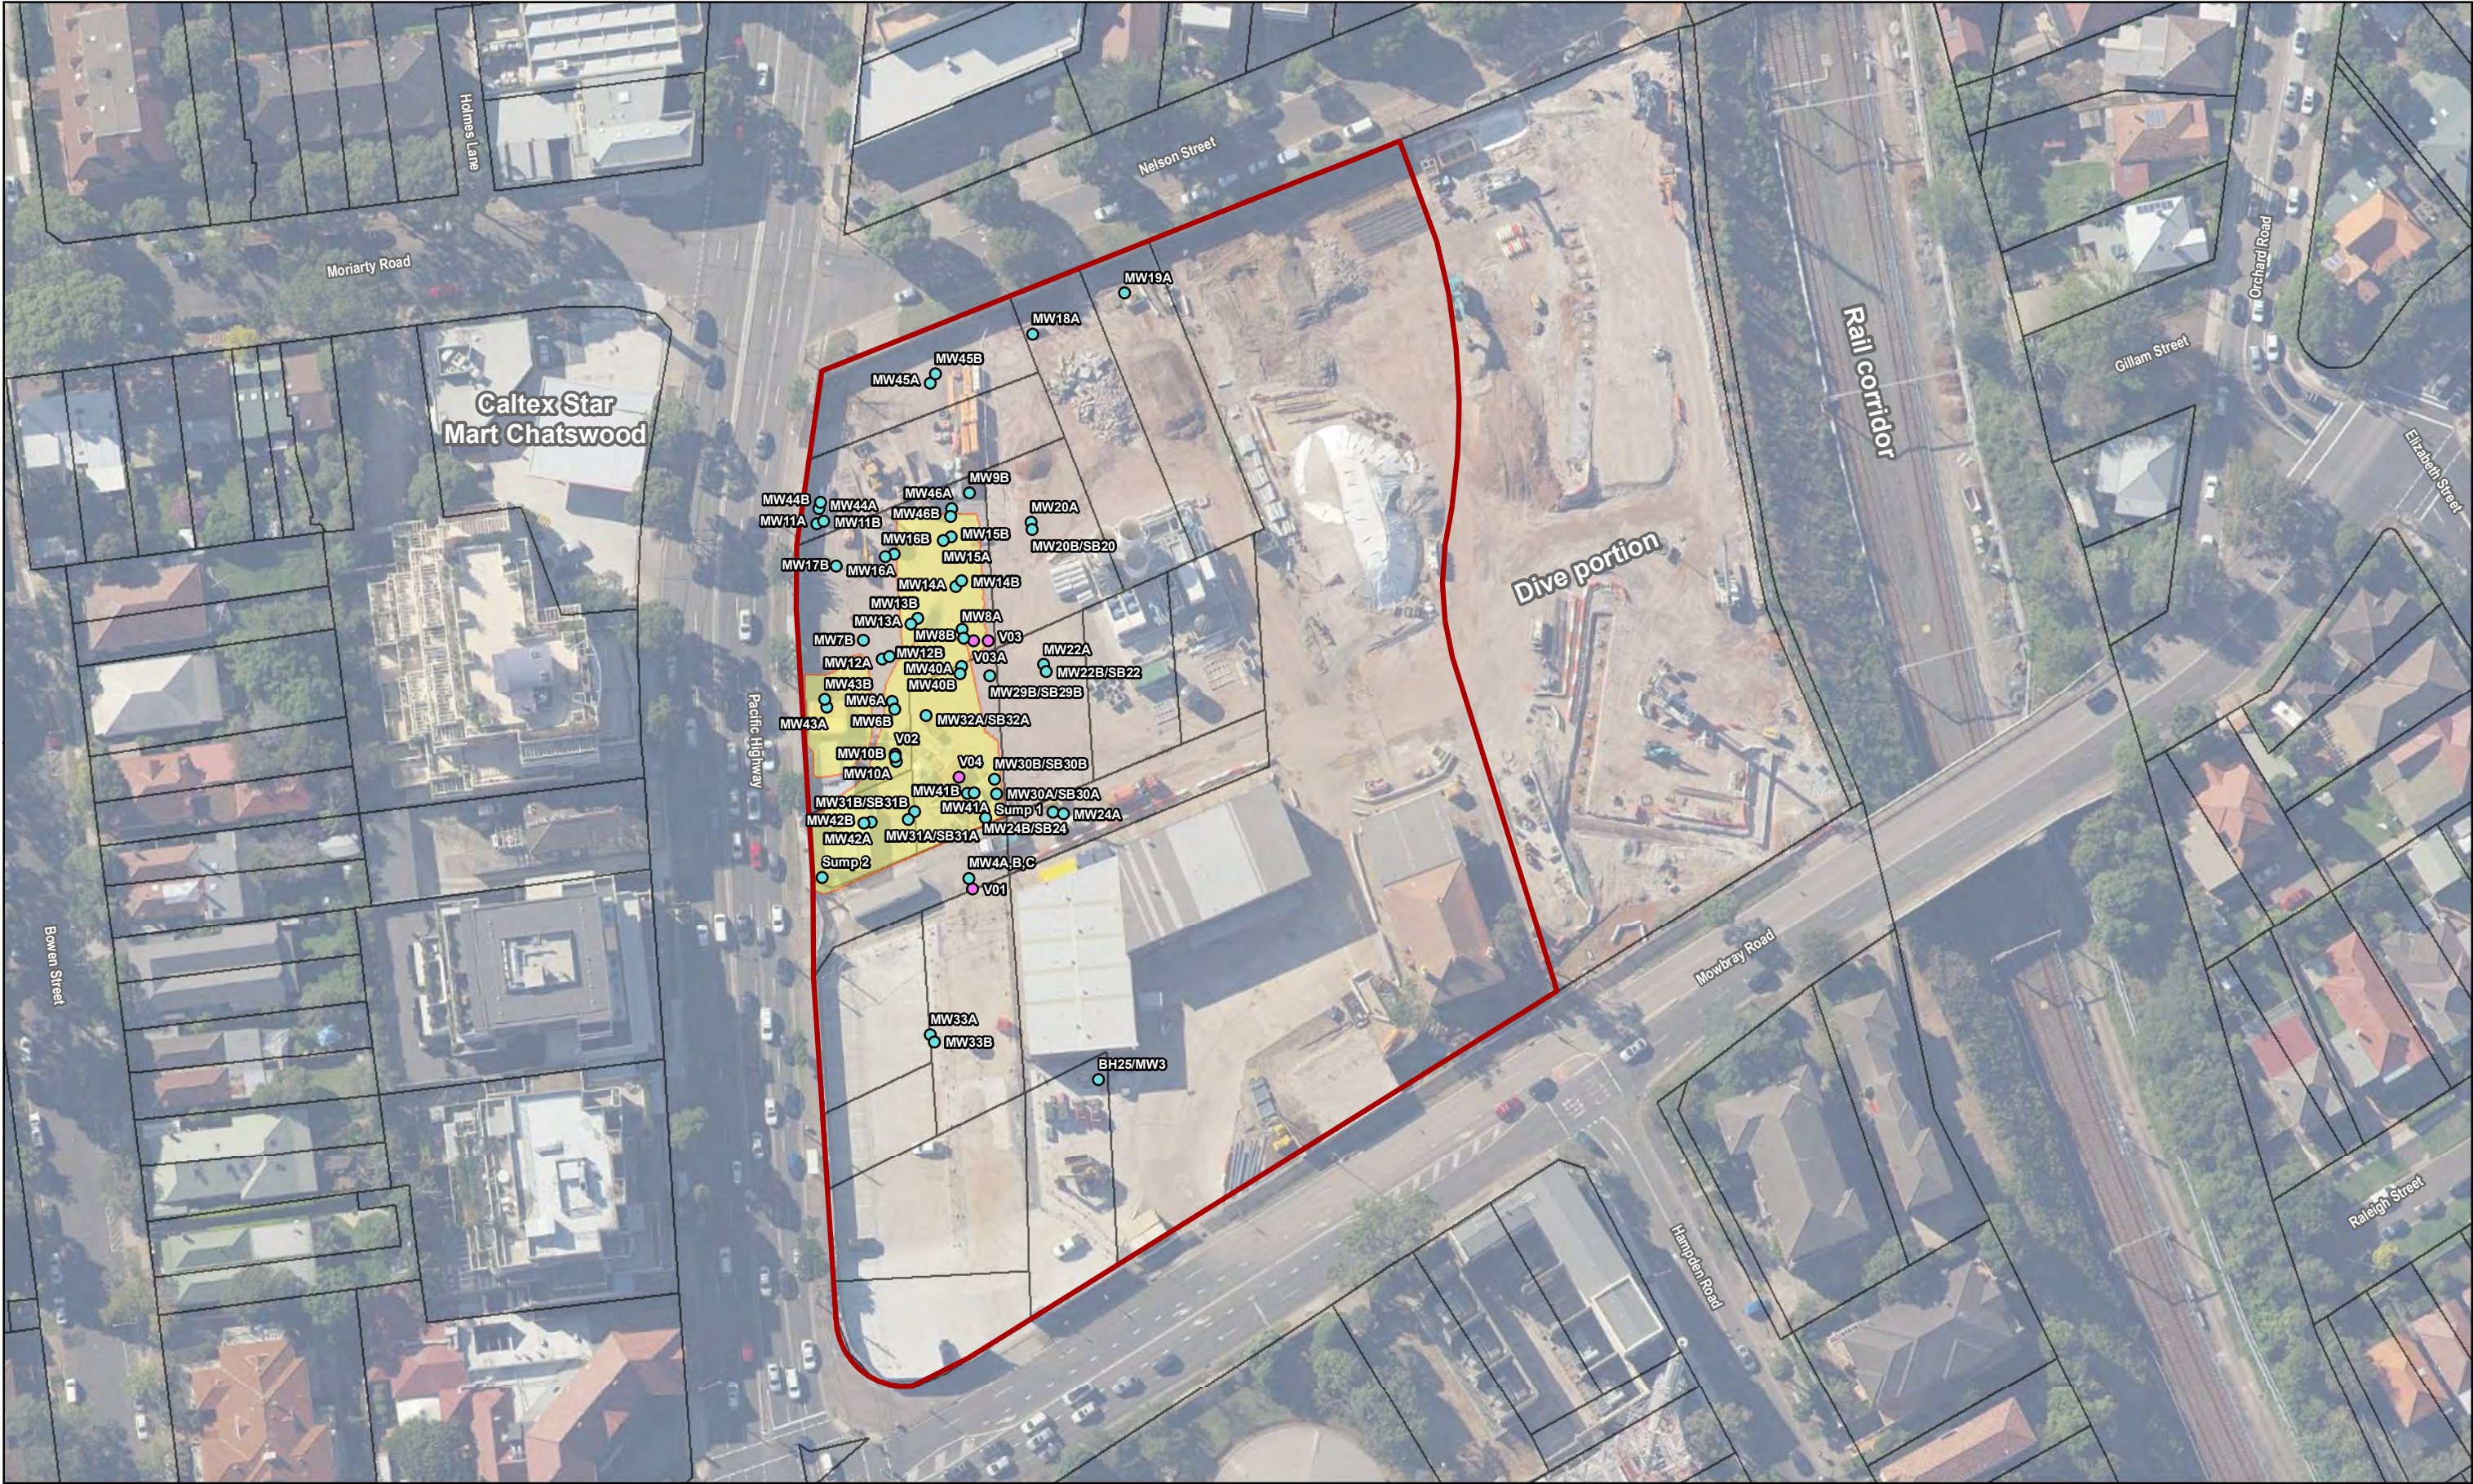
Sydney Metro Project: Contamination  
Summary Report  
**Conceptual Site Model**  
**Pre-Redevelopment Phase**

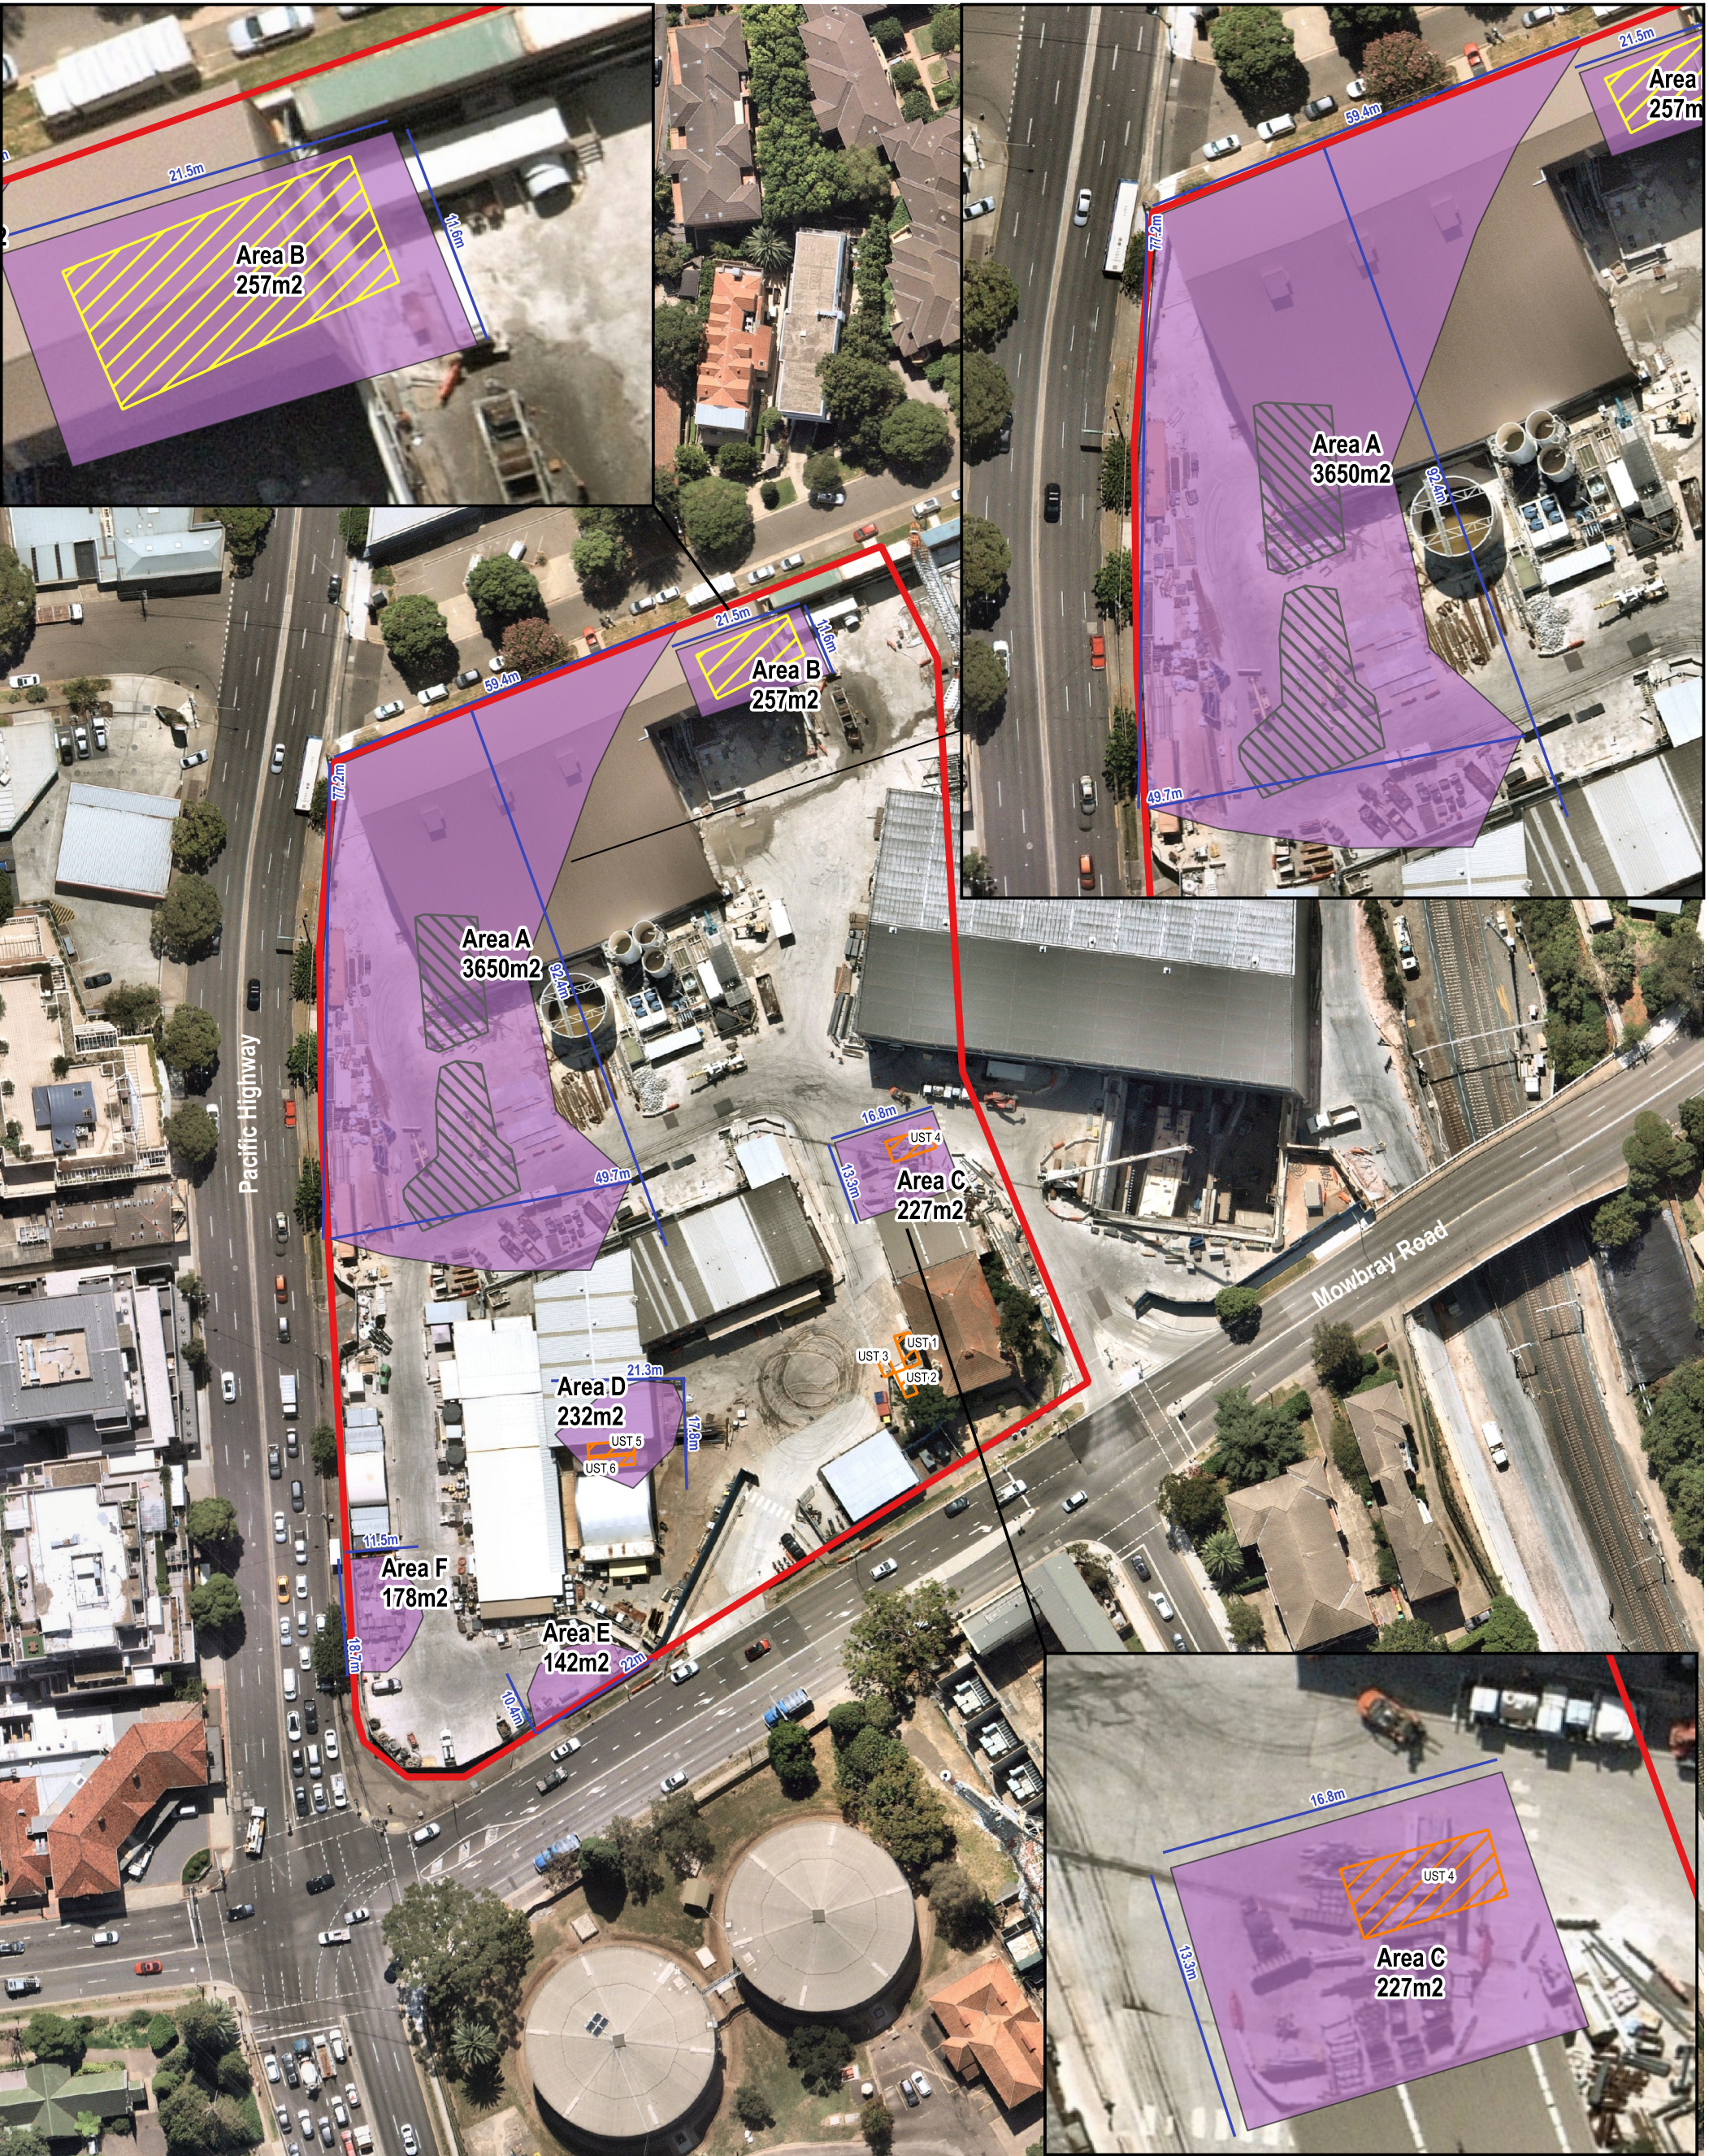
Appendix C-2: Indicative Extent of Remediation

| Scenario 3 - Unrestricted Redevelopment | | |
|---|---|---|
| Approximate max excavation depth | 4.5 | mbgl |
| Approximate excavation area | 8282.985 | m2 |
