# Acid Sulfate Soil Assessment

300 Burns Bay Road, Lane Cove NSW

**Report Title:** Acid Sulfate Soil Assessment; 300 Burns Bay Road, Lane Cove NSW  
**Report Number:** E26484.E14.01\_Rev0

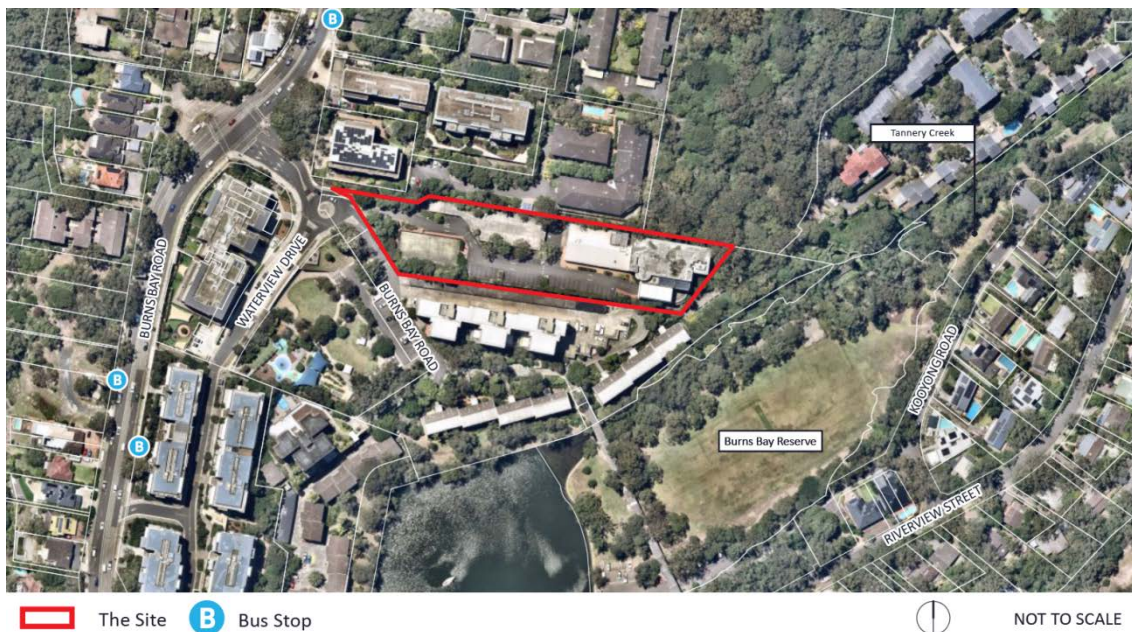
**Figure 1 Site aerial (highlighted in red)**

An aerial of the site illustrated in **Figure 1**.
