Buronga Landfill Expansion

Aboriginal Cultural Heritage Assessment

**Report to Wentworth Shire Council
18 September 2021**

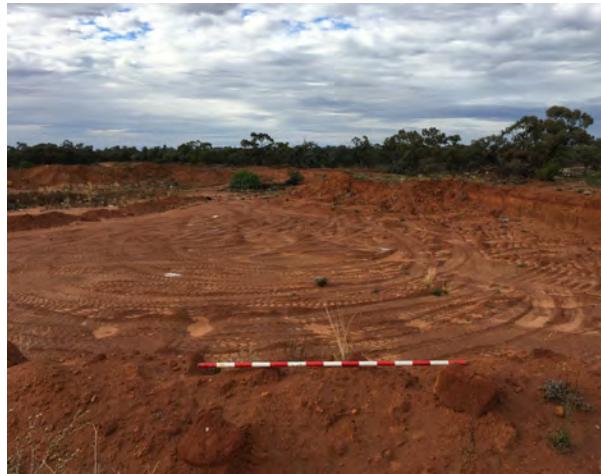
Overall, the environments of the Buronga Landfill Expansion area have been modified by past European land use practices to varying extents (Figures 3-6). The entire area has been used for sheep and cattle grazing following European settlement in the second half of the nineteenth century. Extensive earthworks have occurred in the southern, central and northern parts of the proposed borrow pit areas during past soil stripping and quarrying for previous sand extraction.

Figure 3. Central part of the Buronga Landfill Expansion area, previously quarried for sand.

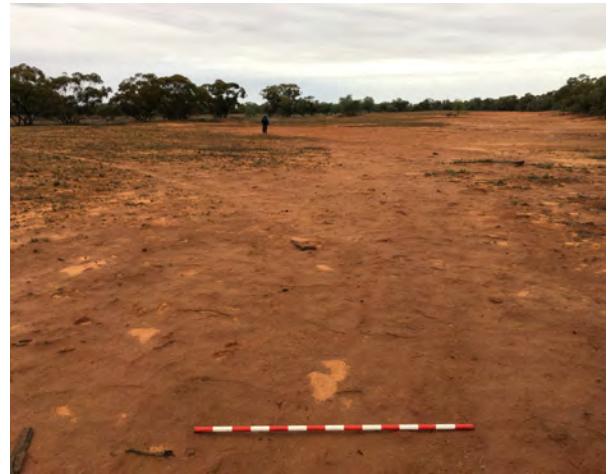
Figure 4. Northern part of the Buronga Landfill Expansion area, previously quarried for sand.

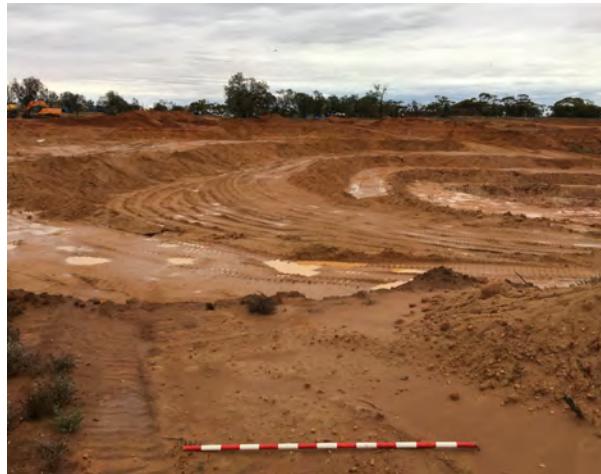
Figure 5. Southern part of the Buronga Landfill Expansion area, previously quarried for sand.

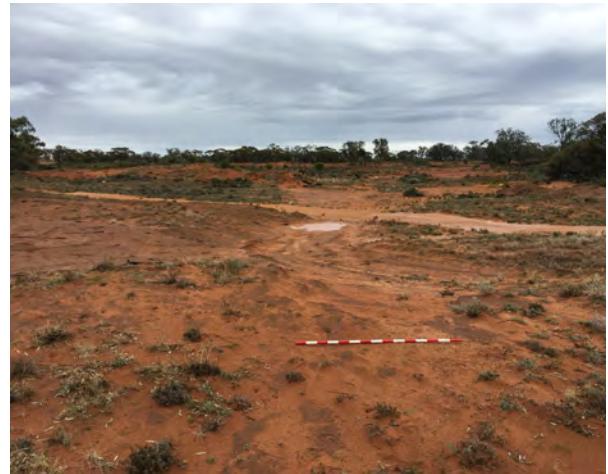
Figure 6. Southern part of the Buronga Landfill Expansion area.

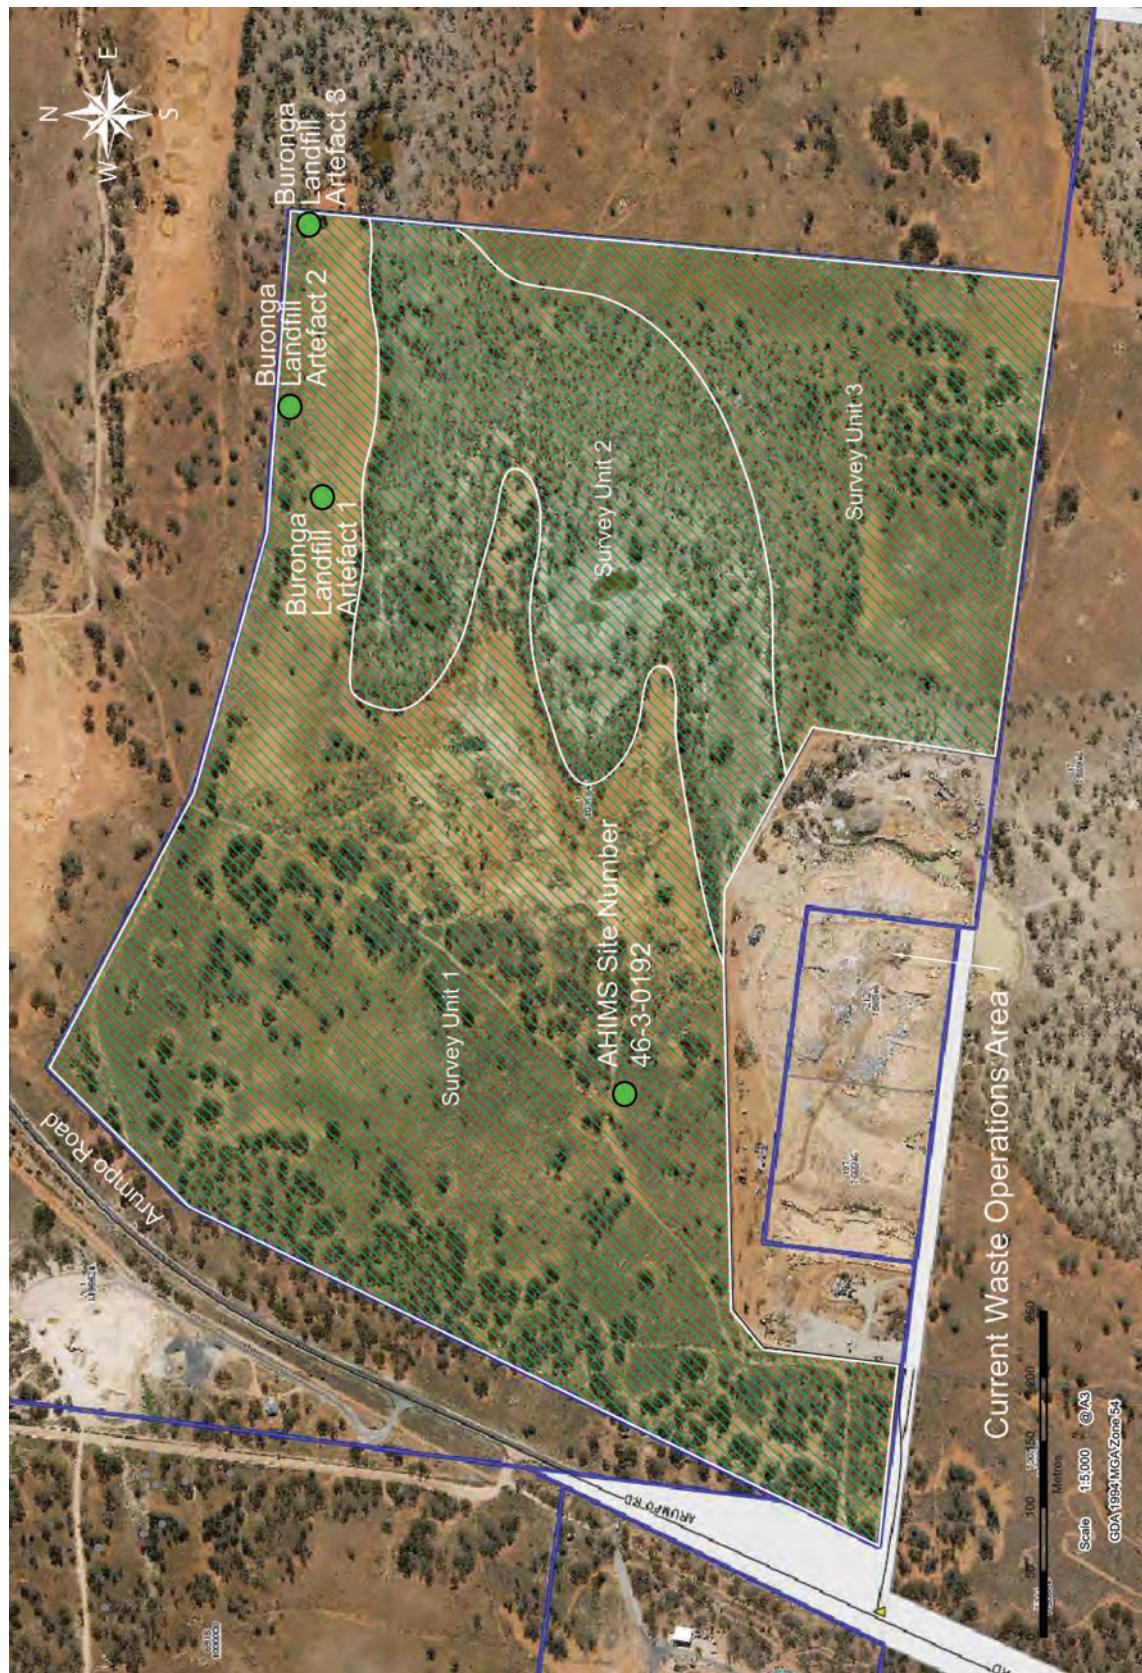
Survey units and descriptions of the visibility conditions for each survey unit are provided in Table 1 and mapped in Figure 9.

Figure 9. Survey units at the Buronga Landfill Expansion Area

All of the Buronga Landfill Expansion area was inspected on foot. The areas covered during the survey are outlined in Table 2 and Figure 9 and summarised by landform in Table 3. Survey coverage was high, given the intensive nature of the survey and the generally excellent conditions of visibility.

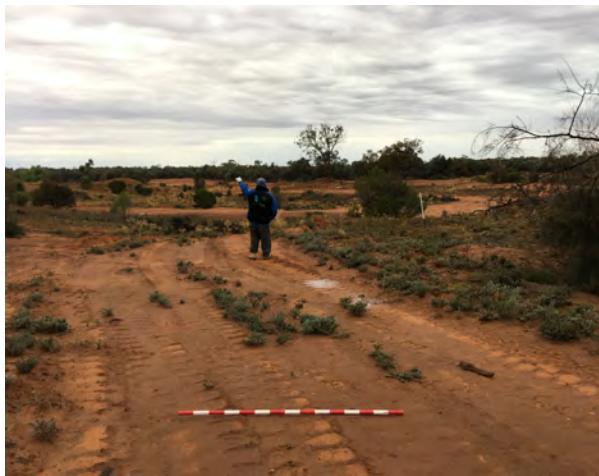
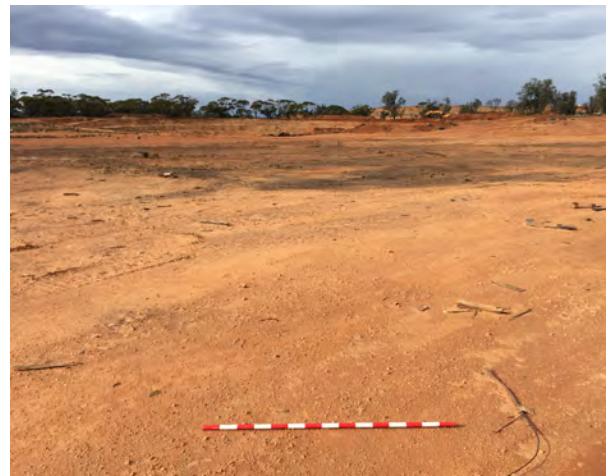
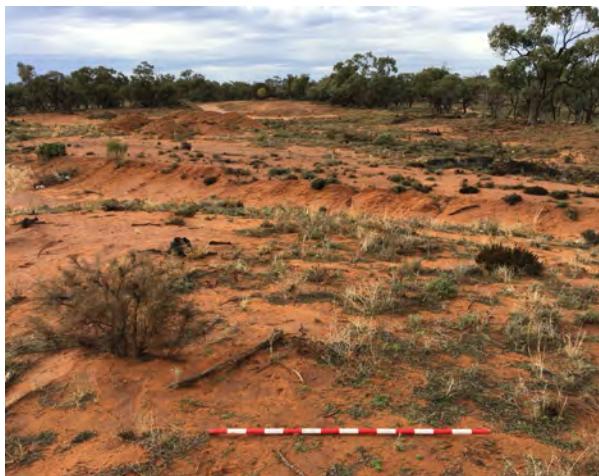
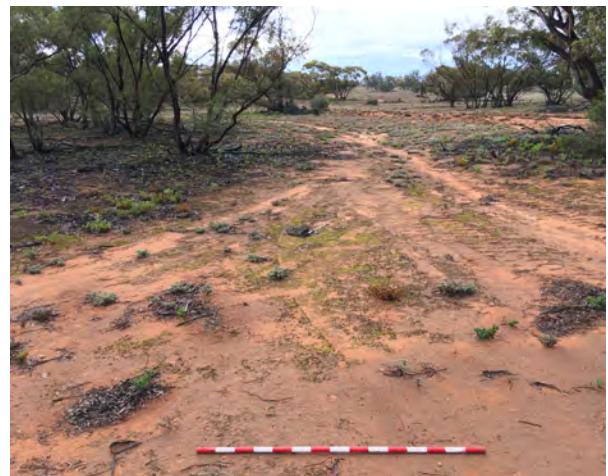
Conditions of ground surface visibility were typically around 70-80 % (Table 1). Grass and herbaceous plant growth was very low and the ground surface was exposed by erosion through quarrying, scalding and gullying and stock and vehicular traffic (Figures 10-13).

Figure 10. Example of Surface Exposure in the Buronga Landfill Expansion area.

Figure 11. Example of Surface Exposure in the Buronga Landfill Expansion area.

Figure 12. Example of Surface Exposure in the Buronga Landfill Expansion area.

Figure 13. Example of Surface Exposure in the Buronga Landfill Expansion area.

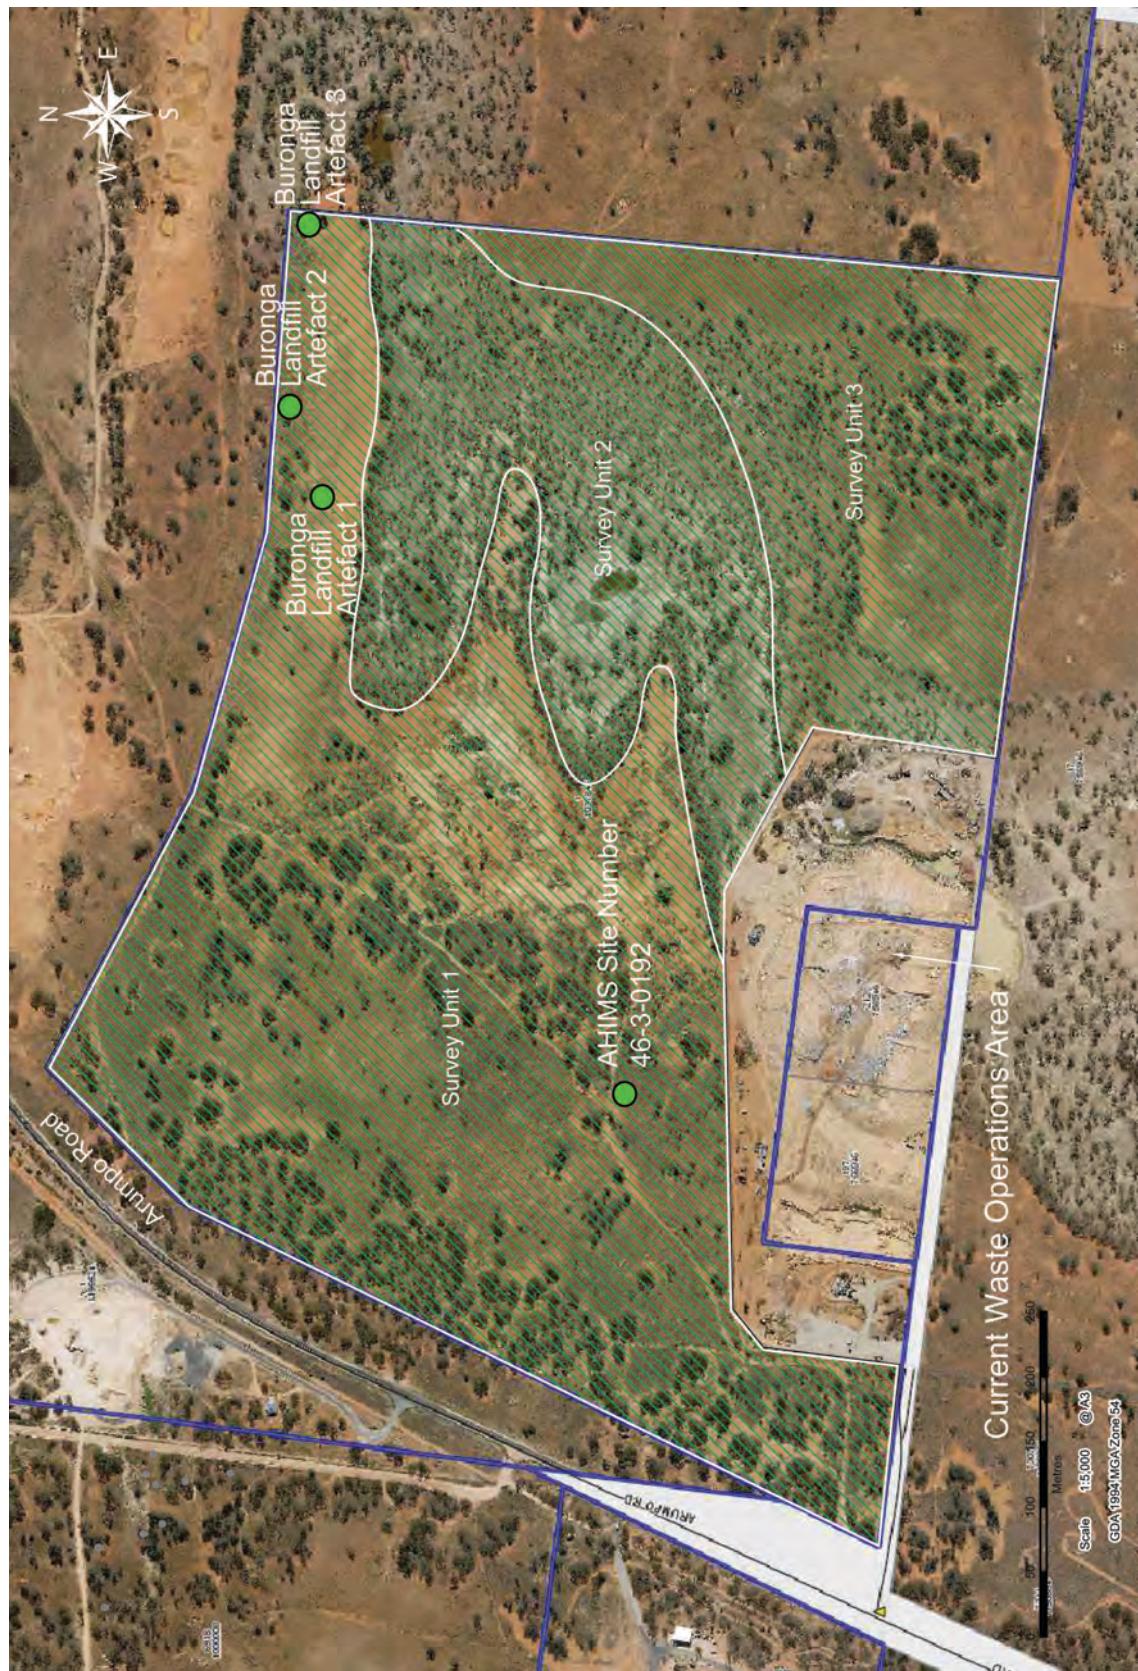
There is one previously recorded Aboriginal object in the proposed works area for the Buronga Landfill Expansion (Table 4; Figure 14). This is AHIMS site number 46-3-0192 (Buronga Landfill Artefact Scatter 1), an isolated find of a broken sandstone core, which had been identified during the Buronga Landfill Project Due Diligence Assessment in 2016 (Watts, 2016) (Figure 15). This Aboriginal object was identified immediately north of the existing Buronga Landfill borrow pit. The Aboriginal object could not be re-identified during the survey of Copper (2016).

Summary descriptions of these features are contained in Table 5 and a map of their locations is depicted in Figure 14.

Figure 14. Aboriginal cultural heritage (isolated finds of stone artefacts) at the Buronga Landfill

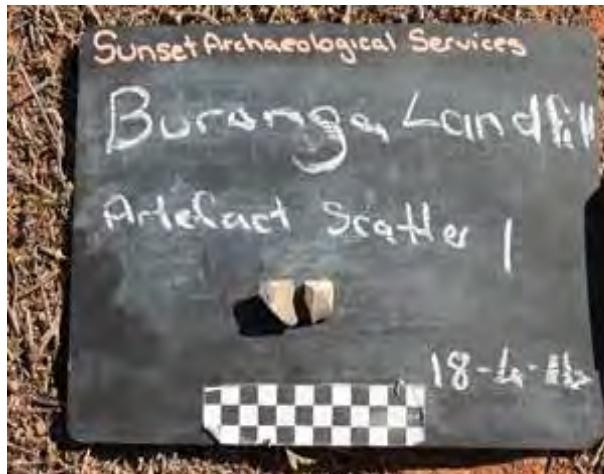
Figure 15. Buronga Landfill Artefact Scatter 1 (AHIMS site number 46-3-0192).

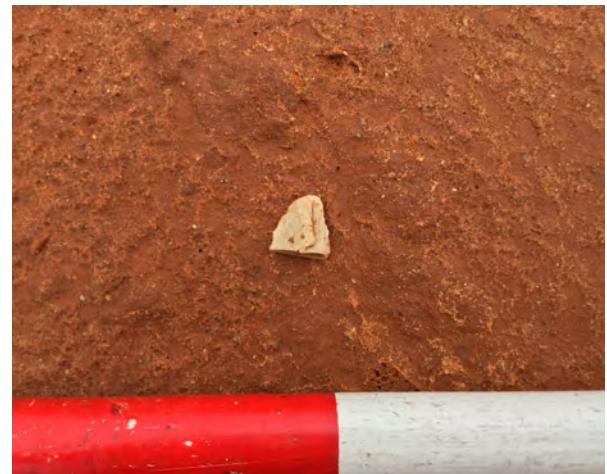
Figure 16. Buronga Landfill Artefact 1 silcrete flake (AHIMS site number 46-3-0203).

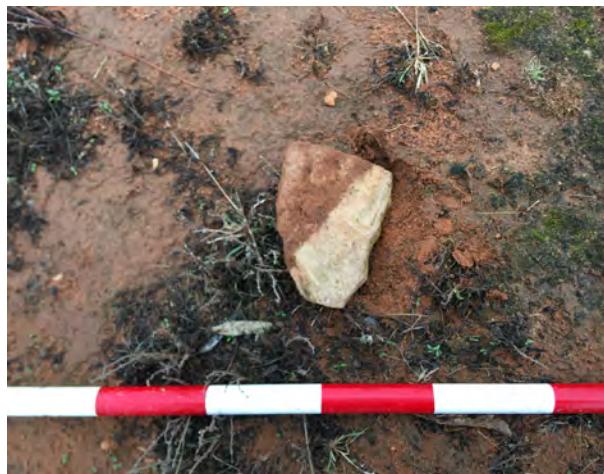
Buronga Landfill Artefact 2 (AHIMS site number 46-3-0204) – a broken sandstone muller (grindstone) on a sandplain in the northeast of the Buronga Landfill Expansion area (Figure 17).

Figure 17. Buronga Landfill Artefact 2 broken sandstone muller/grindstone (AHIMS site number 46-3-0204).

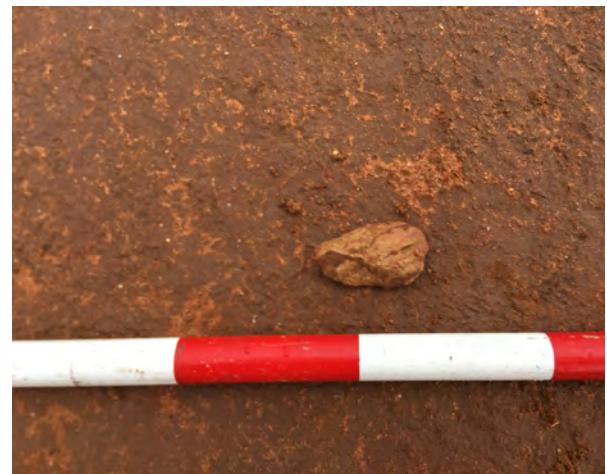
Buronga Landfill Artefact 3 (AHIMS site number 46-3-0205) – a silcrete angular fragment on a sandplain in the northeast of the Buronga Landfill Expansion area (Figure 18).

Figure 18. Buronga Landfill Artefact 3 silcrete angular fragment (AHIMS site number 46-3-0205).
