UXO RISK ASSESSMENT

NEW PRIMARY SCHOOL IN EDMONDSON PARK SITE-SPECIFIC UXO RISK ASSESSMENT

Document Reference: CSG/RCC/210507/RA

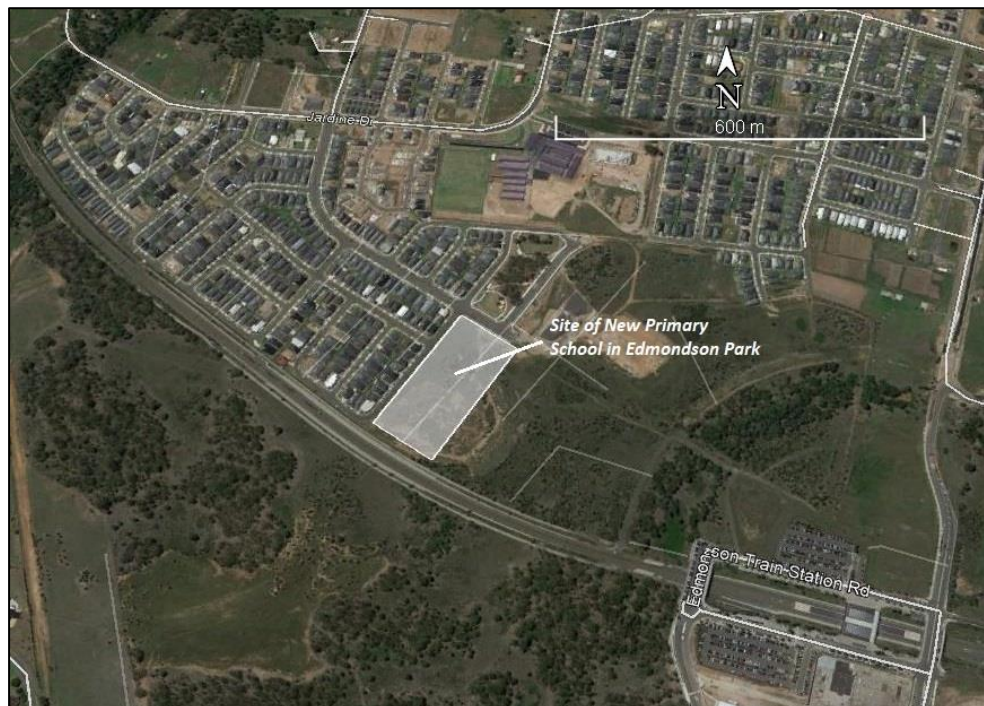
Figure 1: Boundaries of the Site

- 1.4 An image showing the location and boundaries of the Site is shown in Figure 1 below.

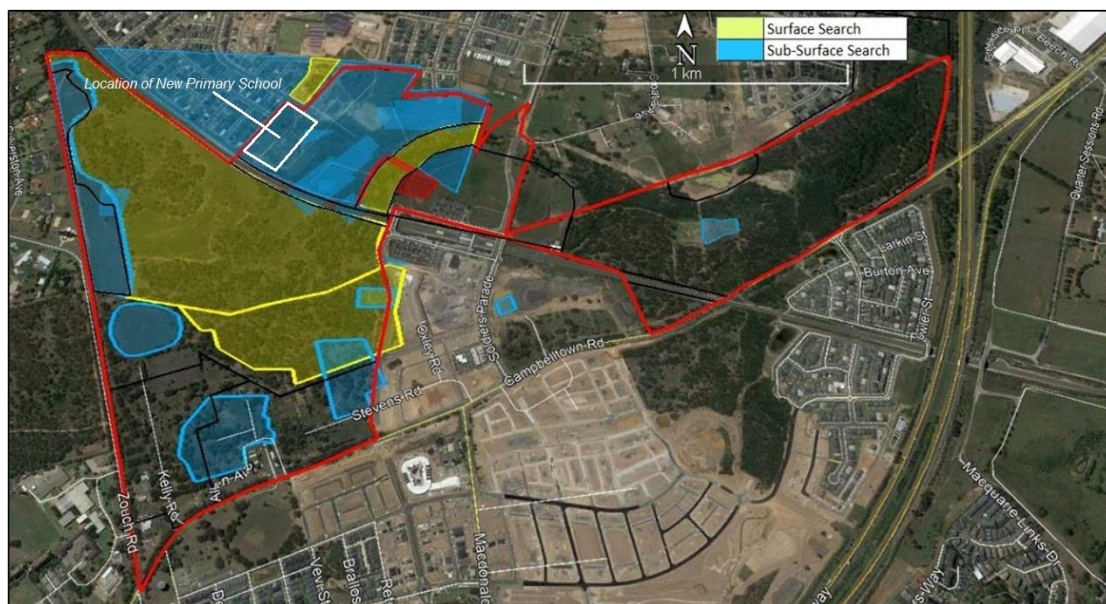
Figure 3: Totality of Area Subjected to UXO Works Since 2000

- 4.8 The totality of the Edmondson Park area subjected to UXO Works since 2000, categorized as either Surface or Sub-Surface Search, is shown in Figure 3 below.

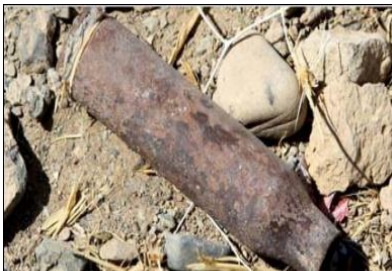
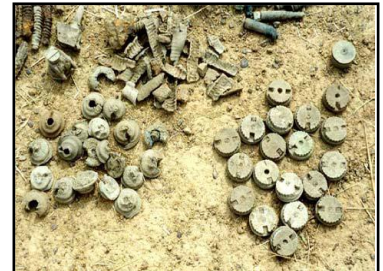
Identification and Characteristics of Explosive Ordnance Waste (EOW)

EOW is the waste material, such as packaging, fragmentation or casings, of munitions that have been fired or used.

EOW poses no threat. However, it should not be handled unless essential to do so and only then if (a) it is 100% definite that the item is EOW and (b) it is necessary to shift it.

You MUST report each find of EOW to your supervisor/site management

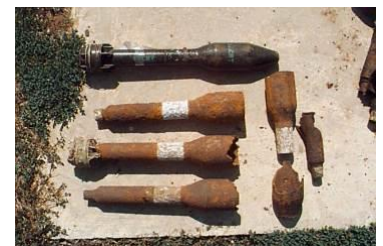
Identification and Characteristics of Explosive Ordnance (EO) & Unexploded Ordnance (UXO)

EO and UXO is any military munition that still contains explosive material. Basically, it looks like what you would expect a military munition to look like.

**IF YOU FIND EO, UXO OR ANY SUSPICIOUS ITEM, YOU MUST TREAT IT AS A UXO.
DO NOT TOUCH IT!!
IMMEDIATELY REPORT IT TO YOUR SUPERVISOR/SITE MANAGEMENT**
