GROUNDWATER MANAGEMENT PLAN

Yiribana Logistics Estate

Prepared for The GPT Group

Report No 30081949_GMP_FINAL

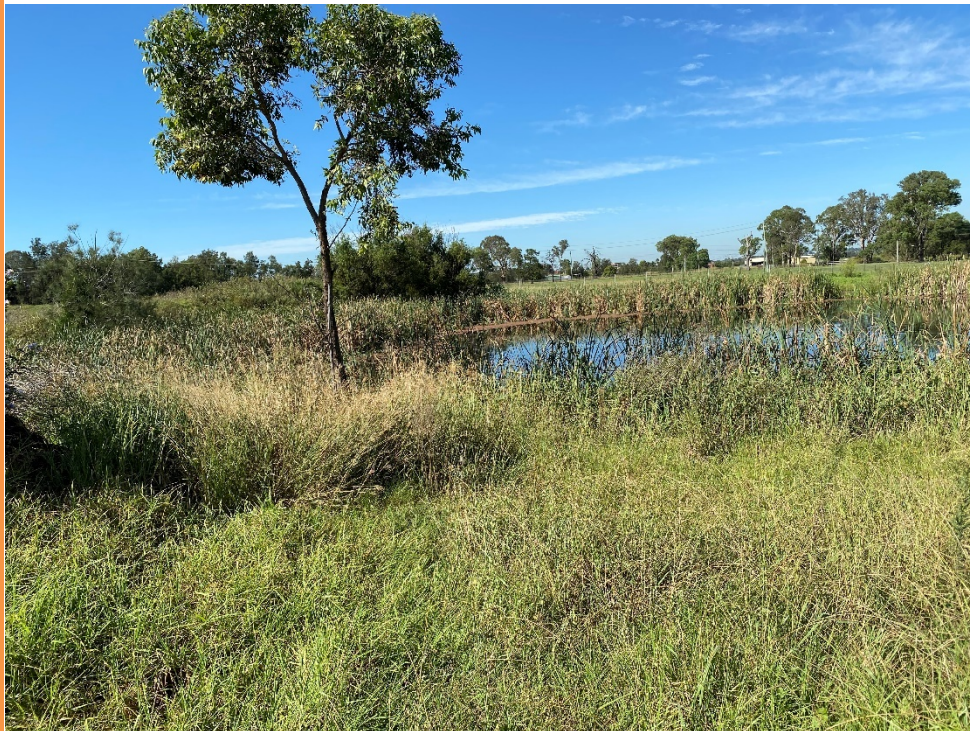
Photo 1 shows the dam located at the most north western corner of the Site. The dam appeared to be three quarters full. Some red coloured algae was observed along the edges of the dam.

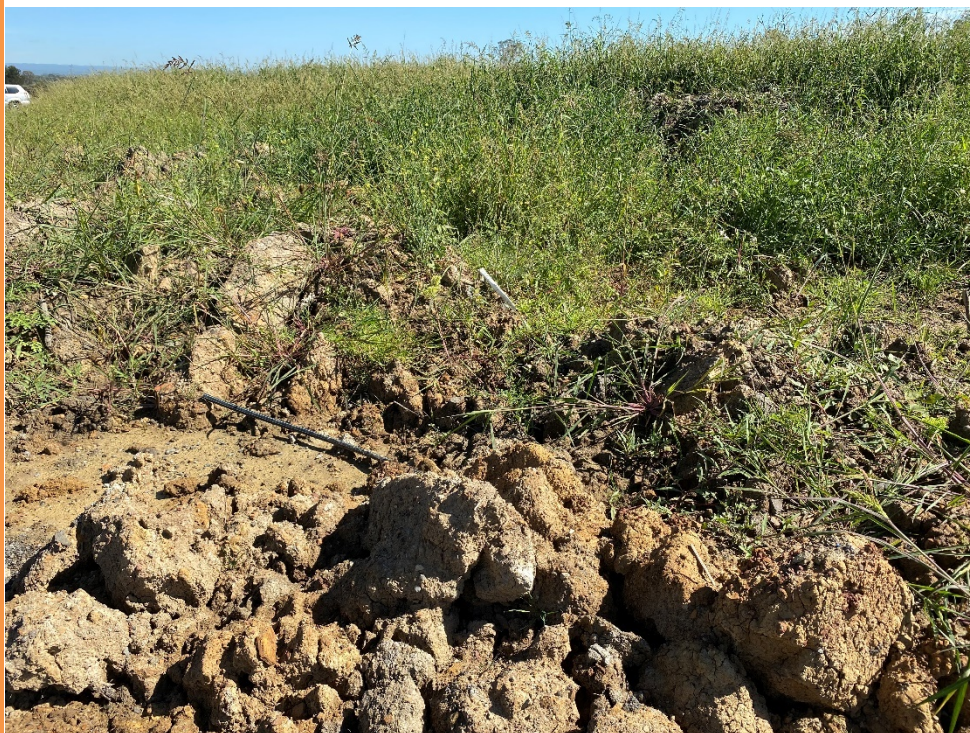
- Several mounds were observed at the north eastern portion of the Site, particularly under the asphalted hardstand. This may indicate the presence of fill material.
- Building waste including fragments of brick and piece of pipe were observed on top of one of the asphalted areas at the north western corner of the Site. A large stockpile of rubble was also observed in this area.
- It was noted that one of the dams located in the north western portion of the Site has been completely drained and dug out. This is the dam that was sampled by KPMG during their GWSWSE (2020).
- No staining or vegetation stress was observed in the areas inspected by Arcadis.
- There were no olfactory indicators of possible contamination noted on-site.

Photo 2 shows some of the building waste including pipe and brick fragments observed in the fill material mounded on top of the asphalted area at the north west of the Site.

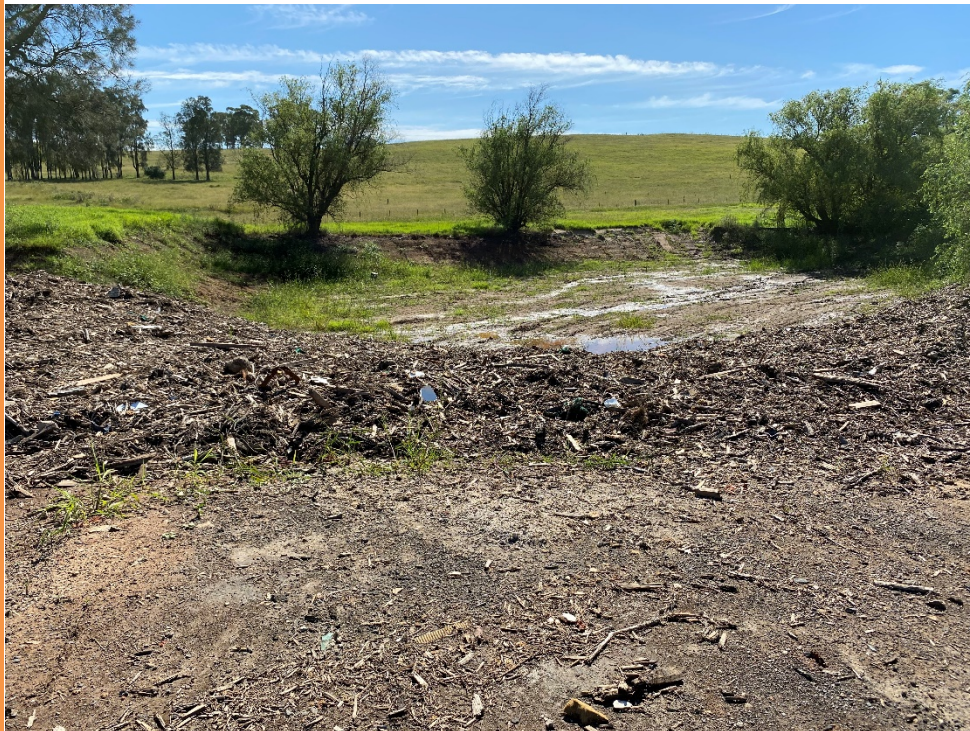
Photo 5 shows the dam located at the central north western corner of the Site. At the time of inspection, this dam was completely drained and dug out.

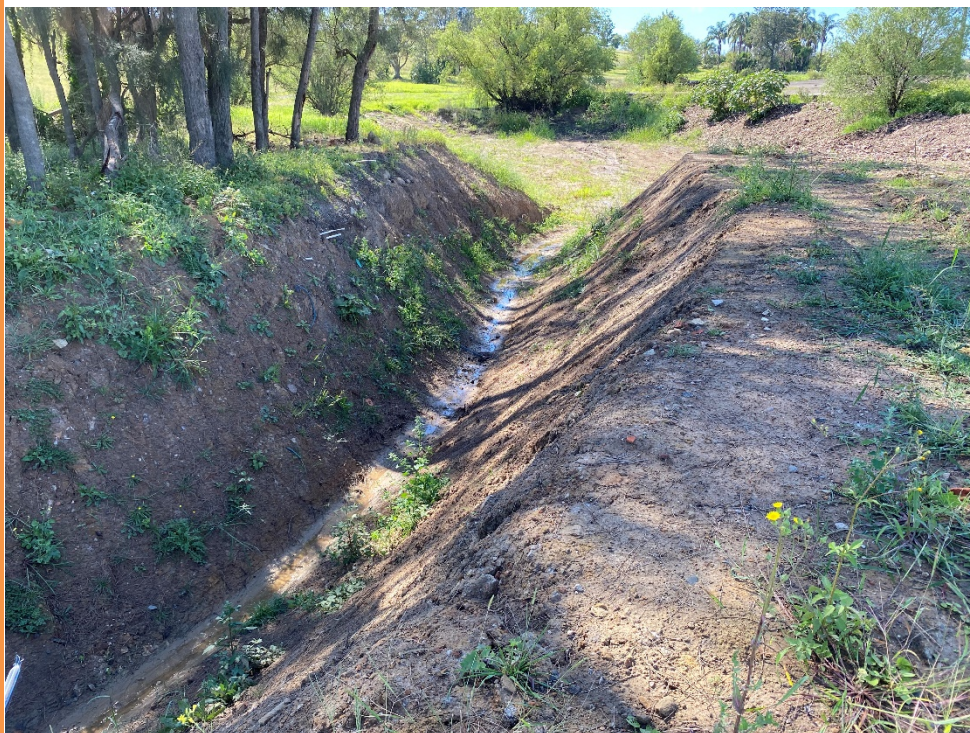
Photo 6 shows a channel attached to the drained dam identified in Photo 6. This channel appeared to lead westward towards the first dam at the north western most portion of the Site.

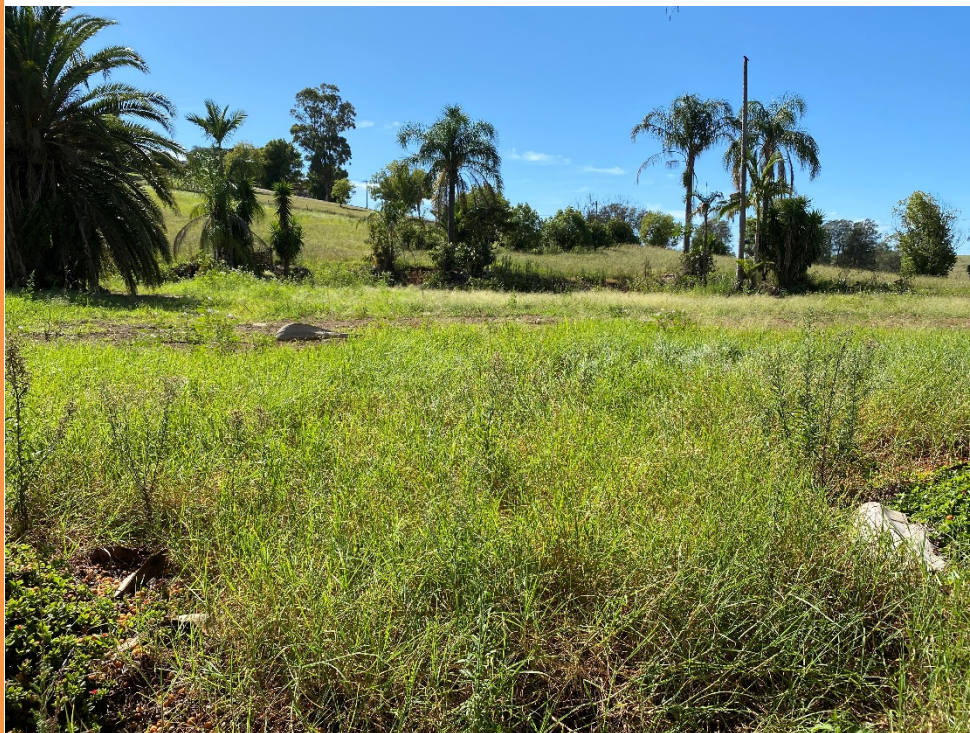
Photo 7 shows part of the steep crest situated at the north eastern corner of the Site.

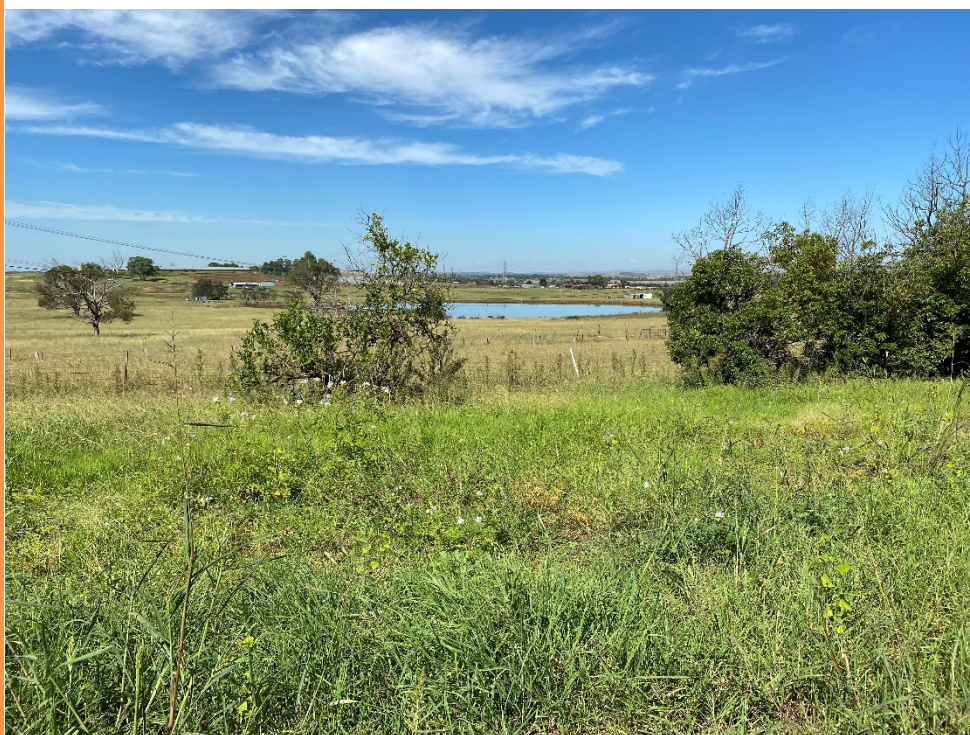
The large dam and surrounding vegetation at the east of the Site can be seen in Photo 8.

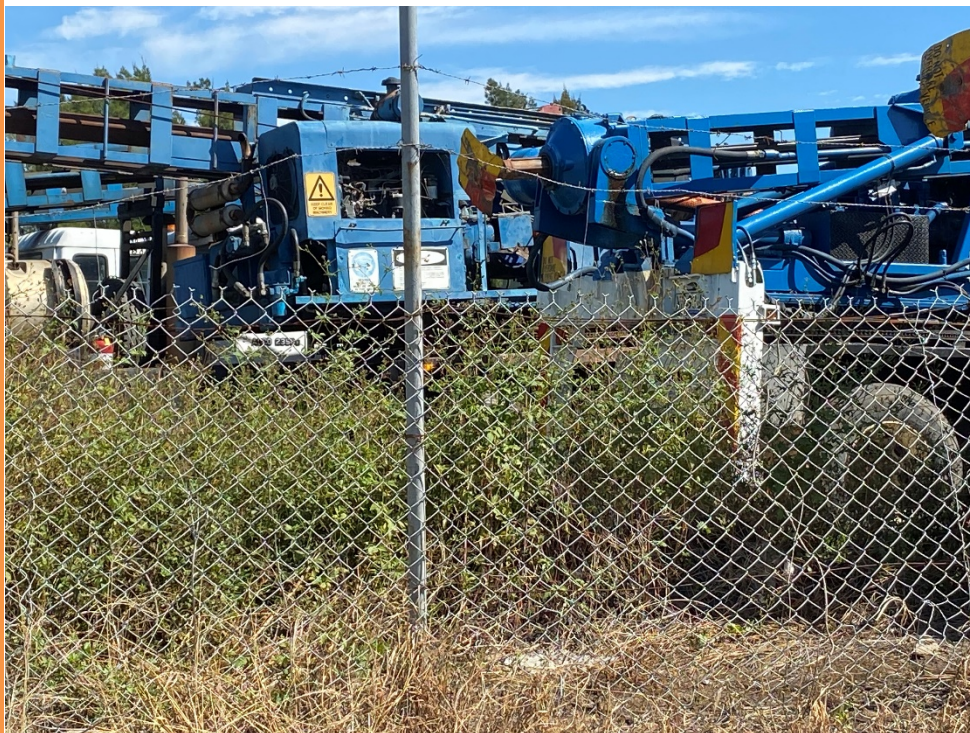
John Robar's drill rigs parked at the centre of the Site.

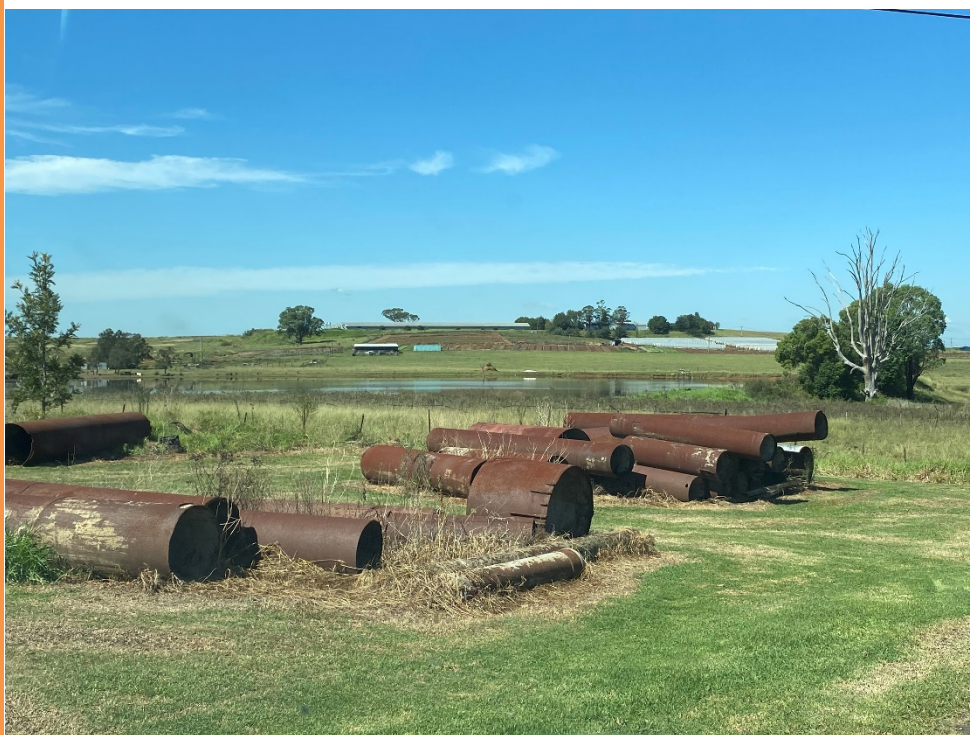
Large pipes were observed to be stored adjacent to John Robar. Beyond this, the large western dam can be seen.
