Remedial Action Plan

*754-770 & 784-786
Mamre Road,
Kemps Creek,
NSW*

29 April 2021

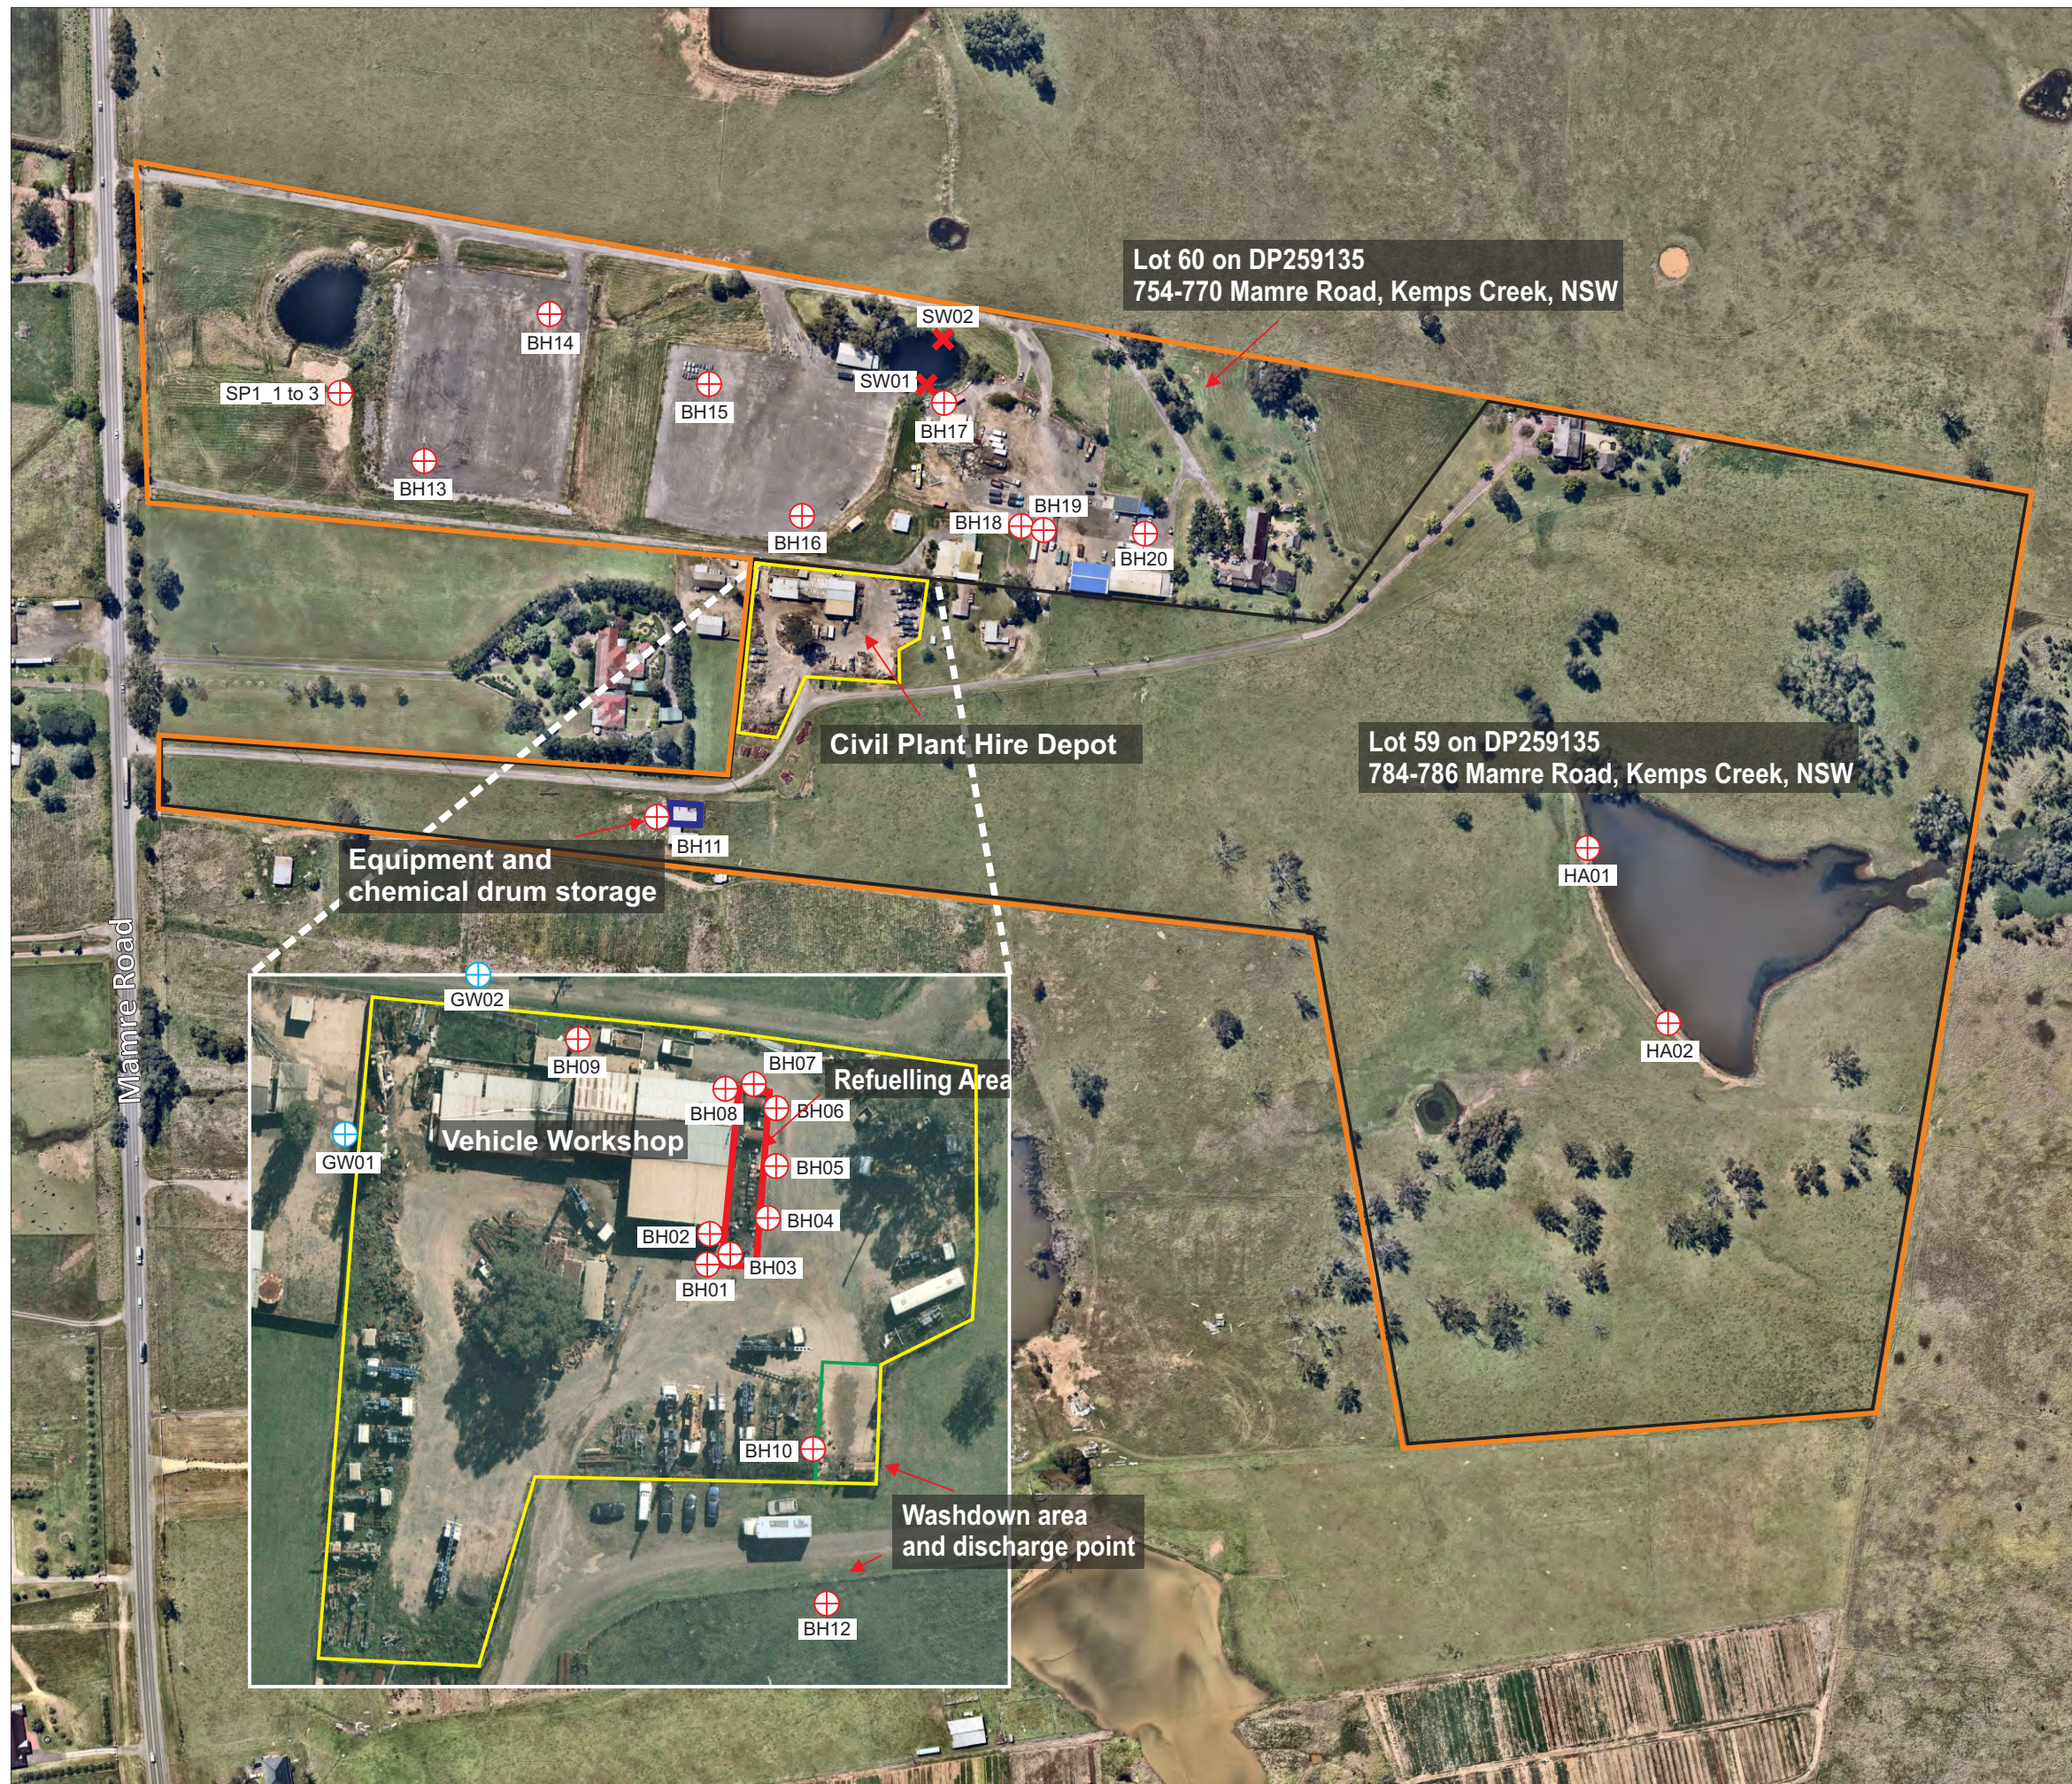
- Site Boundary
- Property Boundary
- Areas of Environmental Concern**
 - Civil Plant Hire Depot
 - Refueling Area:
 - 4,000 L petrol UST
 - 20,000 L diesel UST
 - three (3) ASTs
 - several drums
 - Other Chemical / Equipment Storage
 - Vehicle Washdown Area

- Previous Investigation Sampling Locations**
- KPMG 2019 Soil Sampling Location
 - KPMG 2020d Groundwater Sampling Location
 - KPMG 2020d Surface Water Sampling Location

The ASTs and other chemical drums not listed above were stored within a bunded area but have been noted to be in poor condition. Liquid was noted within the bunded area and heavy staining was noted on the ground surface outside of the bunding. A fuel dispensing bowser was located adjacent to the ASTs and it is understood that refuelling activities had been carried out at 784-786 Mamre Road for many years.

Various quantities of chemicals such as oils, lubricants, degreasers, and solvents were also observed within and around the Vehicle Workshop Building. These chemicals were stored on unsealed areas without secondary containment and hydrocarbon staining was observed on the ground surface within these areas.

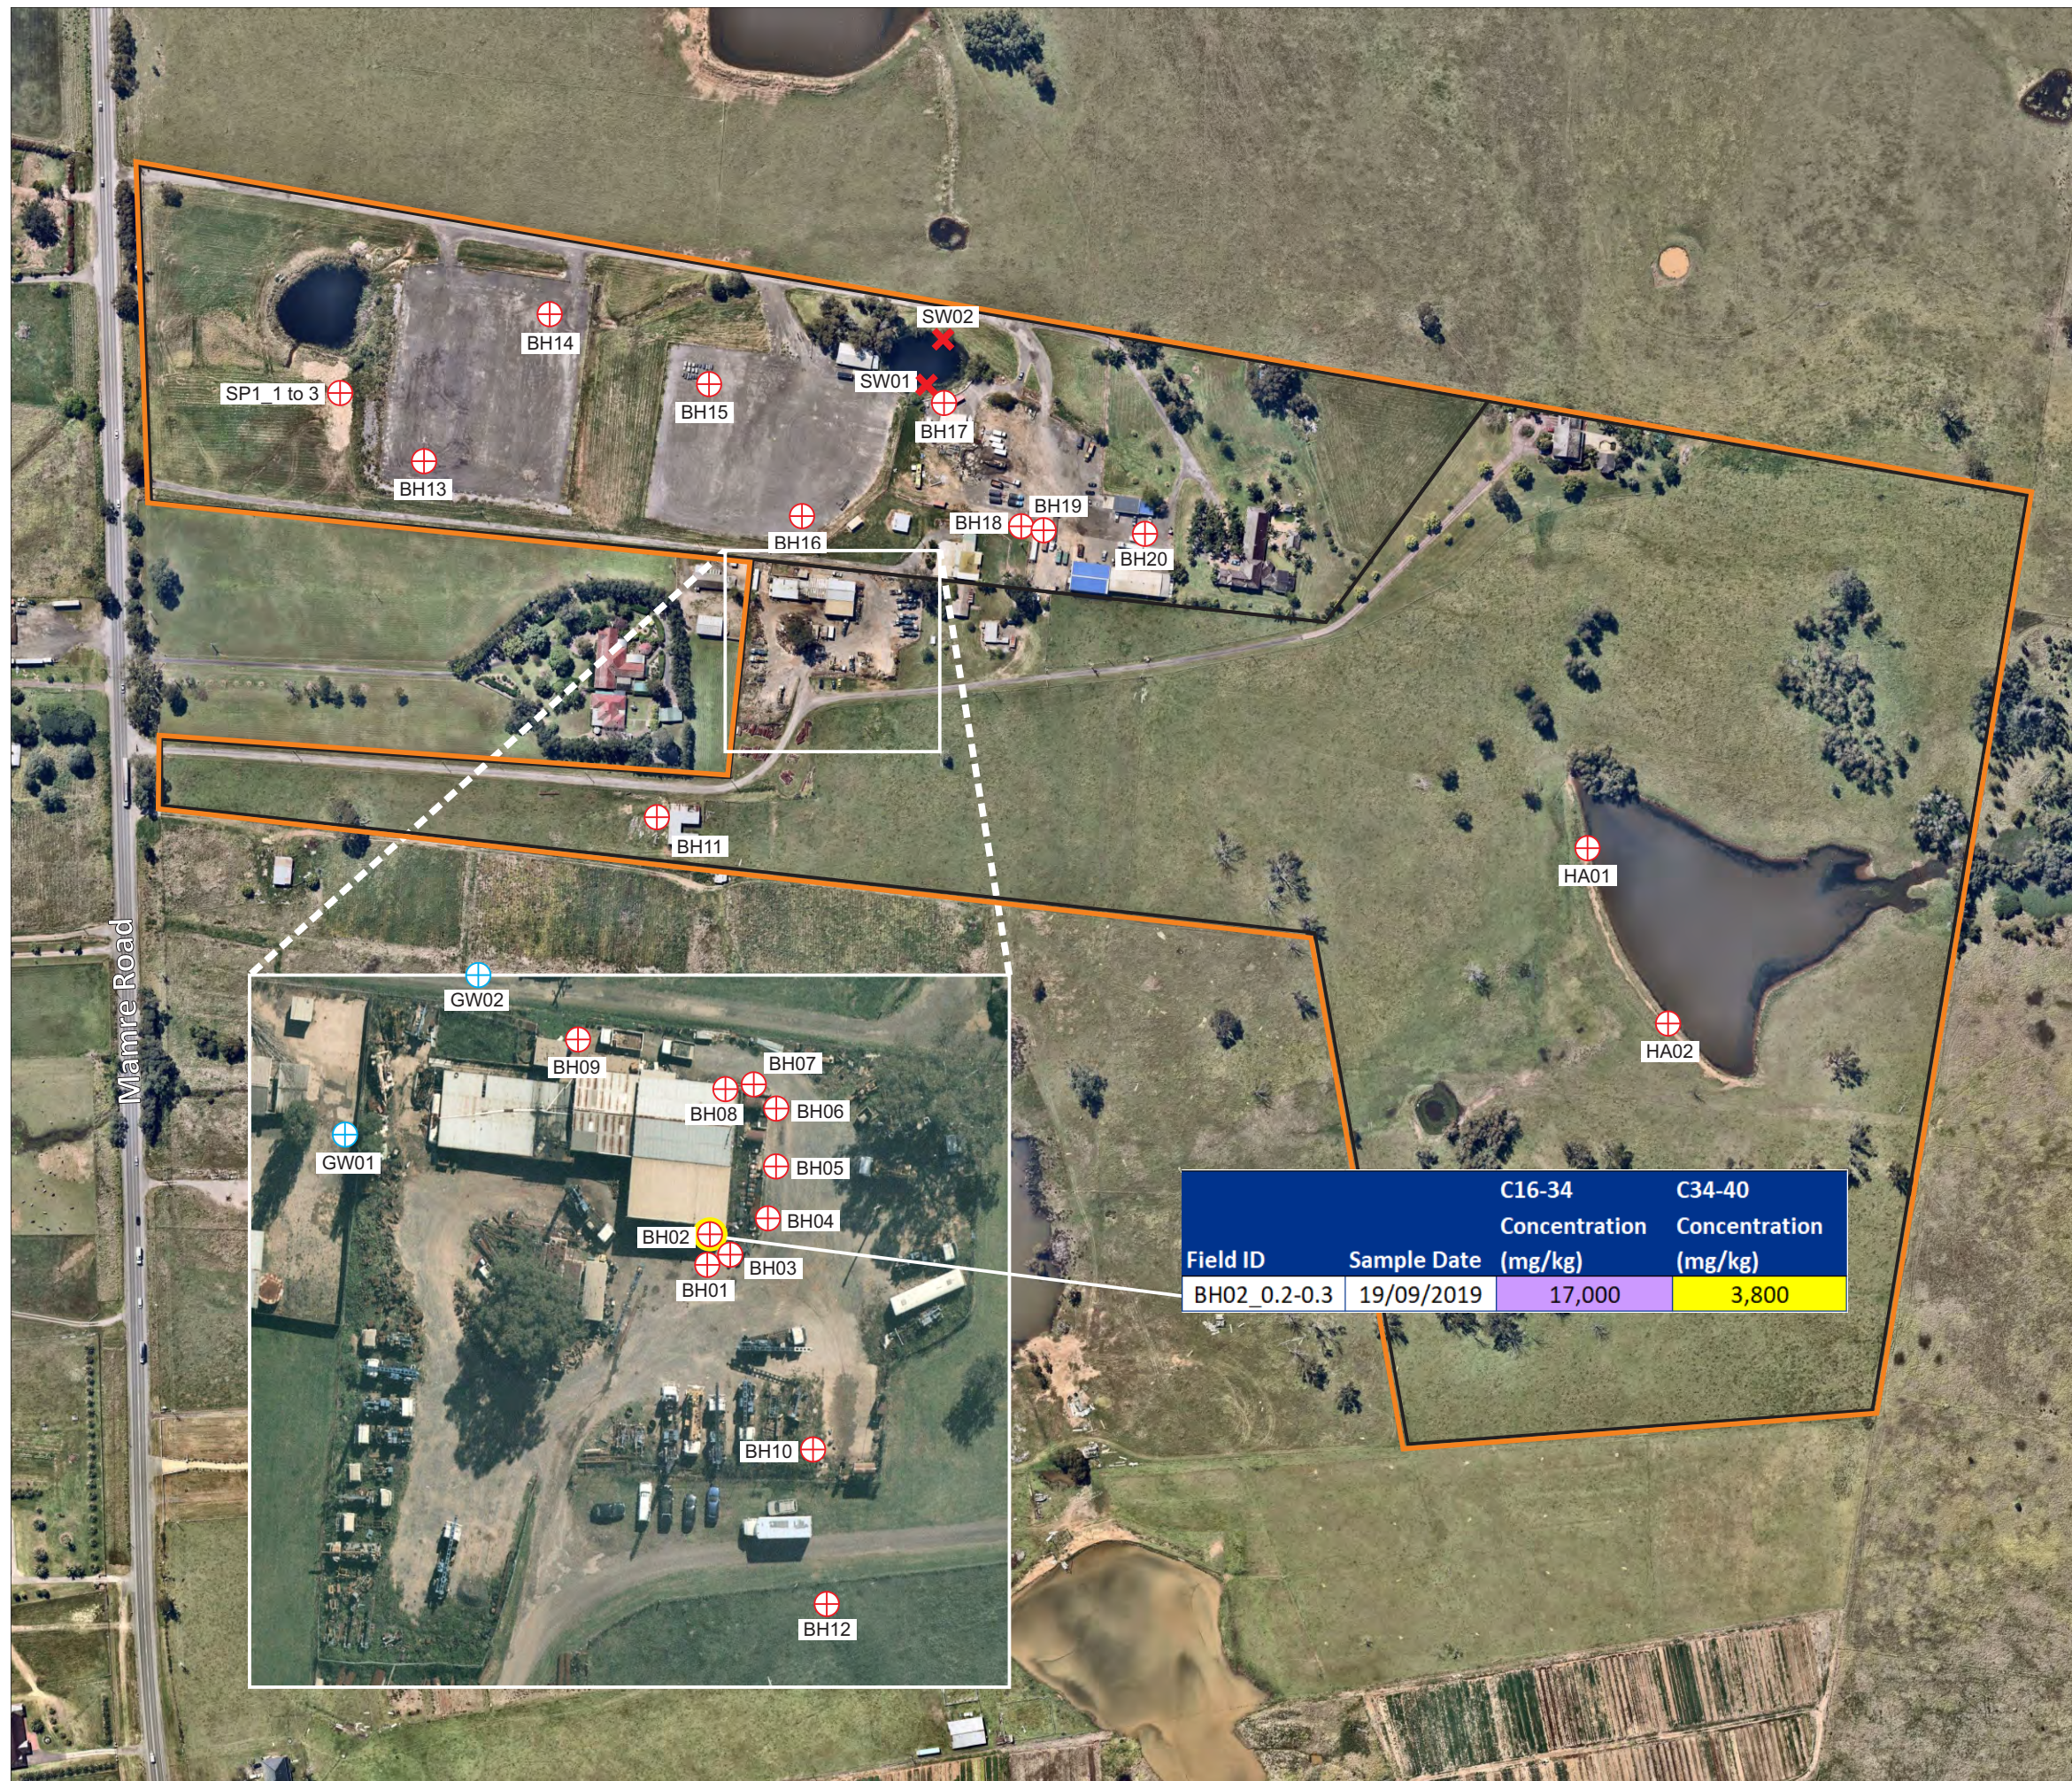
- Site Boundary
- Property Boundary
- Previous Investigation Sampling Locations**
- KPMG 2019 Soil Sampling Location
- KPMG 2020d Groundwater Sampling Location
- KPMG 2020d Surface Water Sampling Location

- Guideline Criteria**
- NEPM 2013 Table 1B(7) Management Limits Commercial / Industrial (Coarse Soil)
- NEPM 2013 Table 1B(6) ESLs for Commercial / Industrial (Coarse Soil)
- TRH Concentration Above Guideline Criteria

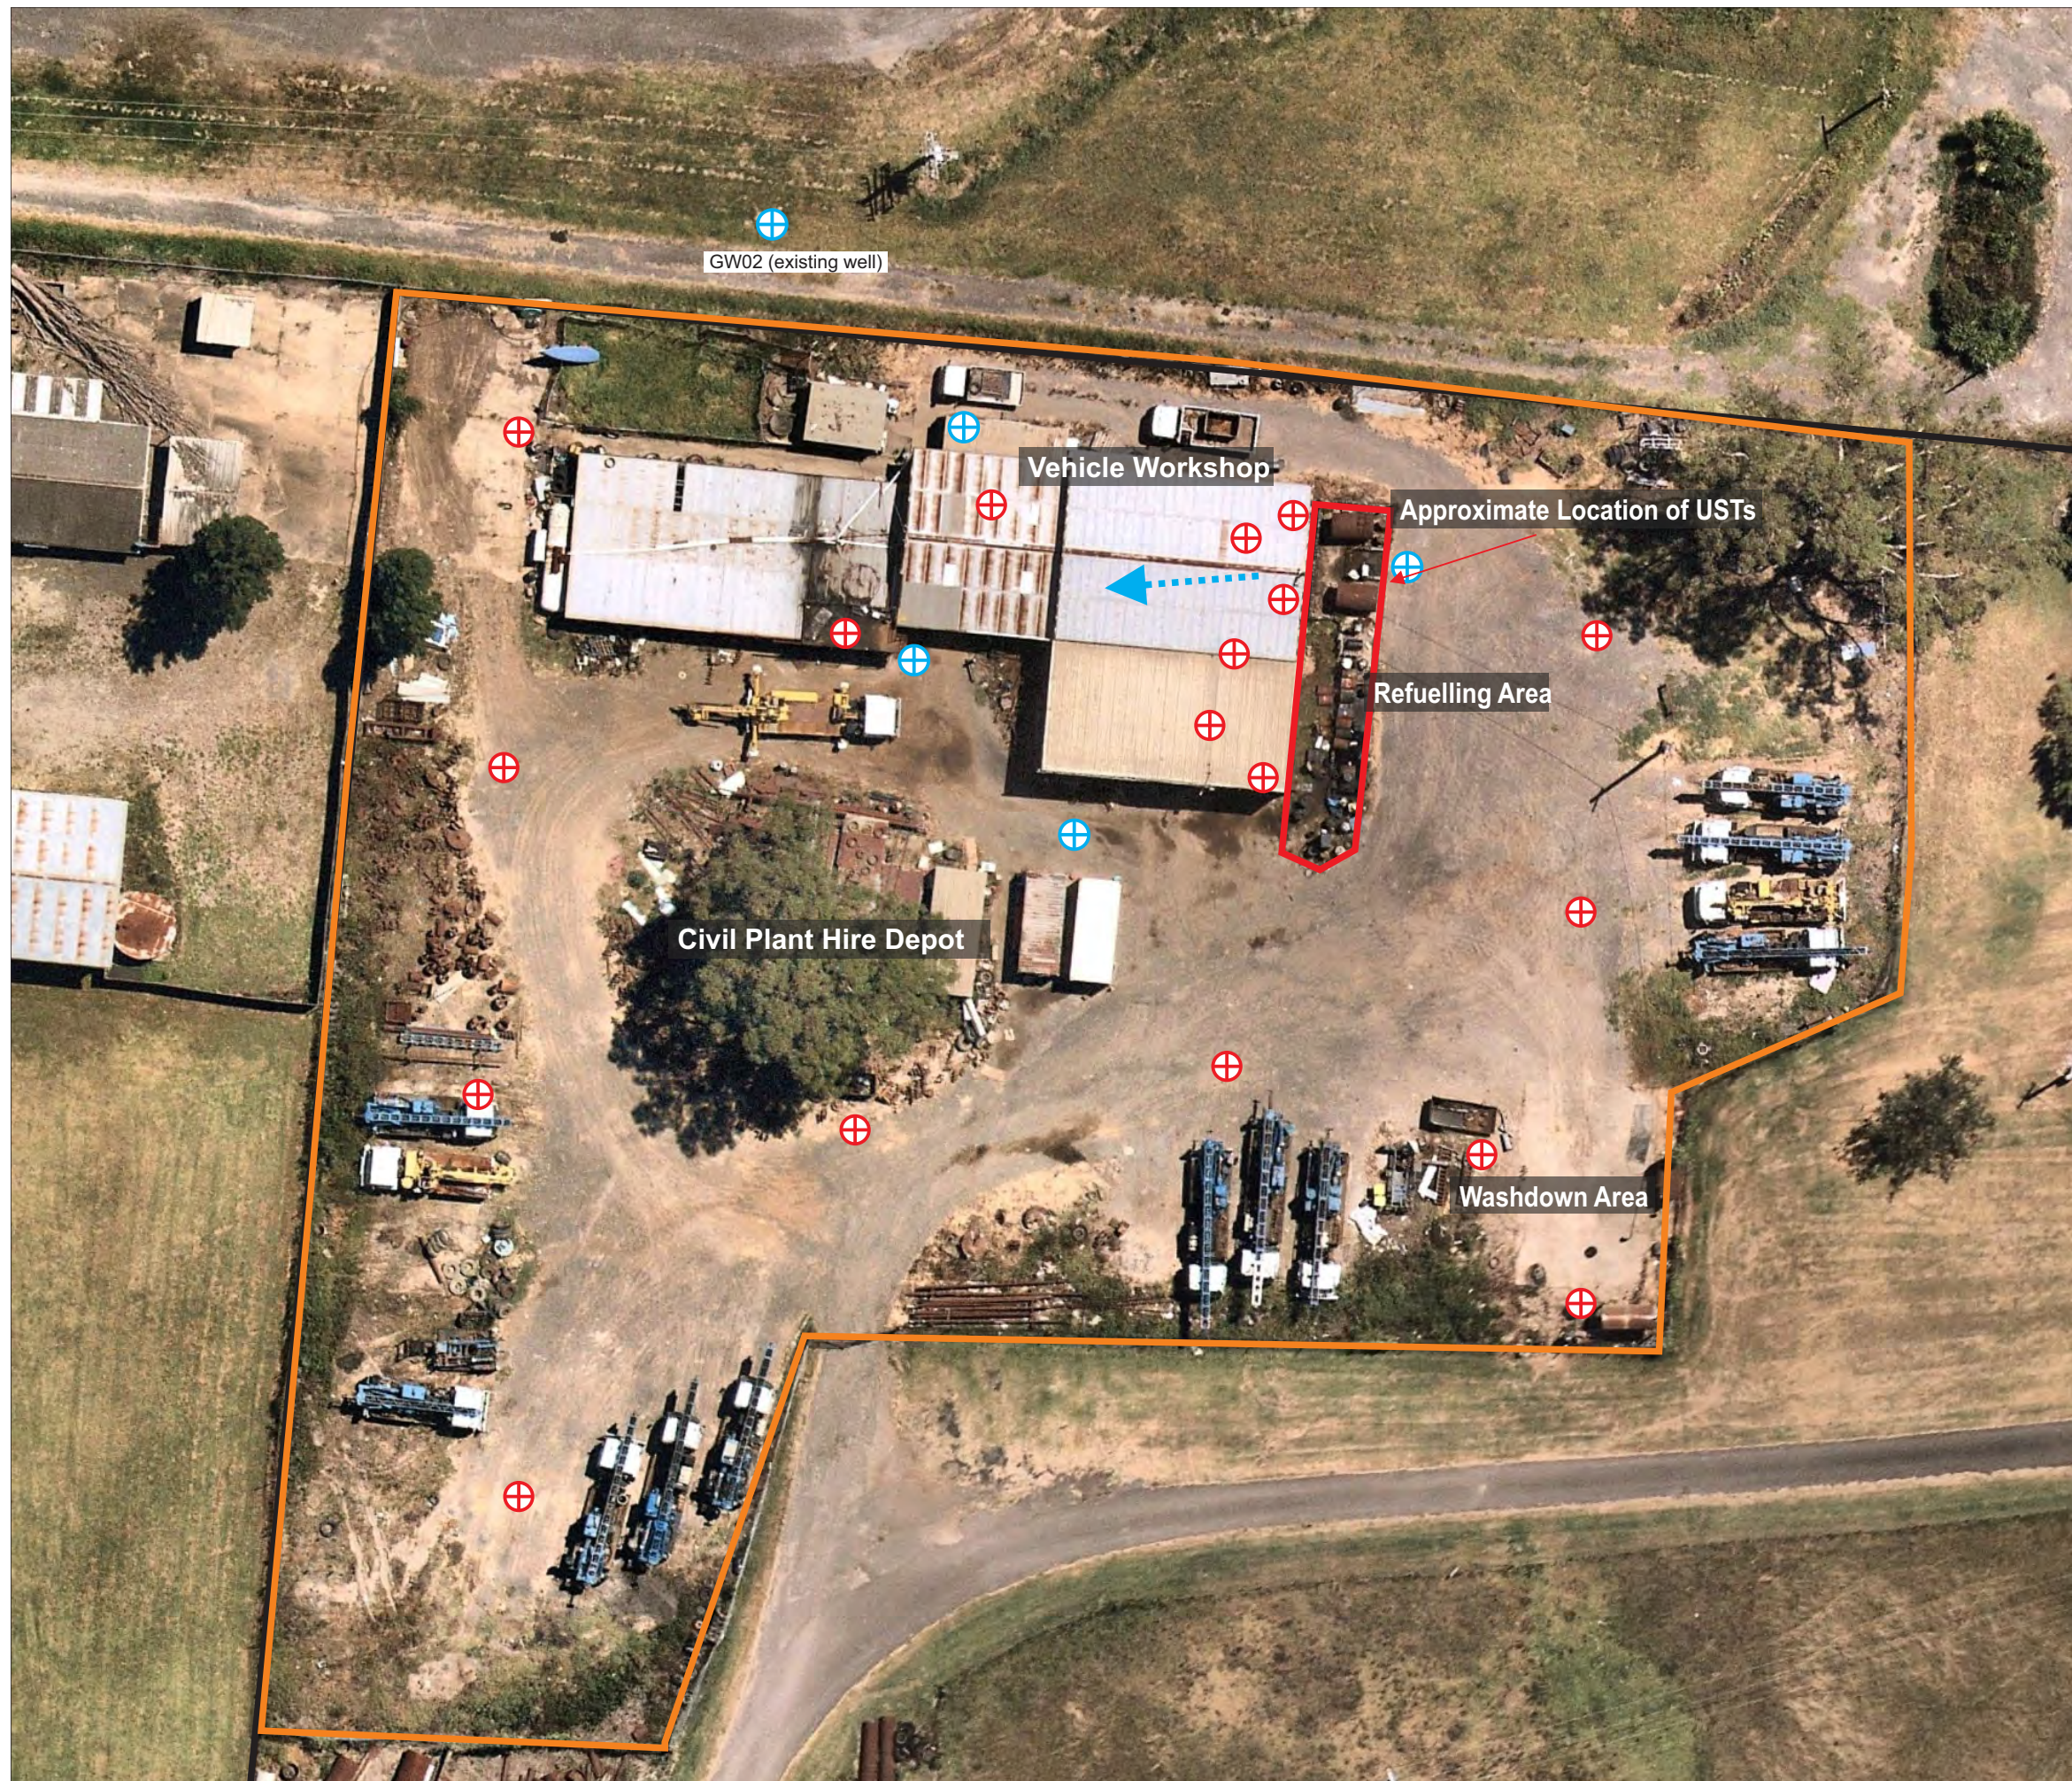
Approximate Remediation Area Boundary

Unexpected finds of potential contamination on site may be identified by visual (appearance or staining) and / or olfactory (odour) evidence. This UFP is applicable to the entire site, however particular care should be taken for site works undertaken in proximity to the Remediation Area illustrated in Figure 5.

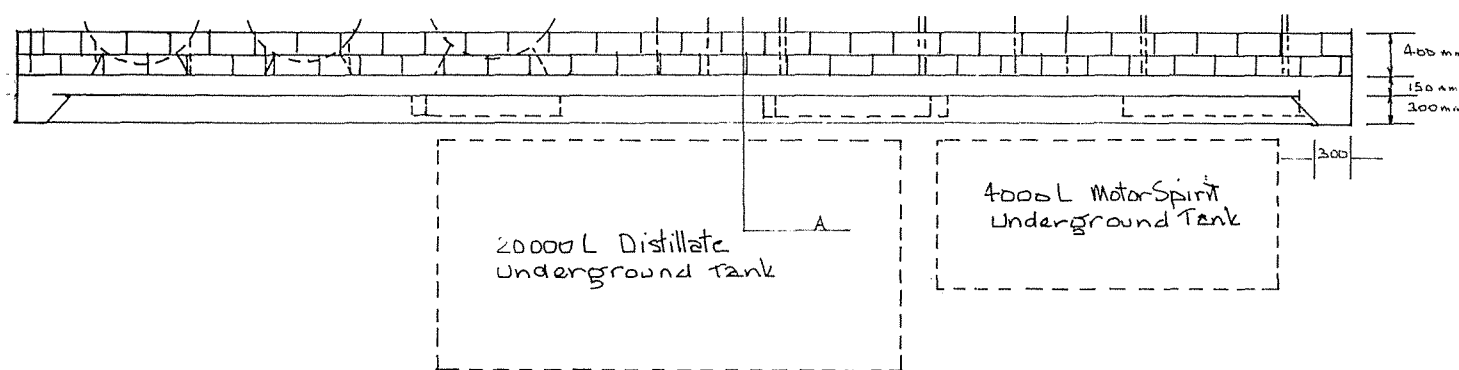
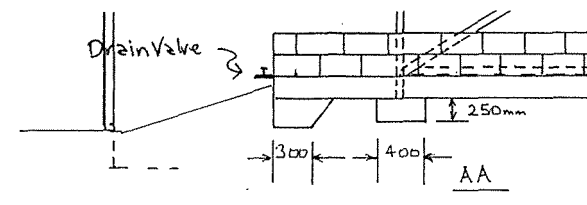
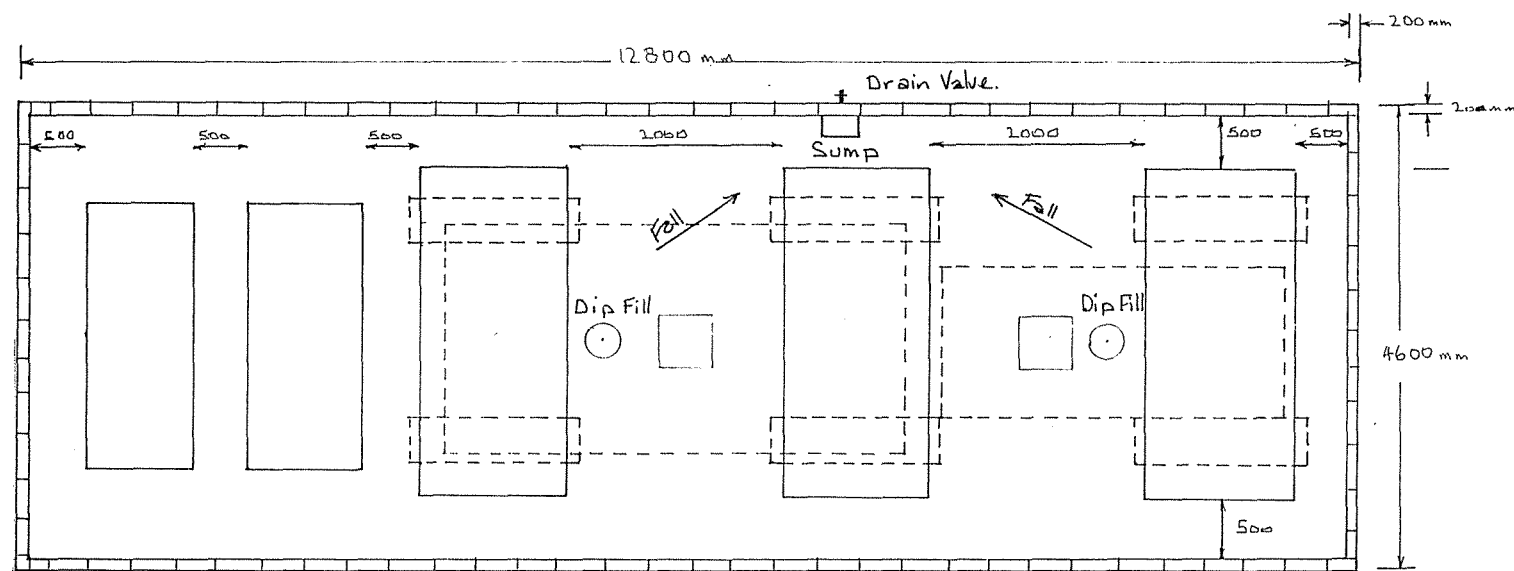
NOTE: Distance from Tank Shell to Bund Crest reduced to 500mm due to Viscosity of product being stored ie: oils.
AS 1940-93 5.9.3(g)

This plan conforms with the
Dangerous Goods Act N.S.W. 1975
and Aust. Standard AS 1940-93
Signed for Robert Boring
Date 20/3/95

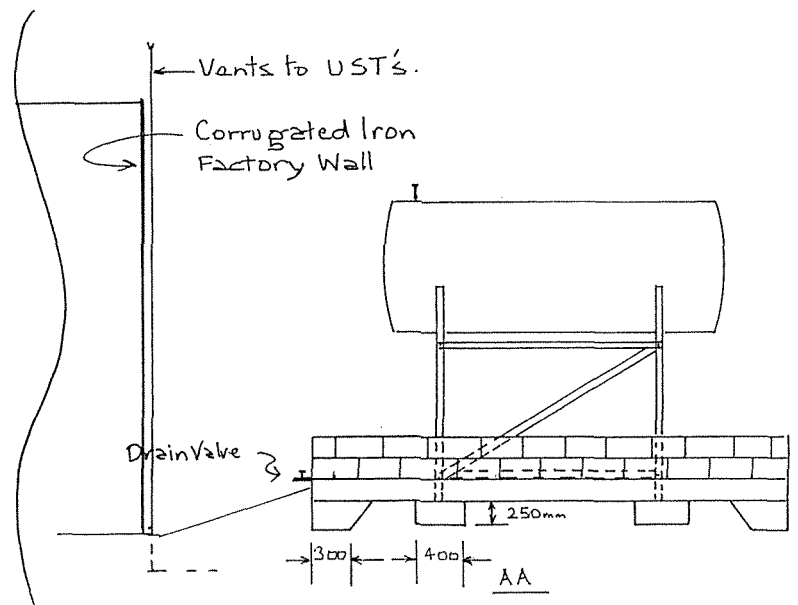
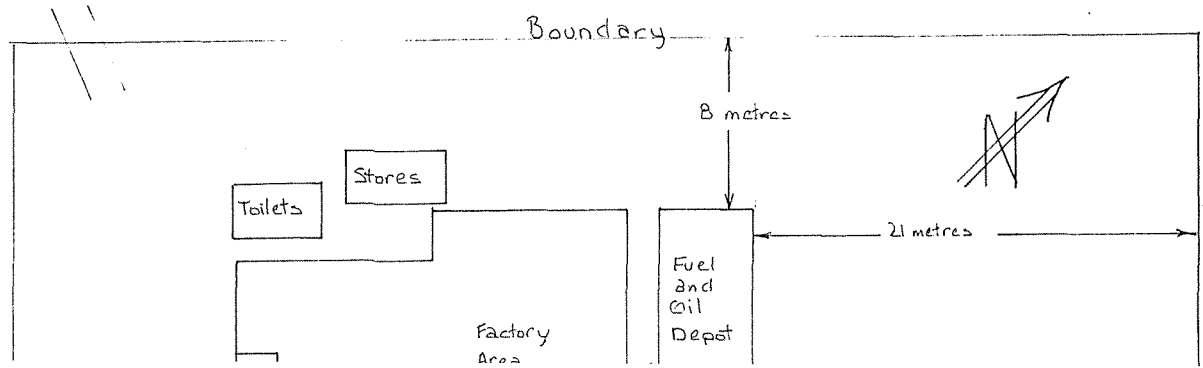
Filled Concrete Block Wall
Slab: 20 mpa - F82 Mesh

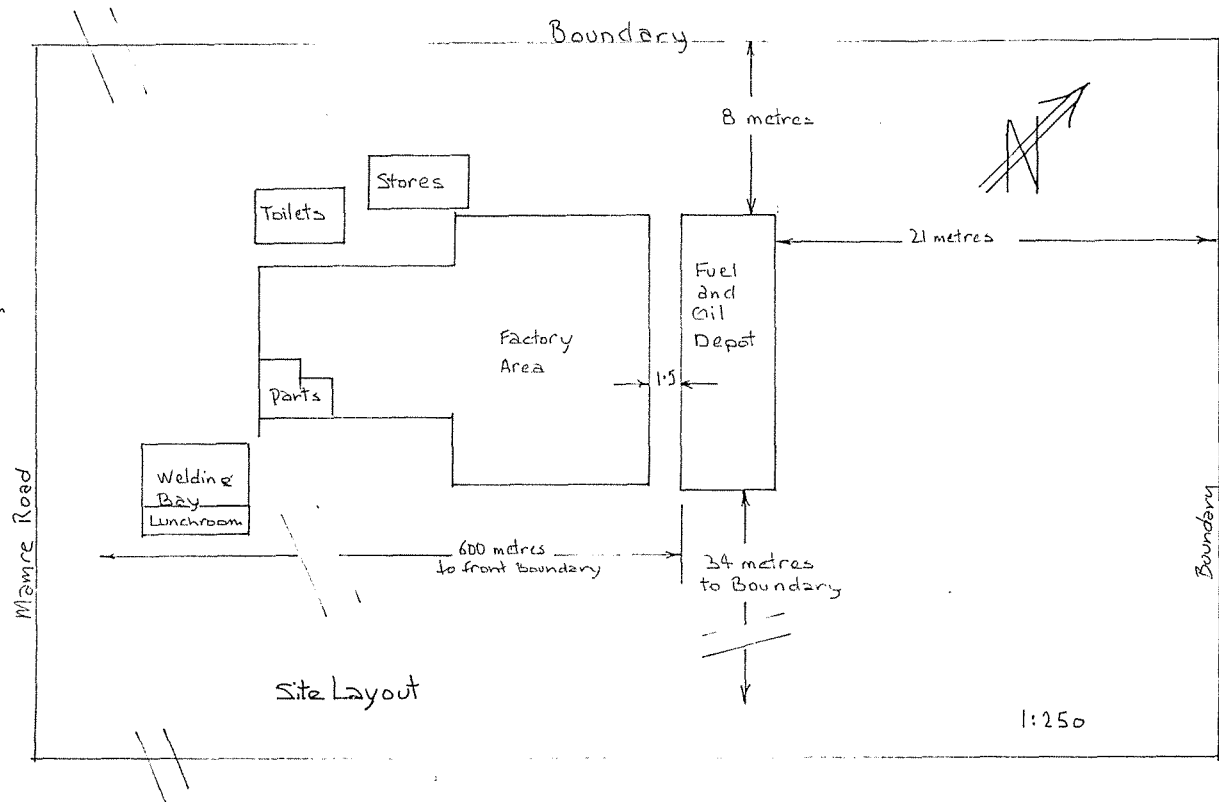
Filled Concrete Block Wall
Slab: 20 mpa - F82 Mesh

This plan conforms with the
Dangerous Goods Act N.S.W. 1975
and Aust. Standard As 1940-93
