Our Ref: PSM4352-003L REV1

RE: 754-770 AND 784-786 MAMRE ROAD, KEMPS CREEK - RESULTS OF GEOTECHNICAL INVESTIGATION

### 1. Introduction

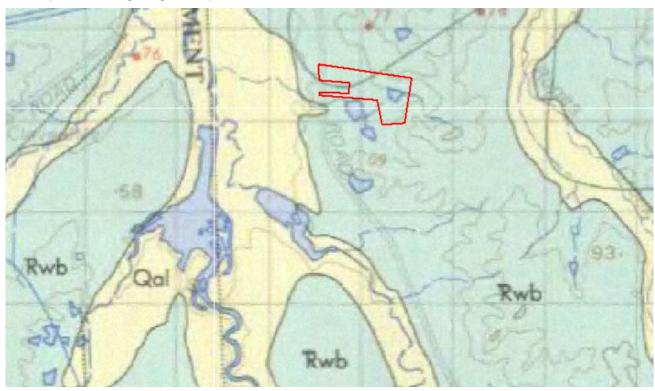
Inset 1: Geological Map for Sydney (The red boundaries mark the approximate site location)

(Qal) fluvial fine-grained sand, silt and clay in areas.

Inset 1 presents the geological map of the site.

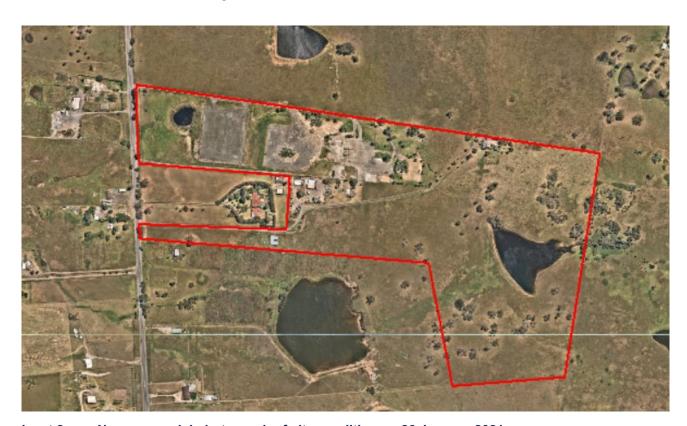
Inset 2: Nearmap aerial photograph of site condition on 26 January 2021

The site is generally sloping towards Badgery's Creek in the southwest direction. It is noted that the regions around the north-east and south-east corner of the site boundaries are steep hills.

- Grassed and vegetated areas
- A residential house, sheds, farmhouses, dirt and gravel roads, dams and a concrete and asphalt hardstand
- There are livestock that graze on the land.

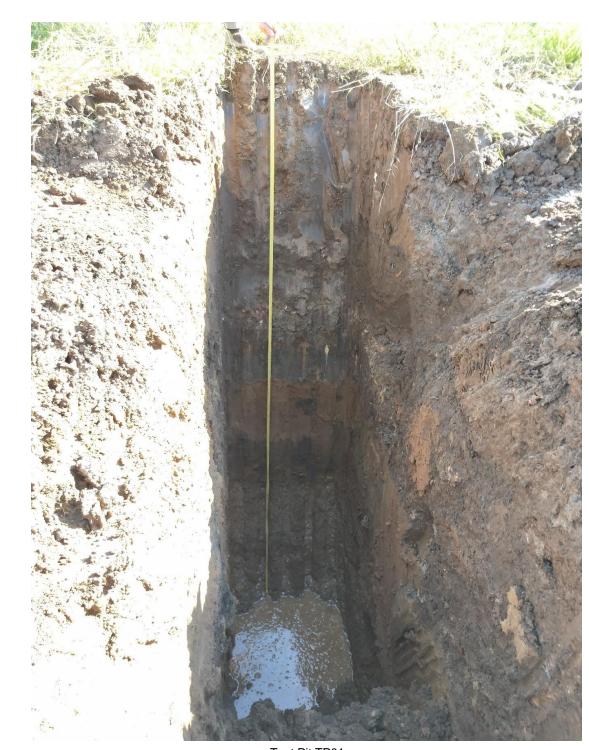
The GPT Group
754 - 786 Mamre Rd, Kemps Creek, NSW
GEOTECHNICAL INVESTIGATION
TEST PIT PHOTOS
TP01

Test Pit ID	Approximate Depth (m)	Material Encountered	Notes
TP01	0 – 1.8	FILL; CLAY, brown, high plasticity, traces of plastic, glass, timber fibres, rootlets and sandstone fragments up to 60 mm, moist, very stiff – hard consistency.  Becomes dry at 0.1 m.	Grass observed on surface.  Pocket Penetrometer (PP) readings of 350, 320 and 400 kPa at 0.3 m depth.  Jar sample taken at 1.6 m.

1.8 – 3.9	CLAY; greyish brown, high plasticity, moist, stiff to very stiff consistency.  Becomes CLAY with Gravel; reddish-brown and mottled grey  Becomes wet at 3.0 m.	PP readings of 180, 200 and 260 kPa at 2.1 m depth.  Water inflow at 3.0 m. CBR Sampling at 3.7 – 3.9 m.

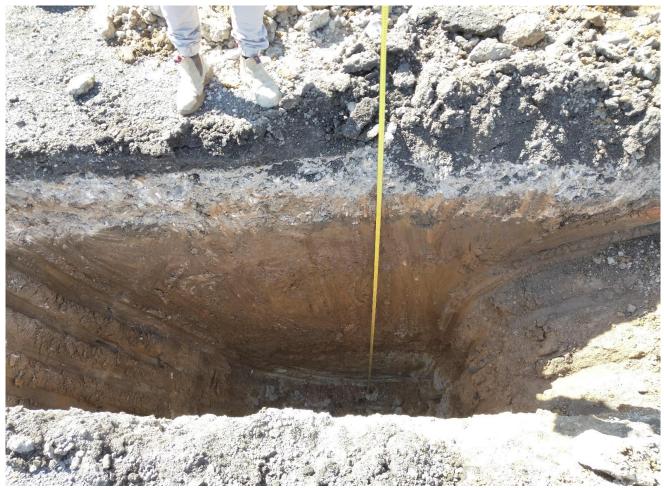
# The GPT Group 754 - 786 Mamre Rd, Kemps Creek, NSW GEOTECHNICAL INVESTIGATION TEST PIT PHOTOS TP02

0.5 – 2.1	FILL; CLAY with silt, brown with mottled reddish brown, high plasticity, trace fine black gravels, moist, stiff to hard consistency.	PP readings of 150, 200, 300, 230, 280 and 400 kPa at 0.7 m depth.
TP02	2.1 – 3.1	CLAY; orange brown, high plasticity, trace fine dark grey clay, moist, firm to stiff consistency.  Becomes pale grey and orange, trace tree rootlet, very stiff consistency at 2.5 m.	Water Seepage observed at 2.4 m.  PP readings of 270, 330 and 380 kPa at 2.7 m depth.

3.1 – 3.2	SHALE: Dark grey and brown, highly weathered, very low to low strength, moist.	
	3.2	TP02 terminated 3.2 m.

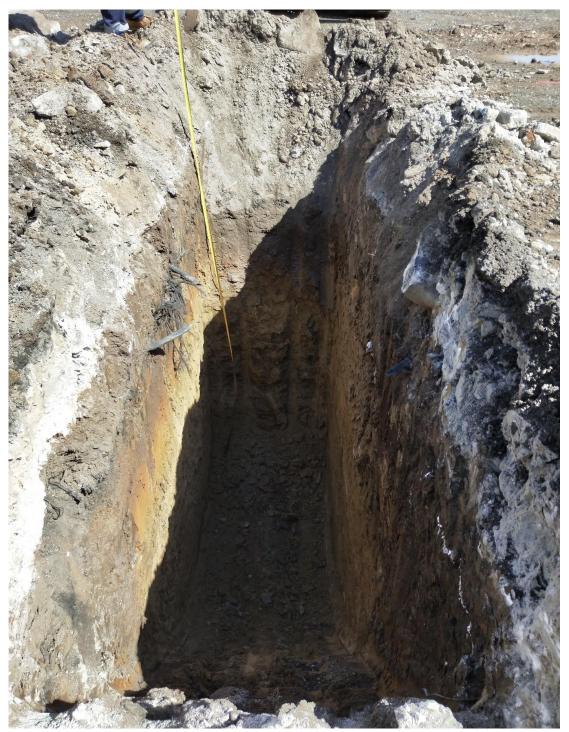
The GPT Group
754 - 786 Mamre Rd, Kemps Creek, NSW
GEOTECHNICAL INVESTIGATION
TEST PIT PHOTOS
TP03

Test Pit ID	Approximate Depth (m)	Material Encountered	Notes
	0 – 0.1	Unsealed GRAVEL and COBBLES; dark grey to black, fine to coarse grained gravels and cobbles up to 70 mm, dry, angular.	
	0.1 – 0.4	FILL; Sandy GRAVEL with CLAY; pale grey, fine to medium grained, sub-angular, medium to high strength gravels, cobbles up to 300 mm, moist. Fill comprises crushed sandstone.	
	0.4 – 0.9	FILL; CLAY, brown, low to medium plasticity, traces of rootlets, plastic, styrofoam, dry, hard consistency.	Organic odour PP readings of 400, 600 and >600 kPa at 0.5 m.
TP03	0.9 – 1.8	CLAY; orange brown with mottled red, medium to high plasticity, moist, very stiff to hard consistency.  Becomes orange/pale brown with mottled pale grey at 1.6 m.	PP readings of 210, 270 and 330 kPa at 1.0 m.
	1.8 – 2.9	SHALE; brownish grey, highly weathered, low to medium strength.	
	2.9	Practical Refusal at 2.9 m.

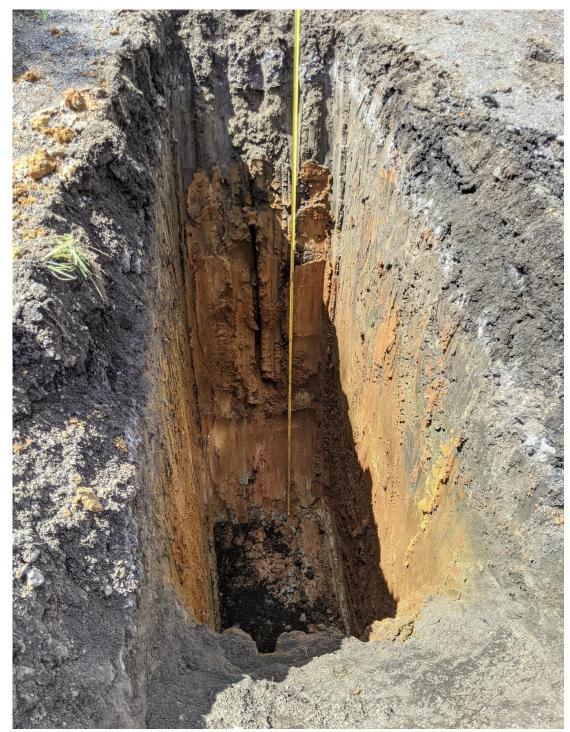
Test Pit ID	Approximate Depth (m)	Material Encountered	Notes
	0 – 0.2	Unsealed GRAVEL with cobbles and sand; fine to coarse grained, sub-angular to angular, rock fragments up to 70 mm, moist, angular.	
TP04	0.2 – 0.4	FILL; Sandy Gravel; dark grey, with rock fragments up to 300 mm. Fill comprises crushed Shale.	
	FILL; Silty CLAY, dark brown, high plasticity, moist, stiff to very stiff consistency.		PP Readings of 310, 310 and 390 kPa at 0.45 m.  Clayey SILT within some regions.
	1.0 – 3.5	CLAY; light brown with mottled grey, medium to high plasticity, moist, stiff to very stiff consistency.  Becomes orange and reddish brown with grey at 1.2 m.  Becomes pale grey with mottled red and trace of shale fragments.	PP Readings of 140, 230 and 240 kPa at 1.3 m.
	3.5	TP04 terminated at 3.5 m.

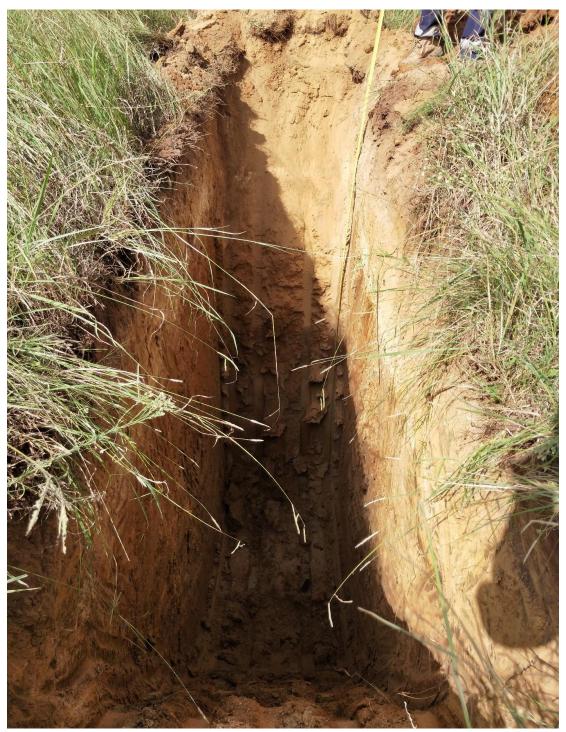
The GPT Group 754 - 786 Mamre Rd, Kemps Creek, NSW **GEOTECHNICAL INVESTIGATION TEST PIT PHOTOS TP05**

Test Pit ID	Approximate Depth (m)	Material Encountered	Notes
	0 – 0.1	TOPSOIL; Silty CLAY, brown, dry, contains rootlets.	Organic odour
TP05	CLAY; yellow-brown, medium plasticity, trace of fine gravel up to 20 mm, dry, hard consistency.  Becomes reddish-brown with mottled grey, high plasticity, moist at 0.7 m.		Organic rootlets at 0.3 m.  PP Readings of 550, 510 and 560 kPa at 1.1 m.  Jar and CBR sampling at 2.0 m.

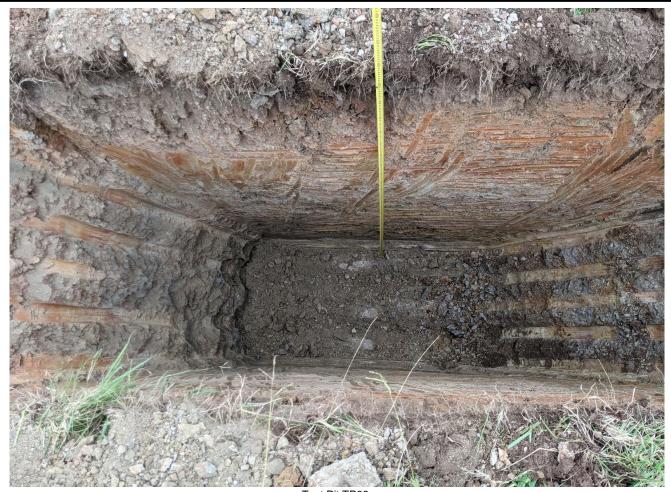
Test Pit TP06

3.0	TP05 terminated at 3.0 m.	
	0 – 0.2	TOPSOIL; Silty CLAY, dark brown, contains rootlets, moist.	
TP06	0.2 – 1.6	CLAY; reddish-brown, medium plasticity, dry, stiff to hard consistency.  Becomes grey with mottled red-brown at 0.6 m.	PP Readings of 450, >600 kPa at 0.5 m. CBR Sampling at 0.8 – 0.9 m.

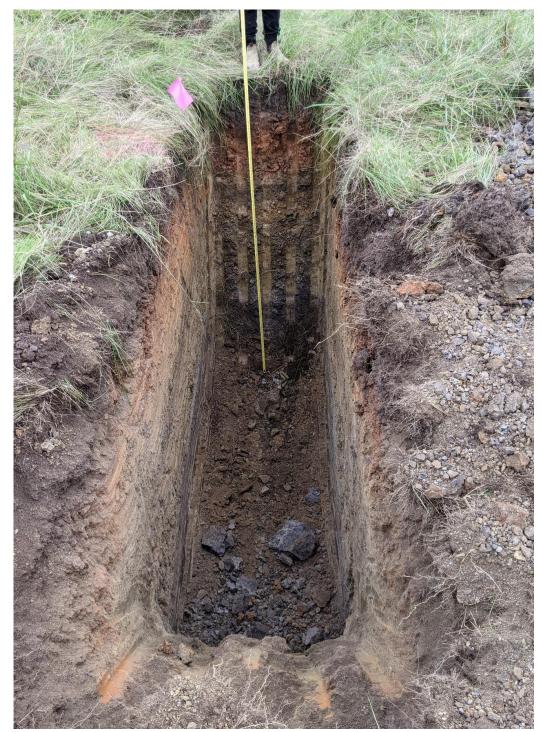
3.0	EOH terminated at 3.0 m.	
	0 – 0.3	TOPSOIL; Silty CLAY, dark brown, contains rootlets, moist.	
	0.3 – 1.3	CLAY; reddish-brown, medium plasticity, dry, very stiff to hard consistency.	PP Readings of 550, >600 kPa at 0.5 m.
TP10	1.3 – 1.6	SHALE; pale grey with orange brown, highly weathered, low strength.

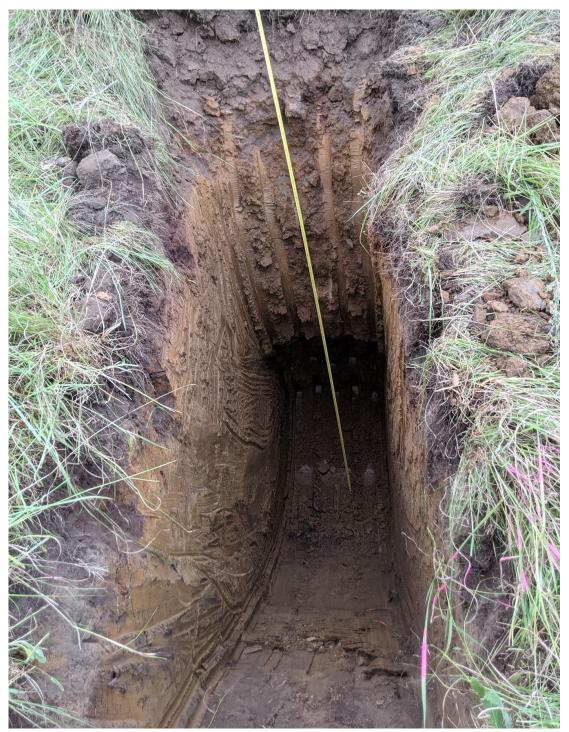
**TP11**

Test Pit ID	Approximate Depth (m)	Material Encountered	Notes
TP11	0 – 0.3	TOPSOIL; Silty CLAY, dark brown, medium plasticity, moist, contains rootlets and tree bark.	
	CLAY; yellow-brown, medium plasticity, trace of fine-grained sand, moist, very stiff to hard consistency.  Becomes CLAY trace sand and gravel, yellow brown with inclusions of black-grey and reddish-brown, fine-grained gravel up to 30 mm, sub-angular at 2.6 m.  Becomes stiff consistency at 3.3 m.		PP Readings of 510, 550, 450 and 510 kPa at 1.6 m.  PP Readings of 330, 200, 500 and 600 kPa at 2.6 m.  PP Readings of 190, 260 and 240 kPa at 3.6 m.  Jar and CBR Sampling at 3.6 m.

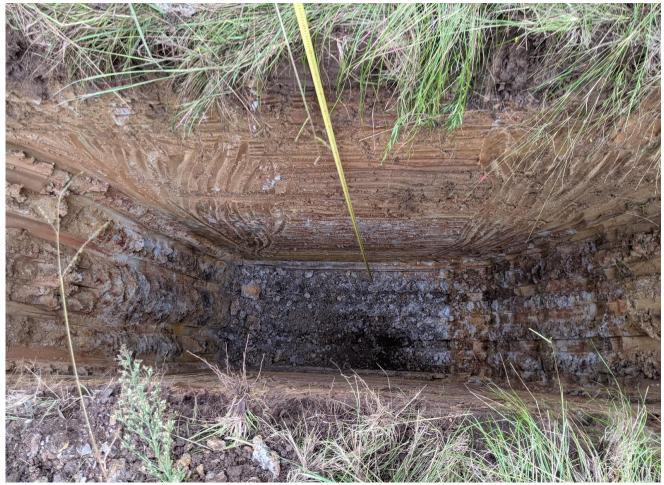
Test Pit TP14

Test Pit ID	Approximat e Depth (m)	Material Encountered	Notes
TP14	0 – 0.2	TOPSOIL; Silty CLAY, dark brown, medium plasticity, contains rootlets.	
	0.2 – 3.0	CLAY; yellow brown, medium plasticity, trace of fine-grained sand, moist, hard consistency.	PP readings greater than 600 kPa at 0.5 m. PP reading of 300, 350
		Becomes trace gravel at 0.9 m.  Becomes pale grey with inclusions of yellow	and 300 kPa at 1.6 m.
		and brown, high plasticity, very stiff consistency.	
		Becomes CLAY trace fine to medium grained sand at 2.2 m.	
		TP14 terminated at 3.0 m.	
TP16	0 – 0.3	TOPSOIL; Silty CLAY, brown to grey, high plasticity, moist, contains rootlets.

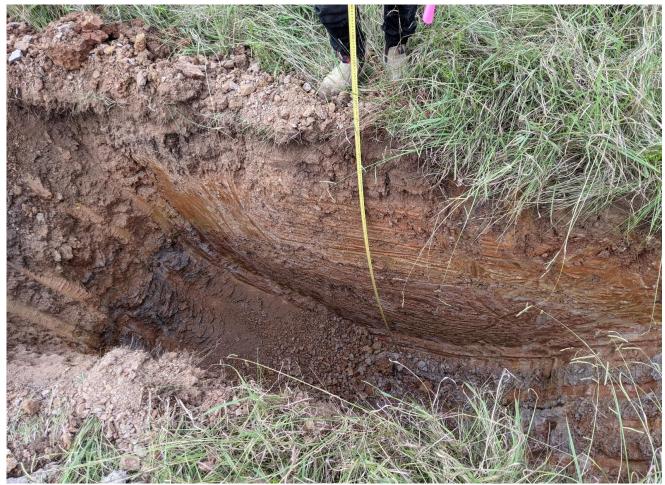
Test Pit TP18

Test Pit ID	Approximat e Depth (m)	Material Encountered	Notes
TP18	0 – 0.3	TOPSOIL; Silty CLAY, dark brown, moist, contains rootlets and vegetation.	
	0.3 – 1.5	CLAY; reddish-brown, medium to high plasticity, dry, very stiff to hard consistency.	PP readings of >600, >600 and 510 kPa at 0.7 m.
		Becomes yellow brown at 0.8 m.	CBR Sampling at 1.2 – 1.8 m.

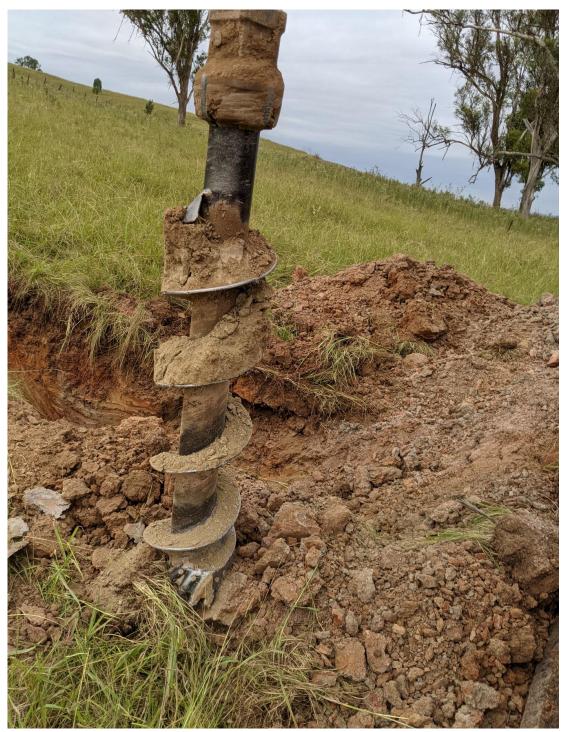
Test Pit TP19

2.5	Practical refusal at 2.5 m.	
TP19 (Auger)	0 – 0.1	TOPSOIL; Silty CLAY, dark brown, moist.	
	0.1 – 2.1	CLAY; pale grey, medium plasticity, dry, stiff consistency.	Rootlets at 0.7 m.
		Becomes CLAY with inclusions of mottled reddish brown, very stiff to hard consistency at 1.1 m.	PP reading of 200, 210 and 230 kPa at 0.7 m.
			PP readings of 550 and 600 kPa at 1.3 m.
		Becomes brown with mottled grey and reddish-brown, high plasticity	Jar Sampled at 1.9 m.
		Becomes brown at 1.8 m.

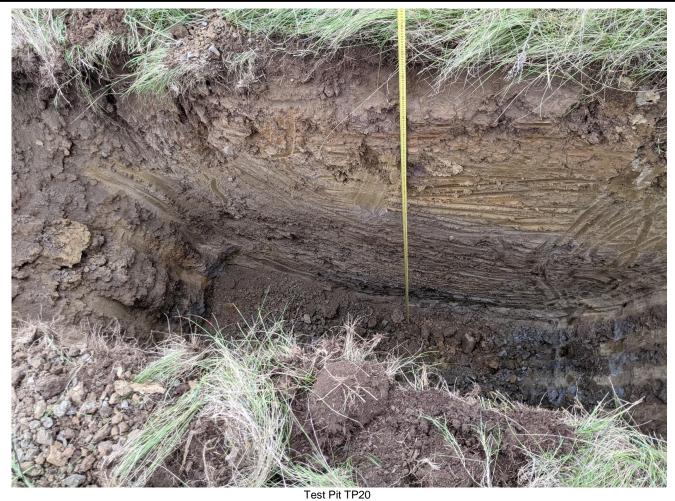
# The GPT Group 754 - 786 Mamre Rd, Kemps Creek, NSW **GEOTECHNICAL INVESTIGATION TEST PIT PHOTOS** TP20

Test Pit ID	Approximat e Depth (m)	Material Encountered	Notes
TP20	0 – 0.1	TOPSOIL; Silty CLAY, dark brown, traces of sub-angular gravel up to 30 mm, moist, contains rootlets.	
	0.1 – 1.7	CLAY; yellow-brown, medium plasticity, dry, very stiff to hard consistency.  Becomes pale grey with mottled yellow brown at 0.6 m.	PP reading of >600 and 450 kPa at 0.45 m.
	1.7 – 2.9	SHALE; pale grey, moderately weathered, low to medium strength, dry.	
	2.9	Practical refusal at 2.9 m.
