ErSed Reference: 22004-ERMR-19-260307

**Re: SSD 10272349 - Yiribana Logistics Estate**

**Environmental Representative: Monthly Report (ERMR #19)**

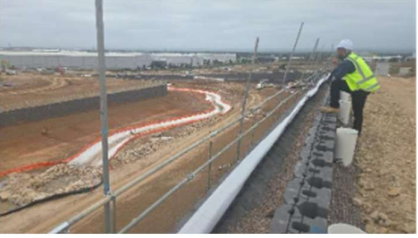
| Photo | Location and comment | Resolution/Action |
|---|---|---|
| | <p><u>Central lined channel – 12/02/2026</u></p> <p>The central swale has been shaped and lined.<br/>Sediment is accumulating within the drain.<br/>The bunds previously at the sides of the drain have been removed.</p> <p><b>The CPESC was contacted and requested to confirm this arrangement with reference to the requirement for compliant controls for all catchments in excess of 2500m<sup>2</sup></b></p> | <p><b>OBSERVATION</b><br/><b>RISK – MEDIUM</b></p> |

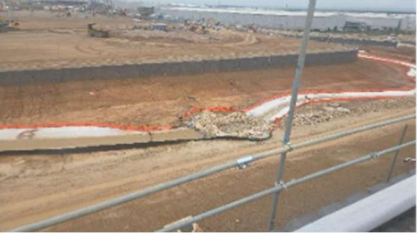
| Photo | Location and comment | Resolution/Action |
|---|---|---|
| | <p><u>Central channel – sediment controls – 12/02/2026</u></p> <p>Sediment controls /fences have been set at the sides of the channel.<br/>Maintenance is required to the controls.<br/>See query above regarding provision of compliant controls.<br/>Maintenance of the controls is required<br/>Note sediment and turbid water within the channel invert.</p> | <p><b>OBSERVATION</b></p> |

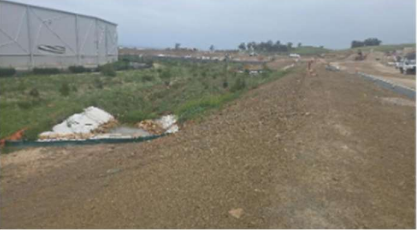
| Photo | Location and comment | Resolution/Action |
|---|---|---|
| | <p><u>Northern batter to Riparian Zone – 12/02/2026</u></p> <p>The batter to the riparian zone is yet to be stabilised or landscaped.<br/>Discussions prior to Christmas indicated that landscape works in this area were to be prioritised.</p> <p><b>Please to confirm when this work is to progress.</b></p> <p>Minor maintenance to the sediment controls in this area is required.</p> | <p><b>OBSERVATION</b></p> |

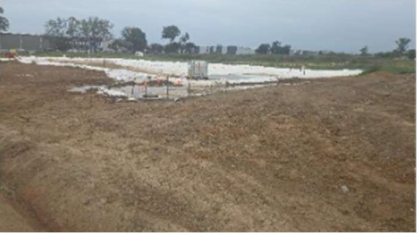
| Photo | Location and comment | Resolution/Action |
|---|---|---|
| | <p><u>Inlet to Western Hess – 12/02/2026</u></p> <p>The inlet to the basin has been moved from the eastern end to the southern side of the forebay.<br/>The surrounds to the inlet are saturated.<br/>This area should be shaped to better formalise the path to the basin.<br/>Please confirm with the CPESC.</p> | <p><b>OBSERVATION</b><br/><b>RISK LOW</b></p> |

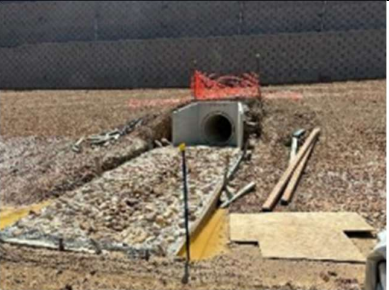
| | | | <p><u>Clean Water drain – 24/02/2026</u></p> <p>Permanent drainage and rock scour protection has been installed.</p> | <p><b>OBSERVATION</b></p> | |

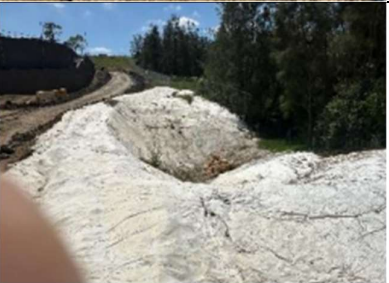
| | | | <p><u>Clean Water drain – inlet – 24/02/2026</u></p> <p>Inlet to the clean water drain was lined with geofabric and was in good condition.</p> | <p><b>OBSERVATION</b></p> | |

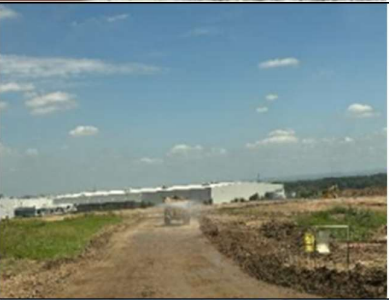
| | | | <p><u>Dust suppression – 24/02/2026</u></p> <p>A water cart was being utilised to suppress dust with no dust plumes observed.</p> | <p><b>OBSERVATION</b></p> | |

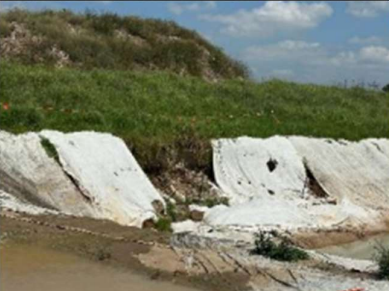
| | | | <p><u>Sediment Basin #4 – 24/02/2026</u></p> <p>Geofabric lining of sediment basin #4 has become damaged and requires replacement</p> | <p><b>OBSERVATION</b></p> <p><b>RISK MEDIUM</b></p> | |

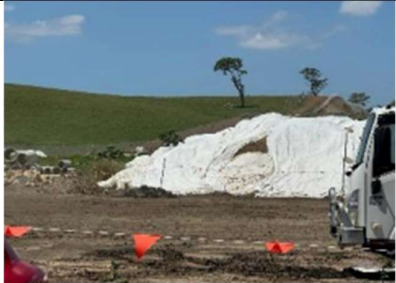
| | | <p><u>Asbestos Stockpile – 24/02/2026</u></p> <p>Parts of the asbestos stockpile have become exposed. The geofabric needs to be reinstated in these areas to ensure full coverage of the stockpile</p> | <p><b>OBSERVATION</b></p> <p><b>RISK LOW</b></p> |

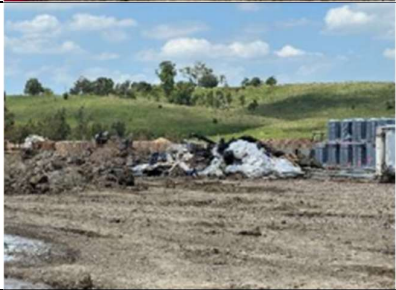
| | | <p><u>Subcontractor Rubbish – 24/02/2026</u></p> <p>Subcontractor rubbish requires removal and is an ongoing issue that needs to be managed</p> | <p><b>OBSERVATION</b></p> <p><b>RISK LOW</b></p> |
