ErSed Reference: 22004-ERMR-23-260707

**Re: SSD 10272349 - Yiribana Logistics Estate**

**Environmental Representative: Monthly Report (ERMR #23)**

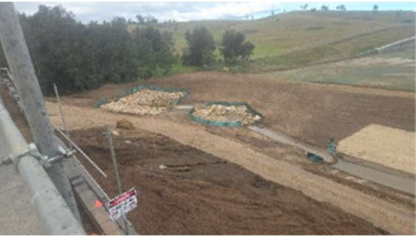
| Photo | Location and comment | Resolution/Action |
|---|---|---|
| | <p><u>Central clean water drainage – 04/06/2026</u></p> <p>The central riparian zone is being progressively topsoiled and landscaped. Jute mesh is being secured over the topsoil and planted.</p> | OBSERVATION |

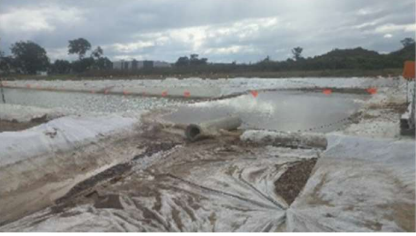
| Photo | Location and comment | Resolution/Action |
|---|---|---|
| | <p><u>Inlet area – East West basin – 04/06/2026</u></p> <p>Maintenance is required to the fabric over the surface in this location.</p> | OBSERVATION |

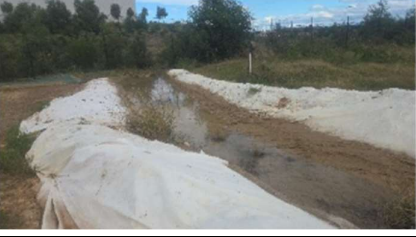
| Photo | Location and comment | Resolution/Action |
|---|---|---|
| | <p><u>East west basin – outlet channel – 04/06/2026</u></p> <p>Water within the basin main bay is clear.</p> <p>The outlet channel is stable however it is sediment stained. – this may be due to sediment from the underside of the fabric. It is suggested that this is re lined / or additional layer installed prior to the site being vacated.</p> | OBSERVATION |

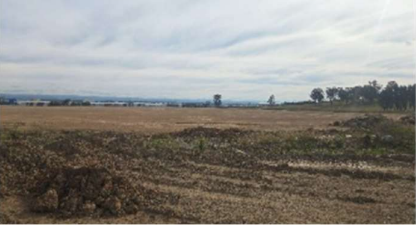
| Photo | Location and comment | Resolution/Action |
|---|---|---|
| | <p><u>WH4 – 18/06/2026</u></p> <p>The ESCP for WH4 indicates:</p> <ul style="list-style-type: none"> <li>• a central swale is provided</li> <li>• swales/diversion drains are provided at the northern, southern and western perimeters to engage the chute to the WH4 HES Basin.</li> <li>• these swales are not in place.</li> </ul> <p>Please review and confirm these works against the specified works.</p> <p>These swales need to be put in place or the ESCP changed to provide an alternative and appropriate control.</p> | OBSERVATION<br>ONGOING |

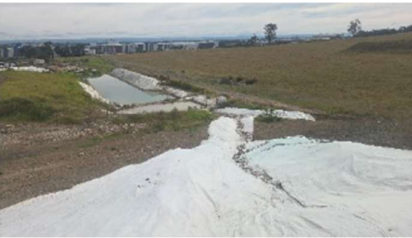
| | | <p><u>Inlet to WH4 basin – 18/06/2026</u></p> <p>Please confirm the drainage provided to this point.<br/>Drainage indicated on the ESCP is not evident on site.</p> | <p><b>OBSERVATION</b><br/><b>For conformation</b></p> |

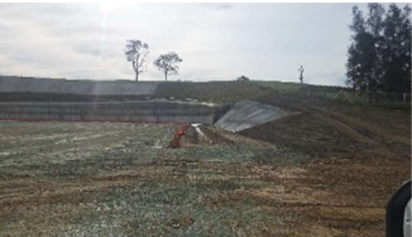
| | | <p><u>WH3 – Perimeter drainage – offsite – 18/06/2026</u></p> <p>The clean water drain has been shaped at the northern boundary to LOT3. The surface to the wall has been secured with fabric. The channel is exposed at the eastern perimeter and is let to connected to the clean water/riparian channel to the south.</p> | <p><b>OBSERVATION</b></p> |

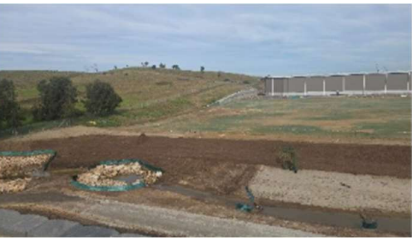
| | | <p><u>Central clean water drain – 18/06/2026</u></p> <p>Polymer is intact over the surface to WH2.</p> | <p><b>OBSERVATION</b></p> |

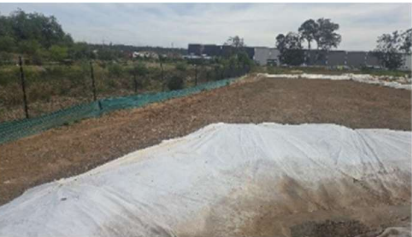
| | | <p><u>Basin surrounds – SW corner – 18/06/2026</u></p> <p>The sediment fences at the south of the exposed area will direct water to the drain/outlet from the basin.<br/>Returns and checks should be considered to control the site water directed to the west.<br/>Stabilisation of the exposed areas should be scheduled.</p> | <p><b>OBSERVATION</b></p> |

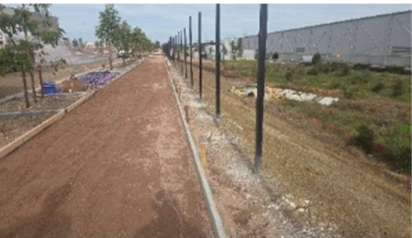
| | | <p><u>Landscaping to Riparian Corridor – 18/06/2026</u></p> <p>Landscape works to the riparian corridor are commencing – topsoil is being spread over the batter.<br/>Sediment controls are to be maintained at the base of the batter's pending completion of landscaping.</p> | <p><b>OBSERVATION</b></p> |
