SOIL SURVEY REPORT

CULCAIRN SOLAR FARM

MARCH 2019

DM McMahon Pty Ltd

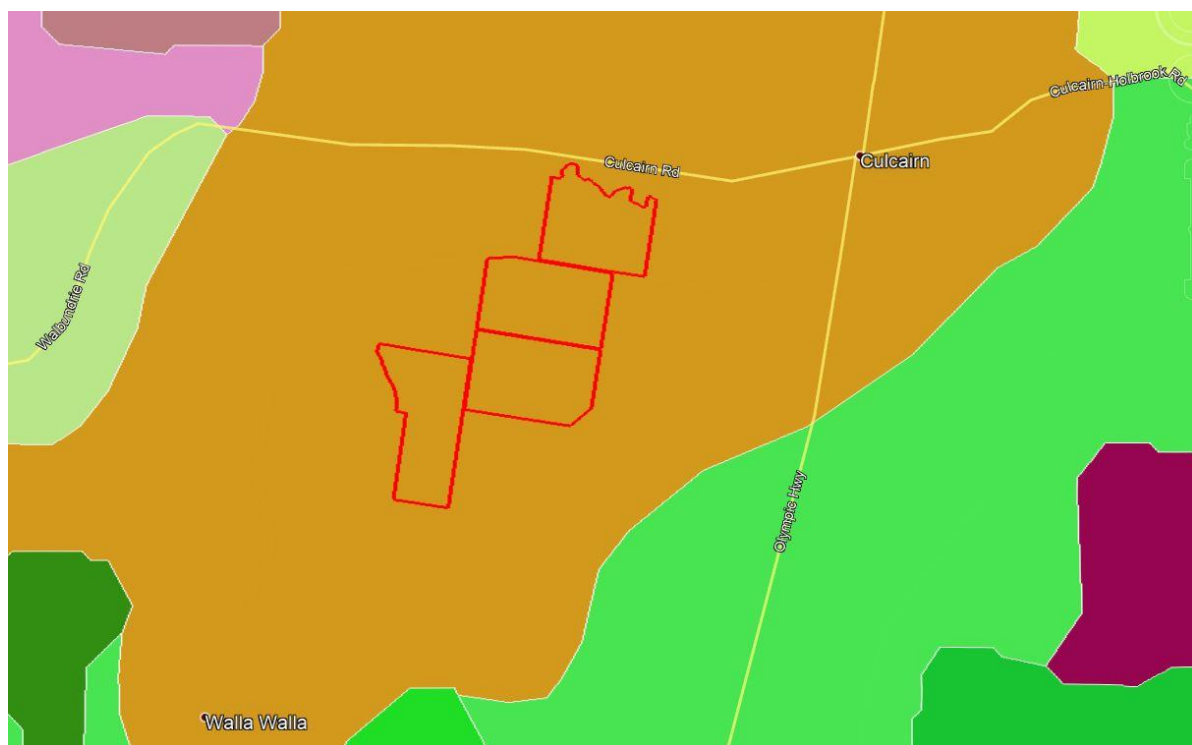
Figure 2: *Digital Atlas of Australian Soils mapping units with site overlay (Va16, Va17, My9 and Va14).*

The site lies within the mapping units **Va17** from the Digital Atlas of Australian Soils (CSIRO, 1991).

"Flat to gently undulating country with some swamps and broken by an occasional low gravelly or stony ridge or hillock: chief soils are hard alkaline yellow mottled soils (Dy3.43) and (Dr2.33), both containing ironstone gravel and sometimes forming soil complexes. Associated are: ridges and hillocks of (Dr2.32, Dr2.42) and (Um4.1) soils similar to unit Qc3; small flat areas of (Dr2.23); and various undescribed soils in local situations, e.g. subjacent to swamps and on stream terraces. Data are limited. Occurs on sheet(s): 3"

As follows is the soil landscape map (eSpade, 2018) which has been generally validated by the soil survey through laboratory and field techniques. As such, management practices can be grouped into management classes of Australian Soil Classification (ASC) units with Chromosols being represented across the Va17 soil type, **Figure 2**. This report identifies management practices for ASC units in Section 6.5 below.
