# **Non-Indigenous Archaeological Assessment**

800 Pittwater Road, Dee Why  
& 224 Headland Road, Curl Curl NSW

Submitted to Midson Group  
On Behalf of St Luke's Grammar School

November 2019

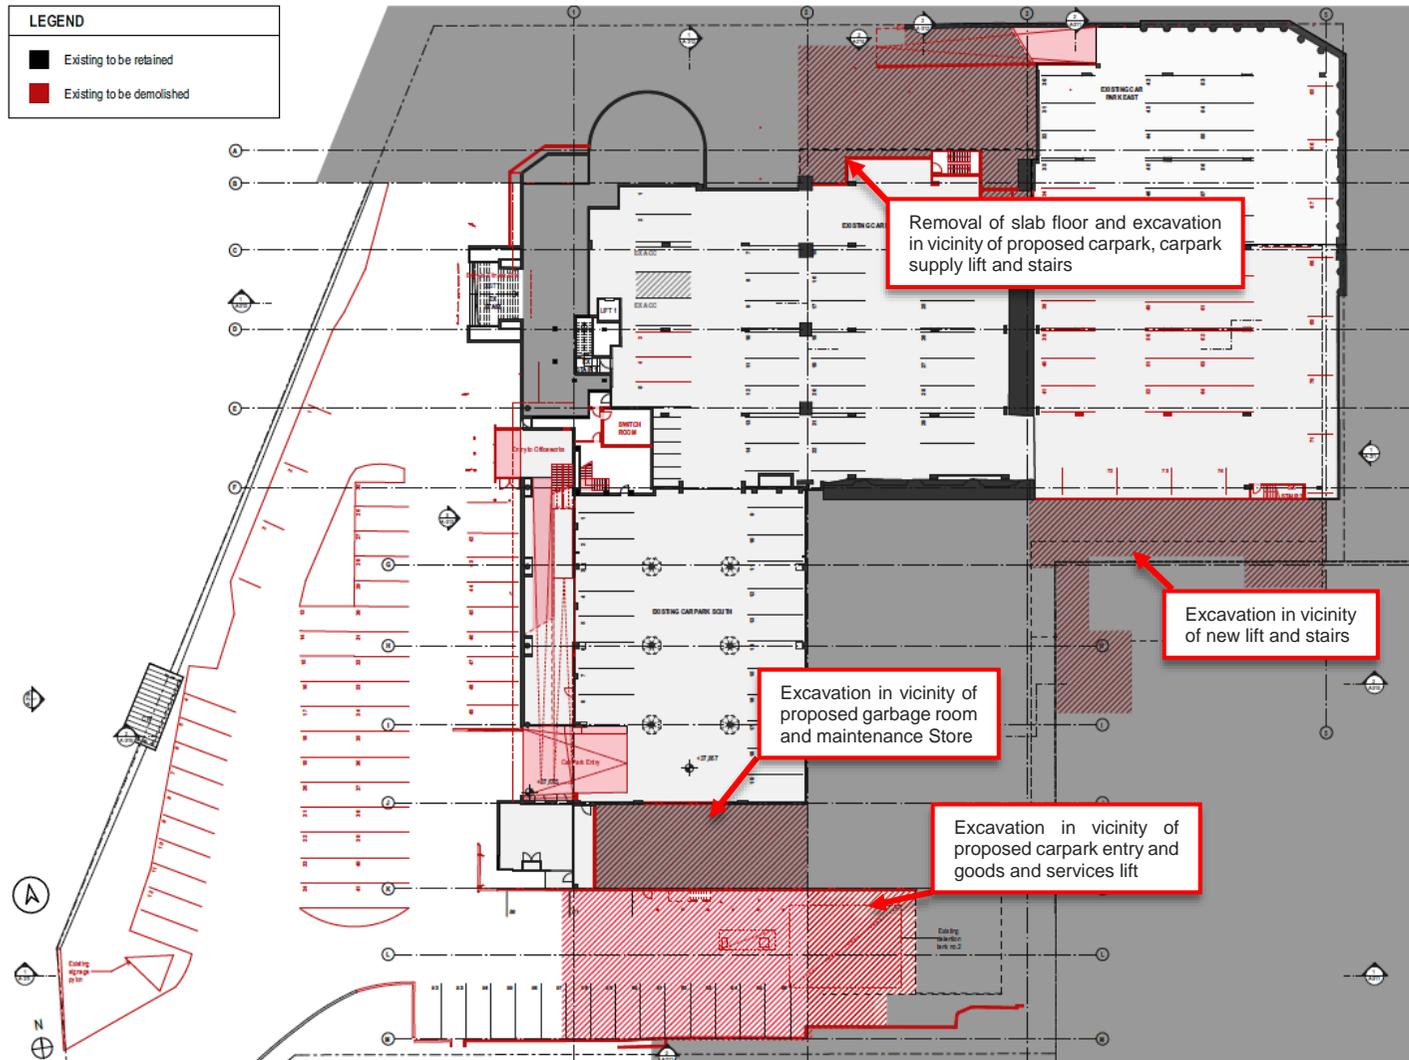
Figure 3: Extent of proposed excavation works at Level 0, 800 Pittwater road (Source: Level 0 Demolition Plan\_800, A-030, Rev A, 29/10/2019, Tonkin Zulaikha Greer Architects)

- **800 Pittwater Road:**
  - carpark, carpark supply lift and stairs at Level 0 (Figure 3)
  - garbage room and maintenance store at Level 0 (Figure 3)
  - carpark entry and goods and services lift at Level 0 (Figure 3)
  - lift and stairs at Levels 0, 1 and 2 (Figure 3 - Figure 7)
- **224 Pittwater Road:**
  - Minor demolition works (Figure 9 & Figure 10)

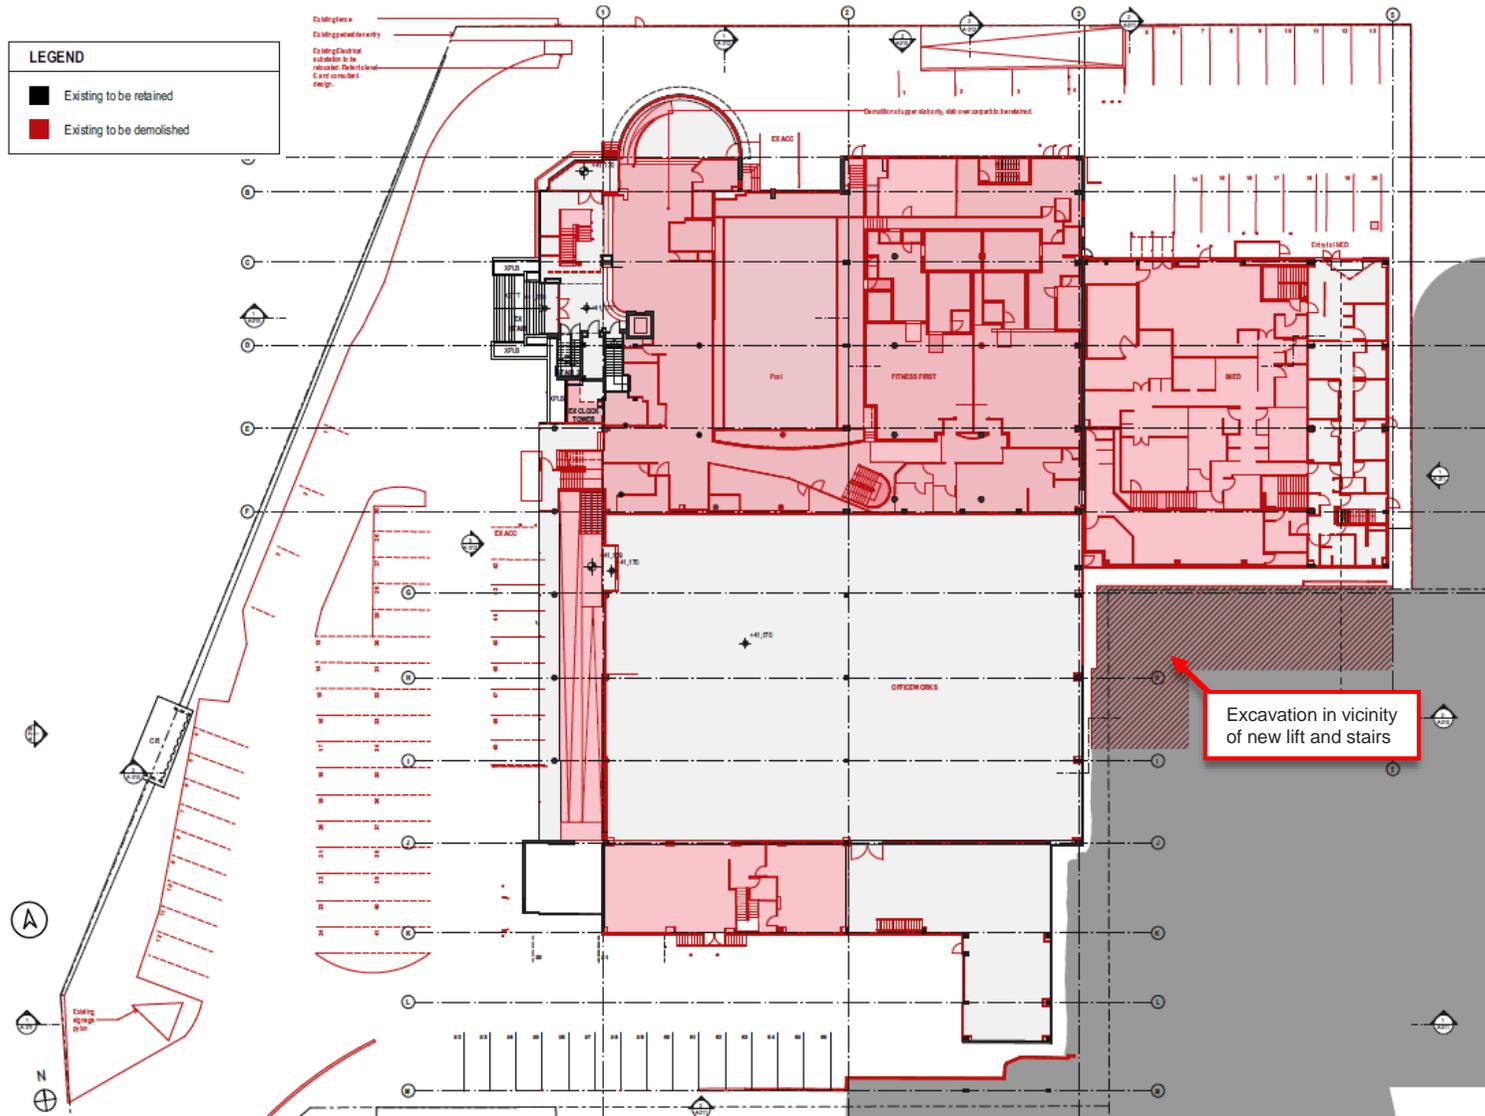
Figure 4: Extent of proposed excavations at Level 1, 800 Pittwater Road (Source: Level 1 Demolition Plan\_800, A-031, Rev A, 29/10/2019, Tonkin Sulaikha Greer Architects)

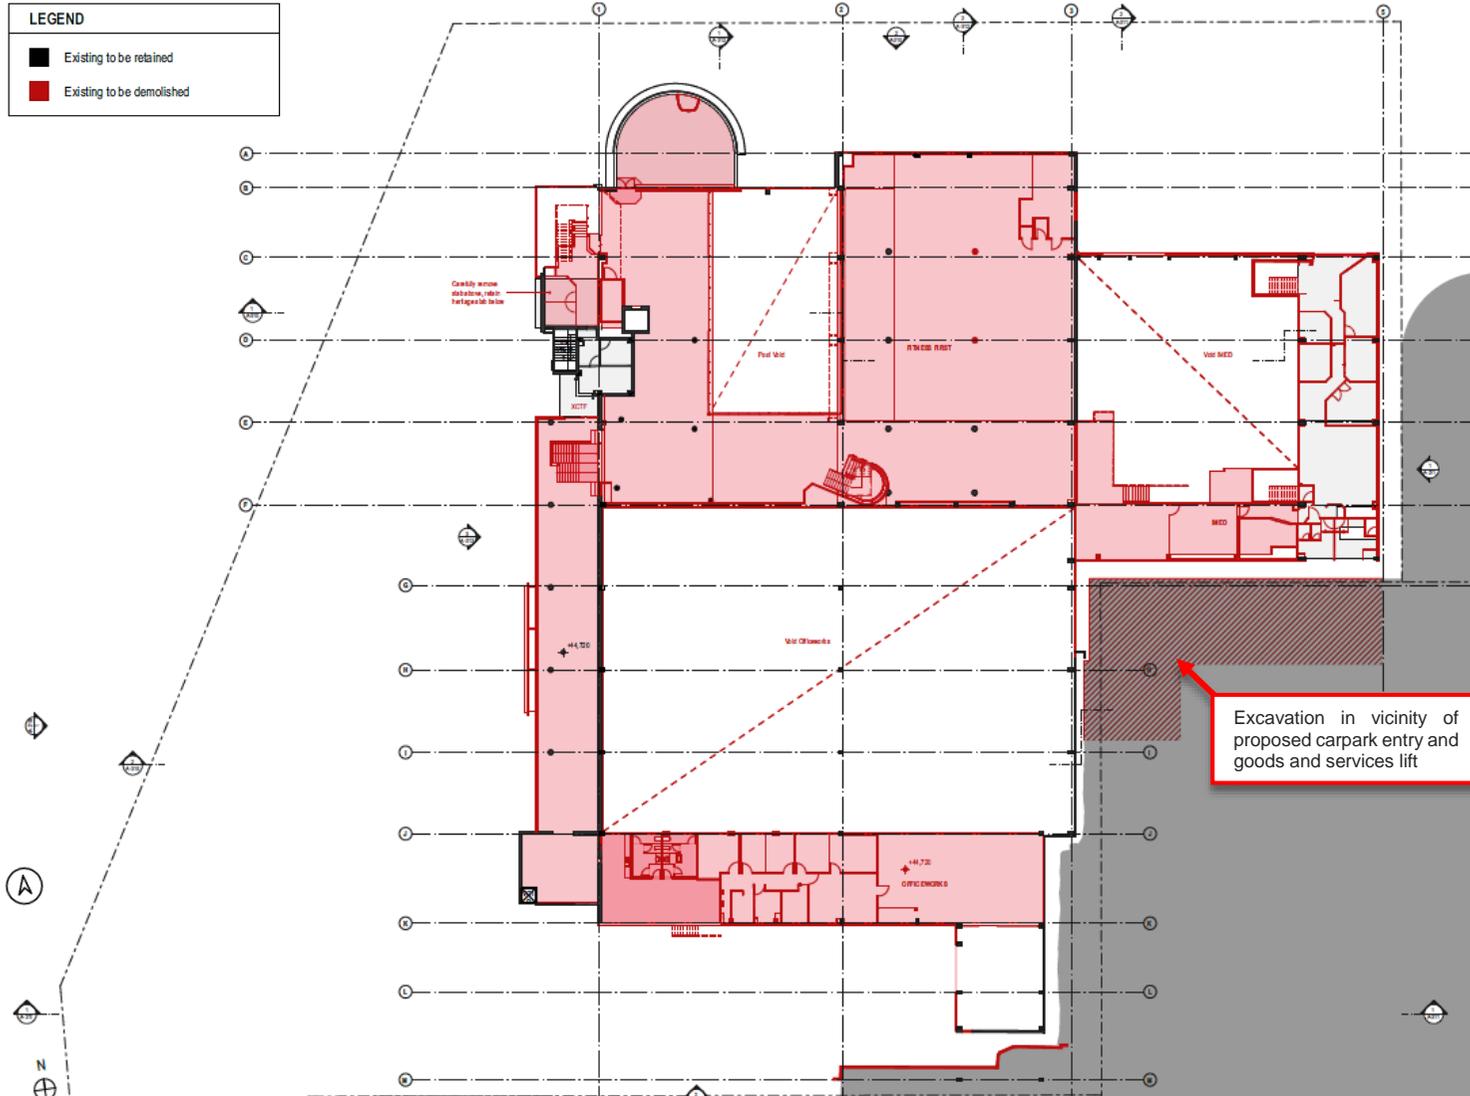
Figure 5: Extent of proposed excavations at Level 2, 800 Pittwater Road (Source: Level 2 Demolition Plan\_800, A-032, Rev A, 29/10/2019, Tonkin Zulaikha Greer Architects)

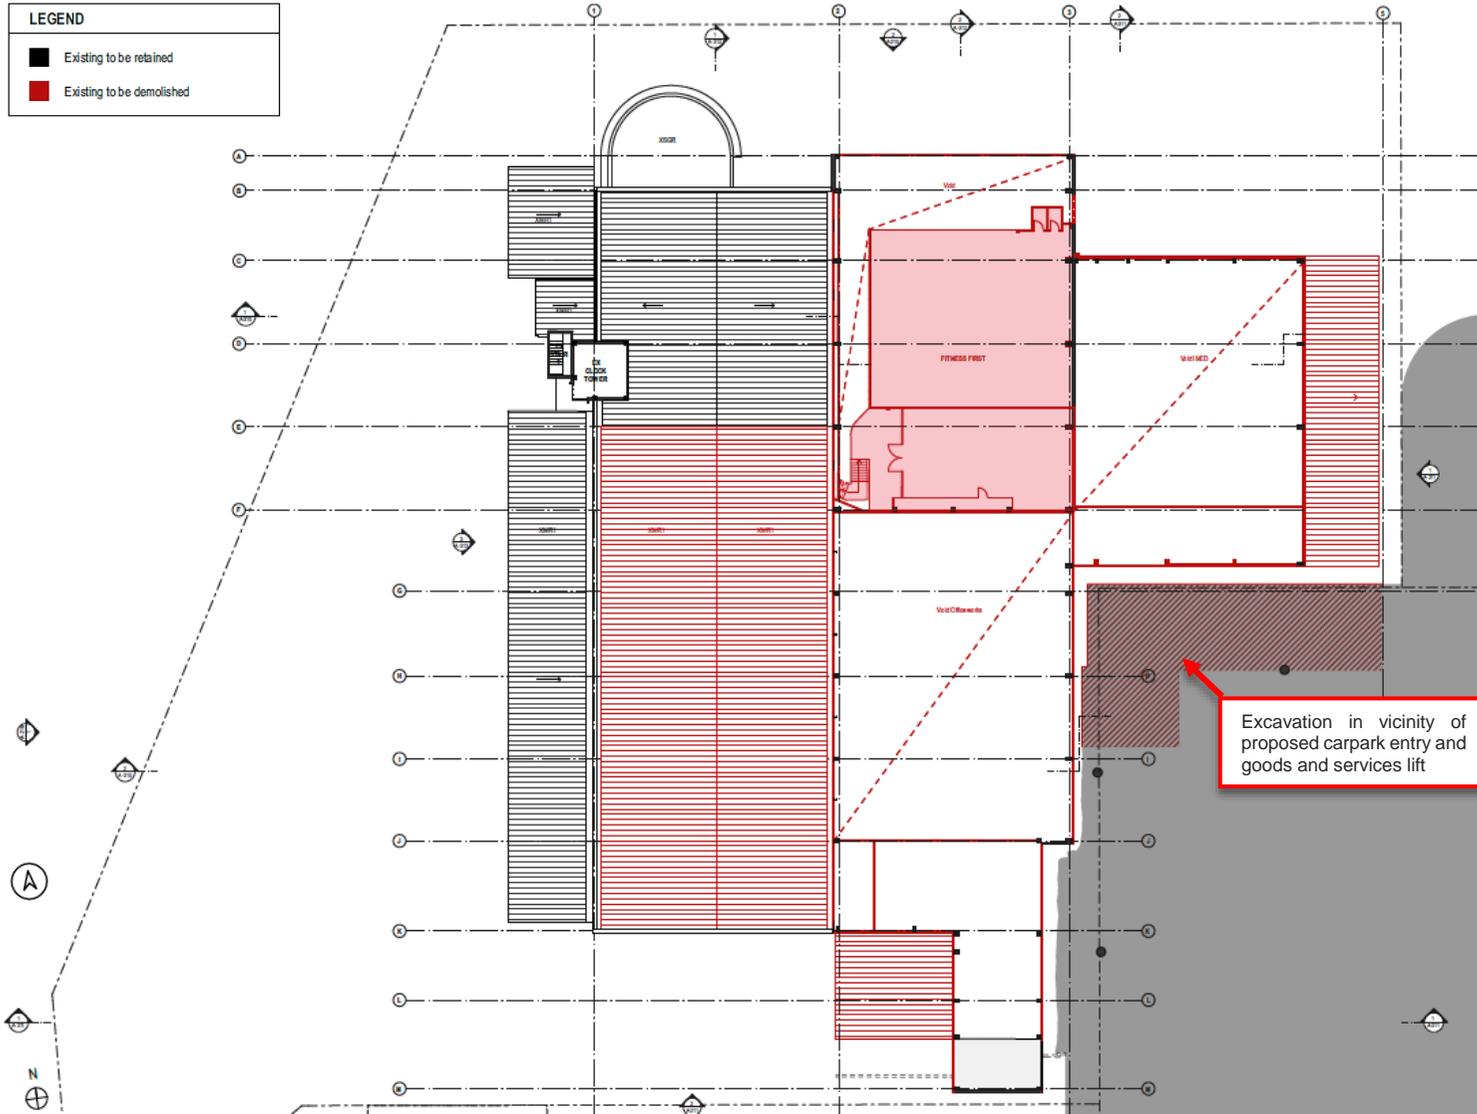
Figure 6: Extent of proposed excavations at Level 3, 800 Pittwater Road (Source: Level 3 Demolition Plan\_800, A-033, Rev A, 29/10/2019, Tonkin Zulaikha Greer Architects)

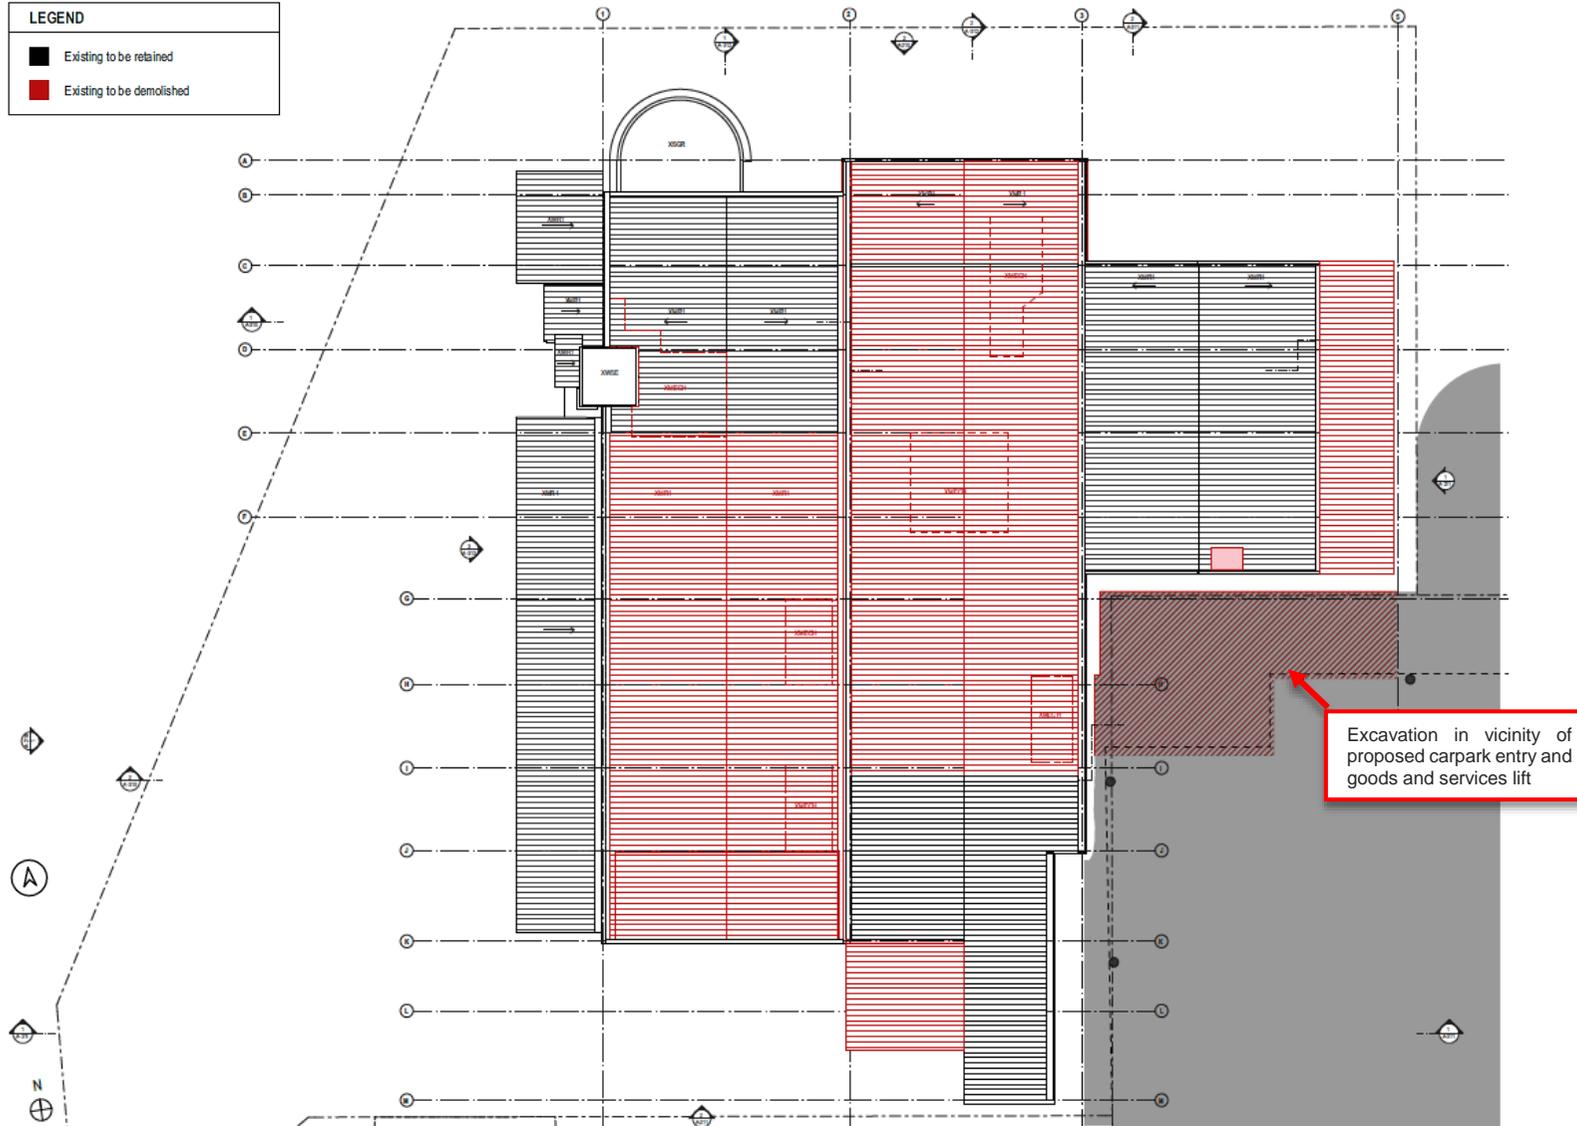
Figure 7: Extent of proposed excavations at Level 4, 800 Pittwater Road (Source: Level 4 Demolition Plan\_800, A-034, Rev A, 29/10/2019, Tonkin Zulaikha Greer Architects)

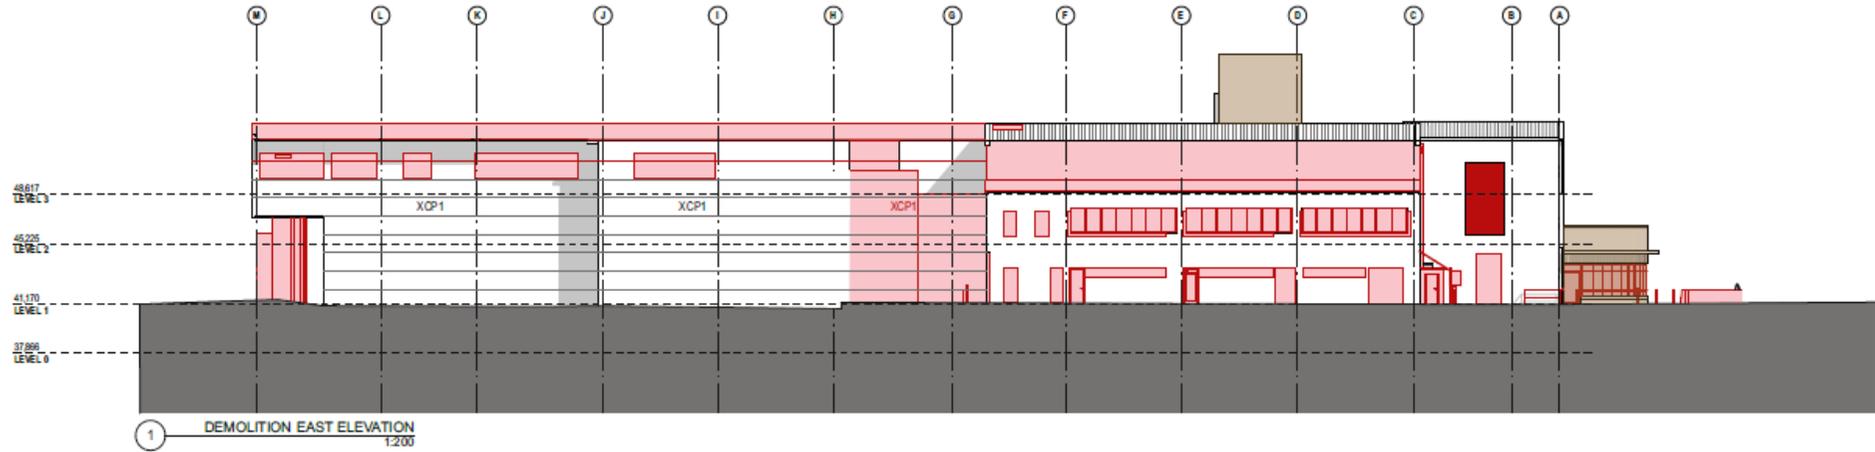
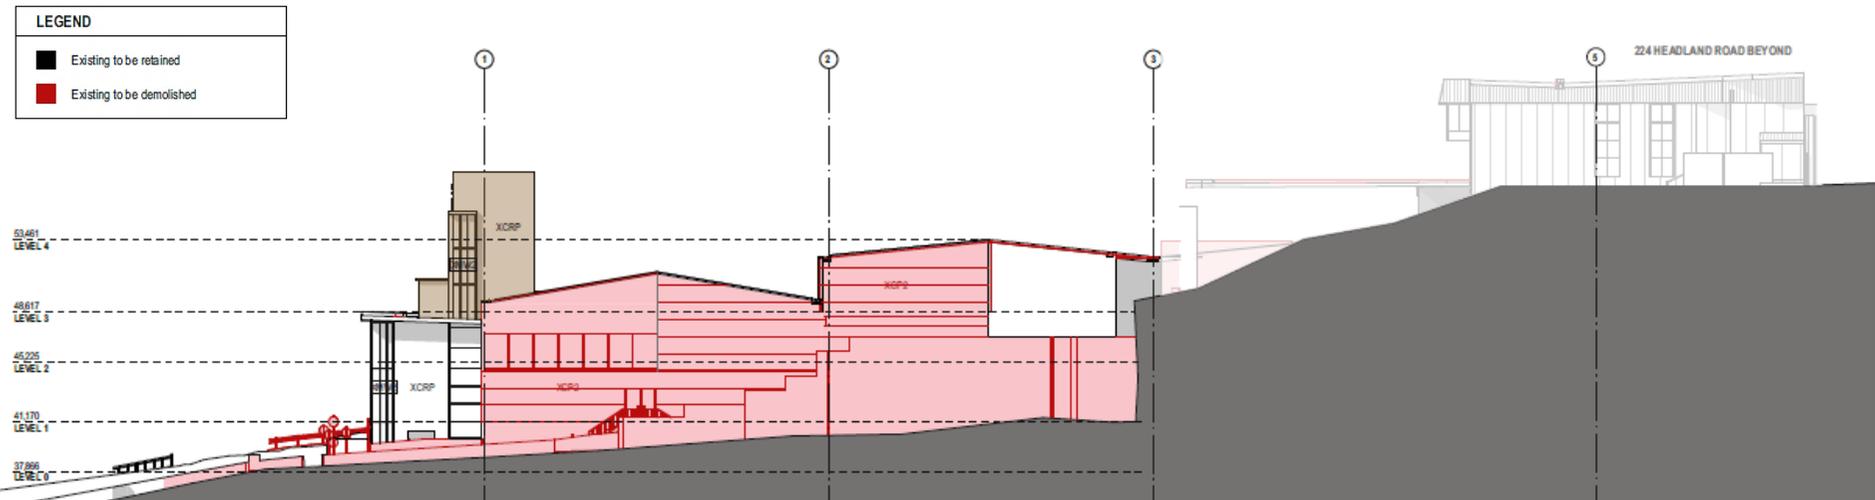
Figure 8: Extent of proposed excavations at 800 Pittwater Road, eastern (above) and southern (below) elevations (Source: East + South Demolition Elevations\_800, A-036, Rev A, 29/10/2019, Tonkin Zulaikha Greer Architects)

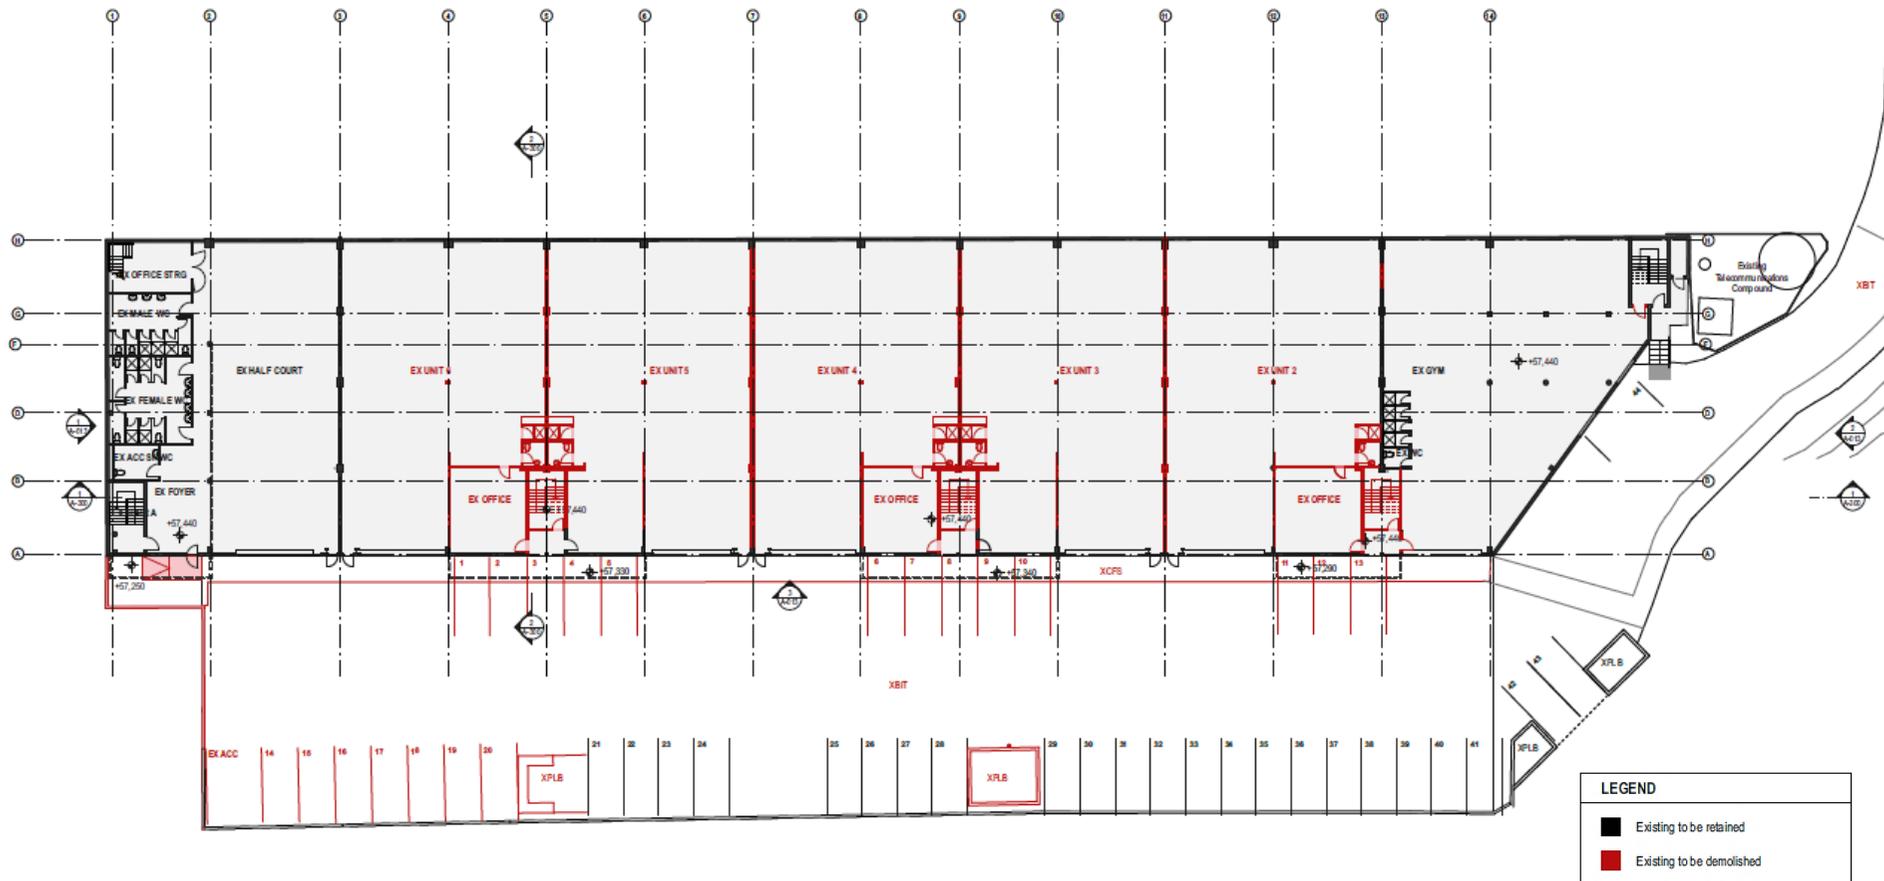
Figure 9: Extent of proposed excavations at 224 Headland Road (Source: Level 0 Demolition Plan\_224, A-040, 29/10/2019, Rev A, Tonkin Zulaikha Greer Architects)

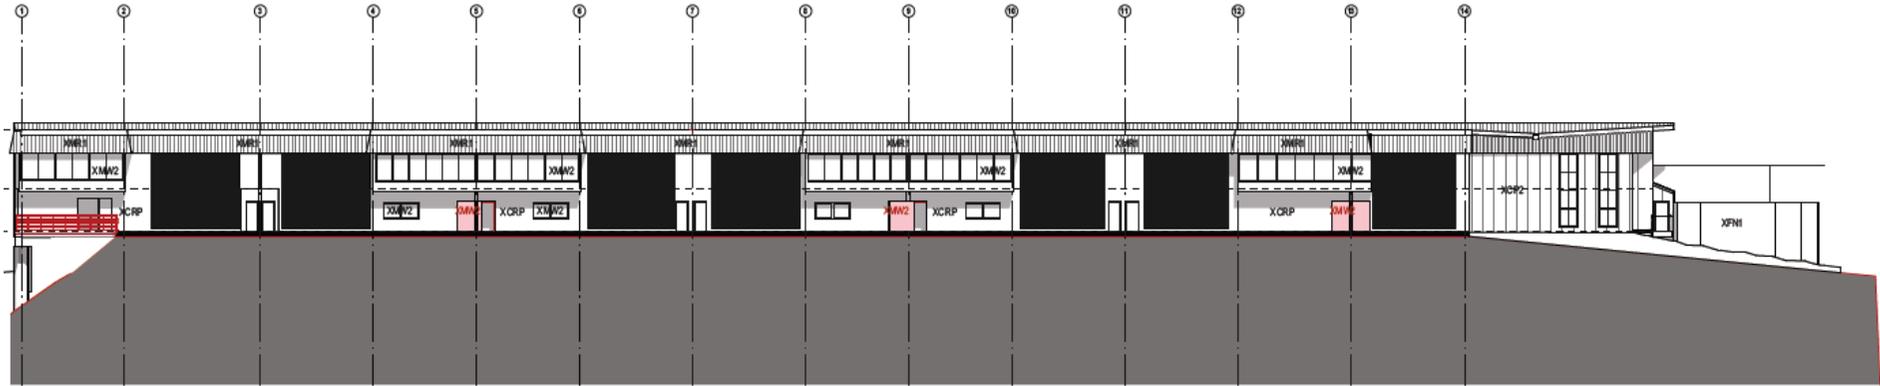
Figure 10: Extent of proposed excavations at 224 Headland Road, western elevation (Source: Demolition Elevations – 224 Headland Road, A-043, Rev A, 29/10/2019, Tonkin Zulaikha Greer Architects)

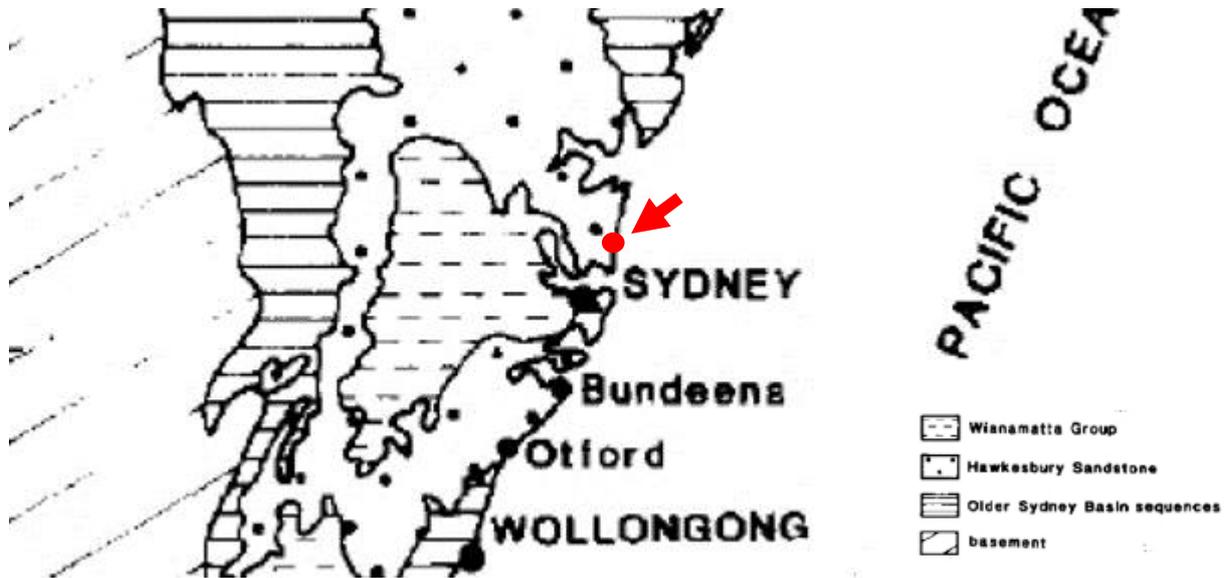
Figure 12: Location of subject site (indicated in red) within the Hawkesbury Sandstone of the Sydney Basin (Source: Rust & Jones, 1987, *Journal of Sedimentary Research*, Vol. 57, No. 2: 222-333)

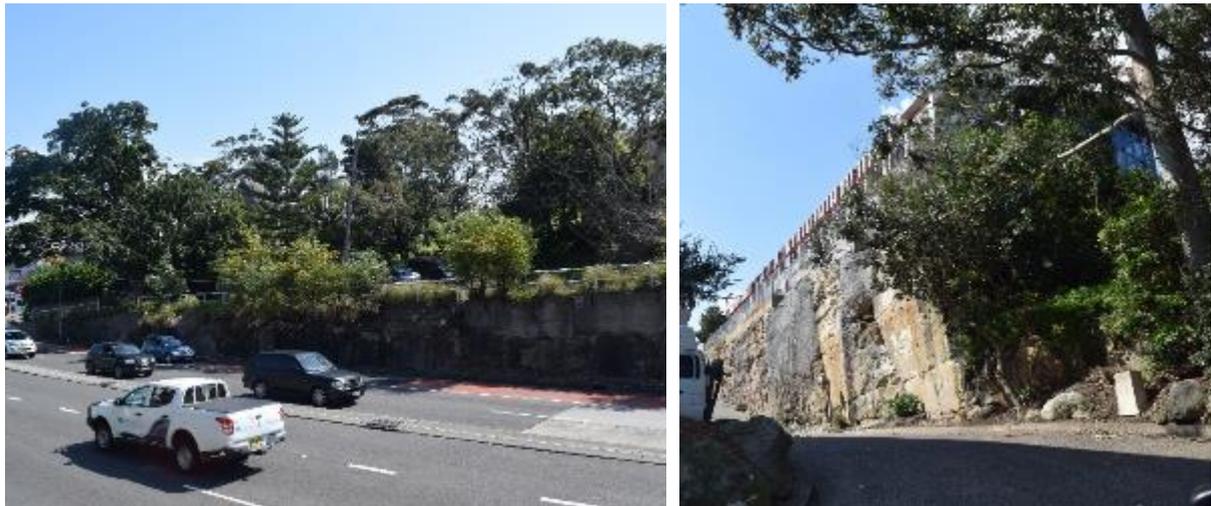
Figure 13: The subject site and surrounds are located on a section of the Hawkesbury sandstone escarpment, which has been extensively excavated in areas, resulting in a topographically varied landscape

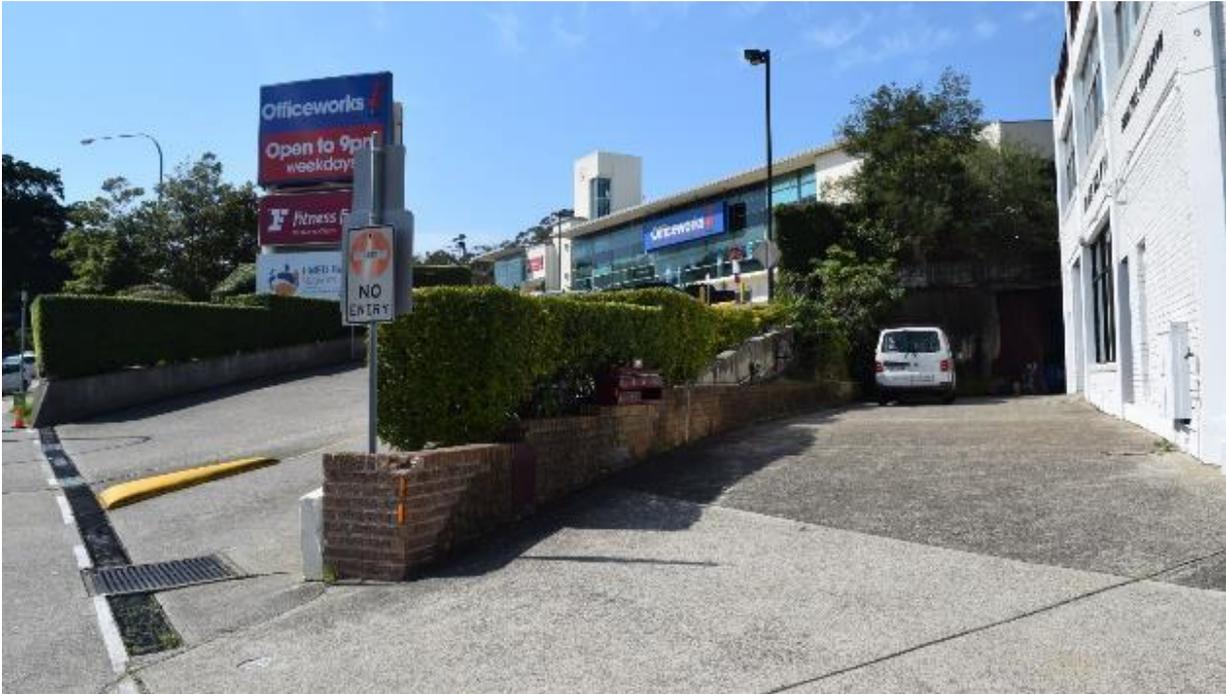
*Figure 14: The landscape slopes to the south-west where it becomes level with Pittwater Road*

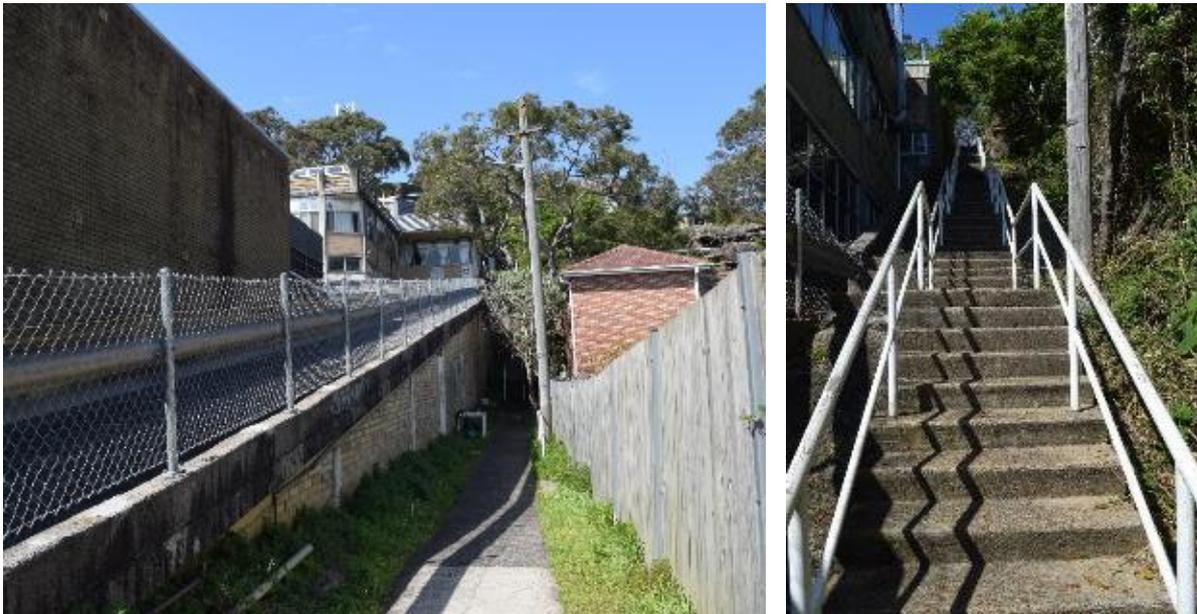
*Figure 15: The landscape steps up sharply to the north-east*

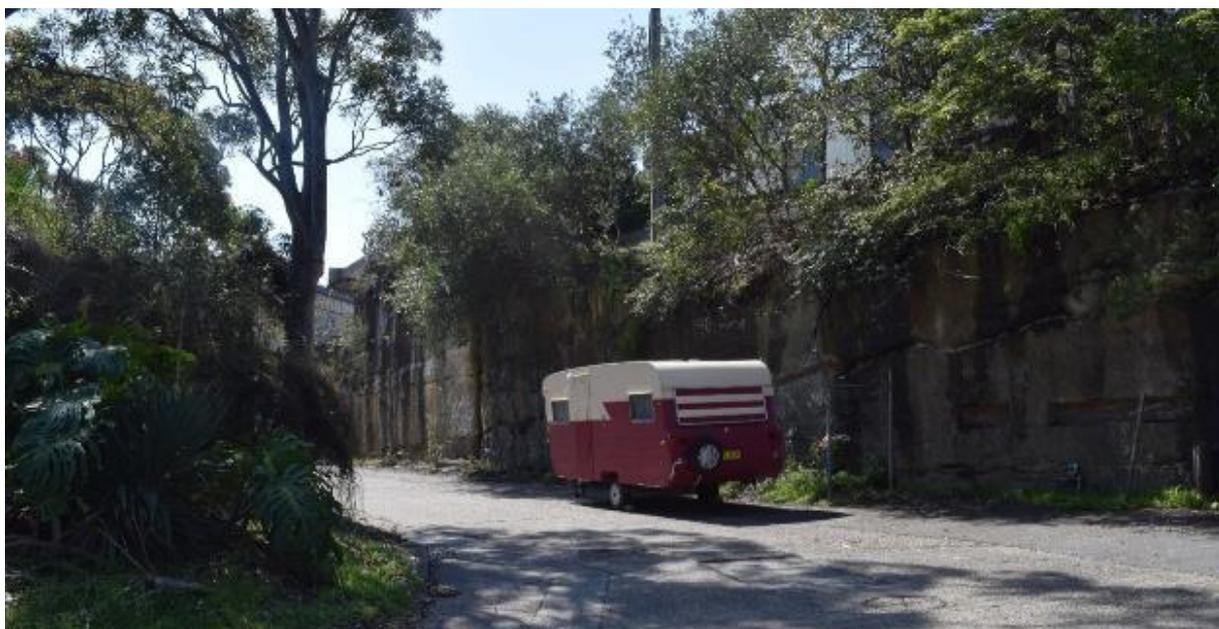
Figure 16: The eastern component of the subject site at 224 Headland Road sits at an elevated location above a sandstone outcrop

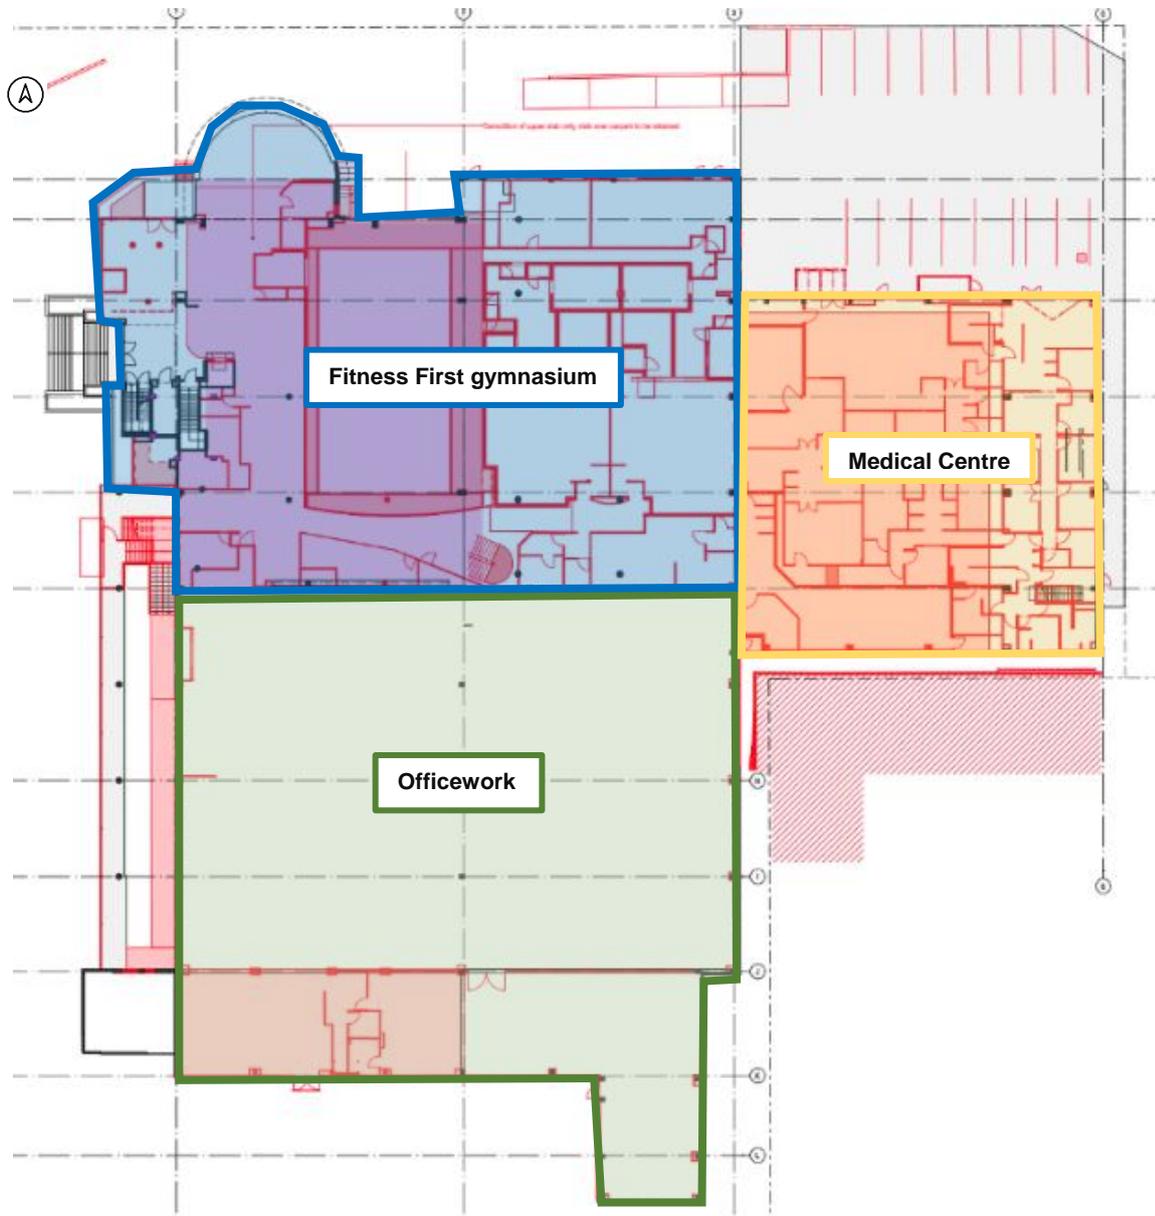
Figure 30: Excerpt from Level 1 Demolition Plan\_800 showing the retail and commercial tenancies within 800 Pittwater Road (Source: Tonkin Zulaikha Greer, drawing no. A-041, 23.08.2019).

The following image details the layout of the existing building at 800 Pittwater Road.

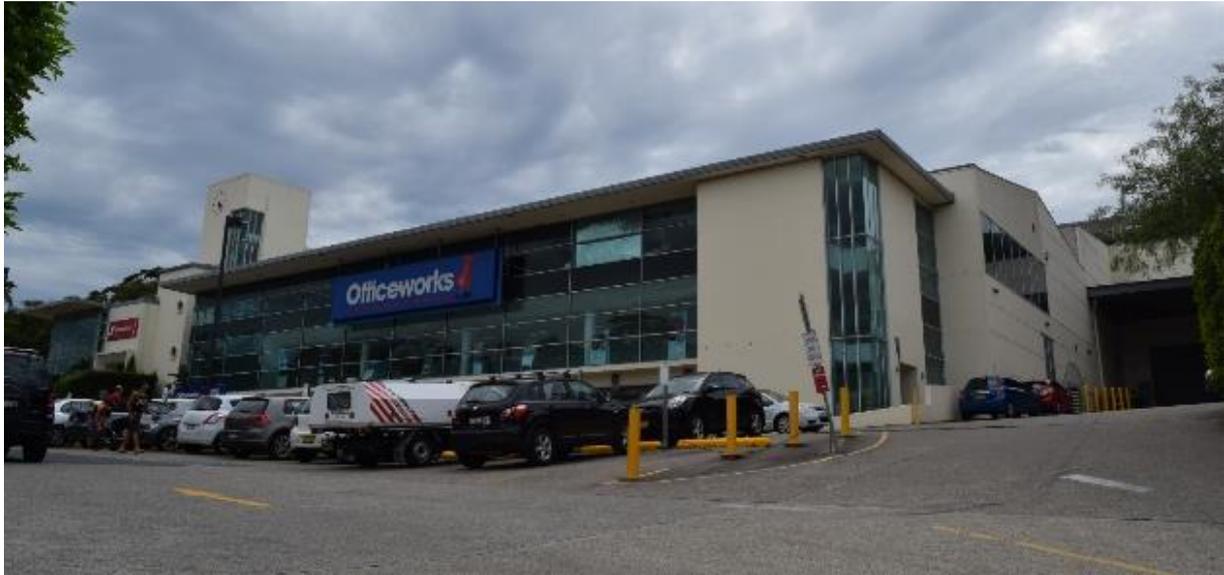
Figure 31: Looking northeast toward the western façade of the subject building within 800 Pittwater Road, from the south-west corner of the site.

The site is an irregular shape with an approximate area of 1.00 hectares (Figure 30). It has a primary frontage and elevation to Pittwater Road, which in turn provides access into the site. The subject site is orientated from north to south with a gradual slope descending toward the south-west (Figure 31).

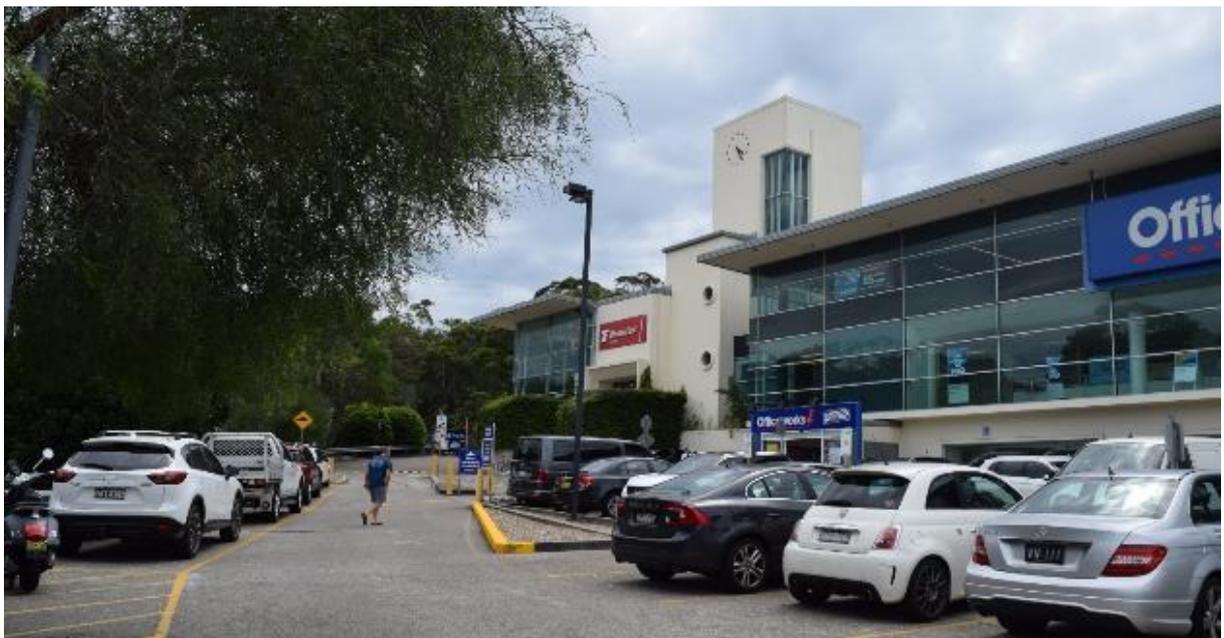
Figure 32: Looking north from the south-west corner of the subject site. Note: the subject site is obscured from Pittwater Road by the vegetation that borders the site to the west.

The subject building comprises the majority of the lot. A concrete paved customer carpark bounds the subject building to the north, west and south, accessed via Pittwater Road in the south-western corner of the site (Figure 32).

A large triangular sign marks the entrance to the carpark, with metal fencing and vegetation bounding the site from Pittwater Road (Figure 32 & Figure 33). The subject site is obscured when viewed from Pittwater Road to the east.

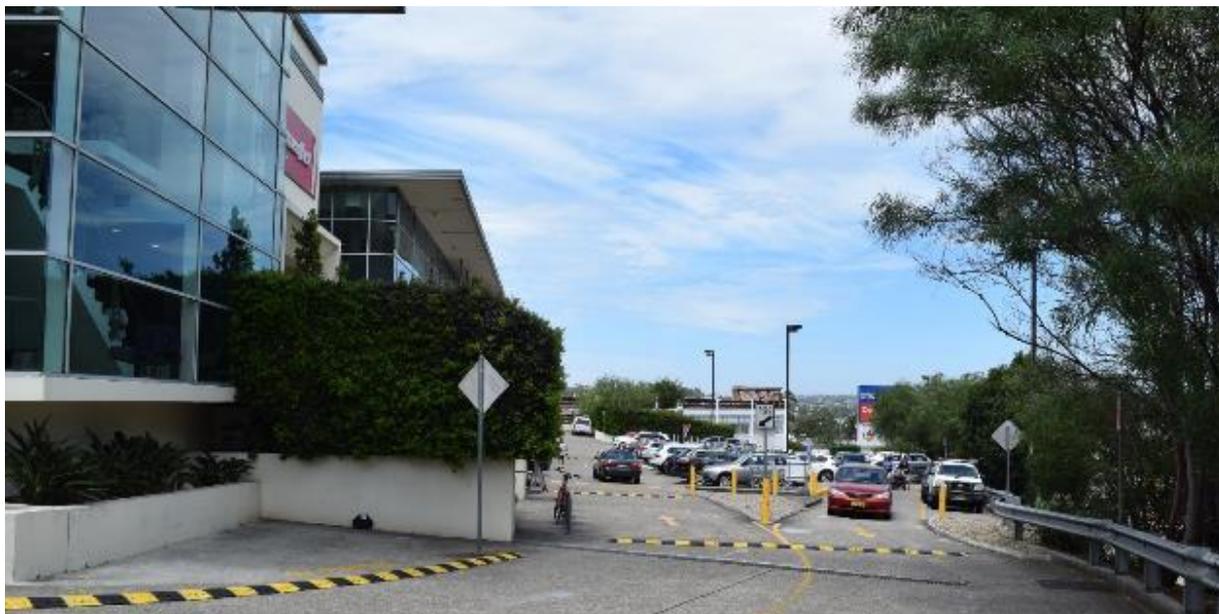
*Figure 33: Looking south from the northern corner of the subject site towards the carpark. Note: the land slopes down from the subject building towards Pittwater road*

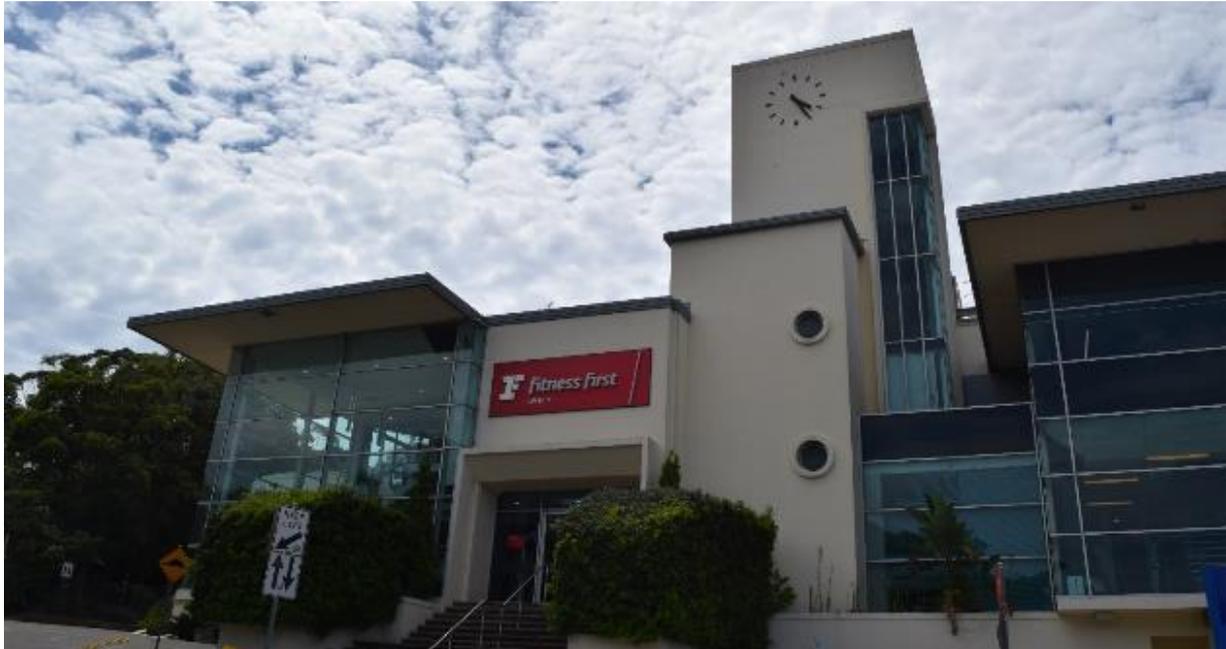
Figure 34: Looking east towards the northern portion of the western façade of the subject building and entrance to the Fitness First gym complex (Source: CPH 2019)

The subject building is an example of 'post-war factory architecture', with light-coloured rendered masonry walls and a prominent off-centre clocktower (Figure 34). The building 'steps up' to the east, in unison with the topography, with 3-4 storeys at the Pittwater frontage and a single-storey warehouse at the rear, which currently houses 'Officeworks'.

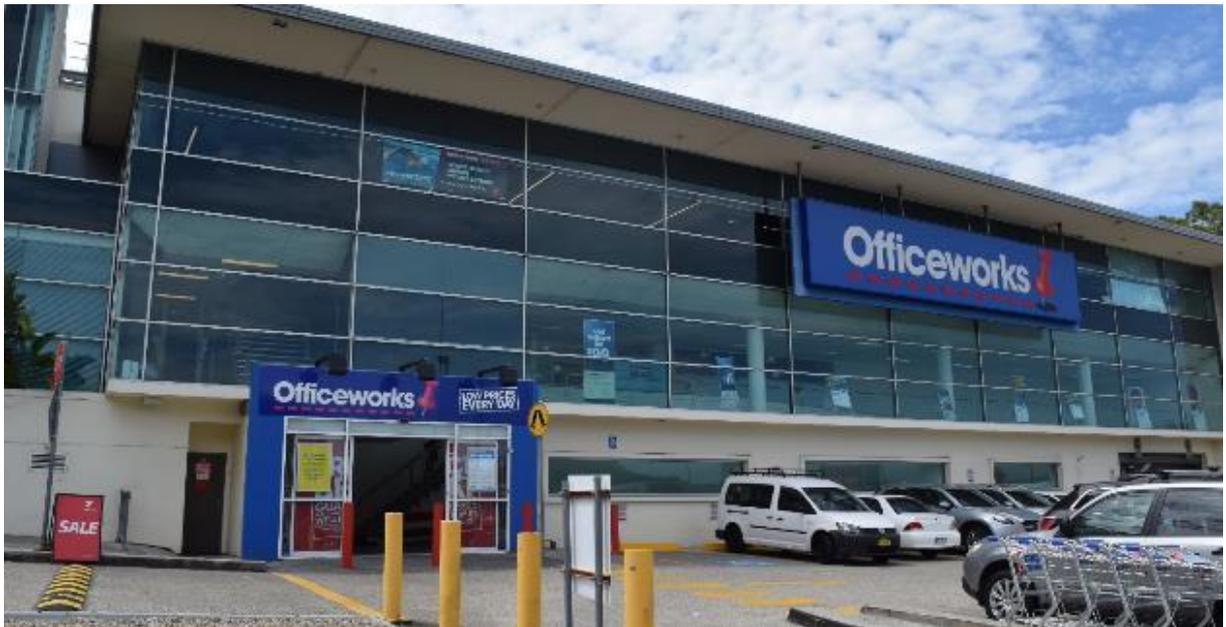
Figure 35: The southern section of the western facade of the building contains a flat overhanging roof

Entrance to the building is gained from the Pittwater frontage (western façade) (Figure 35). The northernmost entry provides access to the Fitness First gym via a set of steps and the southern entrance provides access to Officeworks, which is accessed directly from the ground level via the carpark. An undercover carpark is also accessible from the south with an exit located at the south-western corner.

The Pittwater frontage (western façade) (Figure 35) comprises a flat, overhanging roof. Beyond the Pittwater frontage the building steps up gradually in relation to the site contours.
