# **Non-Indigenous Archaeological Assessment**

800 Pittwater Road, Dee Why  
& 224 Headland Road, Curl Curl NSW

Submitted to Midson Group  
On Behalf of St Luke's Grammar School

November 2019

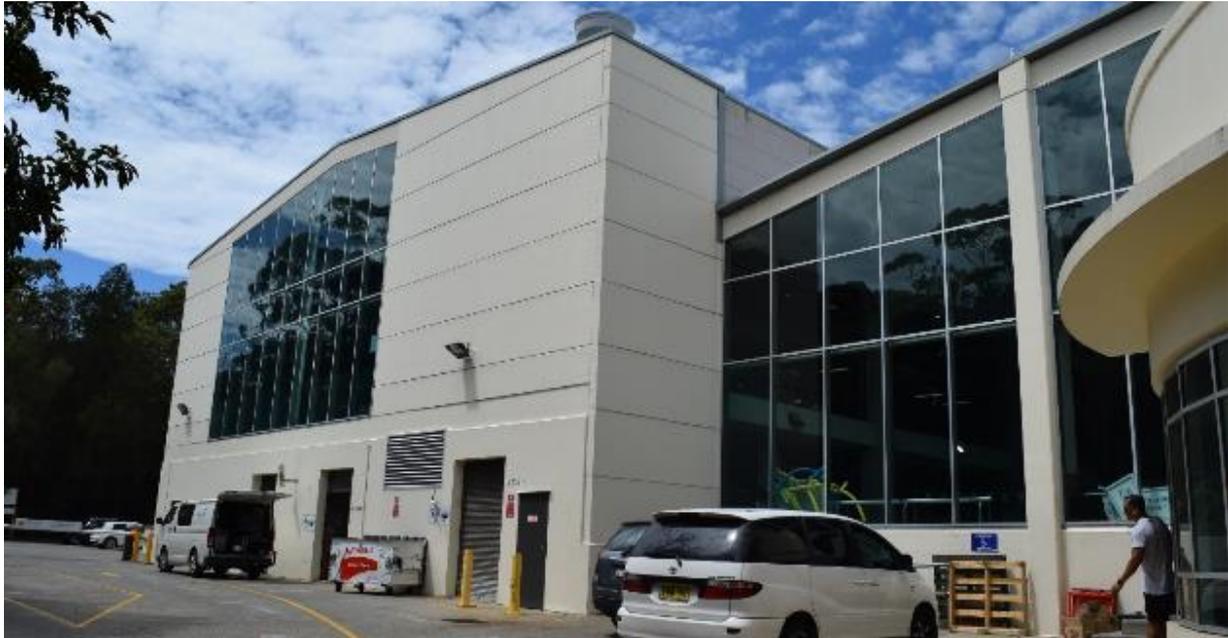
*Figure 36: Looking towards the northern façade of the subject building. This portion of the building is currently occupied by the Fitness First gym*

The northern (Figure 36) and southern facades are similar in style, featuring the same aluminium-framed windows. The northern façade is unique and includes a curved 'former canteen' fitted with windows of the same design (Figure 37).

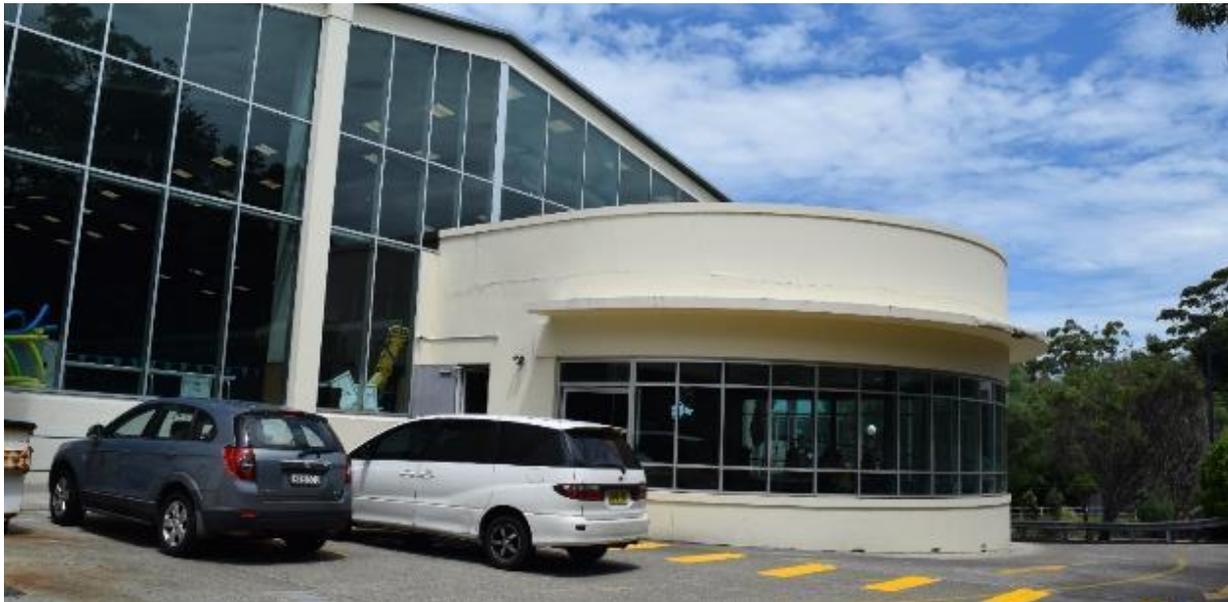
*Figure 37: Looking west towards Pittwater Road and the curved former canteen*

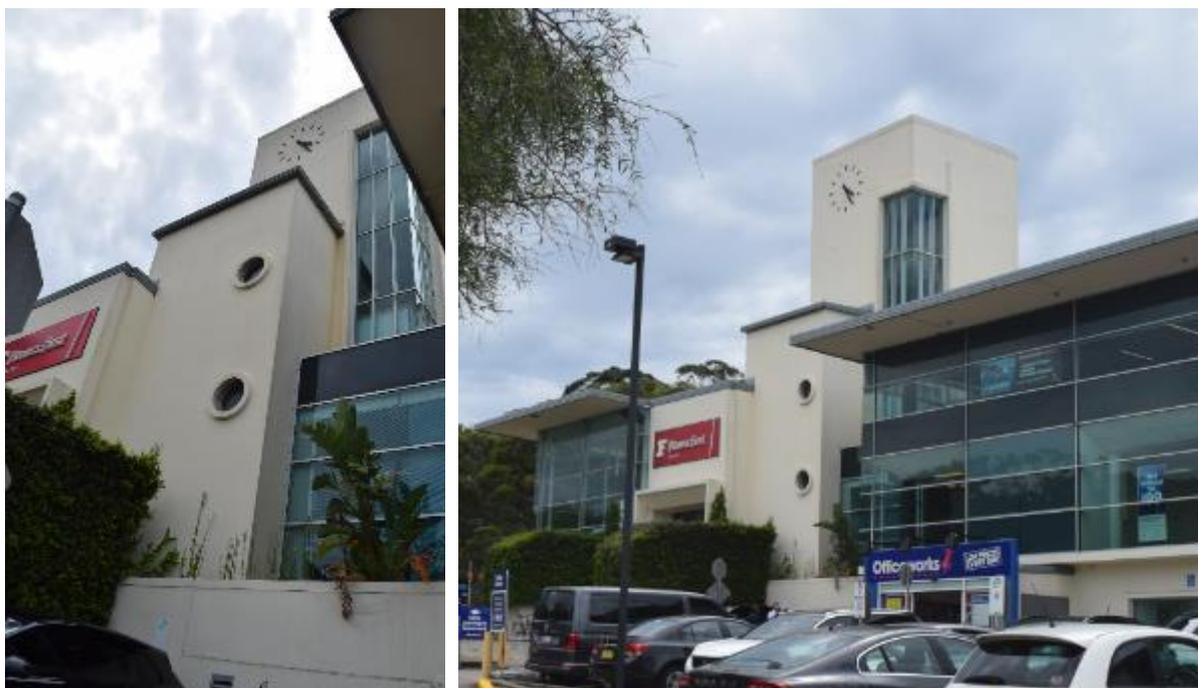
Figure 38: The clock tower is comprised of the same rendered masonry finish as the rest of the building, with a large clock face on the western façade

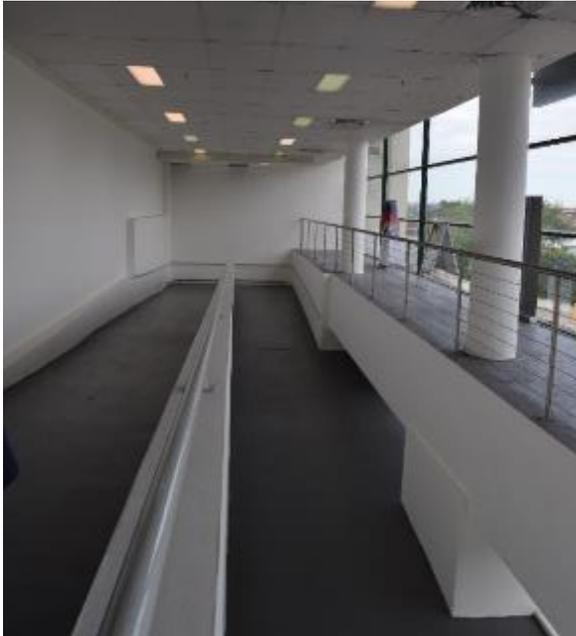
Figure 39: Looking south within the subject building. Note: the accessibility ramp provides entry to the Officeworks

**Officeworks:** The Officeworks tenancy is accessed via the ground floor with access to the store itself by both a set of stairs and supplementary ramp (Figure 39). Both ramp and stairs are bound by metal bannisters with non-slip treads along each riser. The store is entered via a set of automatic glass doors with aluminium-framed on either side (Figure 40).

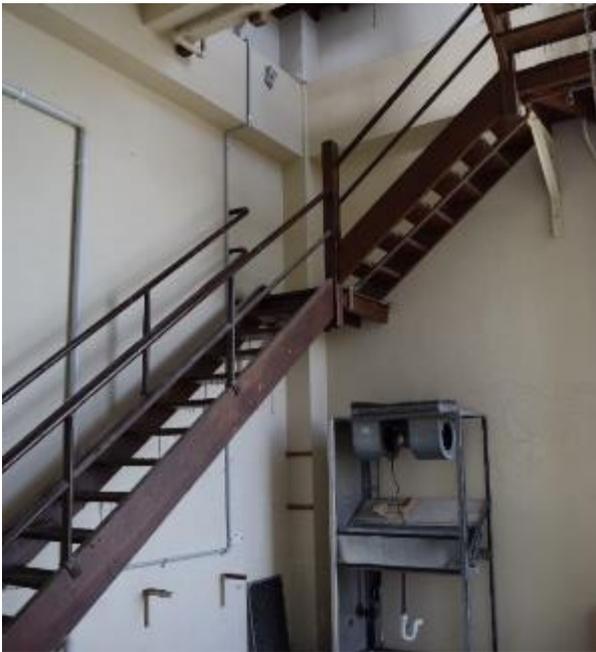
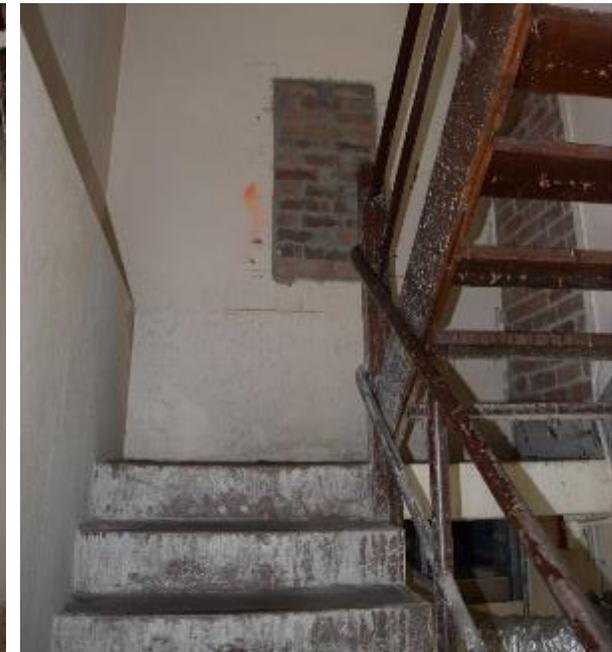
Figure 48: Looking towards timber staircase leading up towards the roof within the clock tower (left). Stairs providing access to the upper and roof levels (right)

**Clocktower:** The interior of the clocktower is accessed through the Fitness First reception area (Figure 47). Corner windows provide views from the second and third floors. A timber staircase affixed to the walls provides access to the roof of the clocktower (Figure 48 & Figure 49). The second and third floor

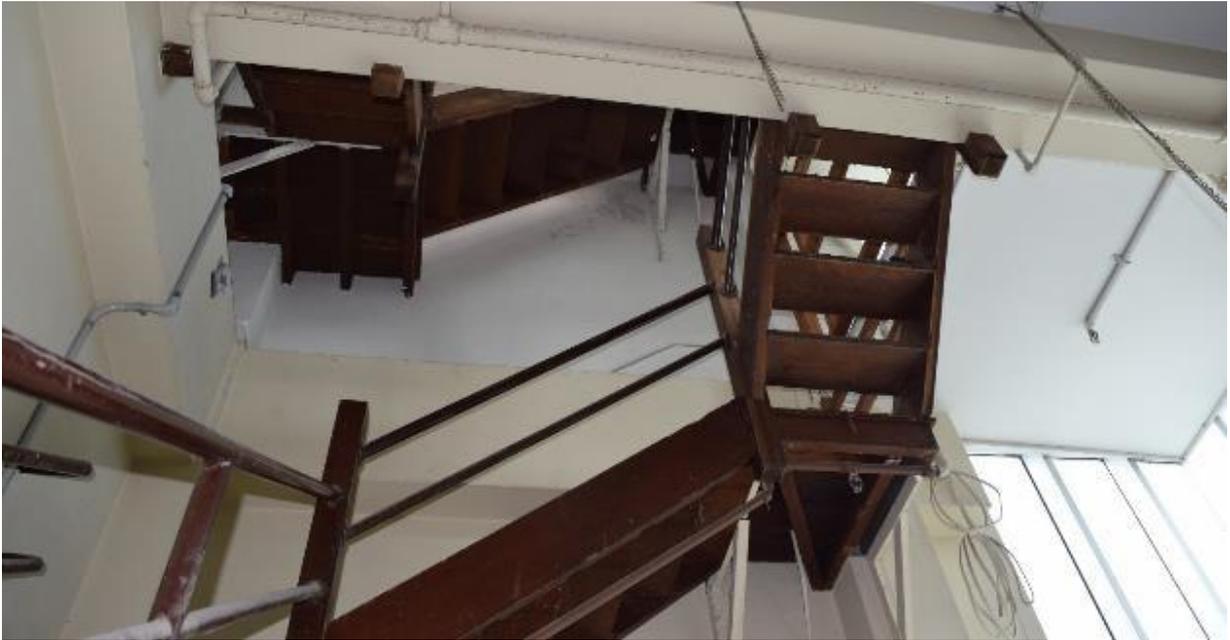
Figure 49: Looking upwards within the clocktower towards the roof.

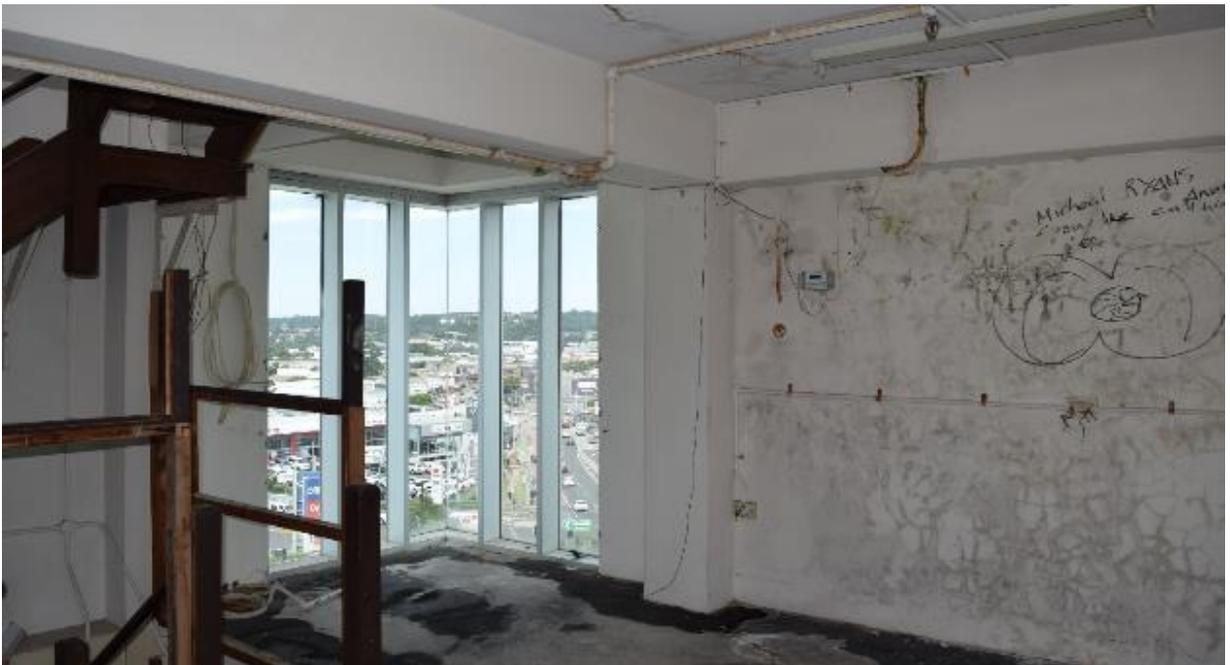
Figure 50: Looking towards the top-floor window within the clocktower. Note: Interior graffiti to the internal walls and rising/falling damp.

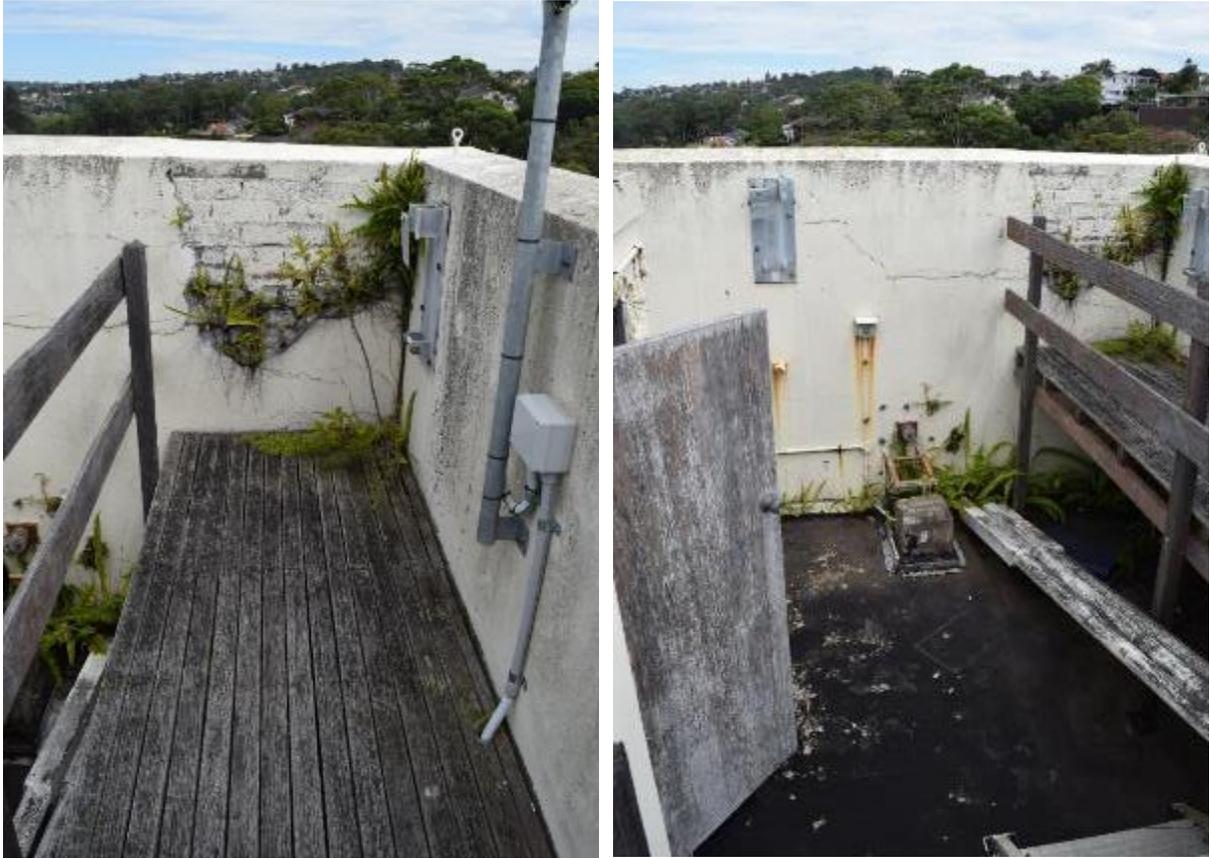
*Figure 51: Image showing the condition of the roof-top of the clocktower including wooden platform and surface mounted conduits (left)*

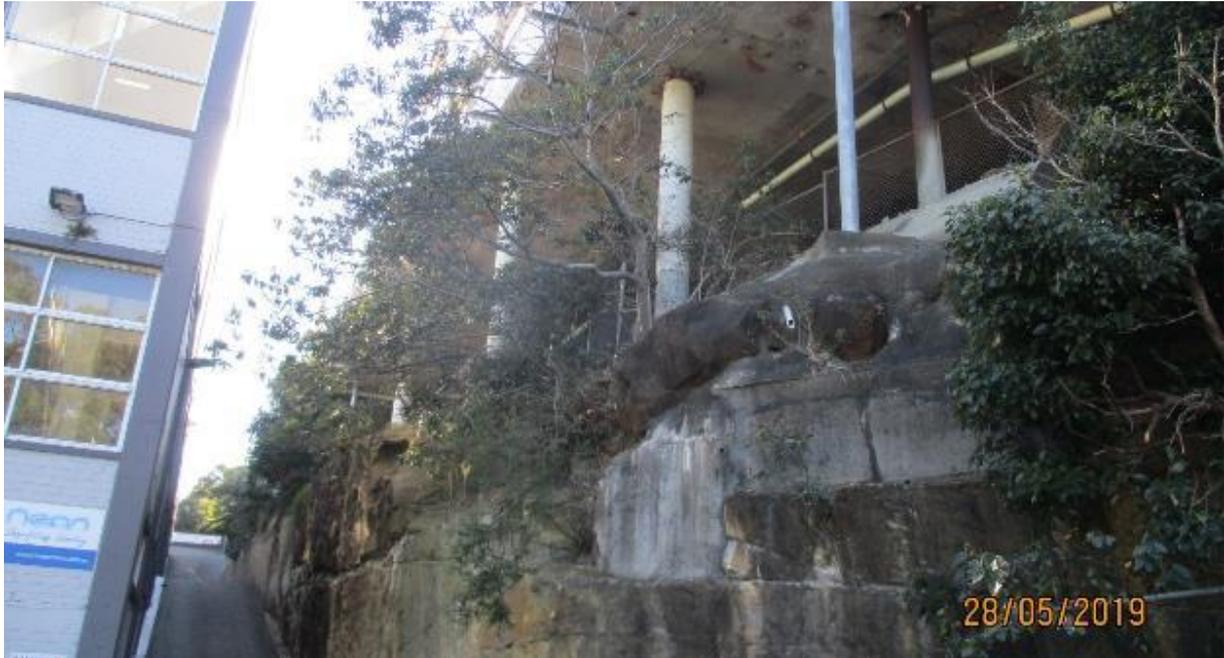
Figure 54: The building sits on a sandstone outcrop and is elevated in relation to the commercial premises to the west (Source: TZG Architects, 2019)

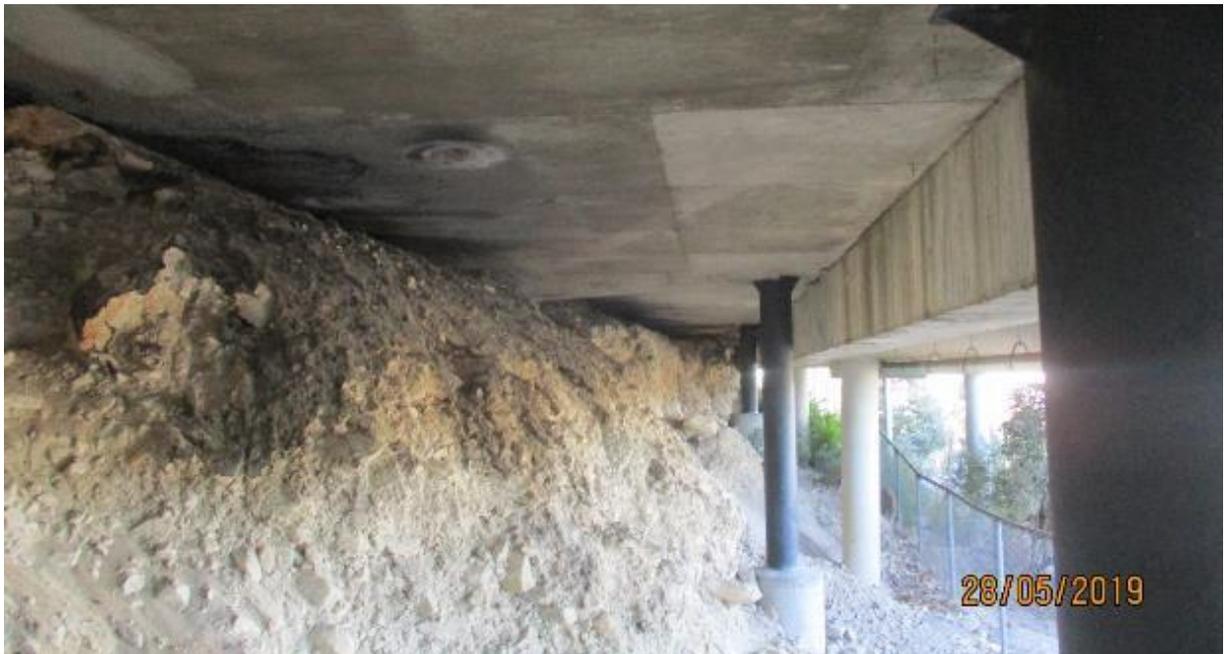
Figure 55: The building is supported by large columns (Source: TZG Architects, 2019)

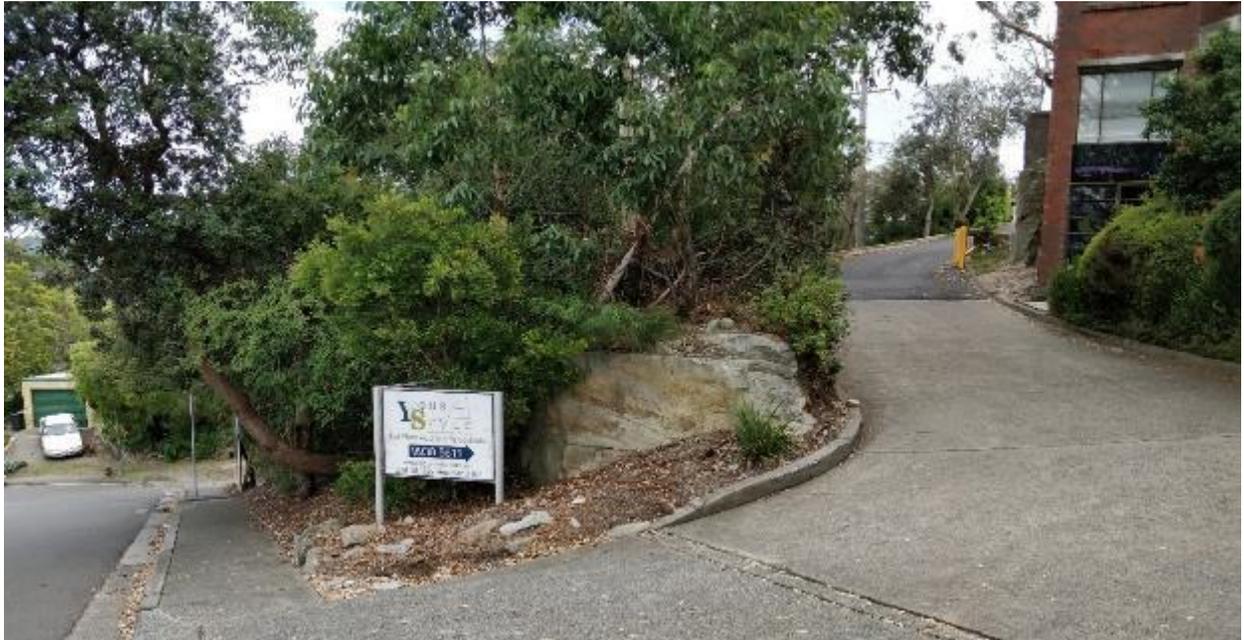
Figure 56: The entrance to 224 Headland Road contains a driveway which continues to the west of the building (Source: TZG Architects, 2019)

The primary entrance to the building consists of a concrete driveway, which extends from Headland Road to the south-east (Figure 56 & Figure 57) and continues around to a carpark on the western side of the building (Figure 58). The building is divided into a number of bays, separated by metal garage roller doors, which front the carpark to the west. The building features a corrugated metal roof with cladding and painted panel clad walls (Figure 59).

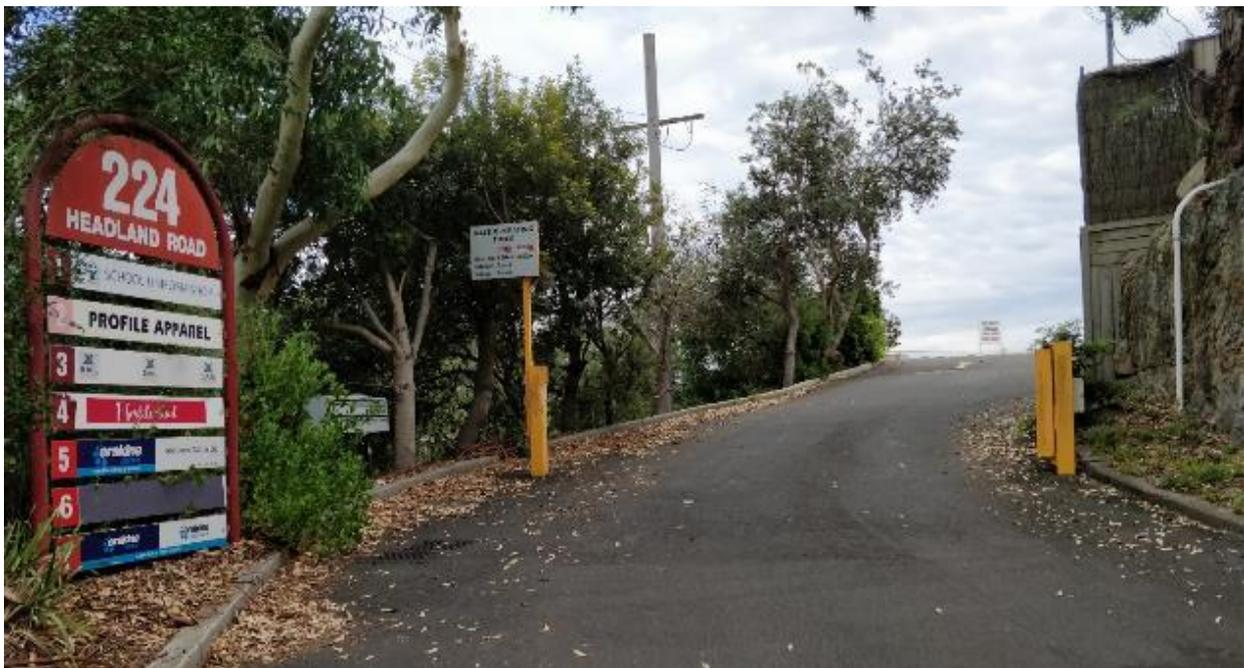
Figure 57: The primary entrance to 224 Headland Road (Source: TZG Architects, 2019)

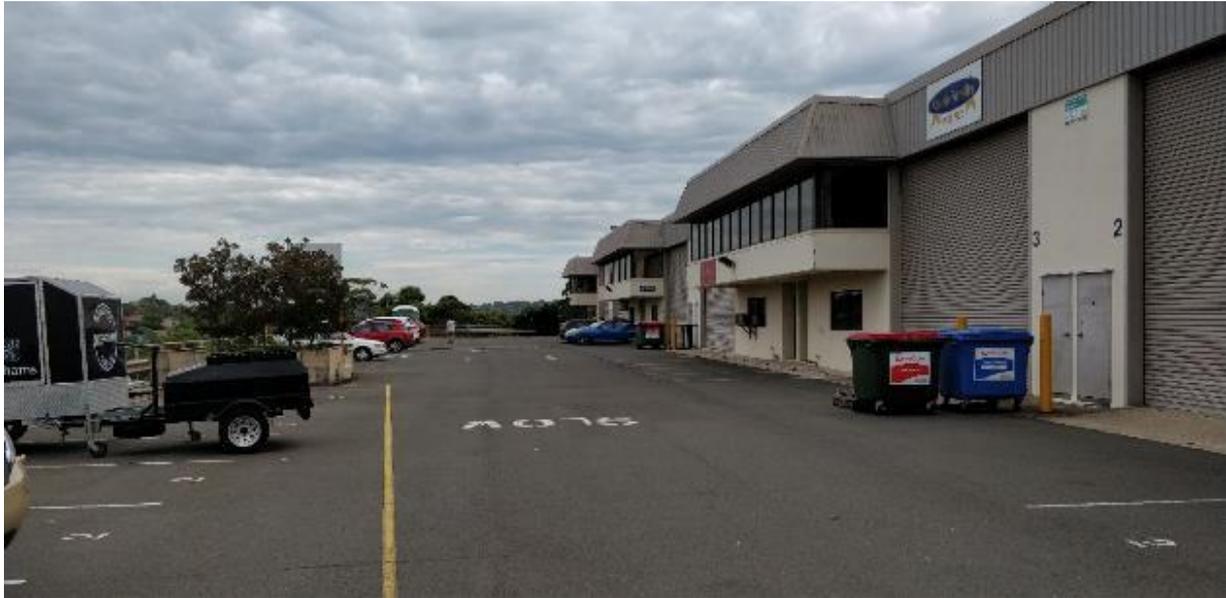
Figure 58: The above-ground carpark which is located on the western side of the building (Source: TZG Architects, 2019)

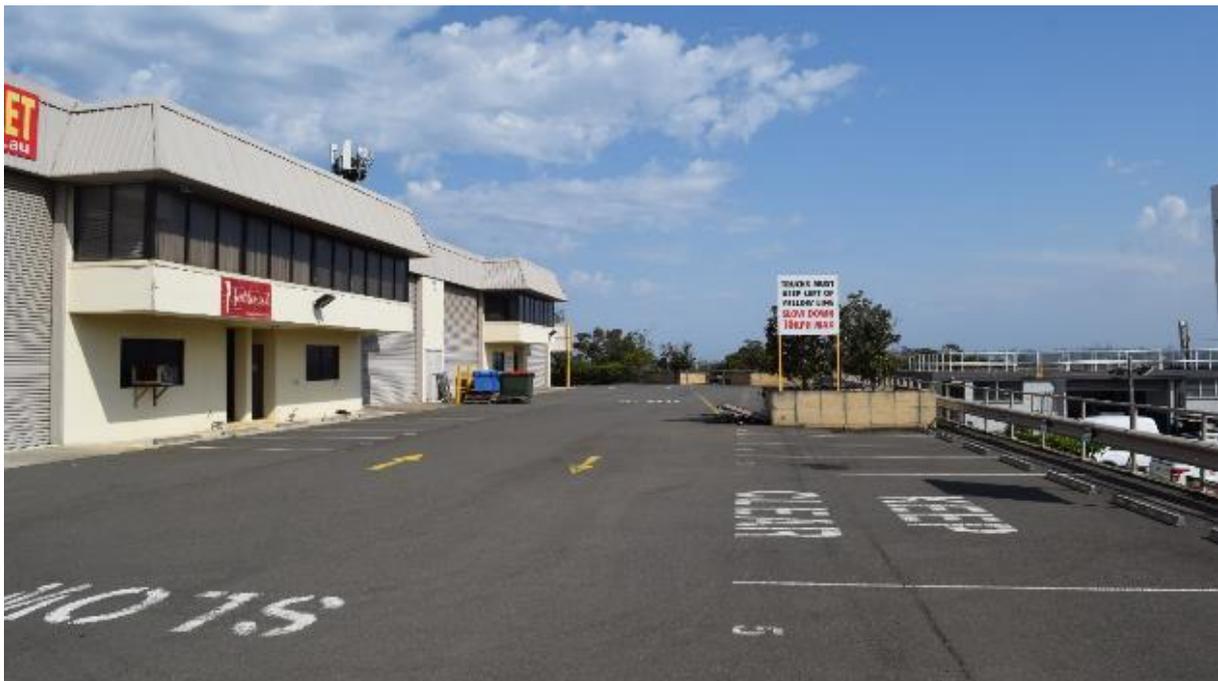
Figure 59: The building contains a corrugated metal roof with painted panel clad walls

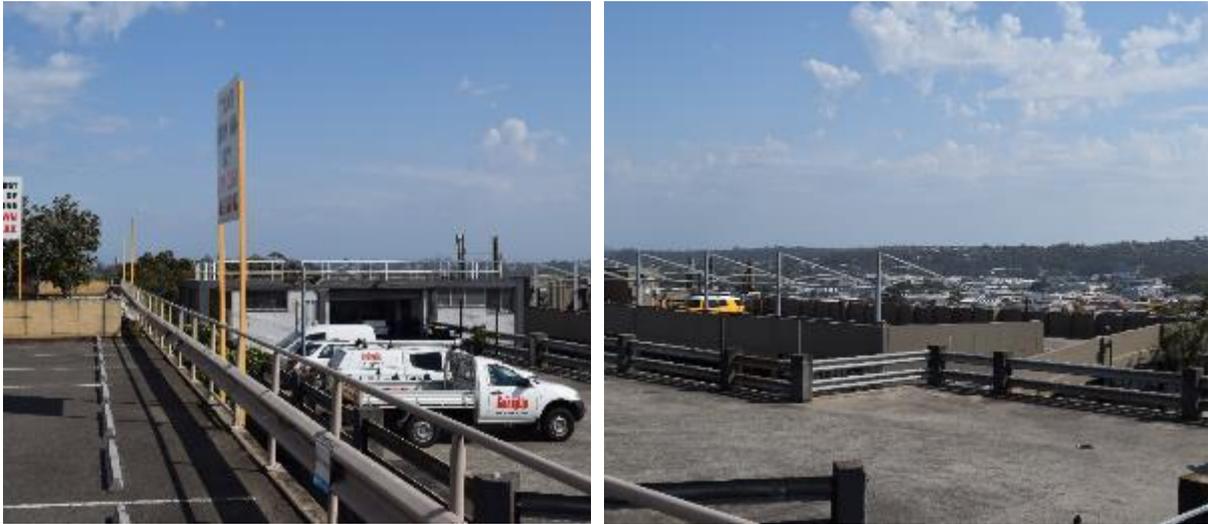
Figure 60: The perimeter of the carpark to the west is bordered by a metal guardrail and fence (left). Views to the west include the roof of the adjacent commercial premises and over Dee Why (right)

The perimeter of the carpark to the west is bordered by a metal guardrail and fence (Figure 60). The roof of the adjacent commercial premises is located immediately to the west (Figure 60). The height of the sandstone ledge upon which the building sits can be observed from the western side of the building (Figure 61).

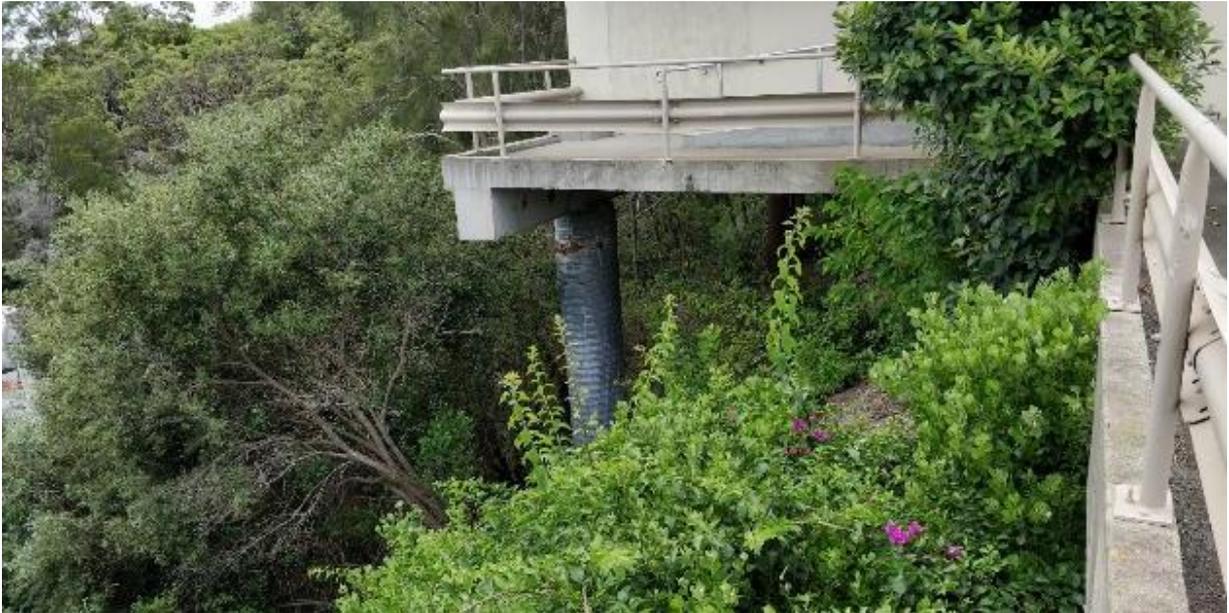
Figure 62: The remainder of the building is supported on columns above a densely-vegetated and steep section of the hillside (Source: TZG Architects, 2019)

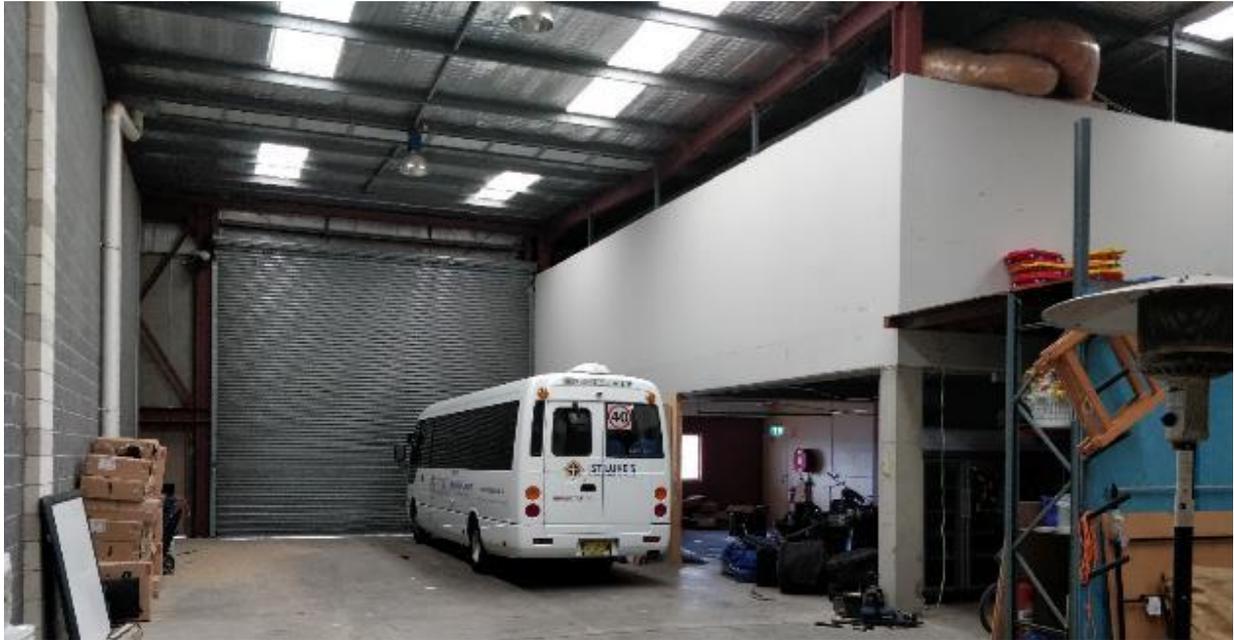
Figure 64: A number of spaces are currently used for storage purposes (Source: TZG Architects, 2019)

The ground level consists of a number of basketball courts (Figure 63) with change room facilities located at the northern end of the building. A number of spaces are currently used for storage purposes (Figure 64 & Figure 65).

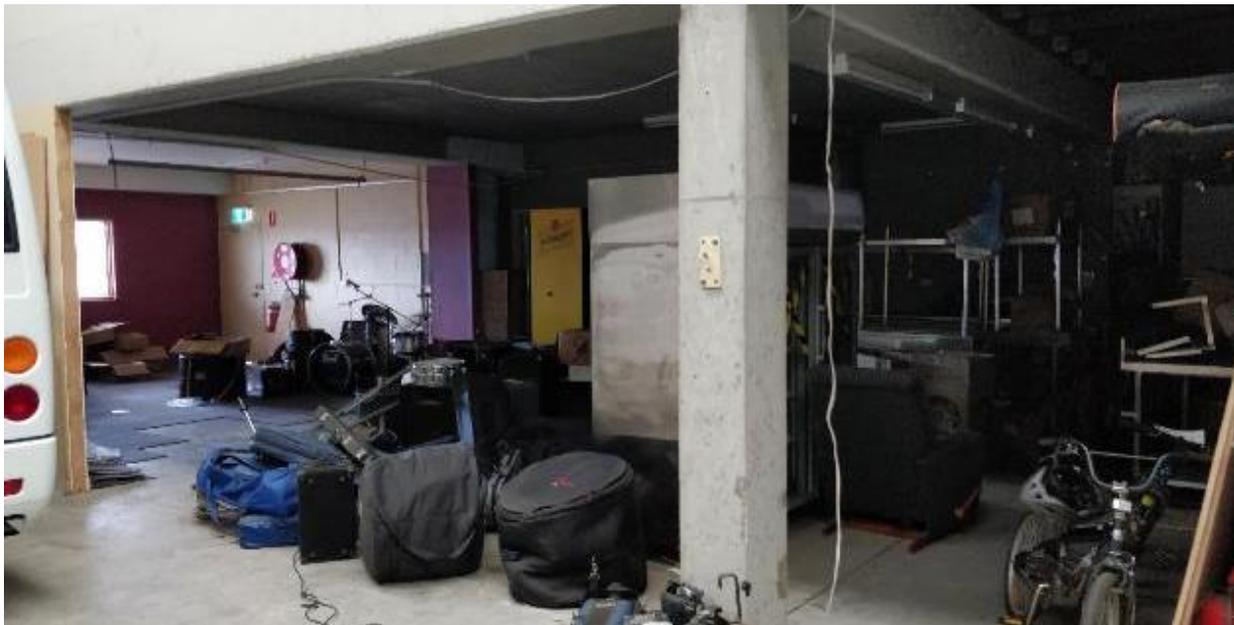
Figure 65: A number of spaces are currently used for storage purposes (Source: TZG Architects, 2019)

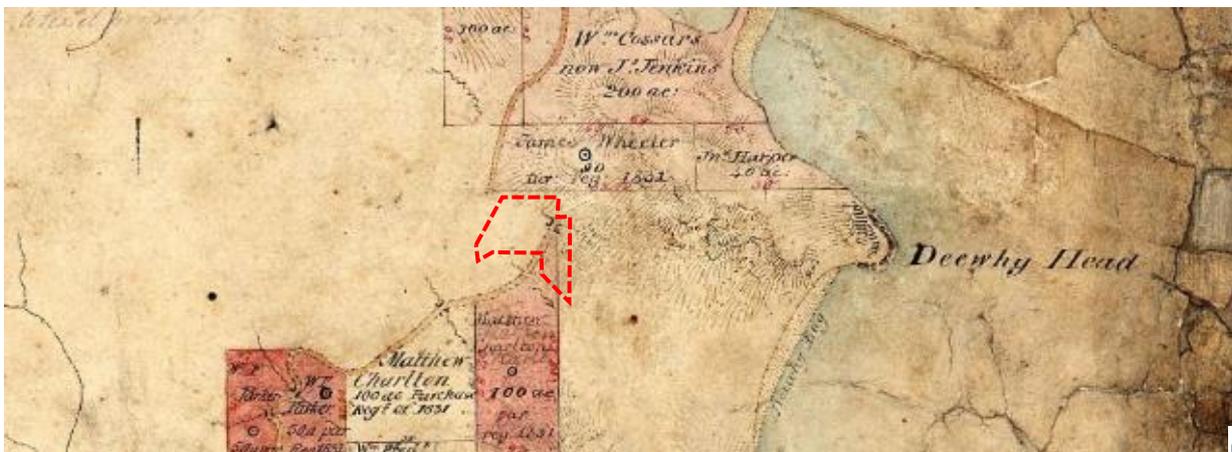
Figure 67: undated, pre 1886 map showing subject site beneath Wheeler estate (Source: Parish of Manly Cove County of Cumberland Cove, Land & Water Conservation Map 140777, accessed 24 September 2019 via: <http://nla.gov.au/nla:obj-230211686/view>).

The landscape surrounding the subject site was noted by early colonialists to be heavily forested, however most of the area was cleared for lumber before 1889.<sup>9</sup> The subject site is located along a stretch of Pittwater Road which was originally part of the original Old Pittwater Road<sup>10</sup>, which was constructed in 1826 by convict James Jenkins with the aid convict labourers (Figure 65).<sup>11</sup> Jenkins was also responsible for the construction of 13 bridges along the route.<sup>12</sup> One undated map suggests that the road even ran through the area now occupied by the subject site (Figure 67).

By 1831 the pastoralist James Wheeler had purchased one of the first properties in the area, a 90 hectare holding directly to the north of the subject site, while a Mathew Charlton occupied part of the site to the south (Figure 67).<sup>13</sup> The site was apparently subdivided between 1881 and 1886 into the Lots 367 - 371, according to the 1886 Cumberland County plan.<sup>14</sup> From 1886 Lots 370 and 371 were occupied by a Jane Malcom, however the site remained undeveloped until as recently as 1943. By 1914 Lot 368 had

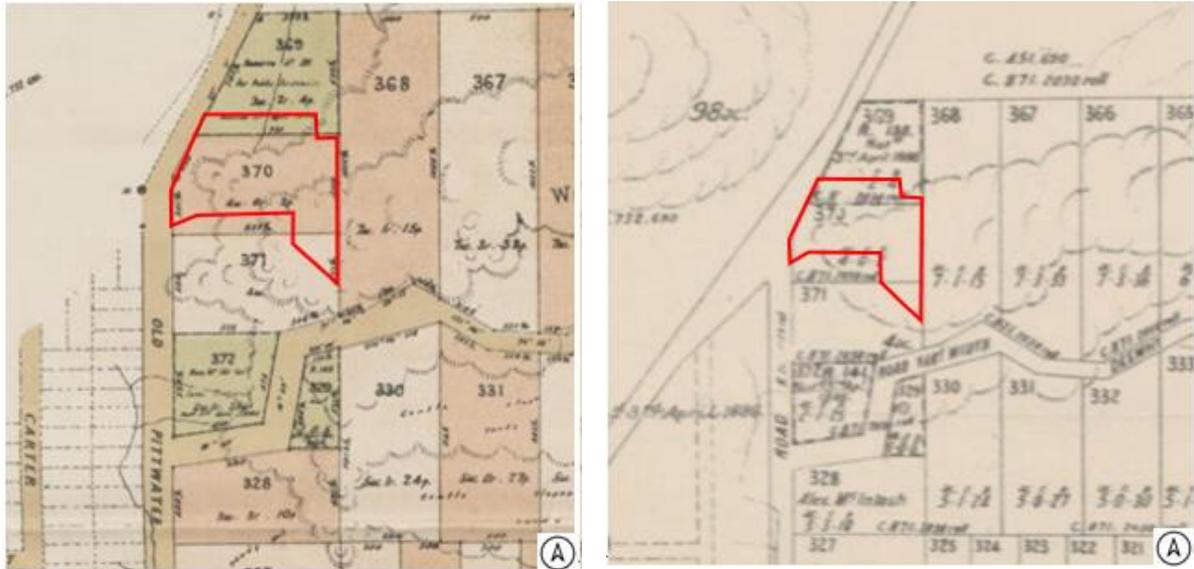
Figure 68: 1886 (left) and 1890 (right) parish maps of the subject site (indicated in red) indicating that the land had been subdivided by this time (Source: Left - Source: Plan 352 Parish Manly Cove, County Cumberland, 1888, available at <https://nla.gov.au/nla.obj-230211686/view>; Right - Parish Manly Cove, County Cumberland, Map 151, available at <http://nla.gov.au/nla.obj-229917580/view>)

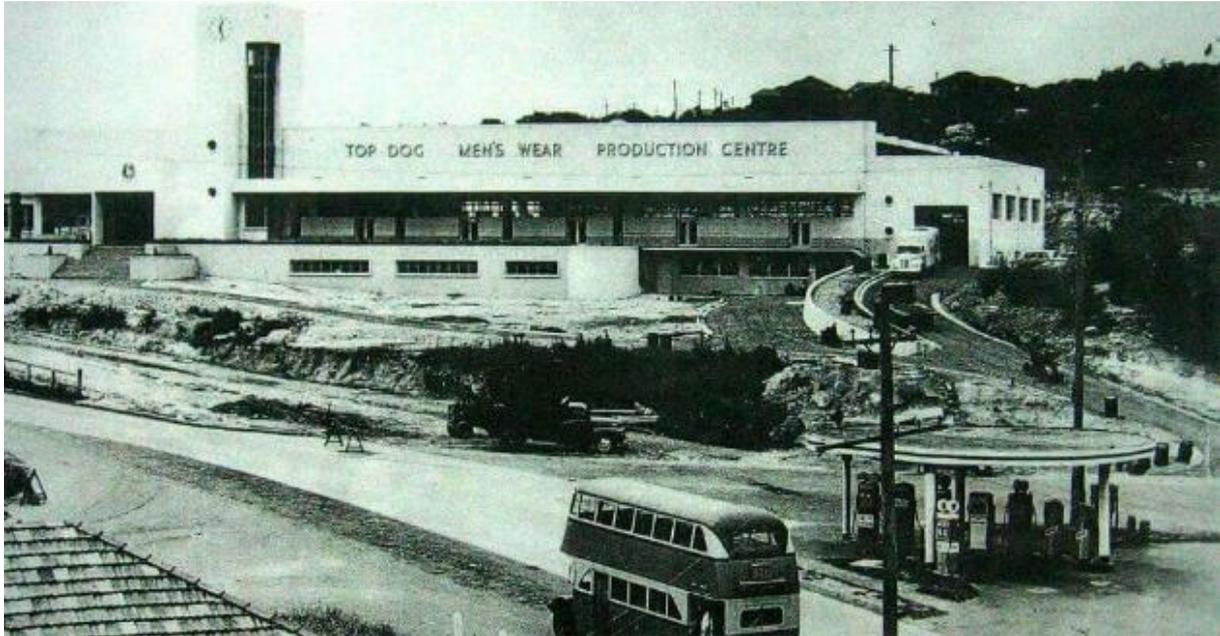
Figure 71: The Top Dog Men's Wear production centre designed by Spencer, Spencer and Bloomfield photographed by Ted Hood with the James' service station and Sydney bus in the foreground, c. 1951 (Source: Warringah Local Studies).

In 1950 the Top Dog factory was constructed on the subject site for the clothing company Sargood Gardiner Ltd as a building designed to be 'worker friendly'<sup>20</sup> (Figure 70). The building was designed by the architectural firm Spencer, Spencer & Bloomfield and was awarded the prestigious Sir John Sulman Medal for architecture the same year<sup>21</sup> (Figure 71-Figure 74). The judges commented that 'we consider this building extremely well designed, planned and executed and that it adds a valuable contribution to industrial architecture.'<sup>22</sup> One of the architects involved, Frank l'Anson Bloomfield, was renowned for his work in NSW during the Inter-War and Post-War periods. Most notably, a number of buildings of his design are included on the Australian Institute of Architects register of Significant Buildings, including Craigend House in Darling Point and the Northern Suburbs Crematorium.<sup>23</sup> The building was a source of employment for Italian migrant women who staffed the factory as machinists.<sup>24</sup> Sargood Gardiner operated the factory until 1957 It was then sold it to Bonds who operated there from 1958 to 1972.<sup>25</sup>

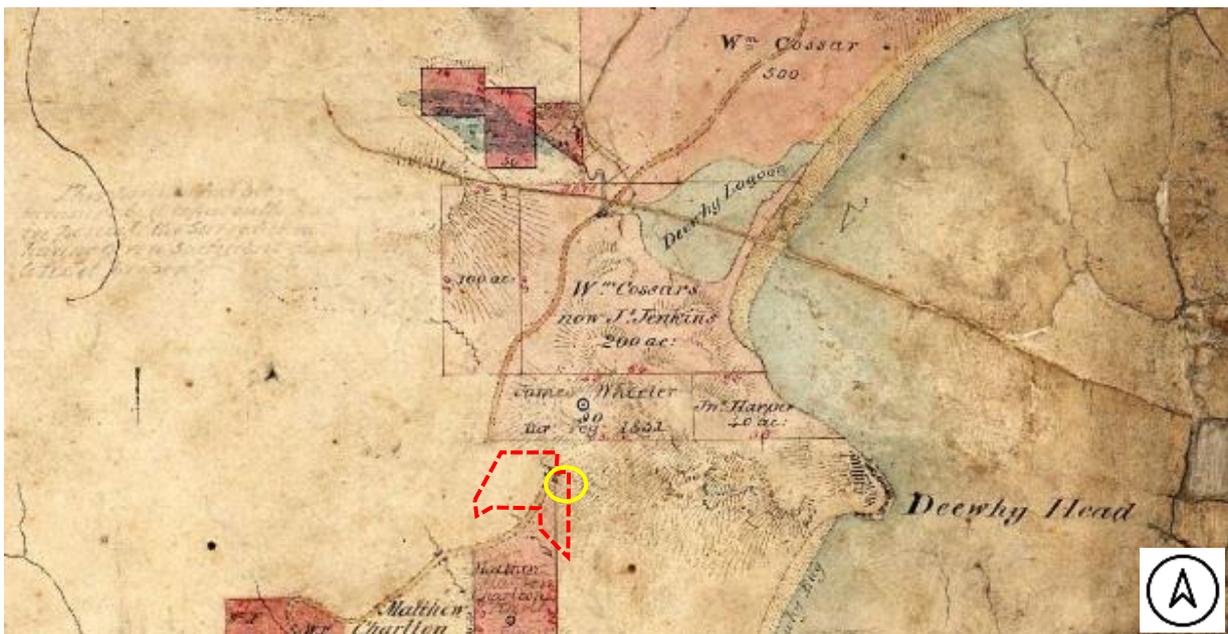
Figure 76: Undated parish map with approximate location of subject site (indicated in red) south of James Wheeler's 1831 land grant and partially within Matthew Charlton's 1831 land grant. Note that a section of Old Pittwater Road and a bridge (circled) are also located within the curtilage of the subject site (Source: Parish of Manly Cove (Sheet 6), undated, 14077701.jp2, HLRV)

An 1881 parish map (Figure 75) indicates that the subject site was located to the south of James Wheeler's 1831 land grant of 90 acres. The location of the subject site is further confirmed by the elevated topography, which is indicated by radial lines on the map. An undated parish map (Figure 76) indicates that the subject site was partially located within Matthew Charlton's land grant of 100 acres. A section of the road, which is located in the north-western component of Matthew Charlton's land and within the curtilage of the subject site, may have been part of Old Pittwater Road, which had been constructed by 1826 at this location.<sup>28</sup> A bridge located at the northern termination of this section of road is likely to have been one of the 13 bridges which was constructed by convict James Jenkins and other convict labourers when the road was established. It is also of note that the land to the east and west remained undeveloped at this time.

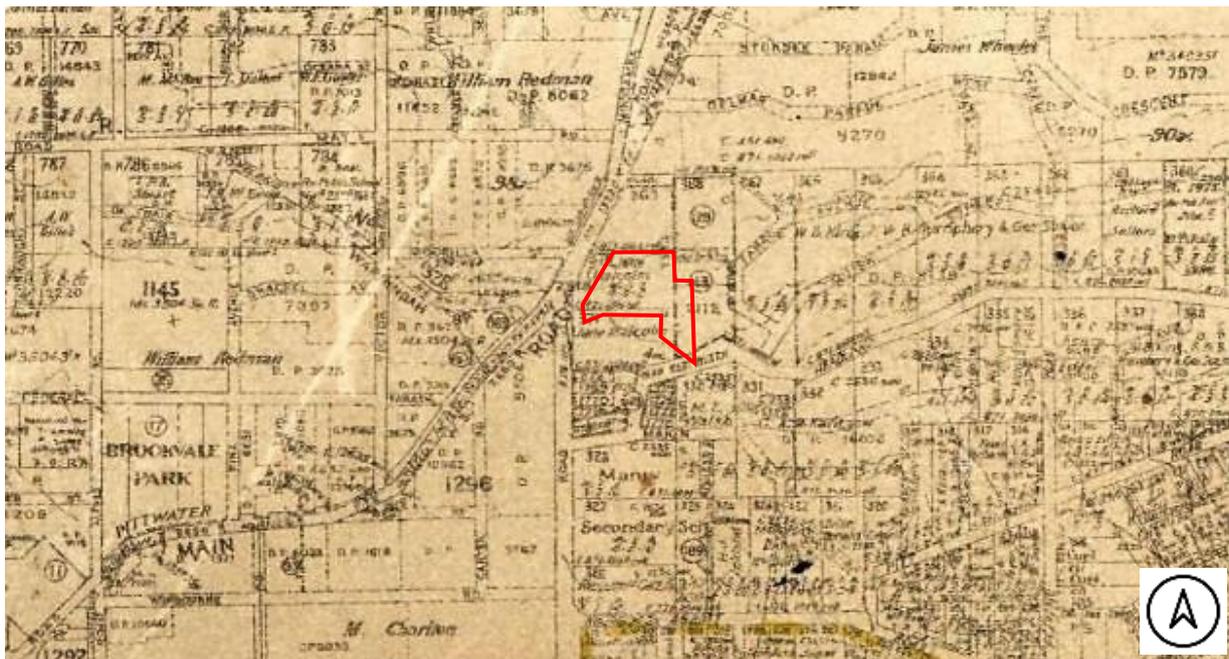
Figure 78: 1923 parish map with subject site indicated in red (Source: Parish of Manly Cove, 1923, 14041802.jp2, HLRV)

Parish maps dating to 1886 and 1890 (Figure 77) indicate that the land had been further subdivided by this time. Pittwater Road, Harbord Road and Headland Road had also been established. A 1923 parish map (Figure 78) indicates that the road configuration and subdivision pattern remained unchanged.

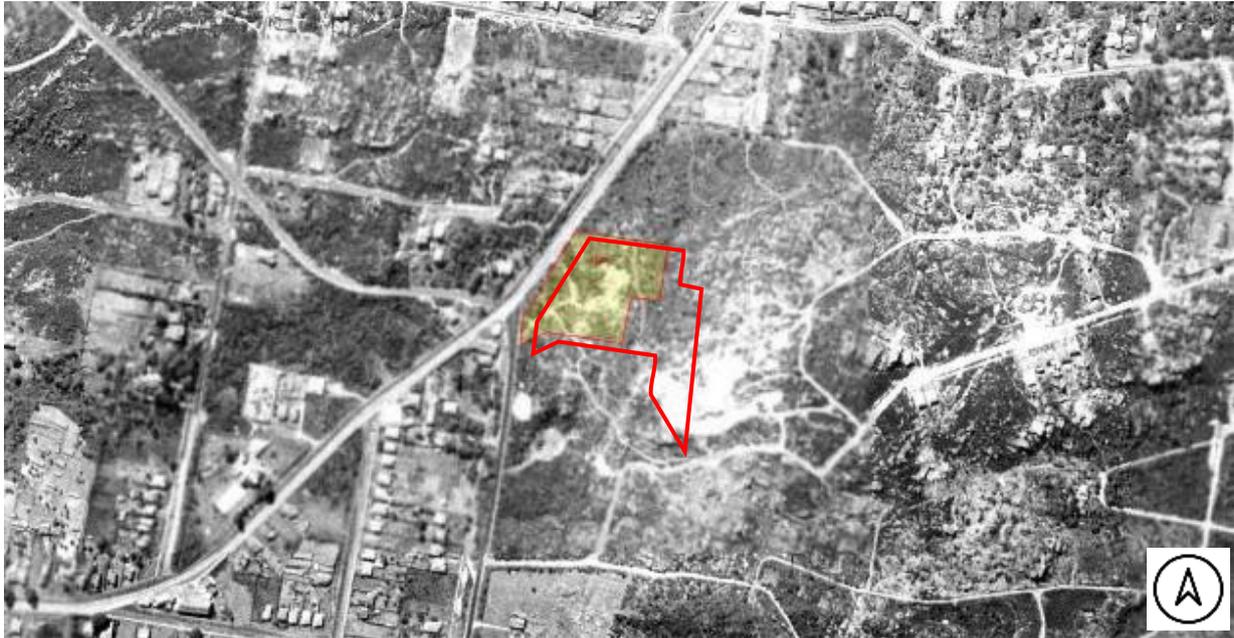
Figure 79: 1943 aerial photograph of subject site (indicated in red) with residential development to the south-west (Source: SIX Maps 2019)

A 1943 aerial photograph (Figure 79) shows that the landscape within and surrounding the subject site had been heavily modified and levelled by this date. Residential development had been established to the south-west of the subject site, whereas the site itself is vegetated and devoid of structures at this time (Figure 80). A number of track lines are apparent throughout the subject site.

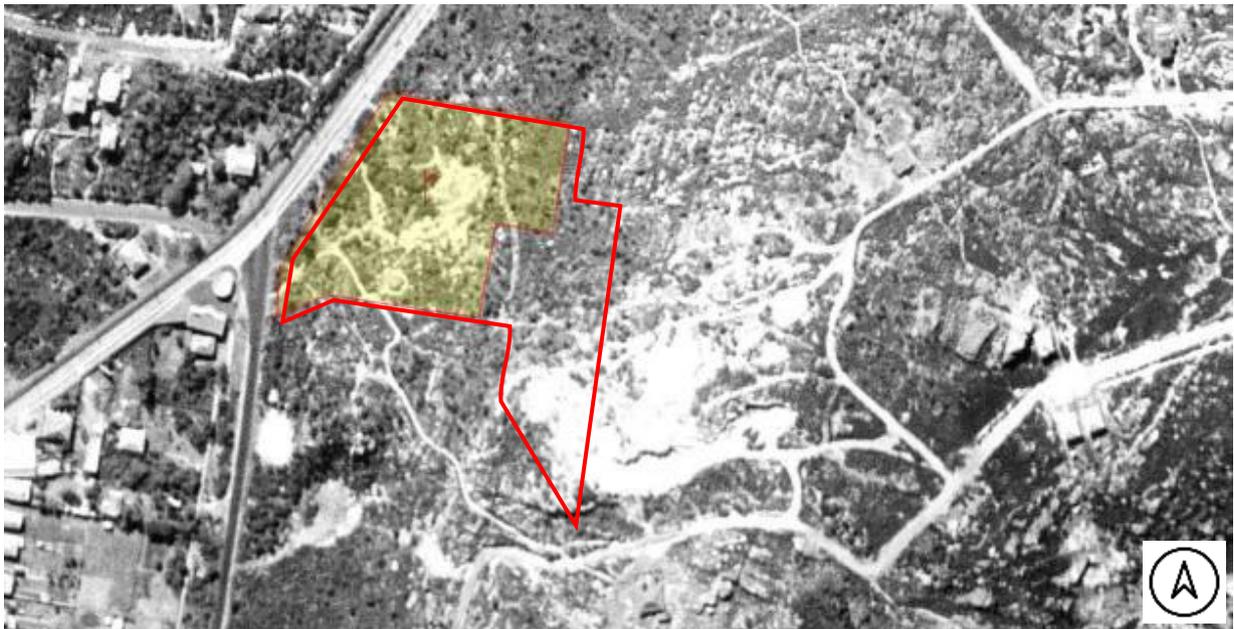
Figure 80: 1943 aerial photograph of subject site (indicated in red) shows an absence of structures at this time (Source: SIX Maps 2019)

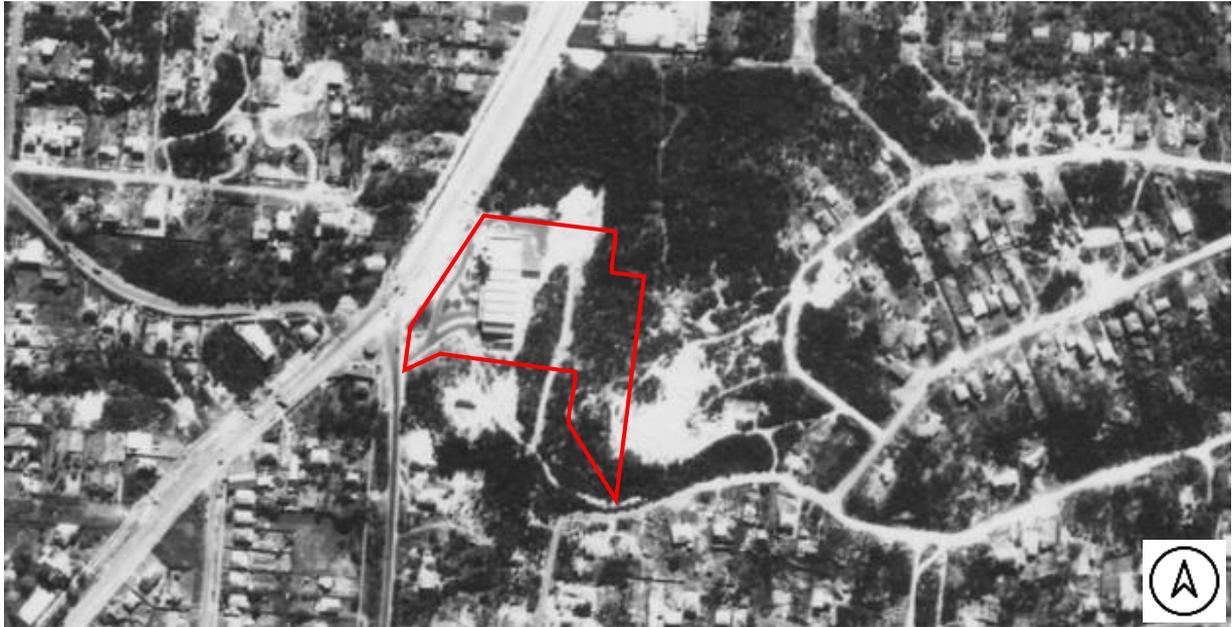
Figure 81: 1951 aerial photograph indicating that the subject site (indicated in red) had been developed by this time (Source: 'Narraweena, Dee Why & Brookvale 1951 - Sydney aerial photo', Andy Brill, flickr, available at <https://www.flickr.com/photos/angeljim46/11267157883/in/photostream/>)

A 1951 aerial photograph (Figure 81) depicts the Top Dog Men's Wear production centre, which had been erected in the western component of the subject site. This would have involved the excavation and removal of a significant quantity of sandstone. A contemporary photograph of the Top Dog Men's Wear production centre shows that significant excavation or grading works had been undertaken in order to establish minor entrance roads to the site. Comparison with the 1943 aerial photograph (Figure 79) suggests that the eastern component of the site, which equates to 224 Headland Road, remained densely vegetated and unchanged at this time.
