# **Non-Indigenous Archaeological Assessment**

800 Pittwater Road, Dee Why  
& 224 Headland Road, Curl Curl NSW

Submitted to Midson Group  
On Behalf of St Luke's Grammar School

November 2019

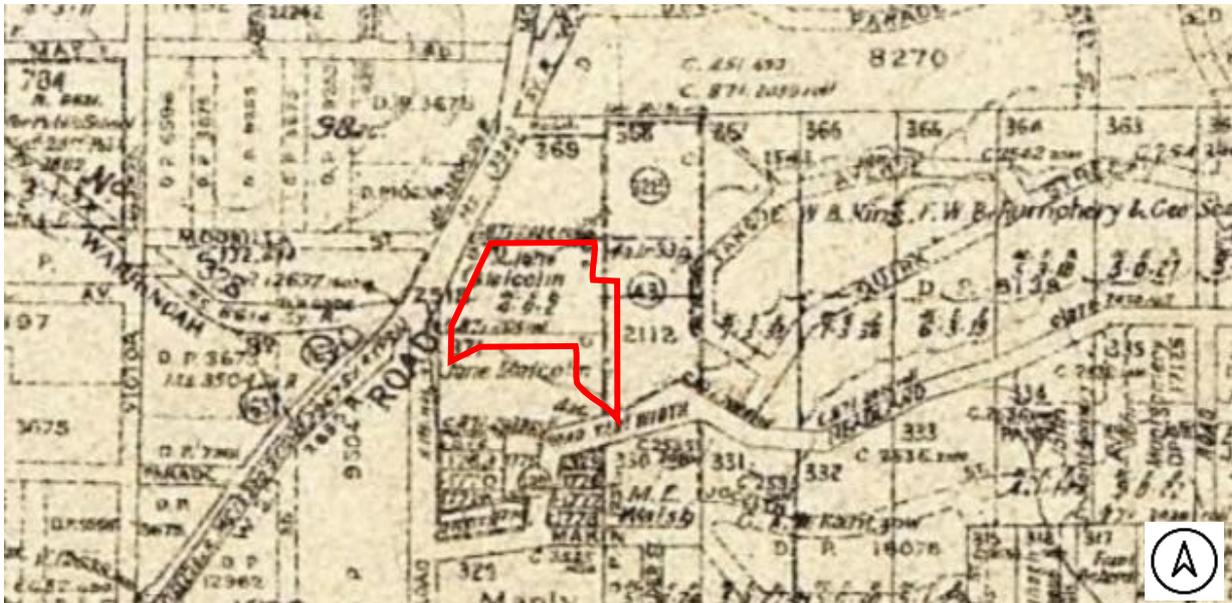
Figure 82: 1953 map of the surrounding area showing the approximate location of the subject site (indicated in red) in association with the name Jane Malcolm (Source: Parish of Manly Cove, County of Cumberland, Land & Water Conservation Map 140425).

A 1953 parish map (Figure 82) indicates that the western component of the subject site, which contained the Top Dog Men's Wear production centre, as well as the land to the immediately south, had come into the ownership of a Jane Malcolm by this time. Headland Road, which today forms the southern boundary of the subject site, had also been constructed by this time.

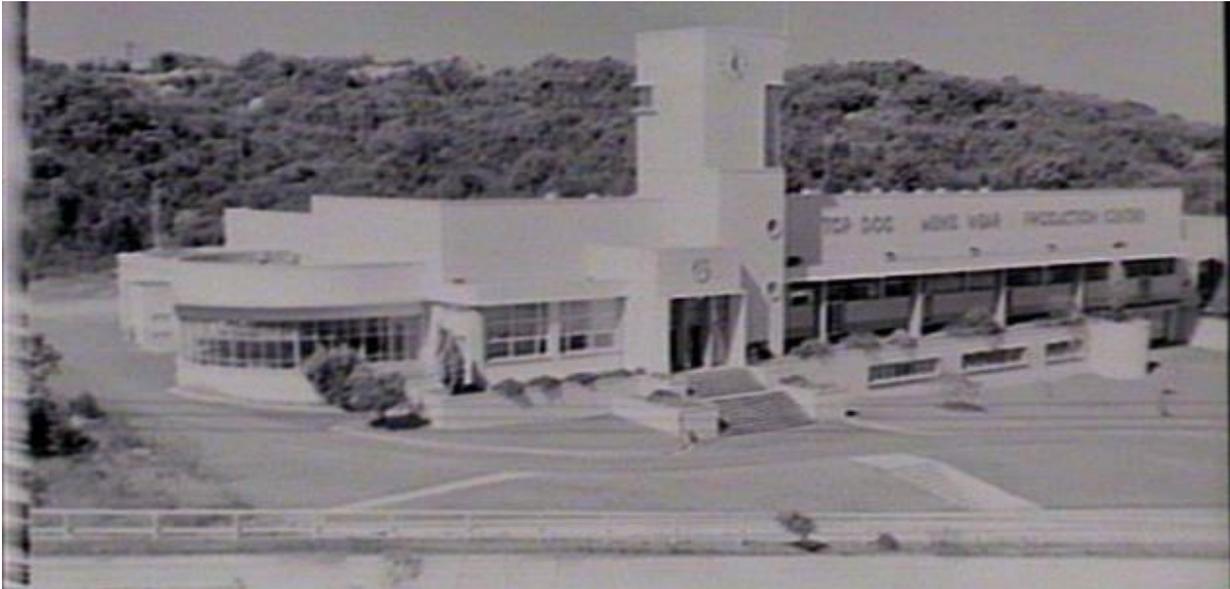
Figure 83: Looking south-east towards the 'Top Dog' production centre, c. 1956 (Source: State Library of New South Wales, reference 230302, IE 2200760).

Photographs of the top Dog Men's Wear production centre dating to 1956 (Figure 83) indicate that landscaping works to the west of the building had been completed by this time. The eastern component of the subject site appears both densely vegetated and elevated (Figure 83).

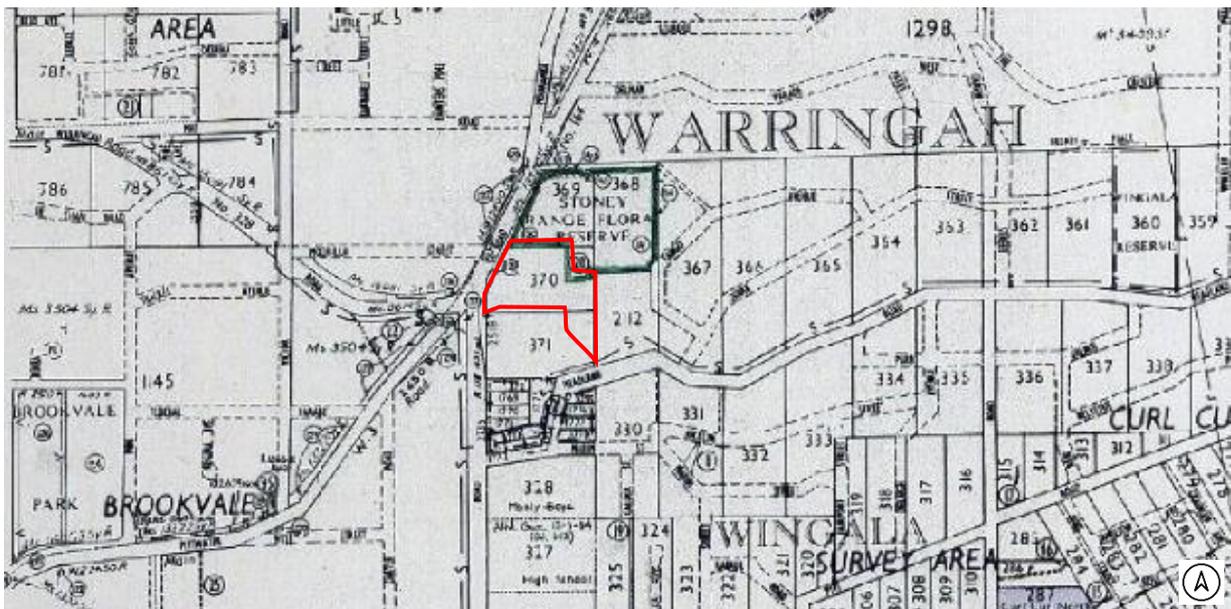
Figure 84: 1970's parish map with location of subject site indicated in red (Source: County of Cumberland (Sheet 6), Parish of Manly Cove, 1970's, phManly\_Cove-Sheet\_6-Cumberland.jp2, HLRV)

Parish maps dating to the 1970's (Figure 84 & Figure 85) indicate that the land immediately to the north-west of the subject site had been designated as the 'Stoney Range Flora Reserve' by this time. This land has remained a public reserve and is today the 'Stoney Range Regional Botanic Garden'.

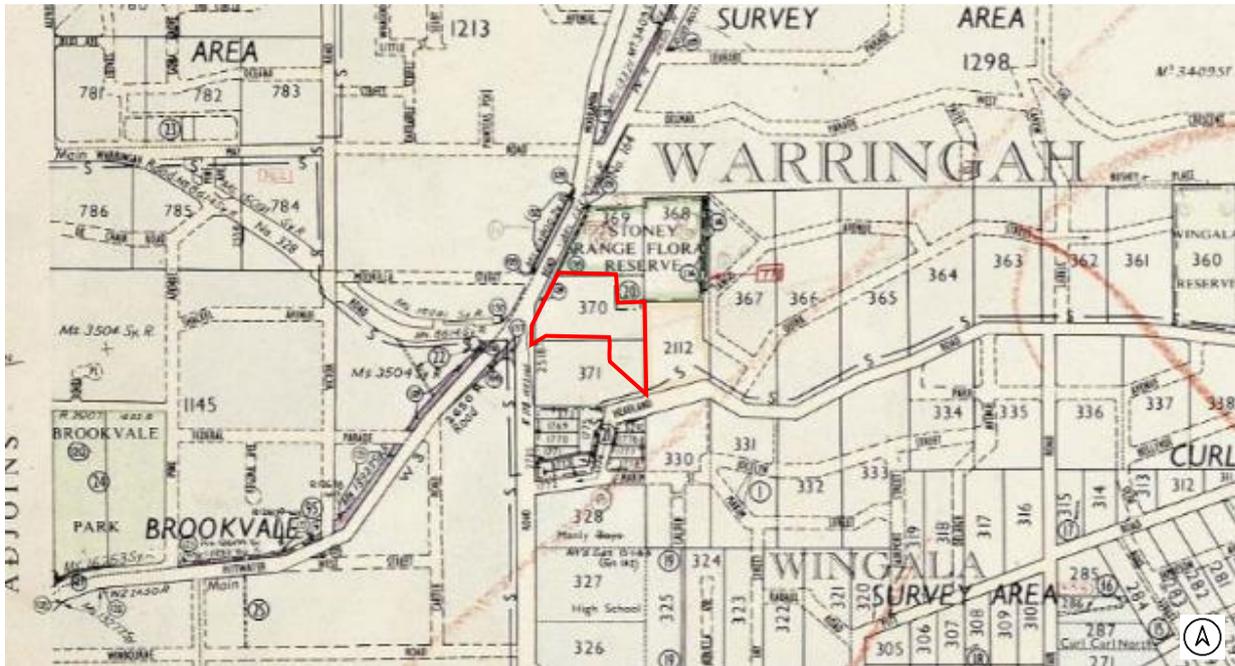
Figure 85: 1971 parish map with location of subject site indicated in red (Source: Parish of Manly Cove, 1971, 14030802.jp2, HLRV)

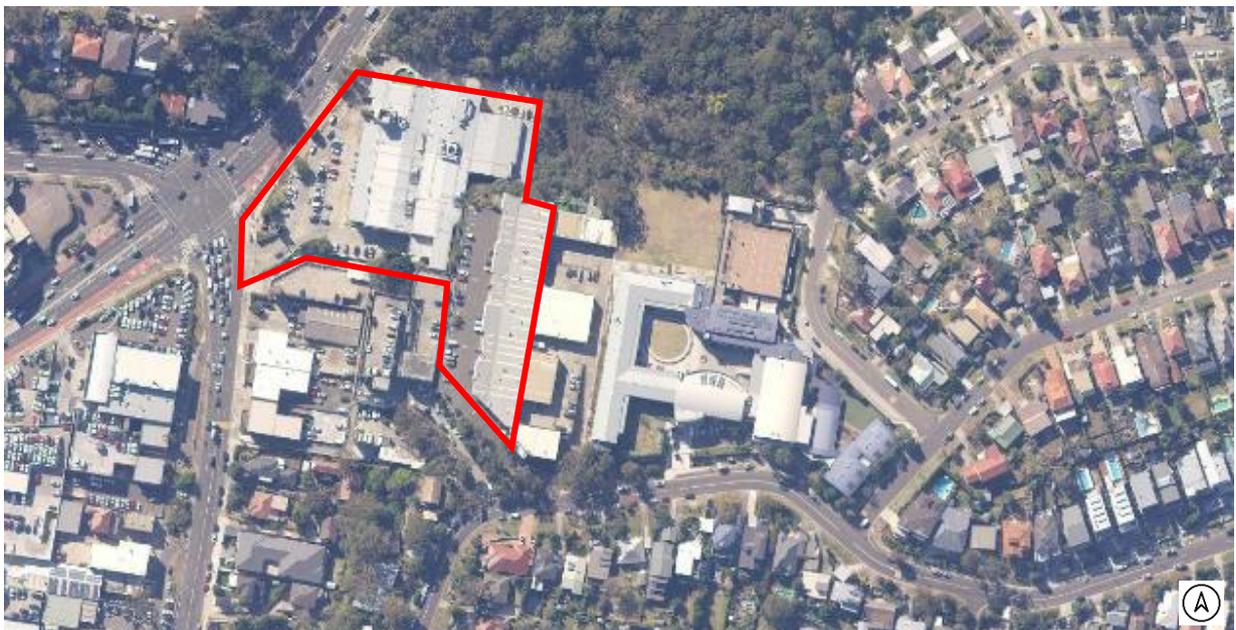
Figure 86: The subject site (indicated in red) today contains commercial buildings and St Luke's Grammar School (Source: SIX Maps 2019)
