The Anglican Schools Corporation
C/- Midson Group Pty Ltd

Detailed Site Investigation:
St Luke's Grammar School Proposed
Senior School and Sports Centre –
800 Pittwater Road, Dee Why &
224 Headland Road, North Curl Curl, NSW

P1907215JR03V01
October 2019

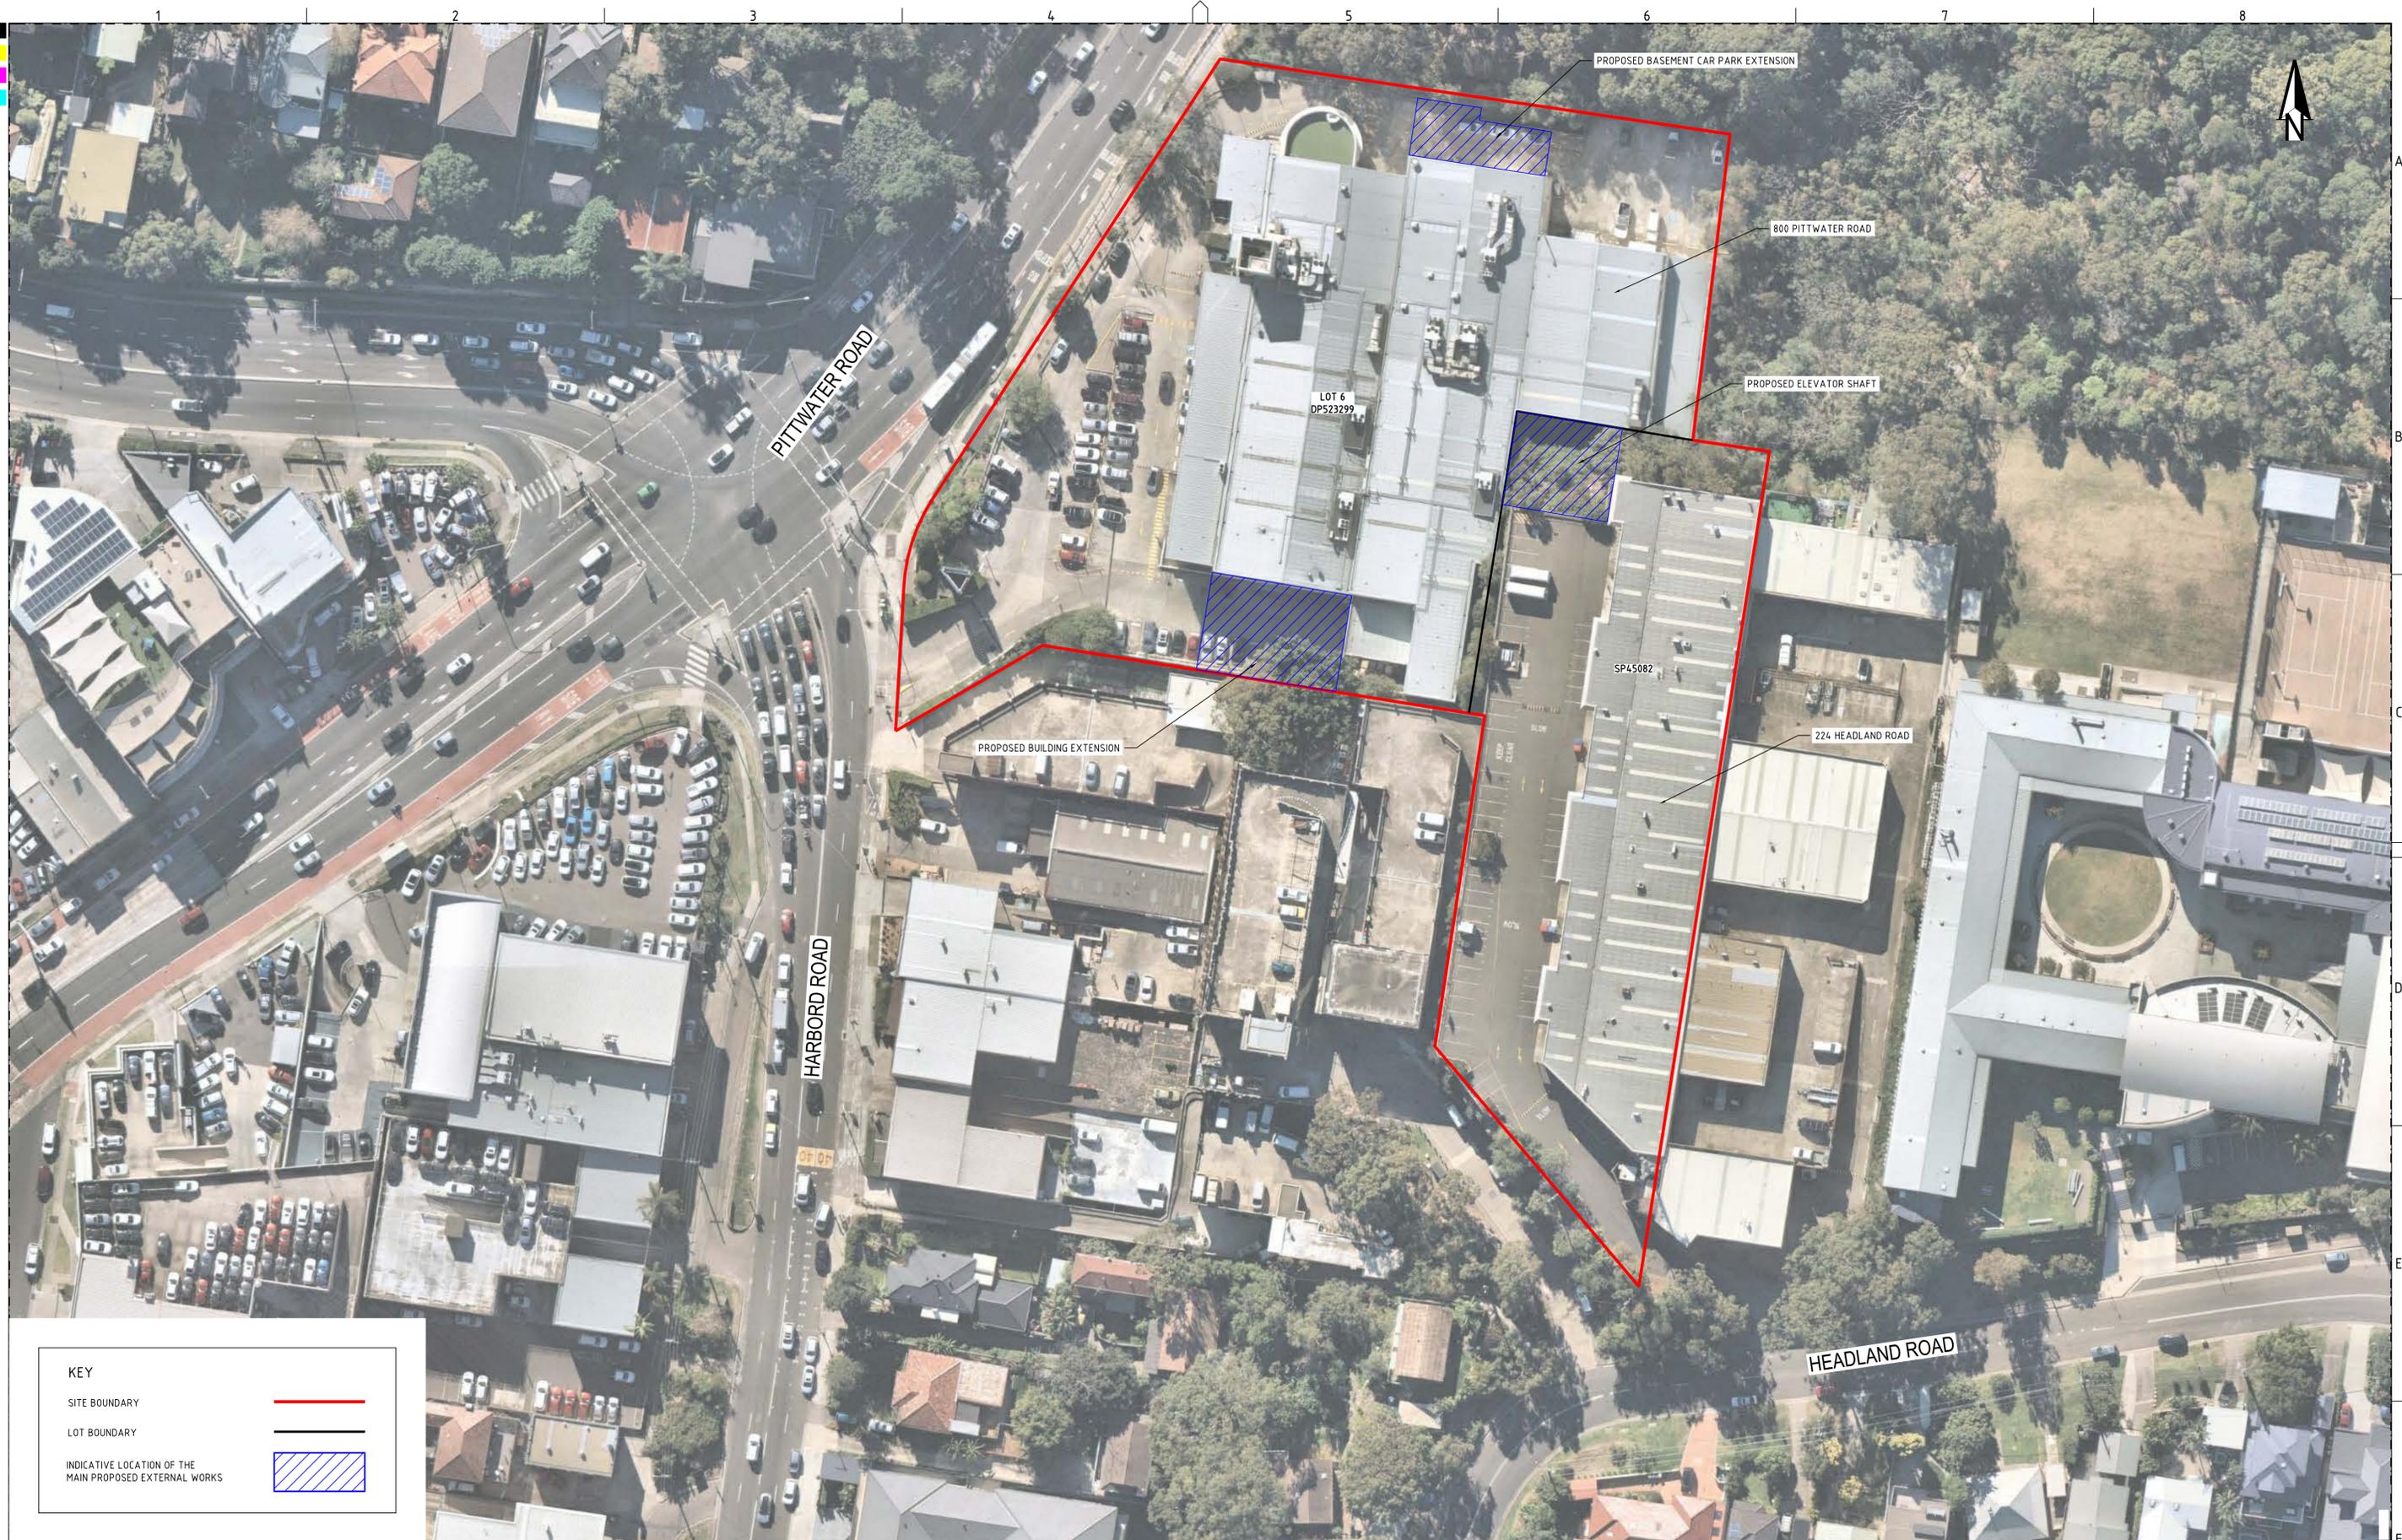
DRAWING TITLE				
FIGURE 1: SITE BOUNDARY NEARMAP (2019)				
PROJECT NO.	PLANSSET NO.	RELEASE NO.	DRAWING NO.	REVISION
P1907215	PS01	R02	PS01-JZ01	A

KEY	
SITE BOUNDARY	
LOT BOUNDARY	
INDICATIVE LOCATION OF THE MAIN PROPOSED EXTERNAL WORKS

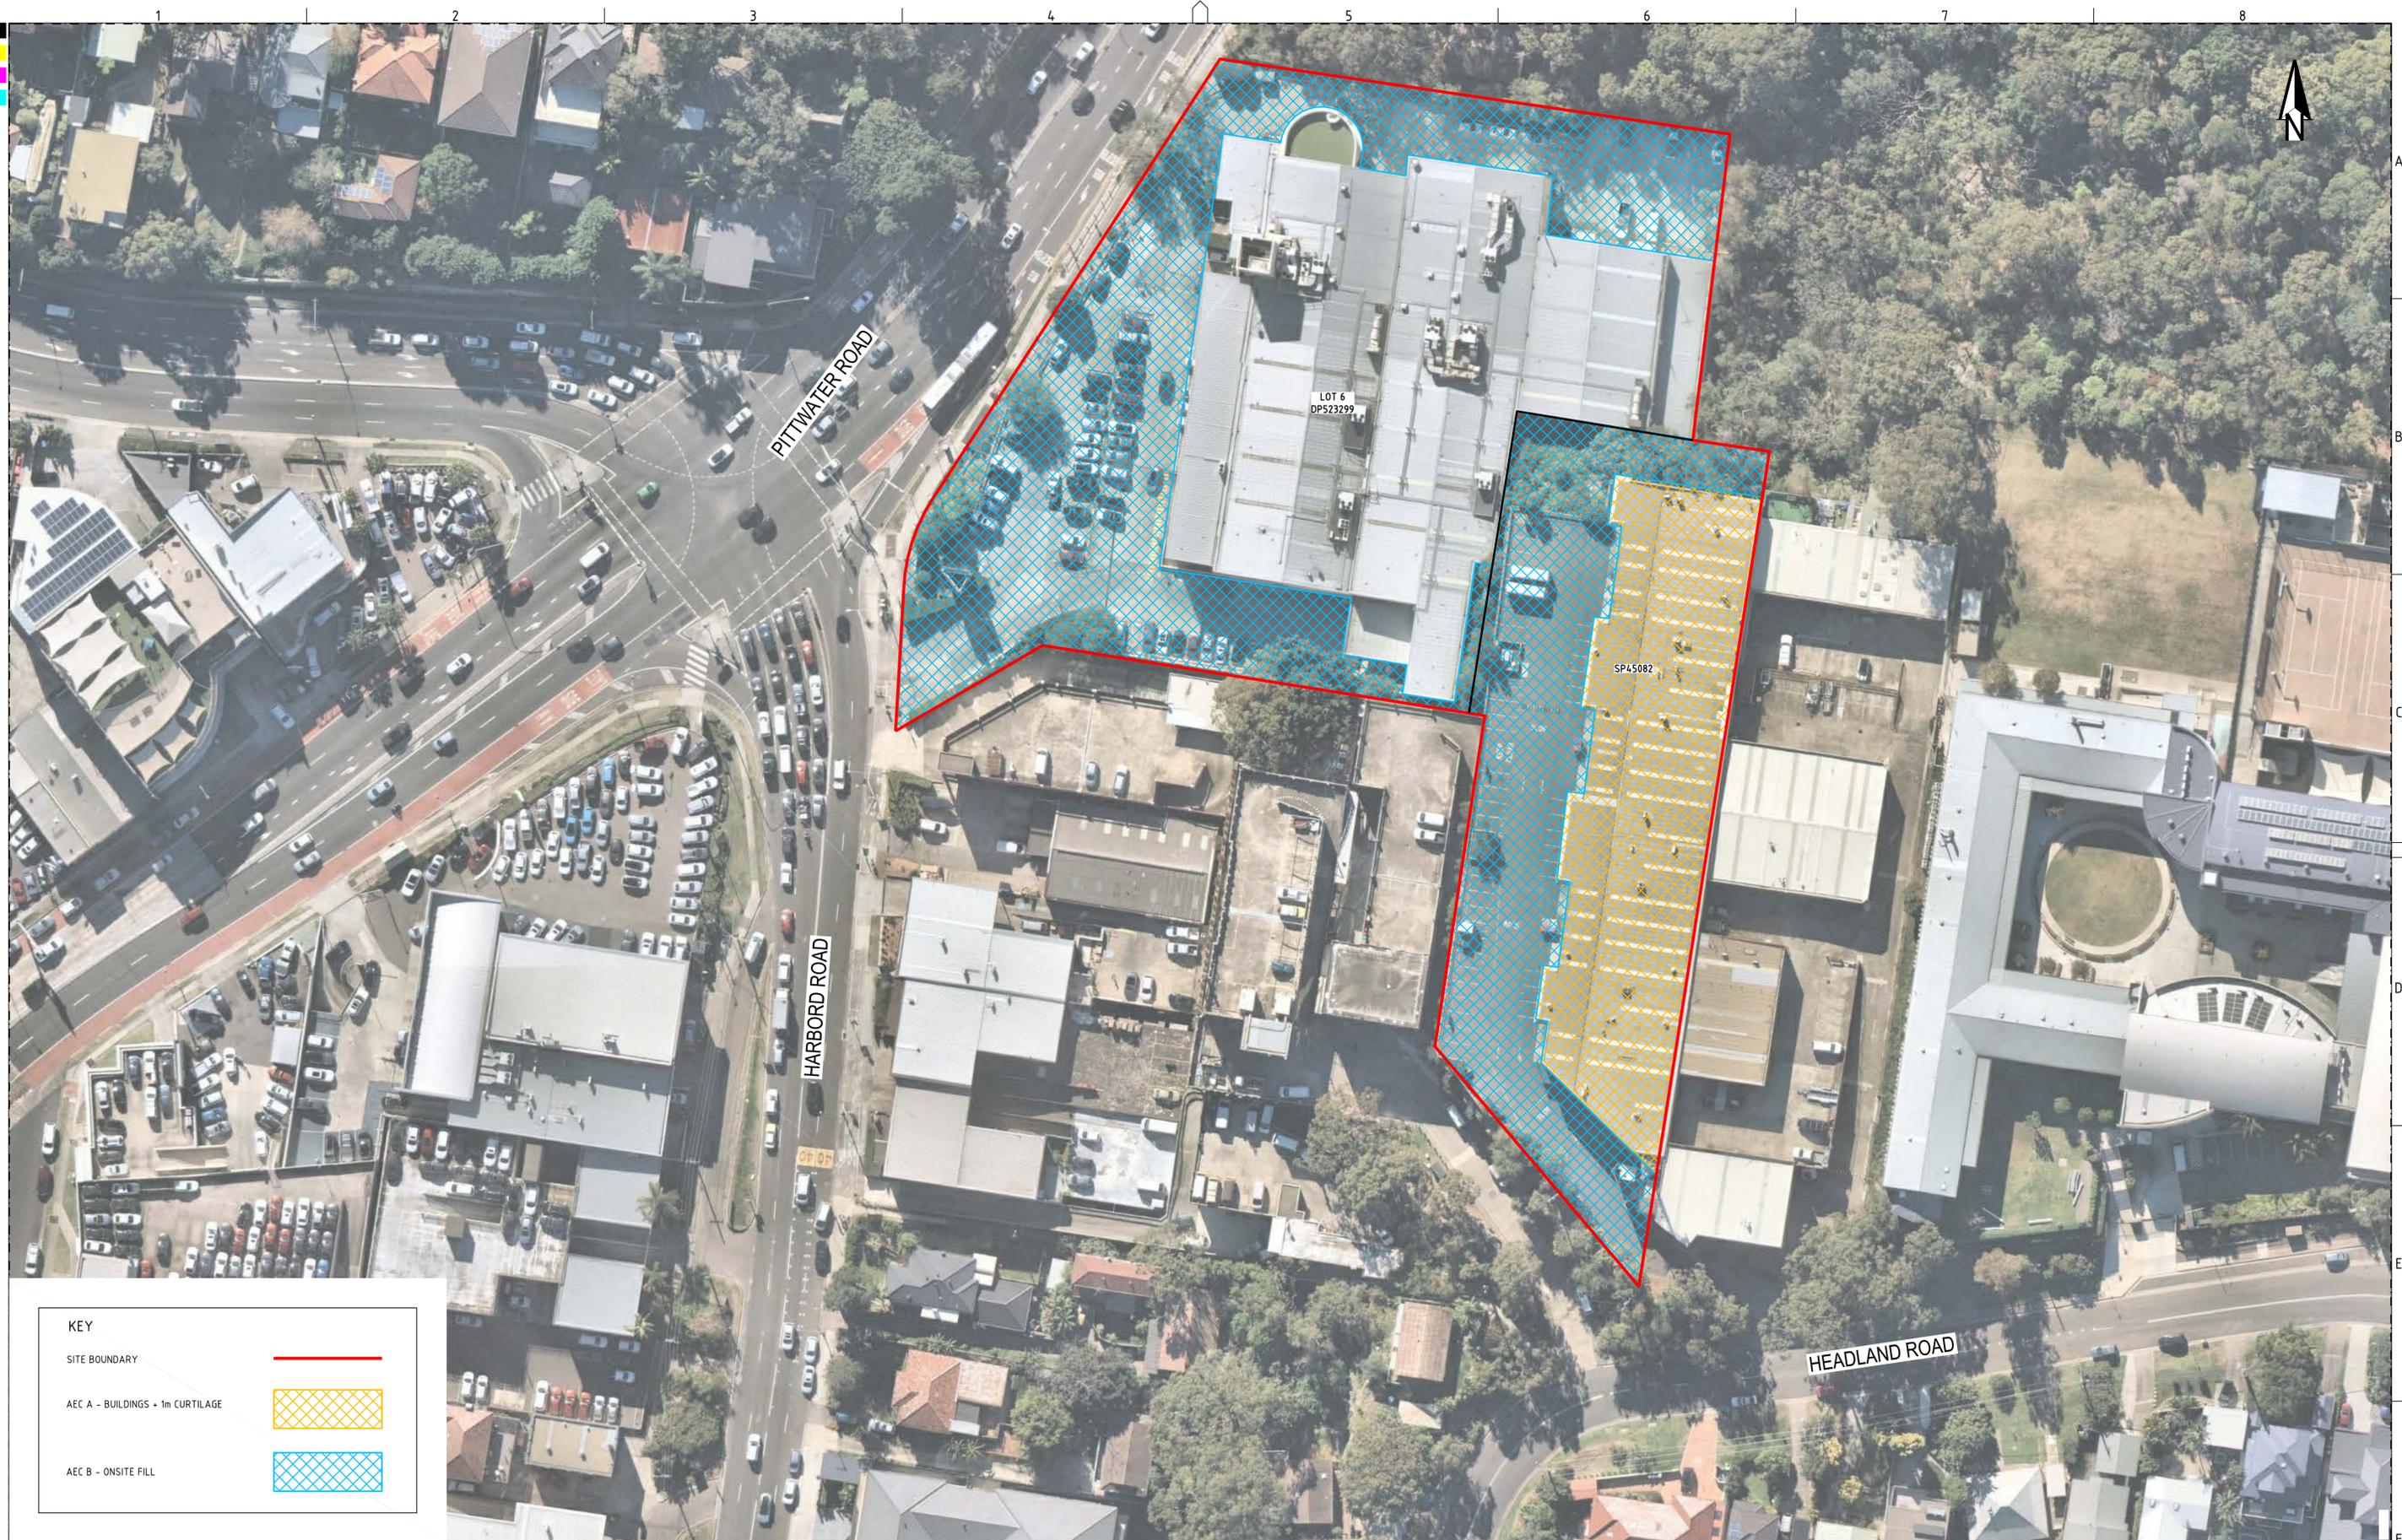
DRAWING TITLE				
FIGURE 2: AEC MAP NEARMAP (2019)				
PROJECT NO.	PLANSSET NO.	RELEASE NO.	DRAWING NO.	REVISION
P1907215	PS01	R02	PS01-JZ02	A

KEY	
SITE BOUNDARY	
AEC A - BUILDINGS + 1m CURTLAGE	
AEC B - ONSITE FILL

Only the building and area of proposed lift shaft/stairs at the 224 Headland Road are considered as areas of environmental concern. Although the external façade and footprint will remain unchanged, internal works consisting of new walls, foundations, trenching for services and excavation will be required.

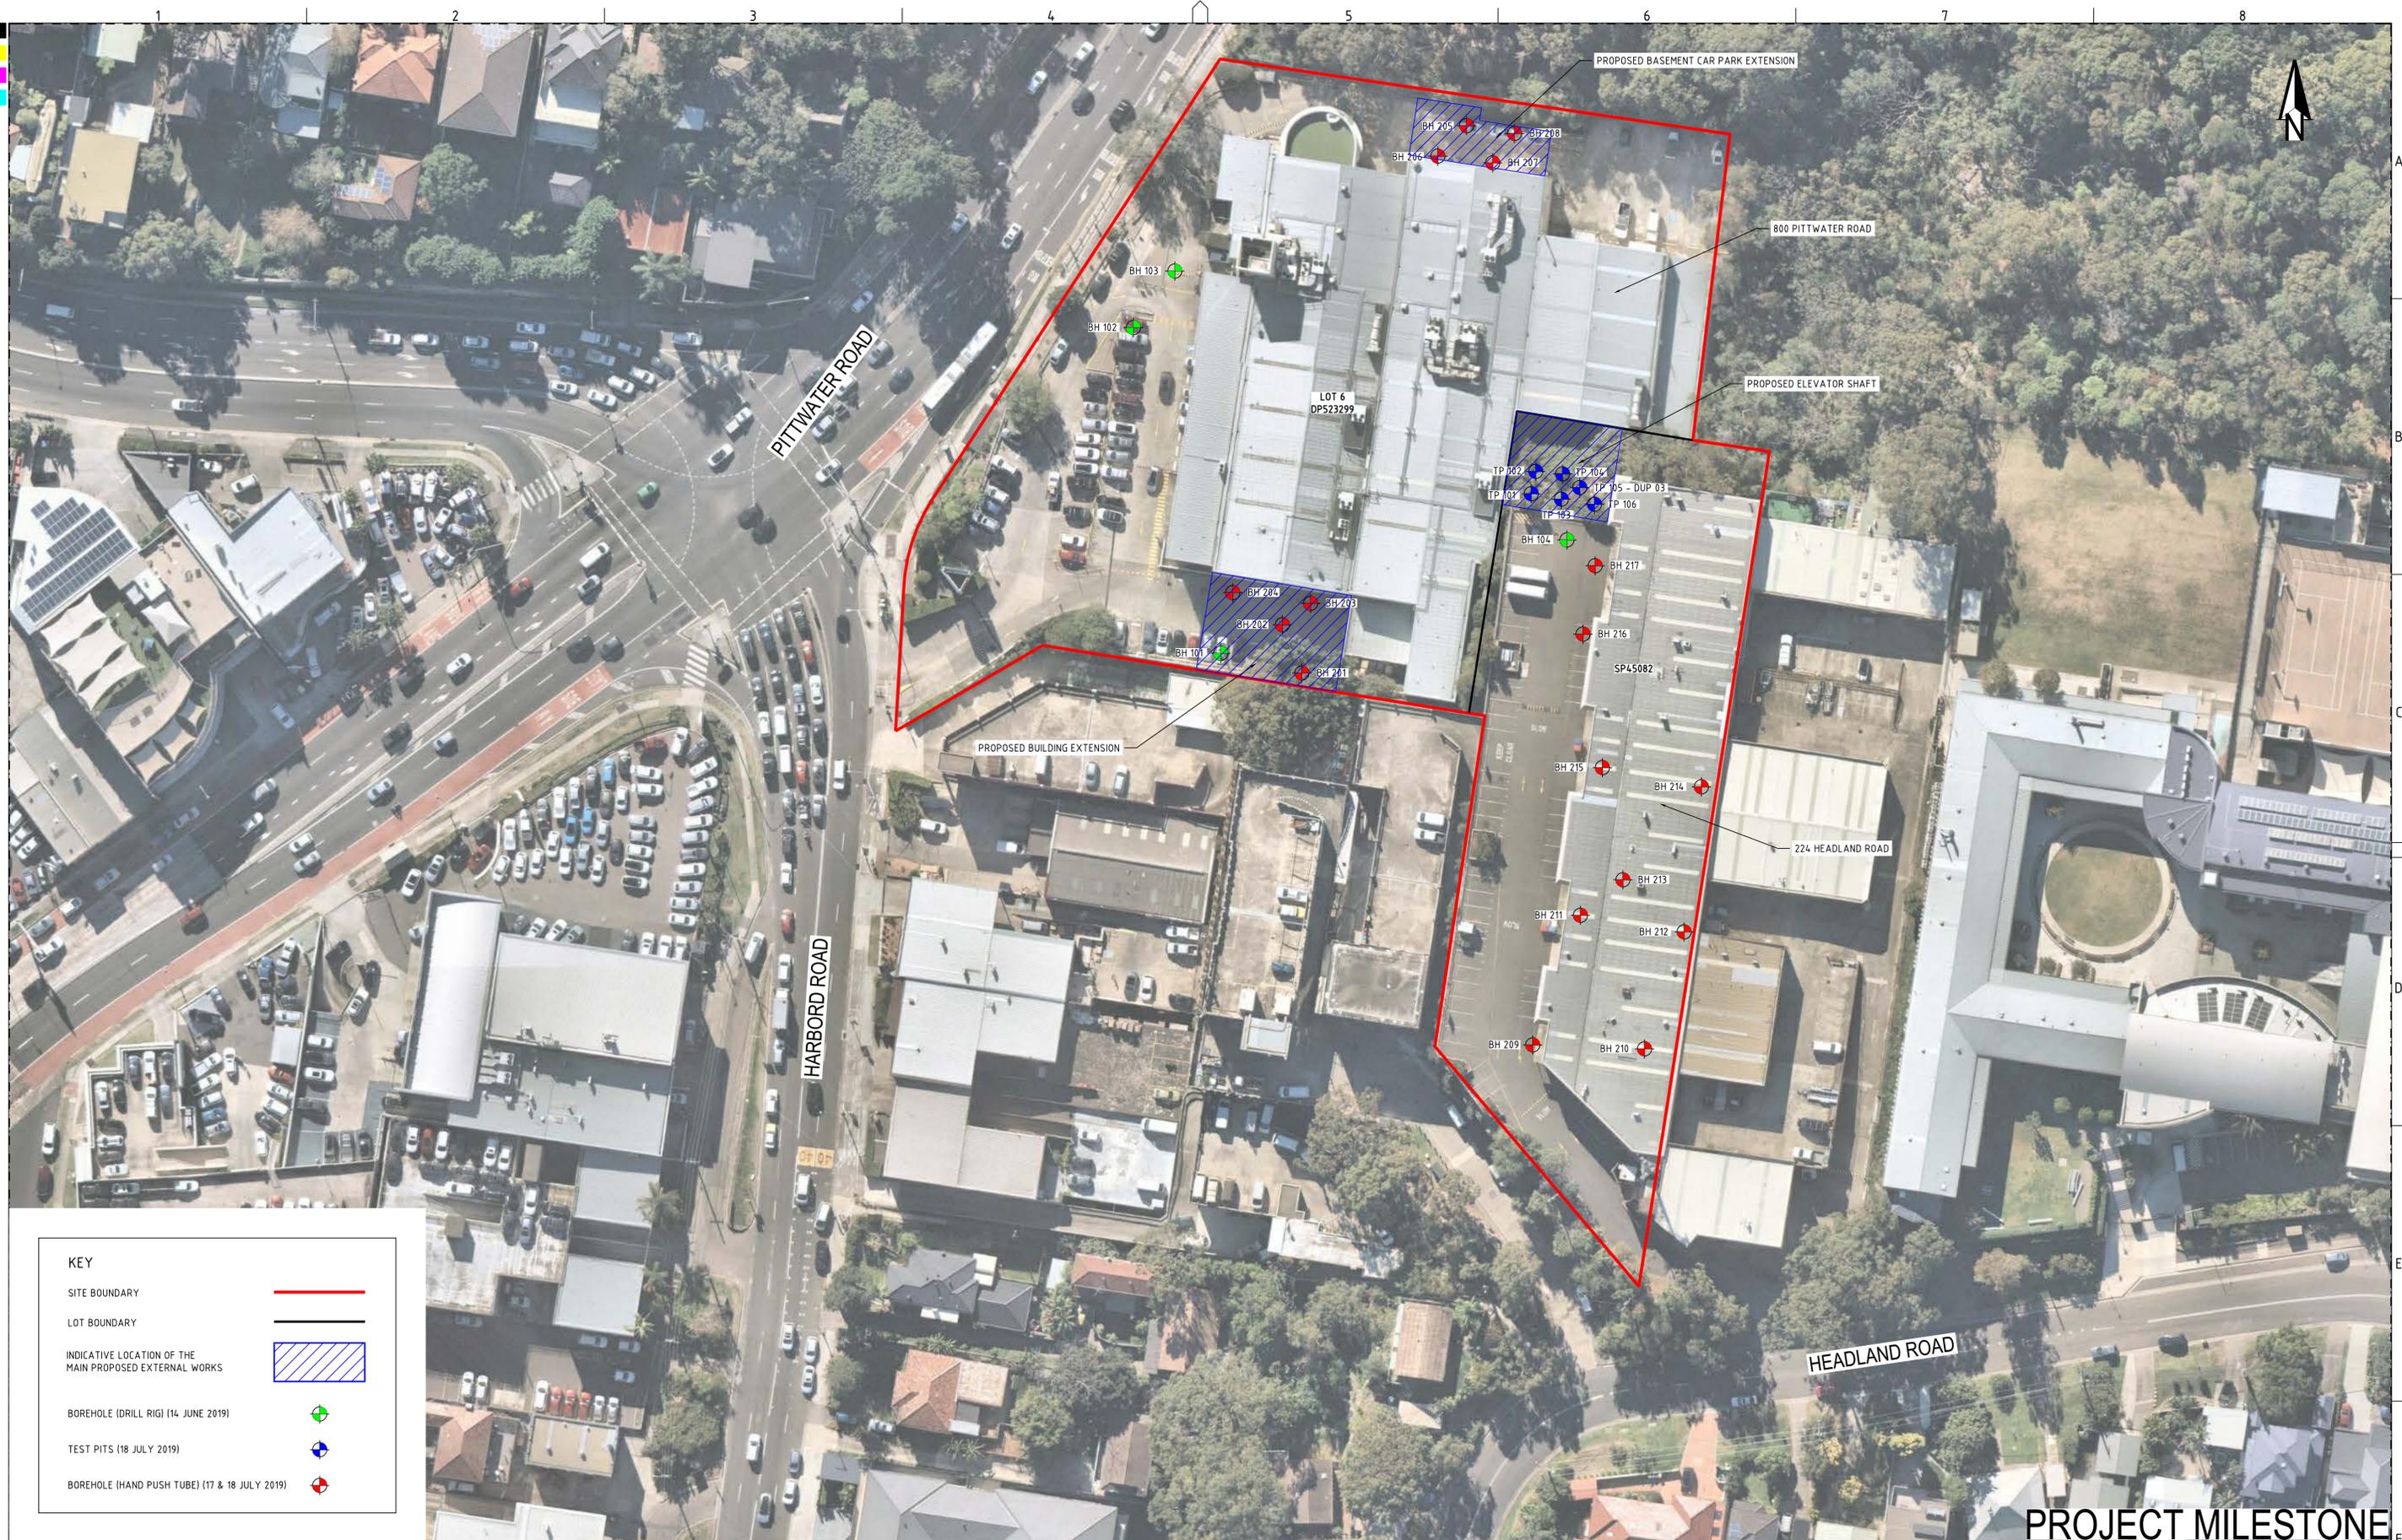
KEY	
SITE BOUNDARY	
LOT BOUNDARY	
INDICATIVE LOCATION OF THE MAIN PROPOSED EXTERNAL WORKS	
BOREHOLE (DRILL RIG) (14 JUNE 2019)	
TEST PITS (18 JULY 2019)	
BOREHOLE (HAND PUSH TUBE) (17 & 18 JULY 2019)

Laboratory chain of custody documentation is provided in Attachment F. Borehole and test pit locations are shown on the sampling plan in Attachment A, and sample depths noted on borehole/test pit logs, provided in Attachment B.
