**Preliminary Phase 1 Site Contamination Assessment**

**Proposed Cultural & Civic Space Project**

**23-31 Gordon Street, Coffs Harbour**

Report No. RGS31785.1-AB

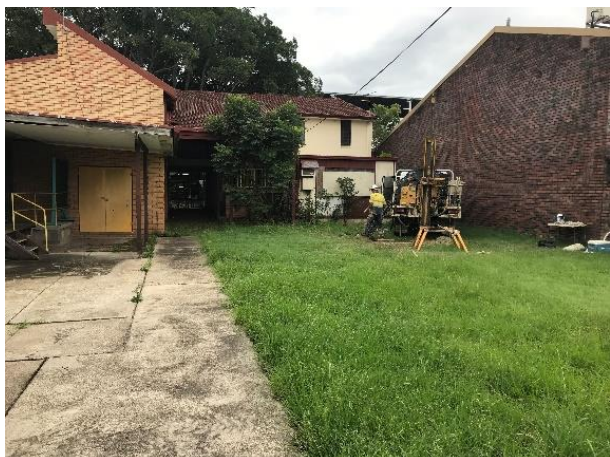
**Plate 1: Site Photographs Illustrating Site Conditions**

*Looking west at structures and grassed area in the northern end of the site.*

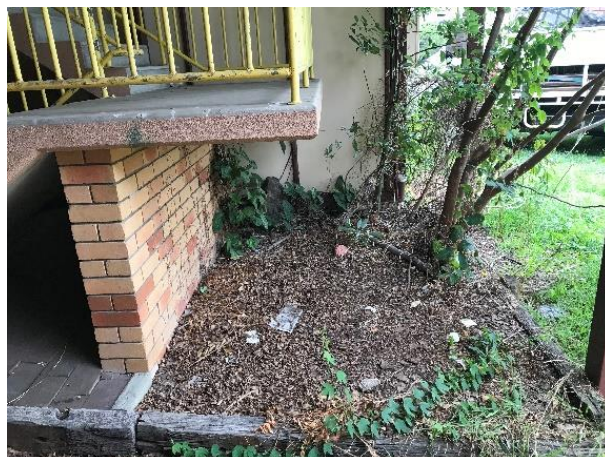
The majority of the three lots are occupied by buildings, concrete slabs, par parks, and garden beds surrounding the buildings. The building materials generally comprise of brick masonry and fibro clad (potential asbestos containing materials and lead based paints).

*Garden bed adjacent to fibro clad structure in the northern end of the site.*

- Undertake a hazardous materials survey prior to demolition of the existing structures at the site. An asbestos clearance certificate should also be obtained by the demolition contractor to certify that all asbestos has been appropriately removed from the site;
- Undertake further site assessment following the demolition of the buildings, floor slabs and pavements to assess possible contamination in these areas;
- Further evaluate potential risks to ecological receptors in relation to heavy metal concentrations in soils; and
- Assess the need for further work based on the conditions encountered following demolition.

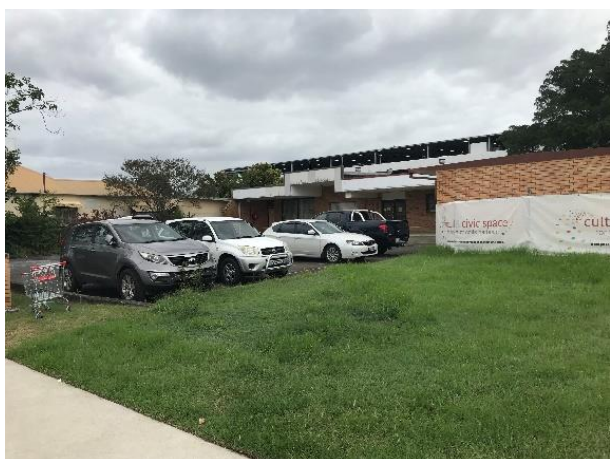
Most of the buildings appear to be run down, however, structurally they appear to be in fair condition. Extensive cracking was observed in the carpark in the centre lot.

*Looking west at the carpark and structures in the middle section of the site.*

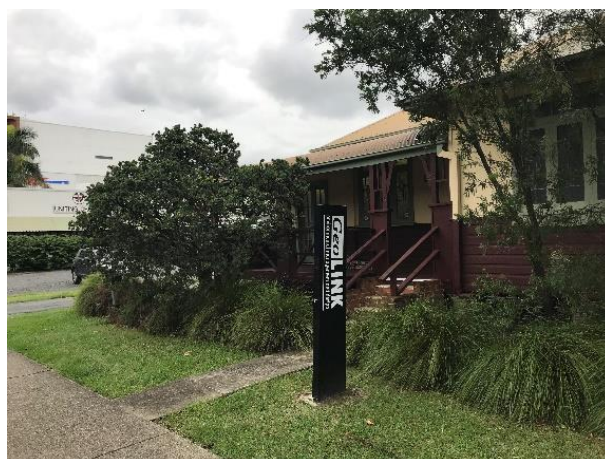
*Building and garden beds at southern end of the site.*

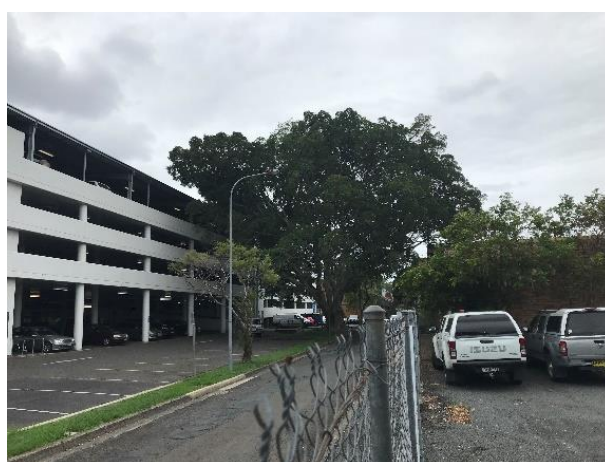
The surrounding area consists residential and commercial buildings. There is a large fig tree approximately 5m to the northwest of the proposed development.

*Large fig tree located to the north of the site.*

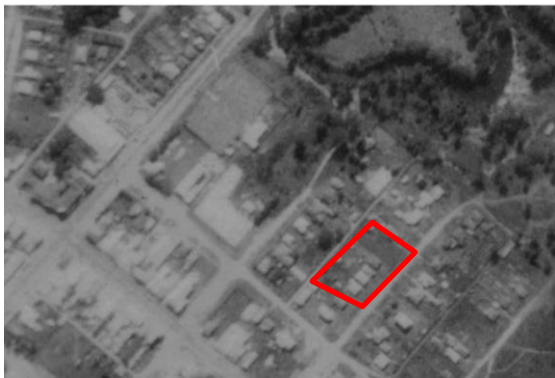
Site appears to contain residential houses with a vacant block at the northern end.	As per site conditions.
1984 (NSW LPI)

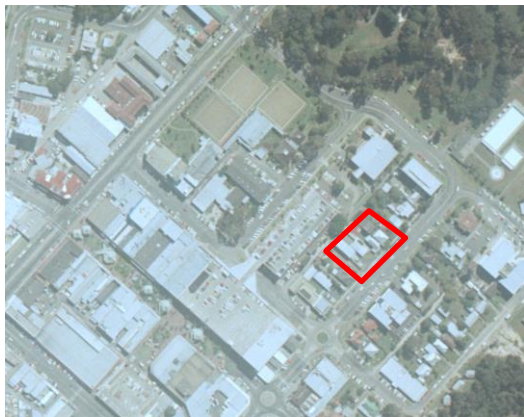
Residential development of the site has occurred.	Residential developments upgrade of roads.
2004 (Google Earth)

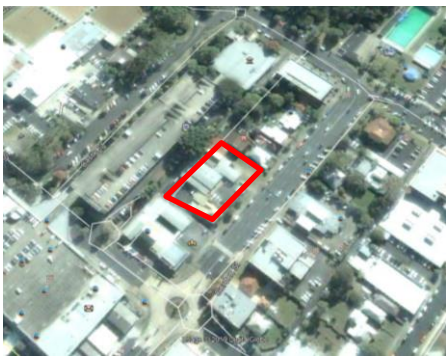
Commercial and residential developments.	Commercial and residential developments.
2018 (Google Earth)

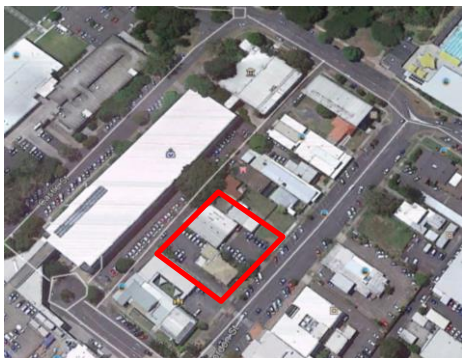
Similar to previous.	Similar to previous.
