**Proposed Cultural and Civic Space Project**

**23-31 Gordon Street Coffs Harbour NSW**

**Geotechnical Report**

Report No. RGS31785.1 – AC Rev. 1

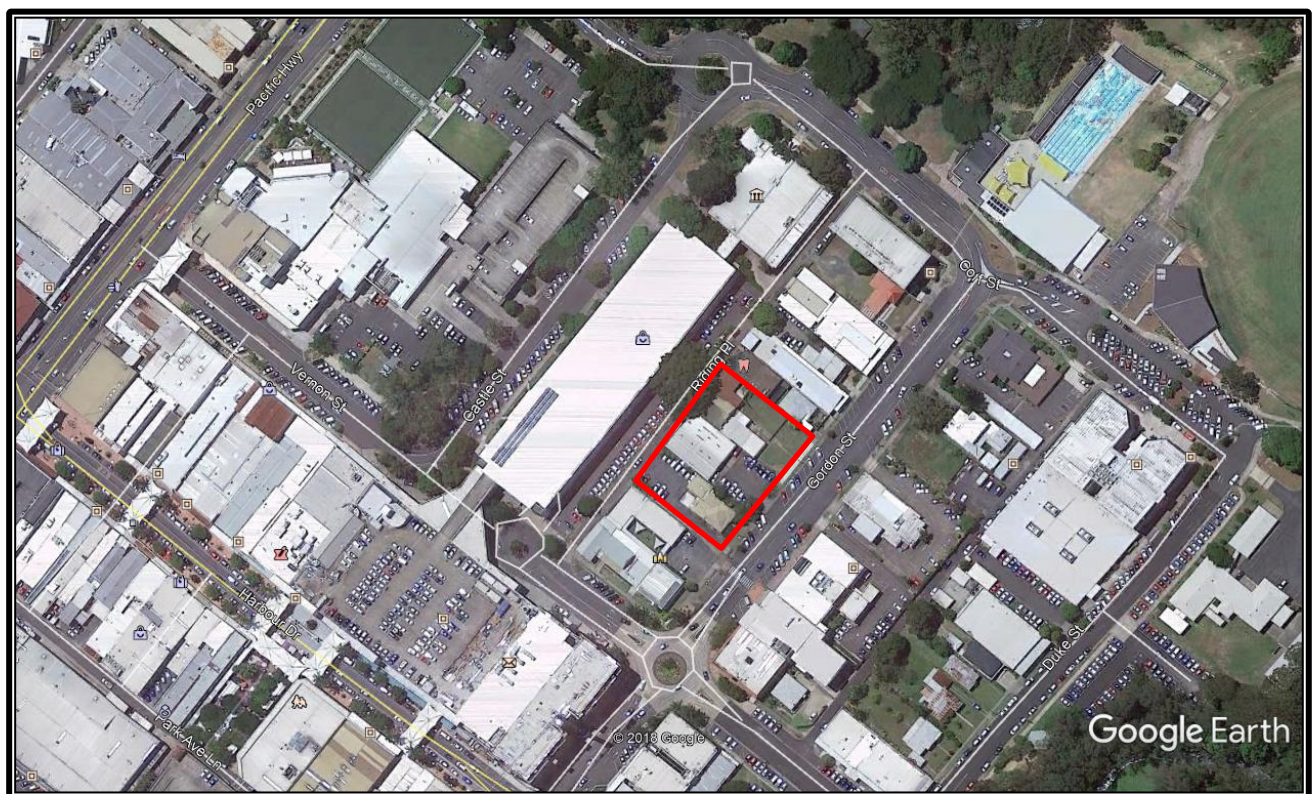
**Diagram 1: Site Location and Setting**

The site is situated within the Coffs Harbour CBD within flat low-lying alluvial topography as illustrated in Diagram 1. The site encompasses an area of approximately 4,000m<sup>2</sup> and is currently occupied by single storey residential and commercial buildings with associated on grade car parking areas. Development to the north comprises single and double storey brick and timber residential buildings on the site boundary, while to the south is a single storey clad structure set back about 2.5m from the boundary. Gordon Street forms the eastern frontage with a lane and on grade carparking beyond to the west.

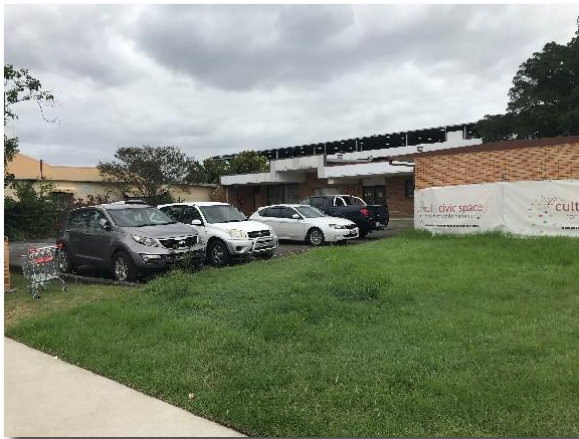
3. Looking southwest at the carpark and structures in the middle section of the site.

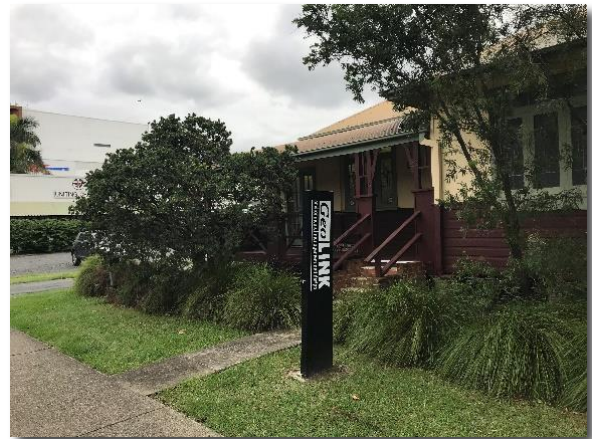
4. Building and garden beds at southern end of the site.

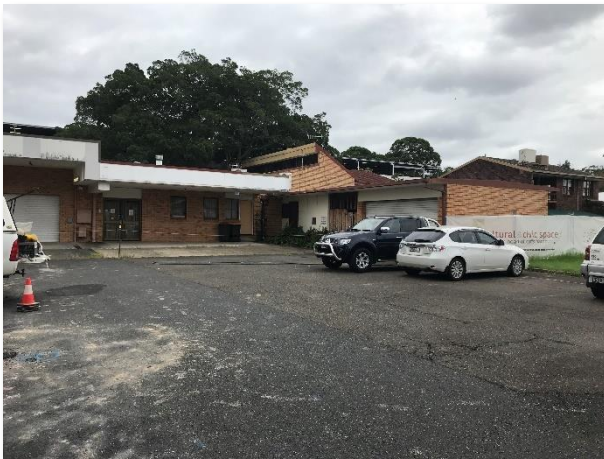
5. Looking west at the carpark and structures in the middle section of the site.

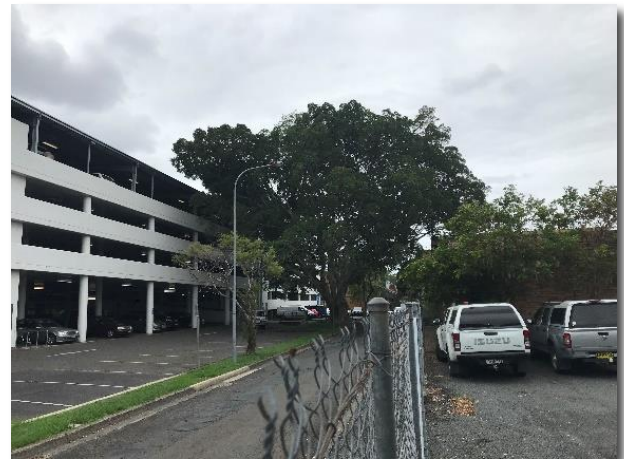
6. Large fig tree located to the northwest of the site.

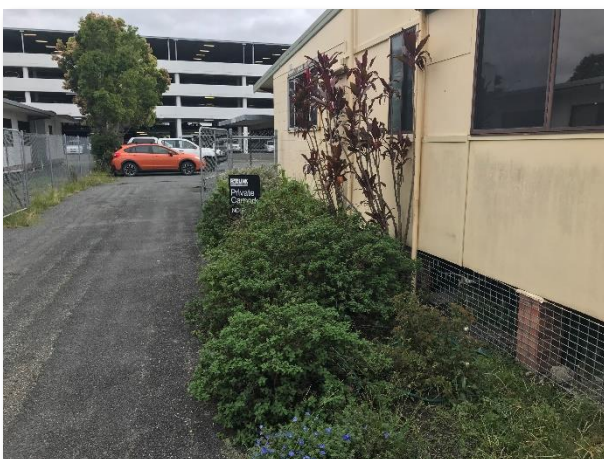
7. Looking west at the access driveway, carpark and structures in the southern section of the site.

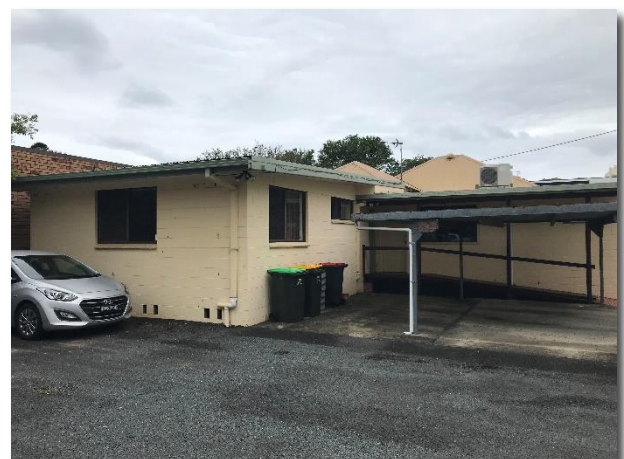
8. Looking north east at the rear of the structures in the southern portion of the site.

Approximately 50% is occupied by buildings while the remaining areas comprise grass, garden beds or sealed carparking areas. The buildings are generally single storey residential (Lot 6, DP758258) or commercial, generally comprising brick masonry and timber framed fibro clad construction. The buildings are run down, however, structurally they appear to be in fair condition. Extensive cracking was observed in the carpark in the centre lot.

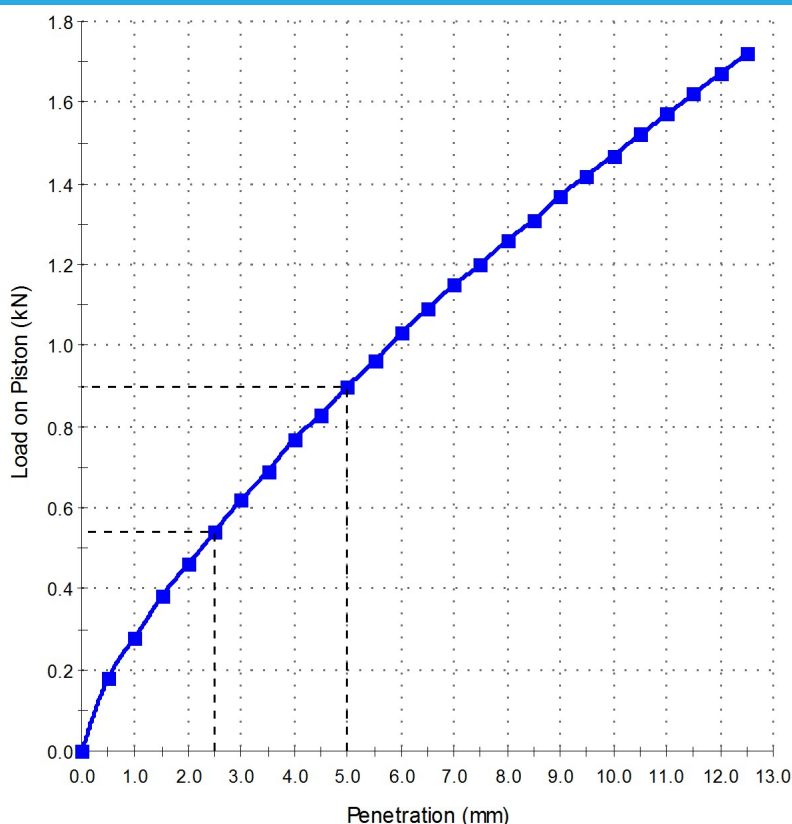
## Load vs Penetration

AS 1289.6.1.1 - 2014

Optimum Moisture Content (%): 18.0

Sample Location	Sample Depth (m)	Material Description	Natural Moisture Content (%)	Optimum Moisture Content (%)	Maximum Dry Density (t/m <sup>3</sup> )	Swell (%)	CBR (%)
CBR 1	0.2 to 0.5	Clayey Silt	18.5	18.0	1.77	0.0	4.5
CBR 2	0.2 to 0.5	Silty Clay	18.4	19.0	1.76	0.0	4.5

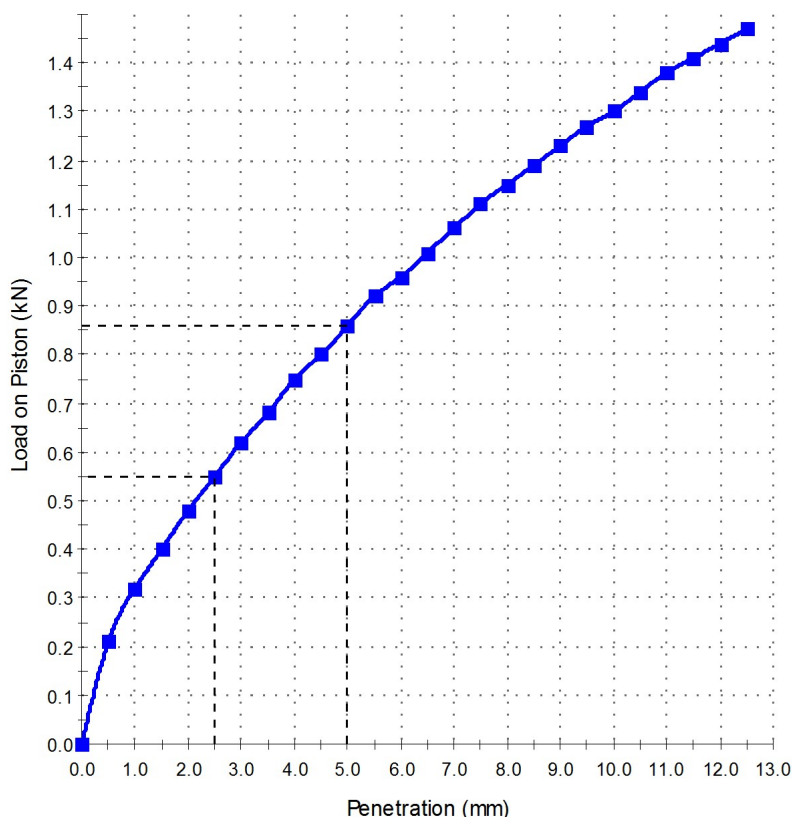
## Load vs Penetration

AS 1289.6.1.1 - 2014
