**Geotechnical Investigation
369-381 President Avenue, Kirrawee, NSW**

**GEOTECHNICAL SITE INVESTIGATION REPORT
FOR
PROPOSED ADDITIONS & ALTERATIONS TO
PRESIDENT PRIVATE HOSPITAL
AT
369-381 PRESIDENT AVENUE
KIRRAWEE, NSW 2232**

Project No: SRE/564/KW/20

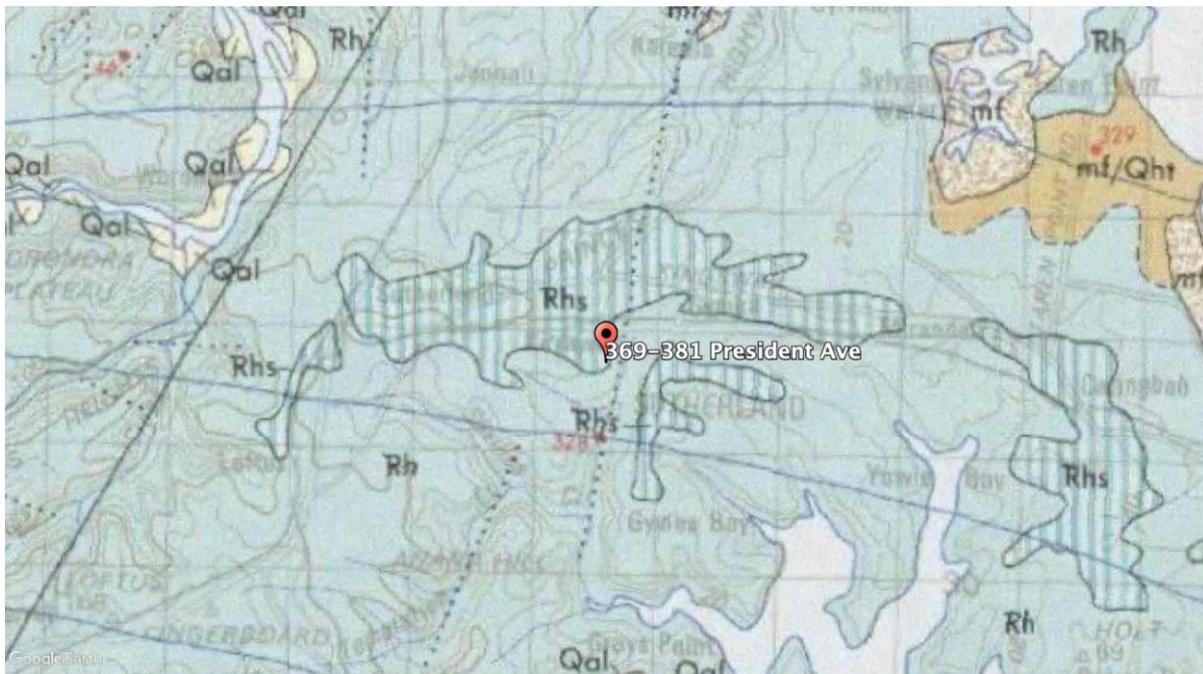
Figure 1 – Portion of the Wollongong – Port Hacking 1:100,000 Geological Series Sheet 9029-9129. Site area location is highlighted in a red/black sign.

From the analysis of Geology of Wollongong – Port Hacking 1:100 000 Geological Series Sheet 9029 - 9129, it is indicated that the site is located within a region of Triassic age, underlain by **Hawkesbury Sandstone (Rh)** formation. The Hawkesbury Sandstone is comprised of medium to coarse-grained quartz sandstone, very minor shale, and laminate lenses. A reproduction of the geological map is shown on following **Figure 1** and is based on a portion of the Sydney 1:100 000 Geological Series Sheet 9130 (interactive resource provided by the Geological Survey of NSW), which depicts the site geological condition.

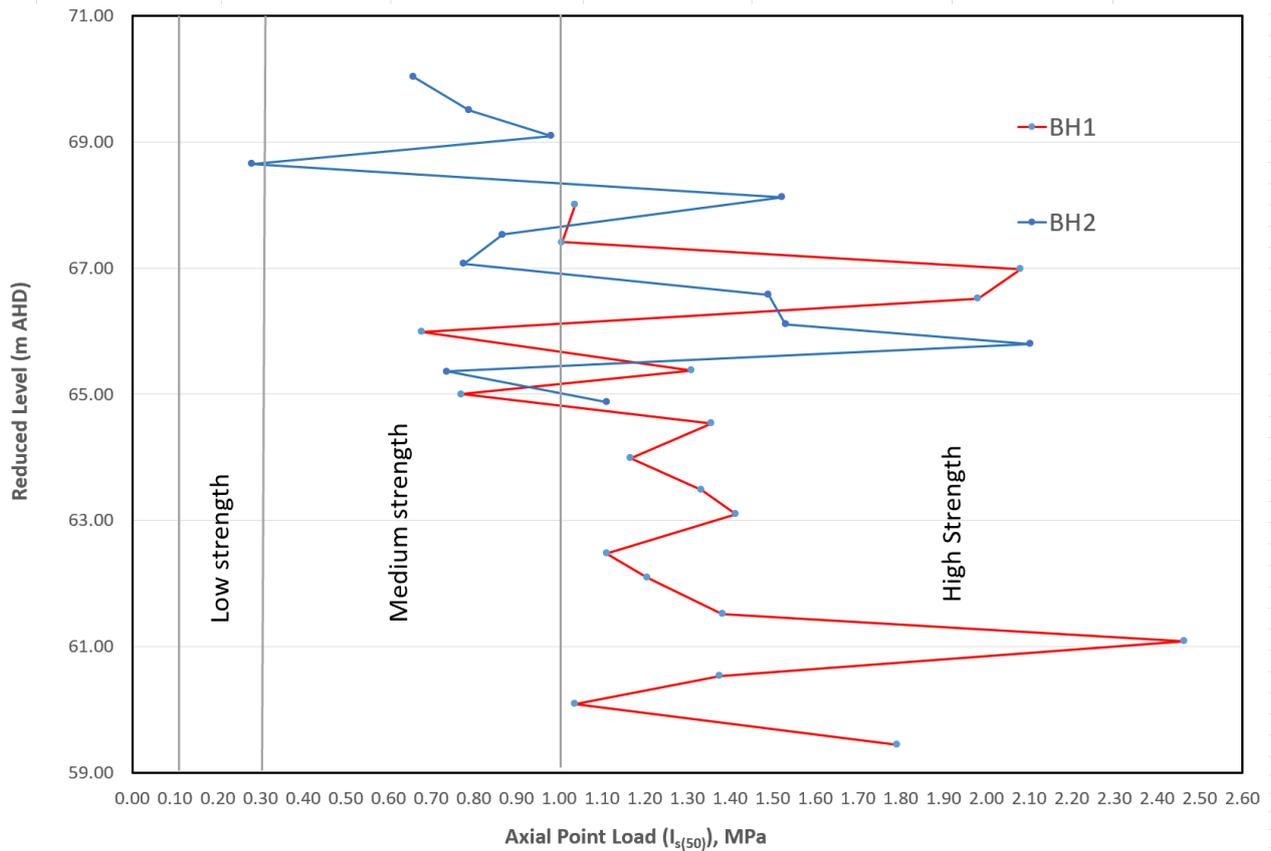
Figure 2 – Axial Point Load Tests Strength Results Plotted against Depth for Boreholes BH1 and BH2.

The following **Figure 2** presents the axial point load strength results plotted against reduced level. The results of axial point load testing indicated $I_s(50)$ results of 0.280 MPa to 2.465 MPa in sandstone, corresponding to low to high strength sandstone. Based on a typical ratio of $I_s(50)$ to unconfined compressive strength (UCS) of 1: 16 to 20 in Hawkesbury Sandstone, this corresponds to UCS values of between 5.6 MPa to 49.3 MPa, and average results of 27.45Mpa.

The **Figure 2** below indicates that the strength profile generally increases with depth.

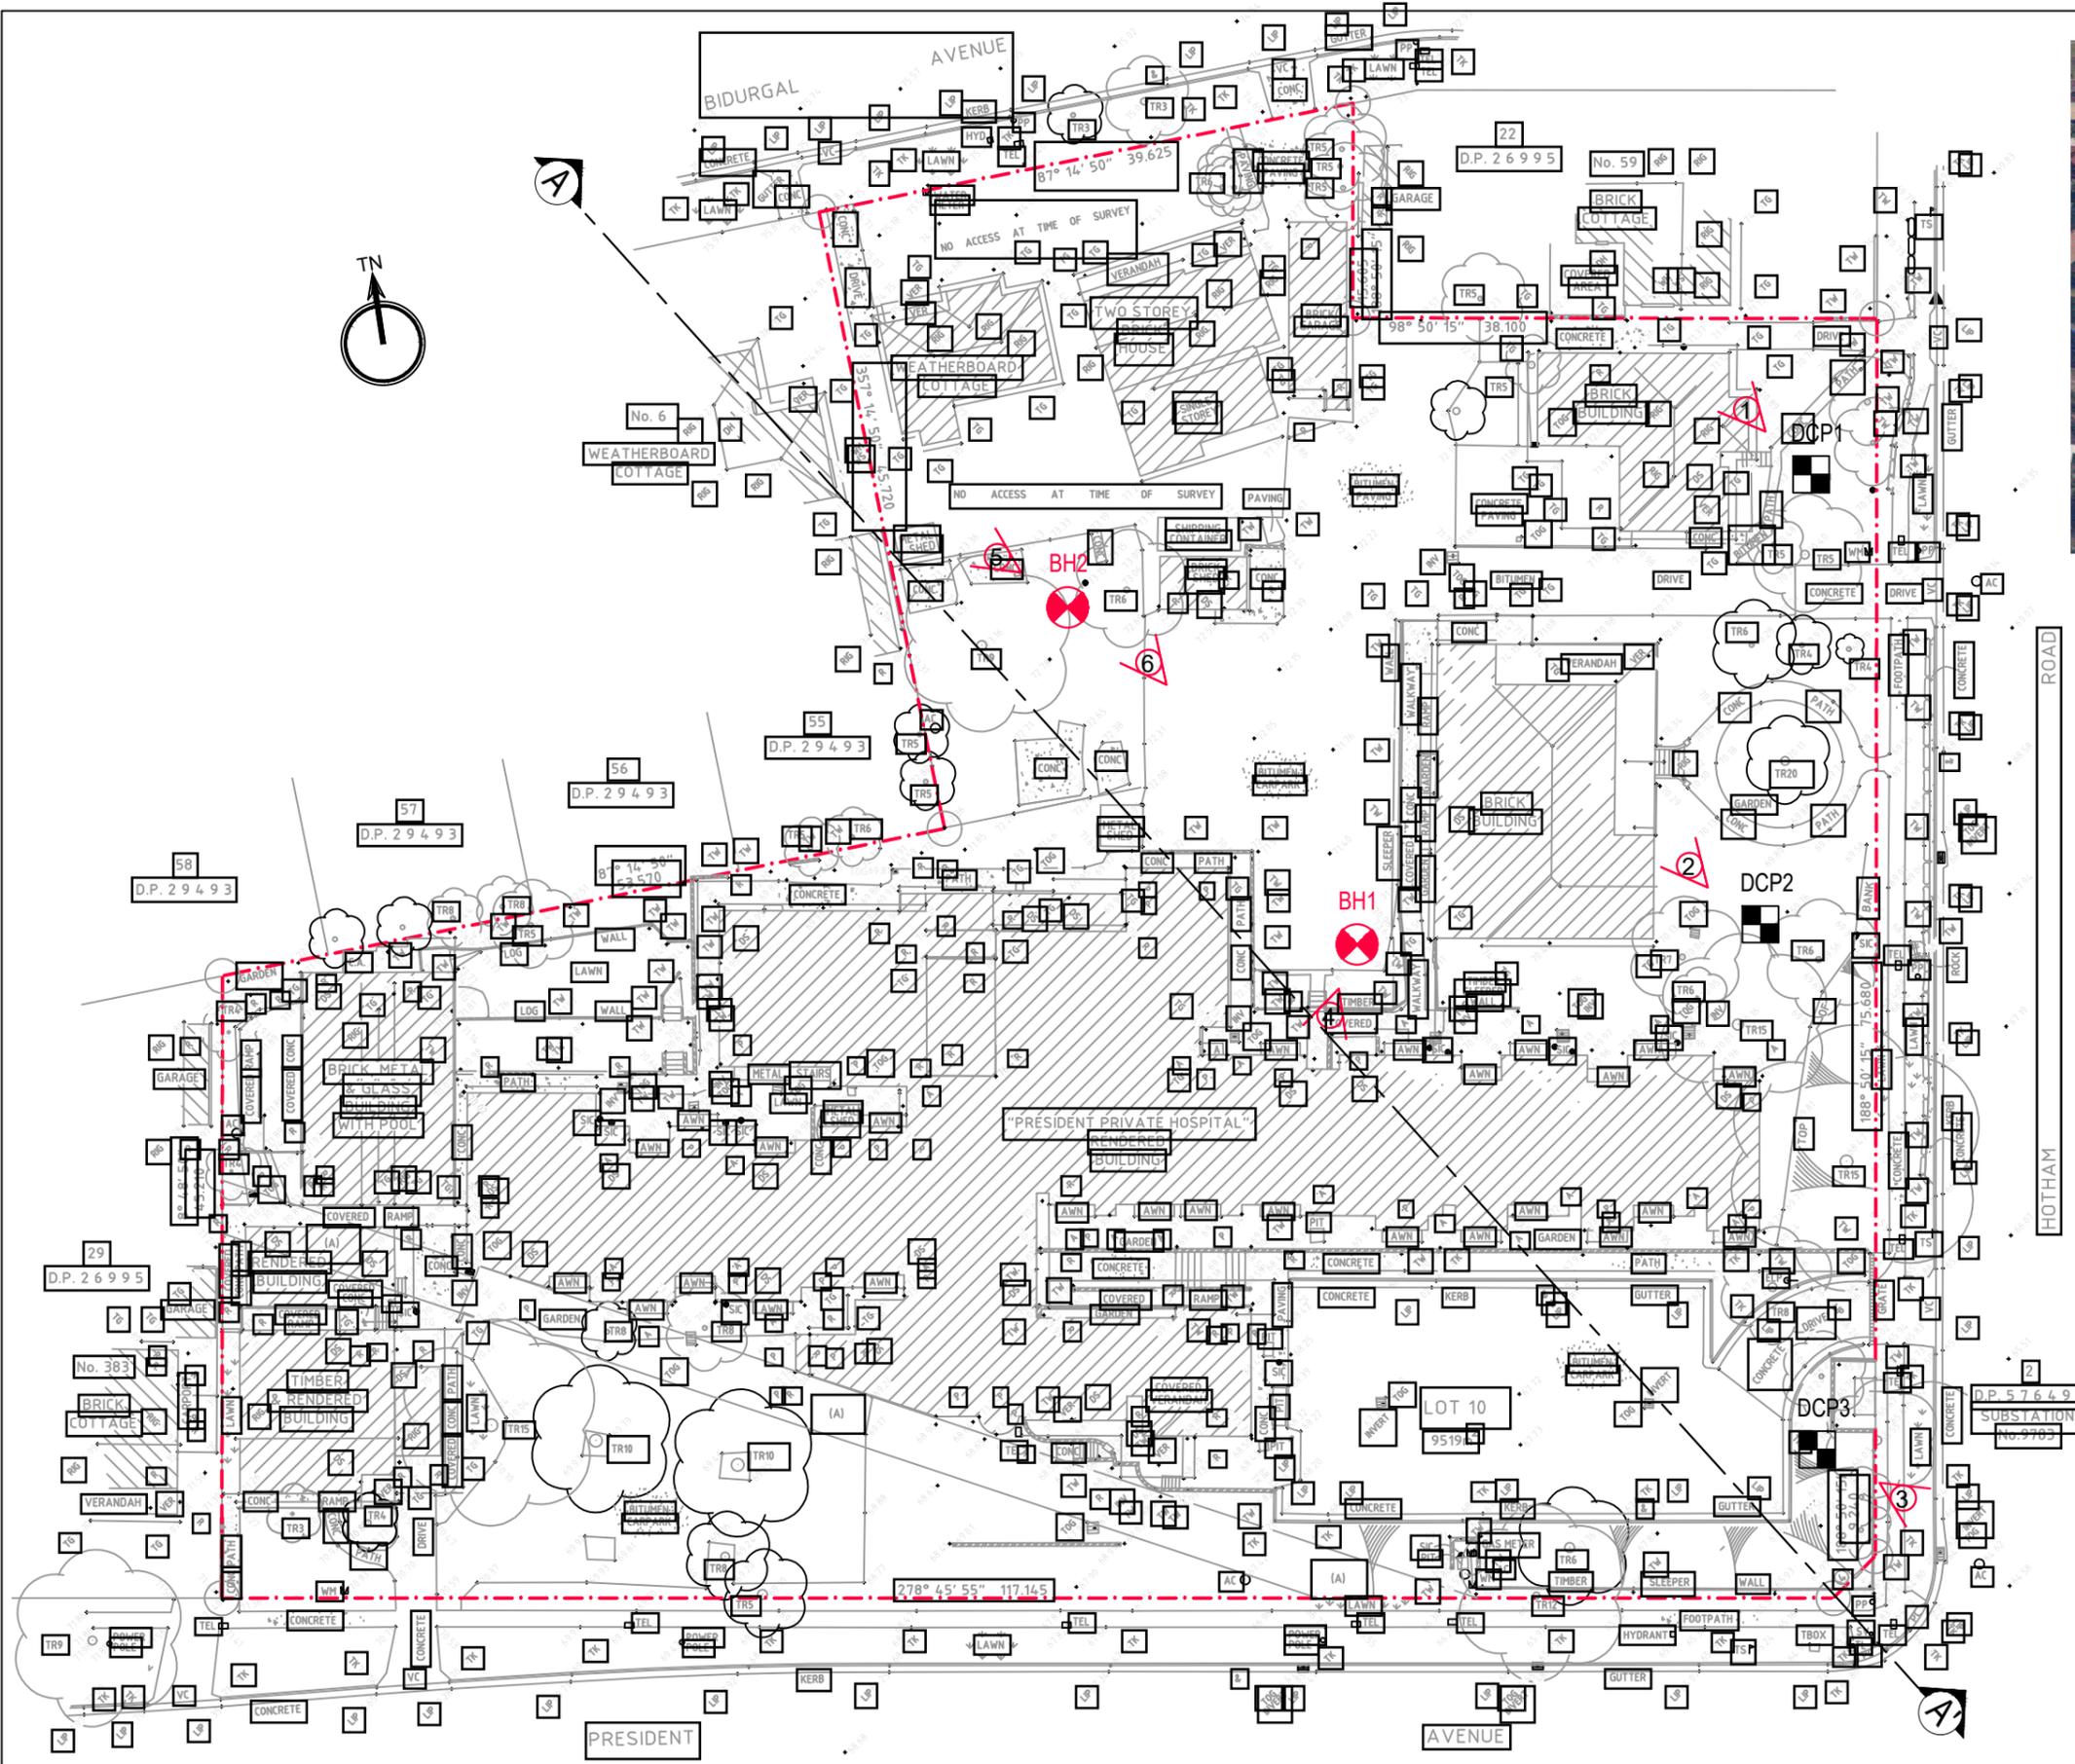
DCP tests, Boreholes & Photos Location Plan

This Drawing is Used to Illustrate
 Boreholes Location Only, and Must Not
 Be Used For Any Other Purpose,
 Copyright Of Source Drawing Remains
 REGISTERED SURVEYORS NSW

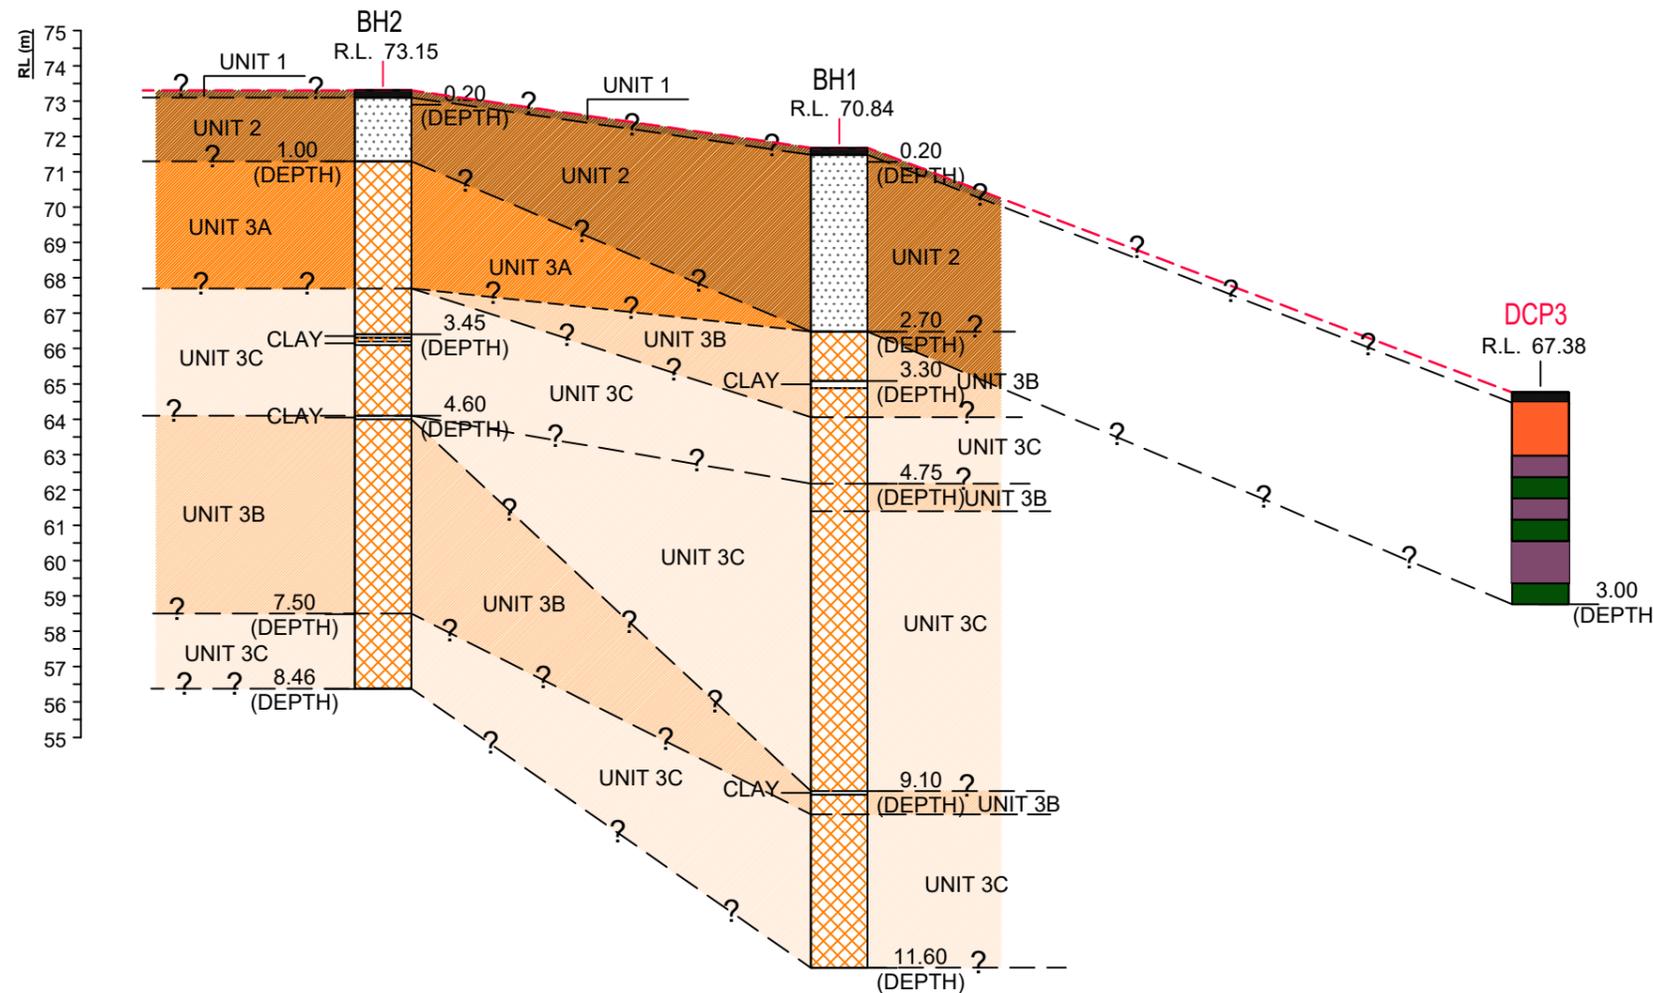
- UNIT 1 - TOP SOILS - SILTY SAND
- UNIT 2 - LOOSE TO VERY DENSE SAND
- UNIT 3A - SANDSTONE CL. V/IV
- UNIT 3B - SANDSTONE CL. III
- UNIT 3C - SANDSTONE - CL. III/I

The geotechnical cross sections presented are a result of a geotechnical interpretation and analyses at the Boreholes location carried only. An inferred correlation of geotechnical units limits between boreholes are carried directly. However, in between boreholes where boreholes were not carried those geotechnical units limits could change and vary. The present geotechnical cross section interpretation its only indicative.

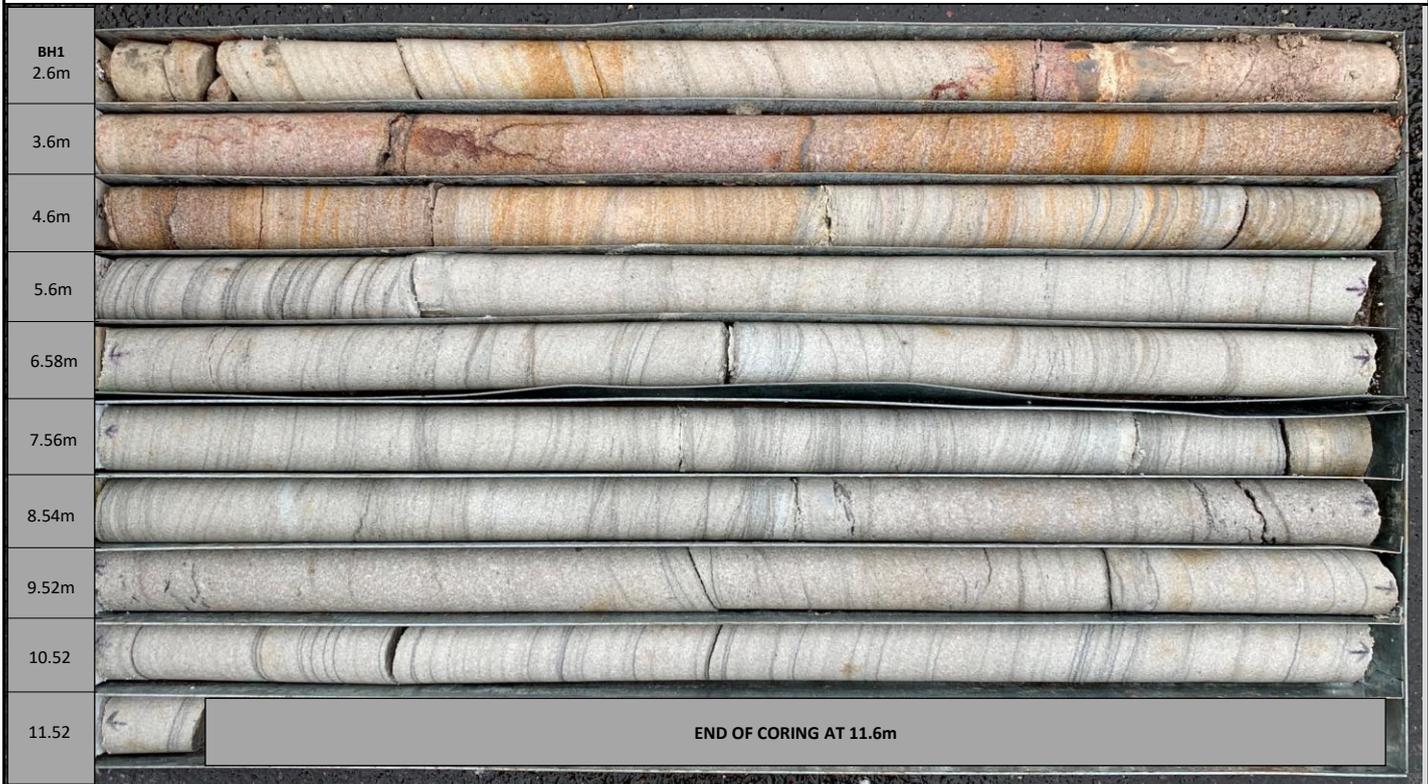
CLIENT:	PRESIDENT PRIVATE HOSPITAL	TITLE:	Rock Core Photograph
PROJECT:	ADDITIONS & ALTERATIONS TO PRESIDENT PRIVATE HOSPITAL	BOREHOLE NO:	BH1
ADDRESS:	369-381 PRESIDENT AVENUE, KIRRAWEE NSW 2232	SCALE:	NTS
PROJECT NO:	SRE/564/KW/20	DATE RECORDED:	29/05/2020

CORING STARTED AT 2.6m

CORING TERMINATED AT 11.6m

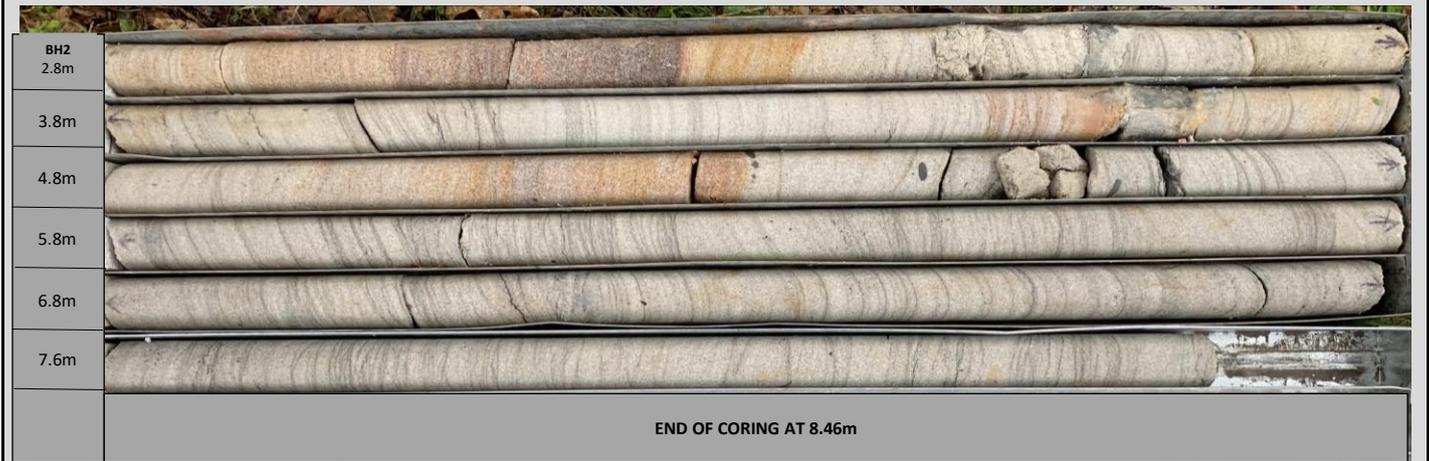
CLIENT:	PRESIDENT PRIVATE HOSPITAL	TITLE:	Rock Core Photograph
PROJECT:	ADDITIONS & ALTERATIONS TO PRESIDENT PRIVATE HOSPITAL	BOREHOLE NO:	BH2
ADDRESS:	369-381 PRESIDENT AVENUE, KIRRAWEE NSW 2232	SCALE:	NTS
PROJECT NO:	SRE/564/KW/20	DATE RECORDED:	29/05/2020

CORING STARTED AT 2.80m

CORING TERMINATED AT 8.46m

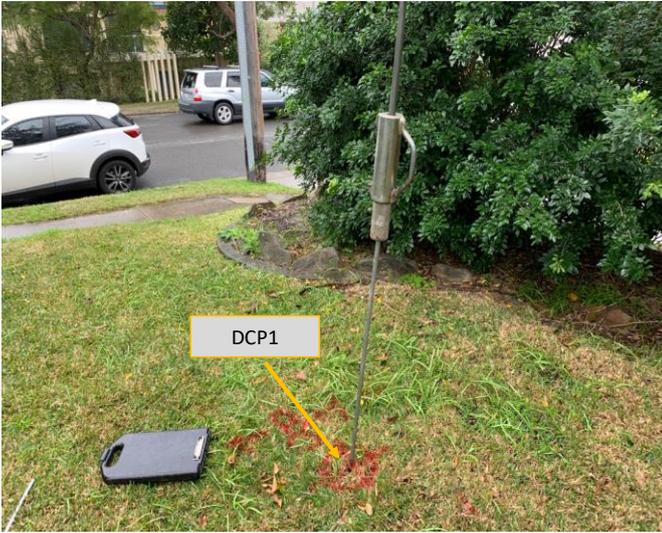
Photo 1 - South-East view to DCP1 test location.

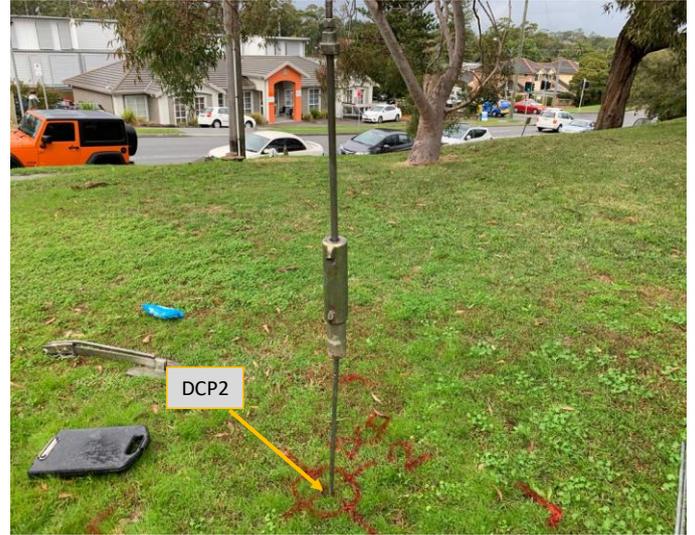
Photo 2 - South-East view to DCP2 test location.

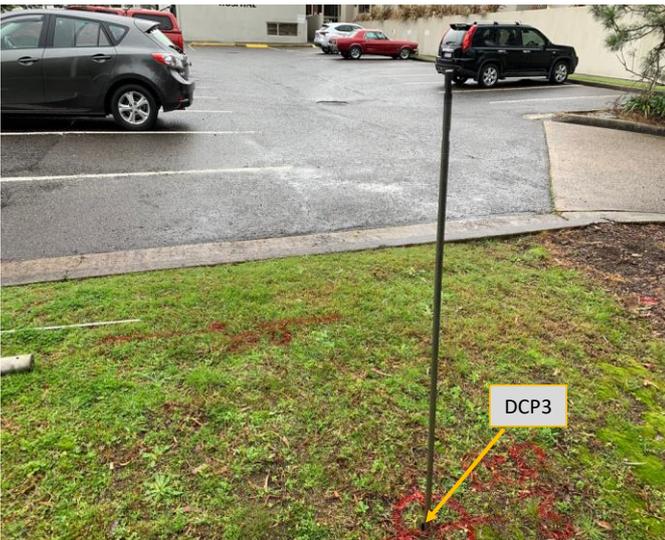
Photo 3 - North-East view to DCP3 test location.

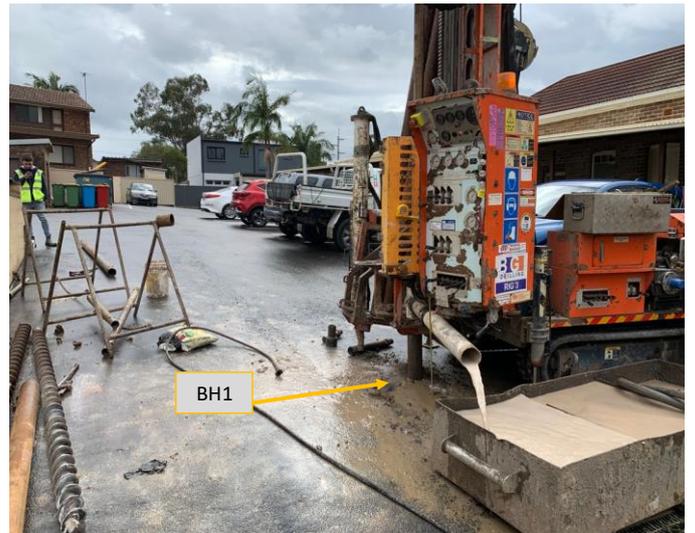
Photo 4 - North-East view to BH1 test location.

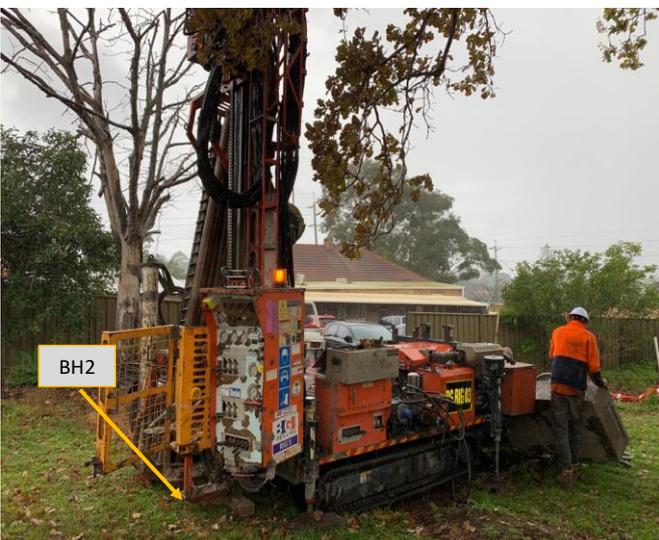
Photo 5 - South-East view to BH2 test location.
