PRESIDENT PRIVATE HOSPITAL ADDITIONS AND ALTERATIONS

THREATNED SPECIES REPORT As per BDAR Waiver SSD 103320 (Bats and other Mammals)

Inspection Date: 2 April 2020

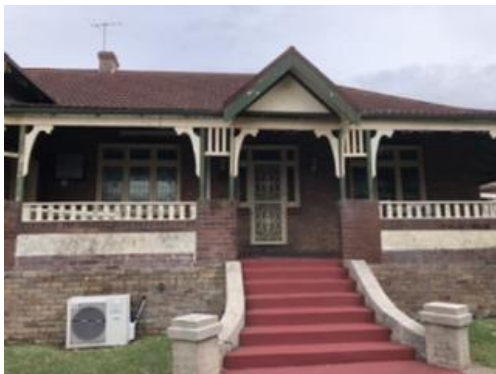
Photo 1 – Hotham House

Location:	Findings:
65 Hotham Road (Hotham House)	Findings- Visual Inspection 1 and 2 did not find any significant current animal activity. However, brush tail possum droppings were found throughout the roof cavity. The scat did not appear to be fresh or recent. The Thermal Inspection found no thermal signatures. The Baton XD did not locate any bat signals. The evidence suggests that currently no significant animal activity exists to Hotham House despite previous Brush Tail Possum activity.
63 Hotham Road (Administration Building)	Findings- Visual Inspection 1 and 2 did not find any significant current animal activity. The Thermal Inspection found no thermal signatures. The Baton XD did not locate any Bat signals. The evidence suggests that currently no significant animal activity to 63 Hotham – Administration Building.
Existing Hospital and Original Cottage (Rehab Centre)	Findings- Visual Inspection 1 and 2 did not find any significant current animal activity. However, brush tail possum droppings were found throughout the roof cavity. The scat did not appear to be fresh or recent. The Thermal Inspection found no thermal signatures. The Baton XD did not locate any bat signals. The evidence suggests that currently no significant animal activity exists to Existing Hospital and Original Cottage despite previous Brushtail possum activity.

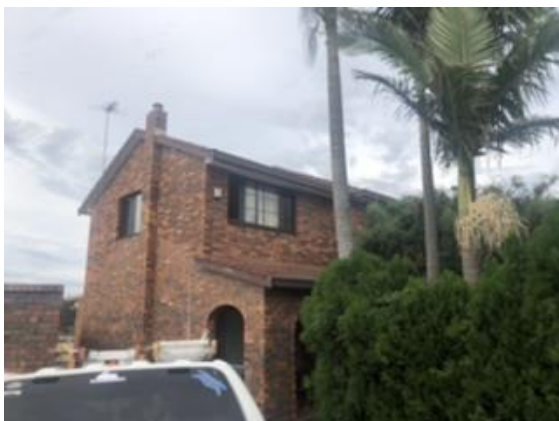
Photo 4 – Residential Building

2 Bidurgal Street (Existing Residential Dwelling)	<p>Findings- Visual Inspection 1 and 2 found a live Brushtail Possum residing in the roof cavity. Fresh scat also accompanied the observation. Both Thermal inspections found thermal signature in the shape of a brushtail possum. The Baton XD did not locate any bat signals. The inspection indicated that the rear eave of the structure had fallen away and is indicative of a potential entry point. The evidence clearly indicates the presents of a Brush Tail Possum to 2 Bidurgal Street.</p>

Brushtail Possum (*Trichosurus vulpecula*) currently inhabits the main dwelling at 2 Bidurgal Street. It is considered essential that at least 7-10 days before any proposed demolition of this building that a possum cage be used to trap and relocate the possum. As demolition is proposed re locating the possum outside regularly guidelines is strongly recommended.

If demolition is a considerable time away and the possum is trapped it is strongly recommended that the eave to the rear section of the dwelling is rectified. This will stop further entry or re- entry of the possum/s.

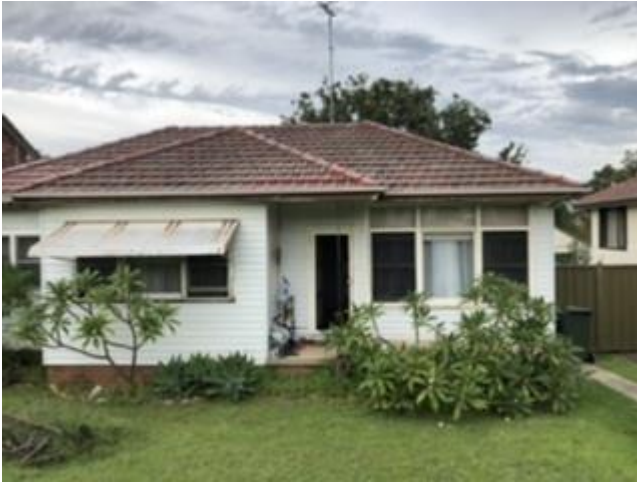
Photo 5 – Residential Building

<p>Photo 7 showing collapsed eave and entry point to the rear of 2 Bidurgal Street.</p>
<p>4 Bidurgal Street (Existing Residential Dwelling)</p>	<p>Findings- Visual Inspection 1 and 2 did not find any significant current animal activity. The Thermal Inspection found no thermal signatures. The Baton XD did not locate any Bat signals. The evidence suggests that currently no significant animal activity to 4 Bidurgal Street</p>

As situations can change rapidly and animals could inhabit dwellings overnight, it is recommended that an additional visual inspection of all premises is conducted no more than 7-10 days prior to scheduled demolition of any of the investigated dwellings.

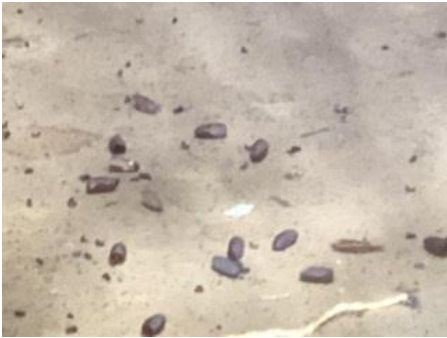
<p>Photo 6 showing fresh Brushtail Possum scat in roof cavity of 2 Bidurgal Street.</p>
