President Private Hospital
Remediation Action Plan

369-381 President Avenue
Kirrawee, NSW

28 October 2020

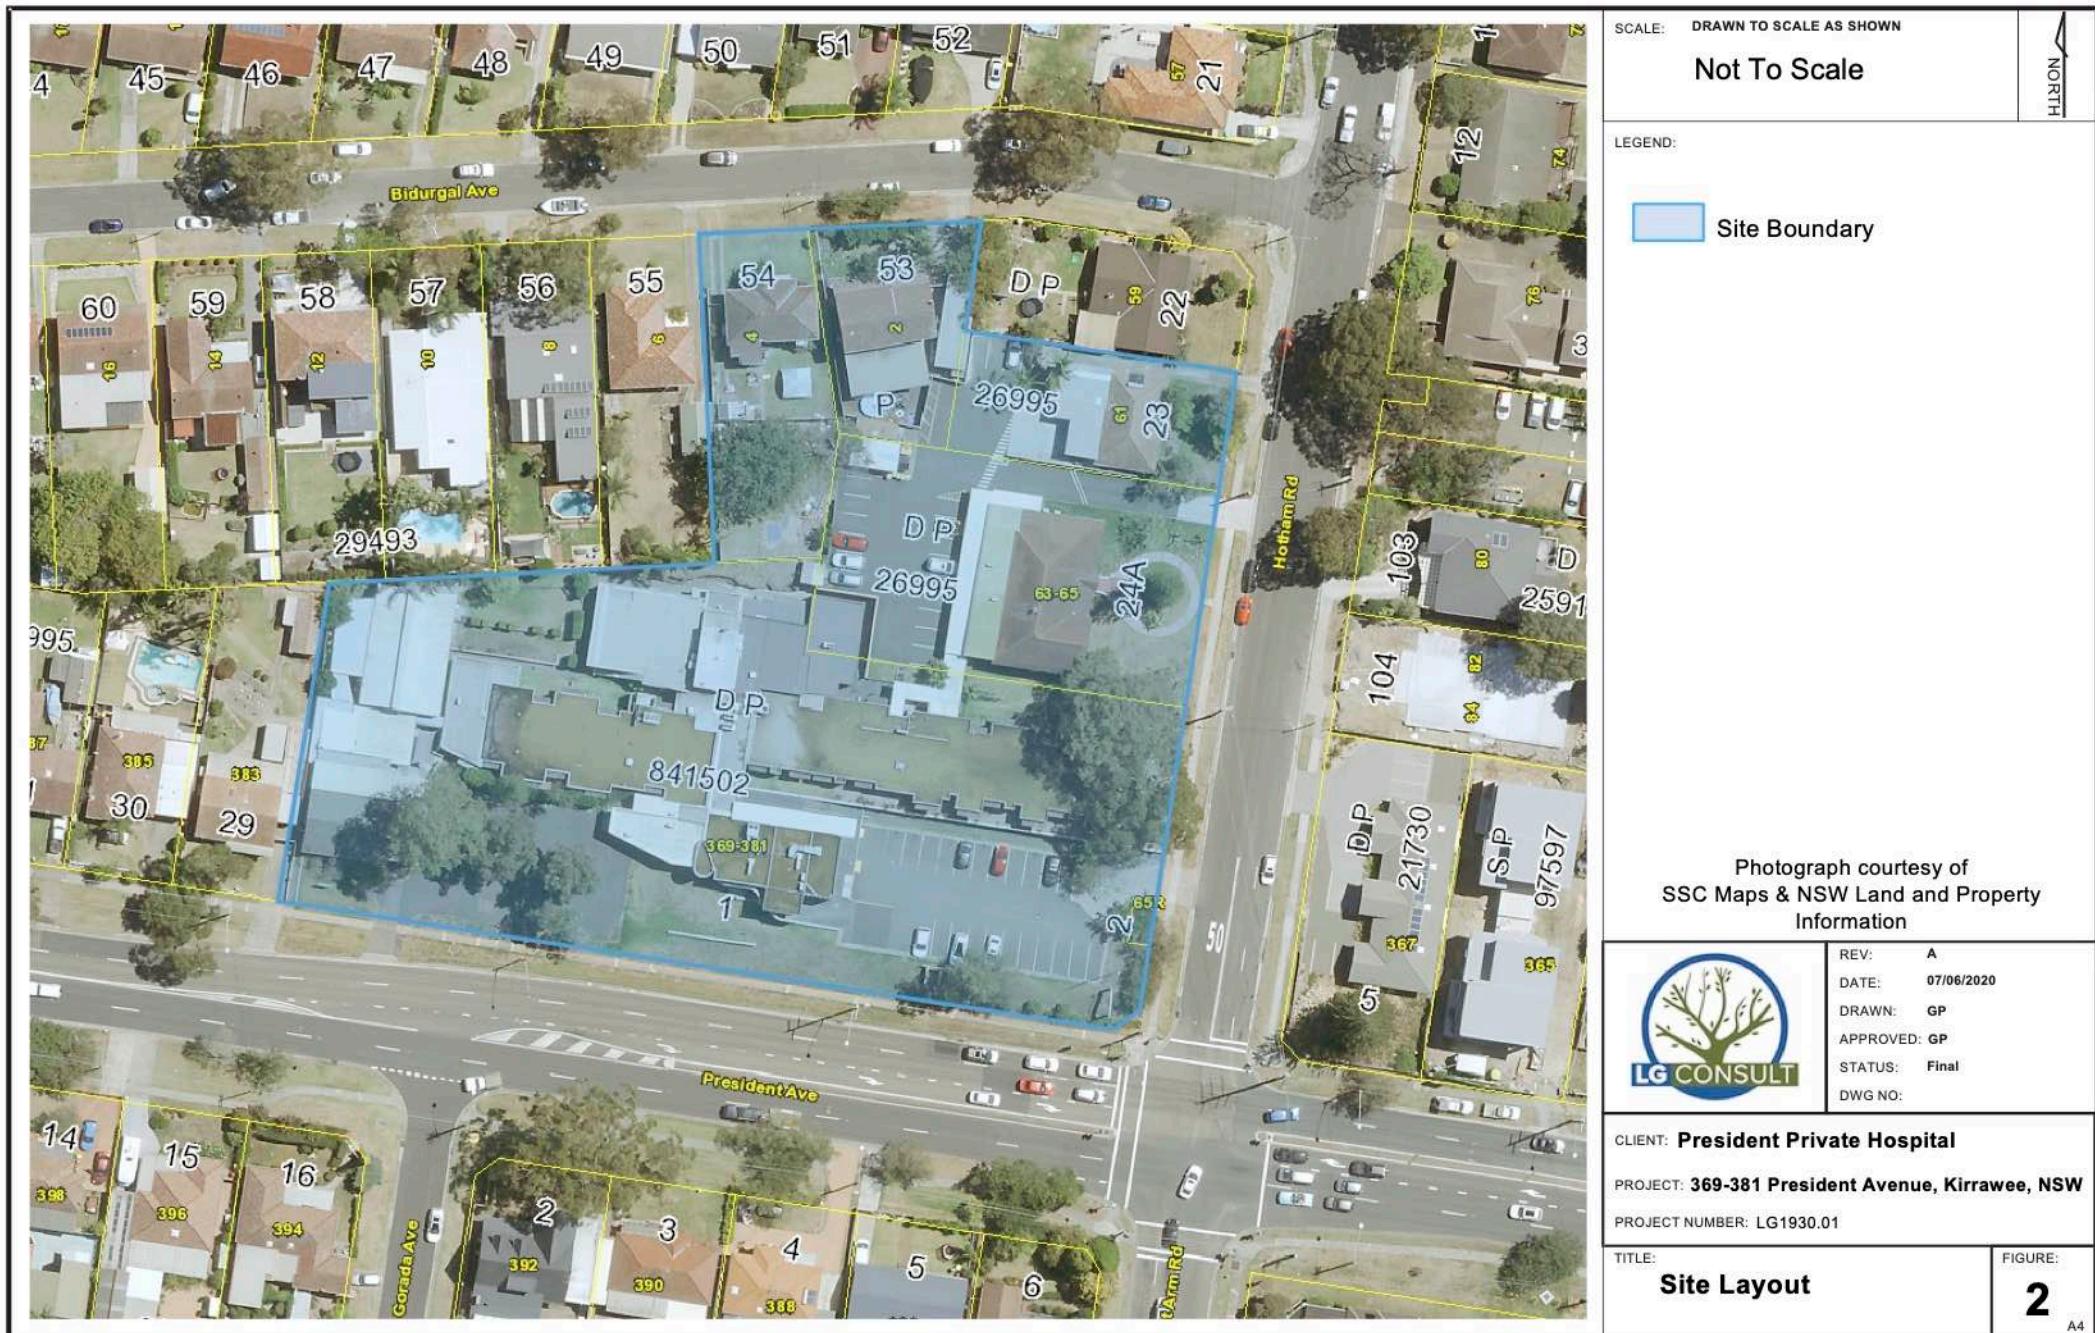
The site layout is presented in **Figure 2** and the site identification details are summarised in **Table 1**.

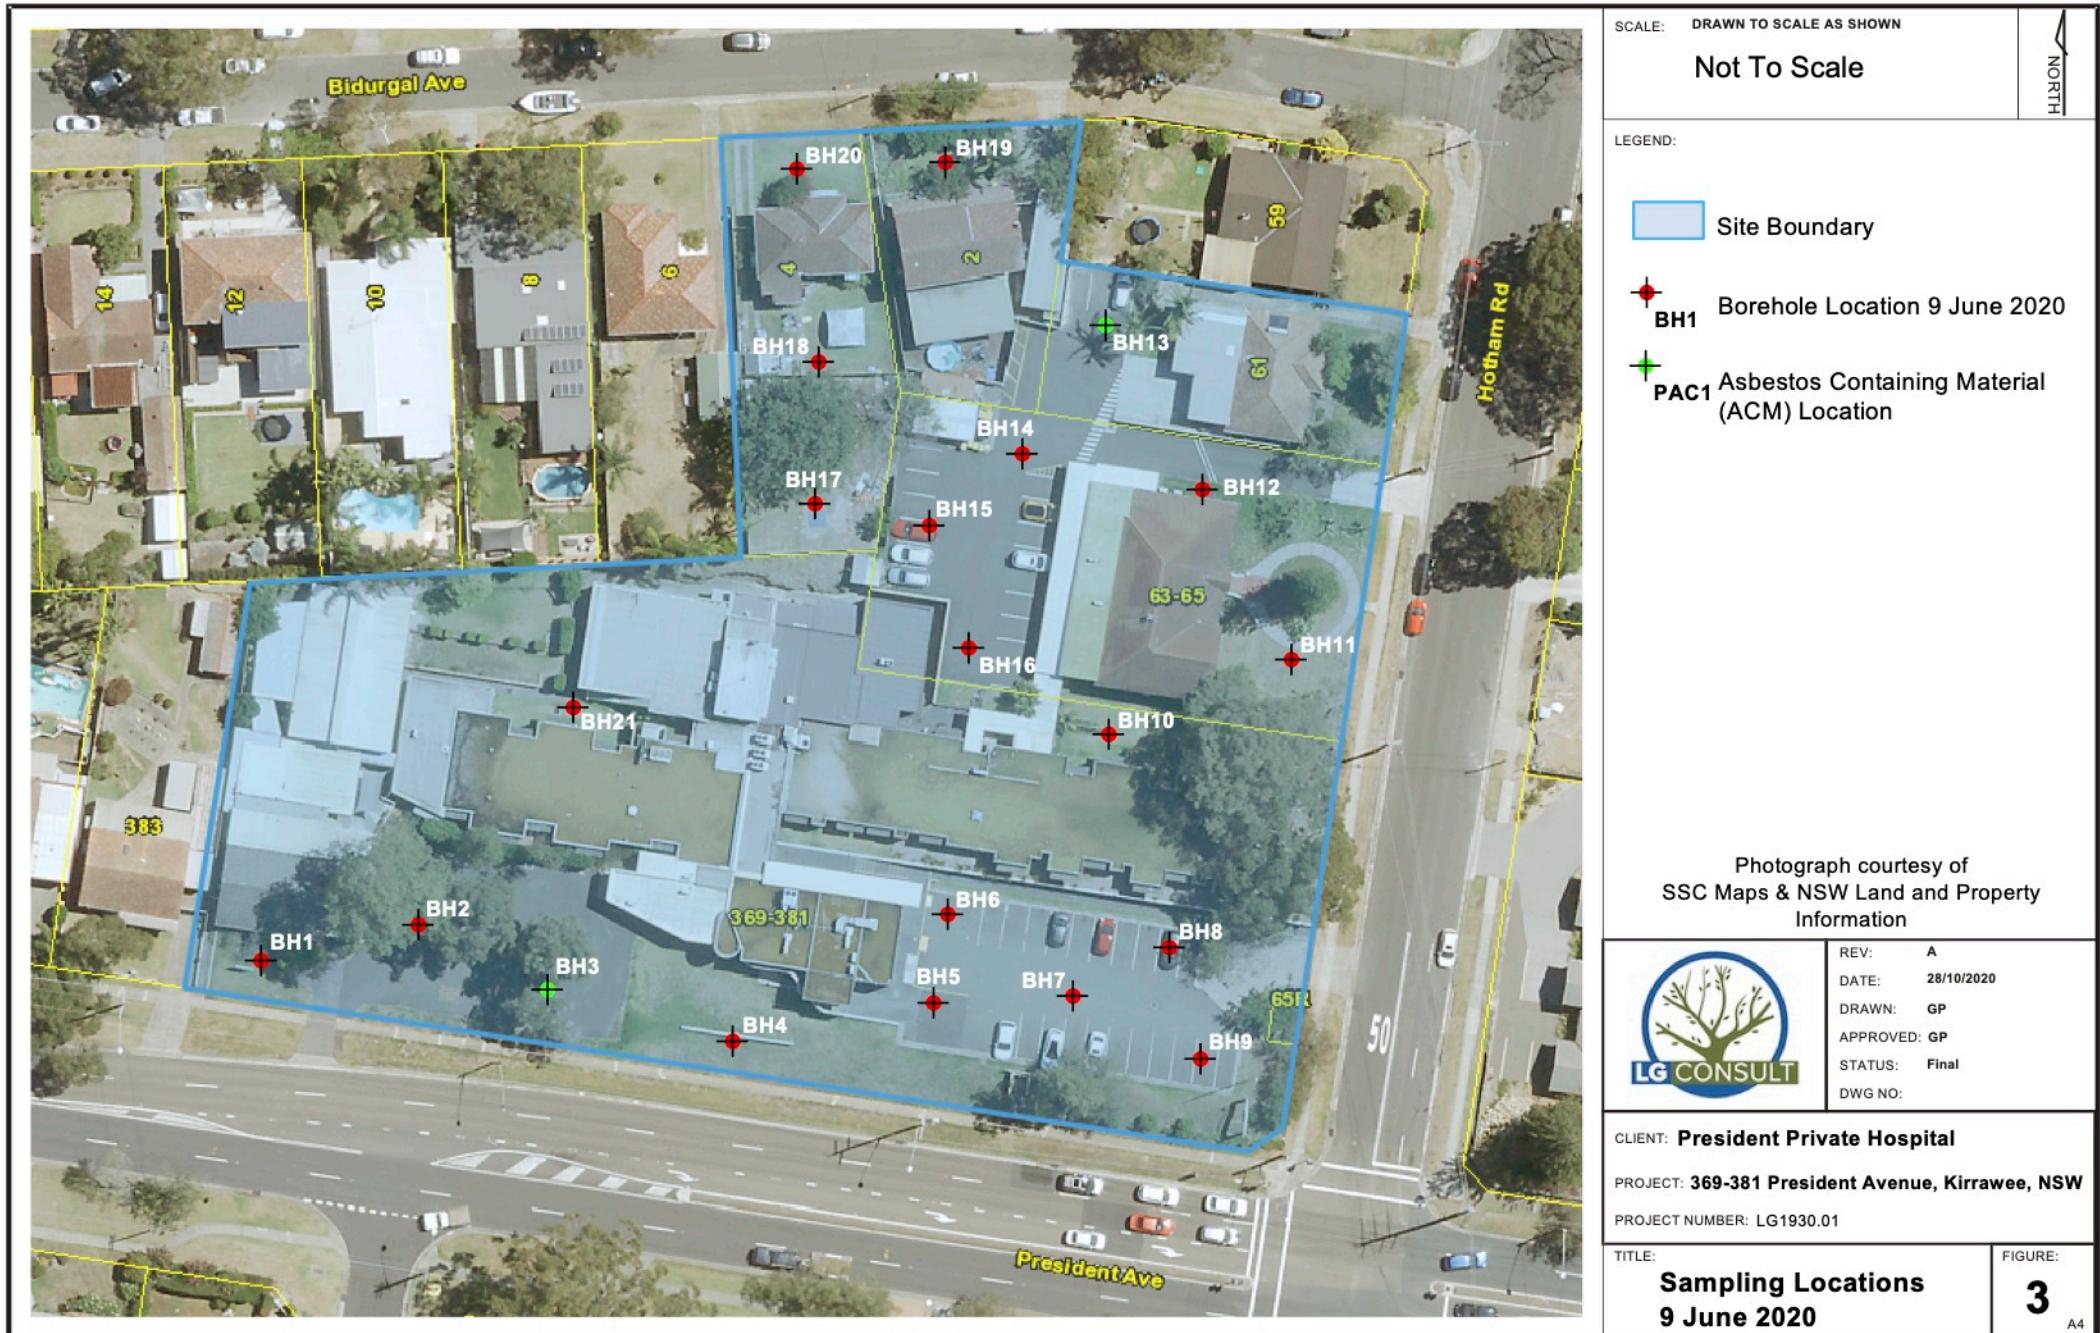
Soil sample locations are shown in **Figure 3**, and analytical results are summarised in **Table A** attached.

Excavation and removal of AF/FA impacted areas (AECs 1 and 2) estimated at approximately 9 m³ (refer to **Figure 3**), with approximate depths ranging 0.0 to 0.5 m bgs.

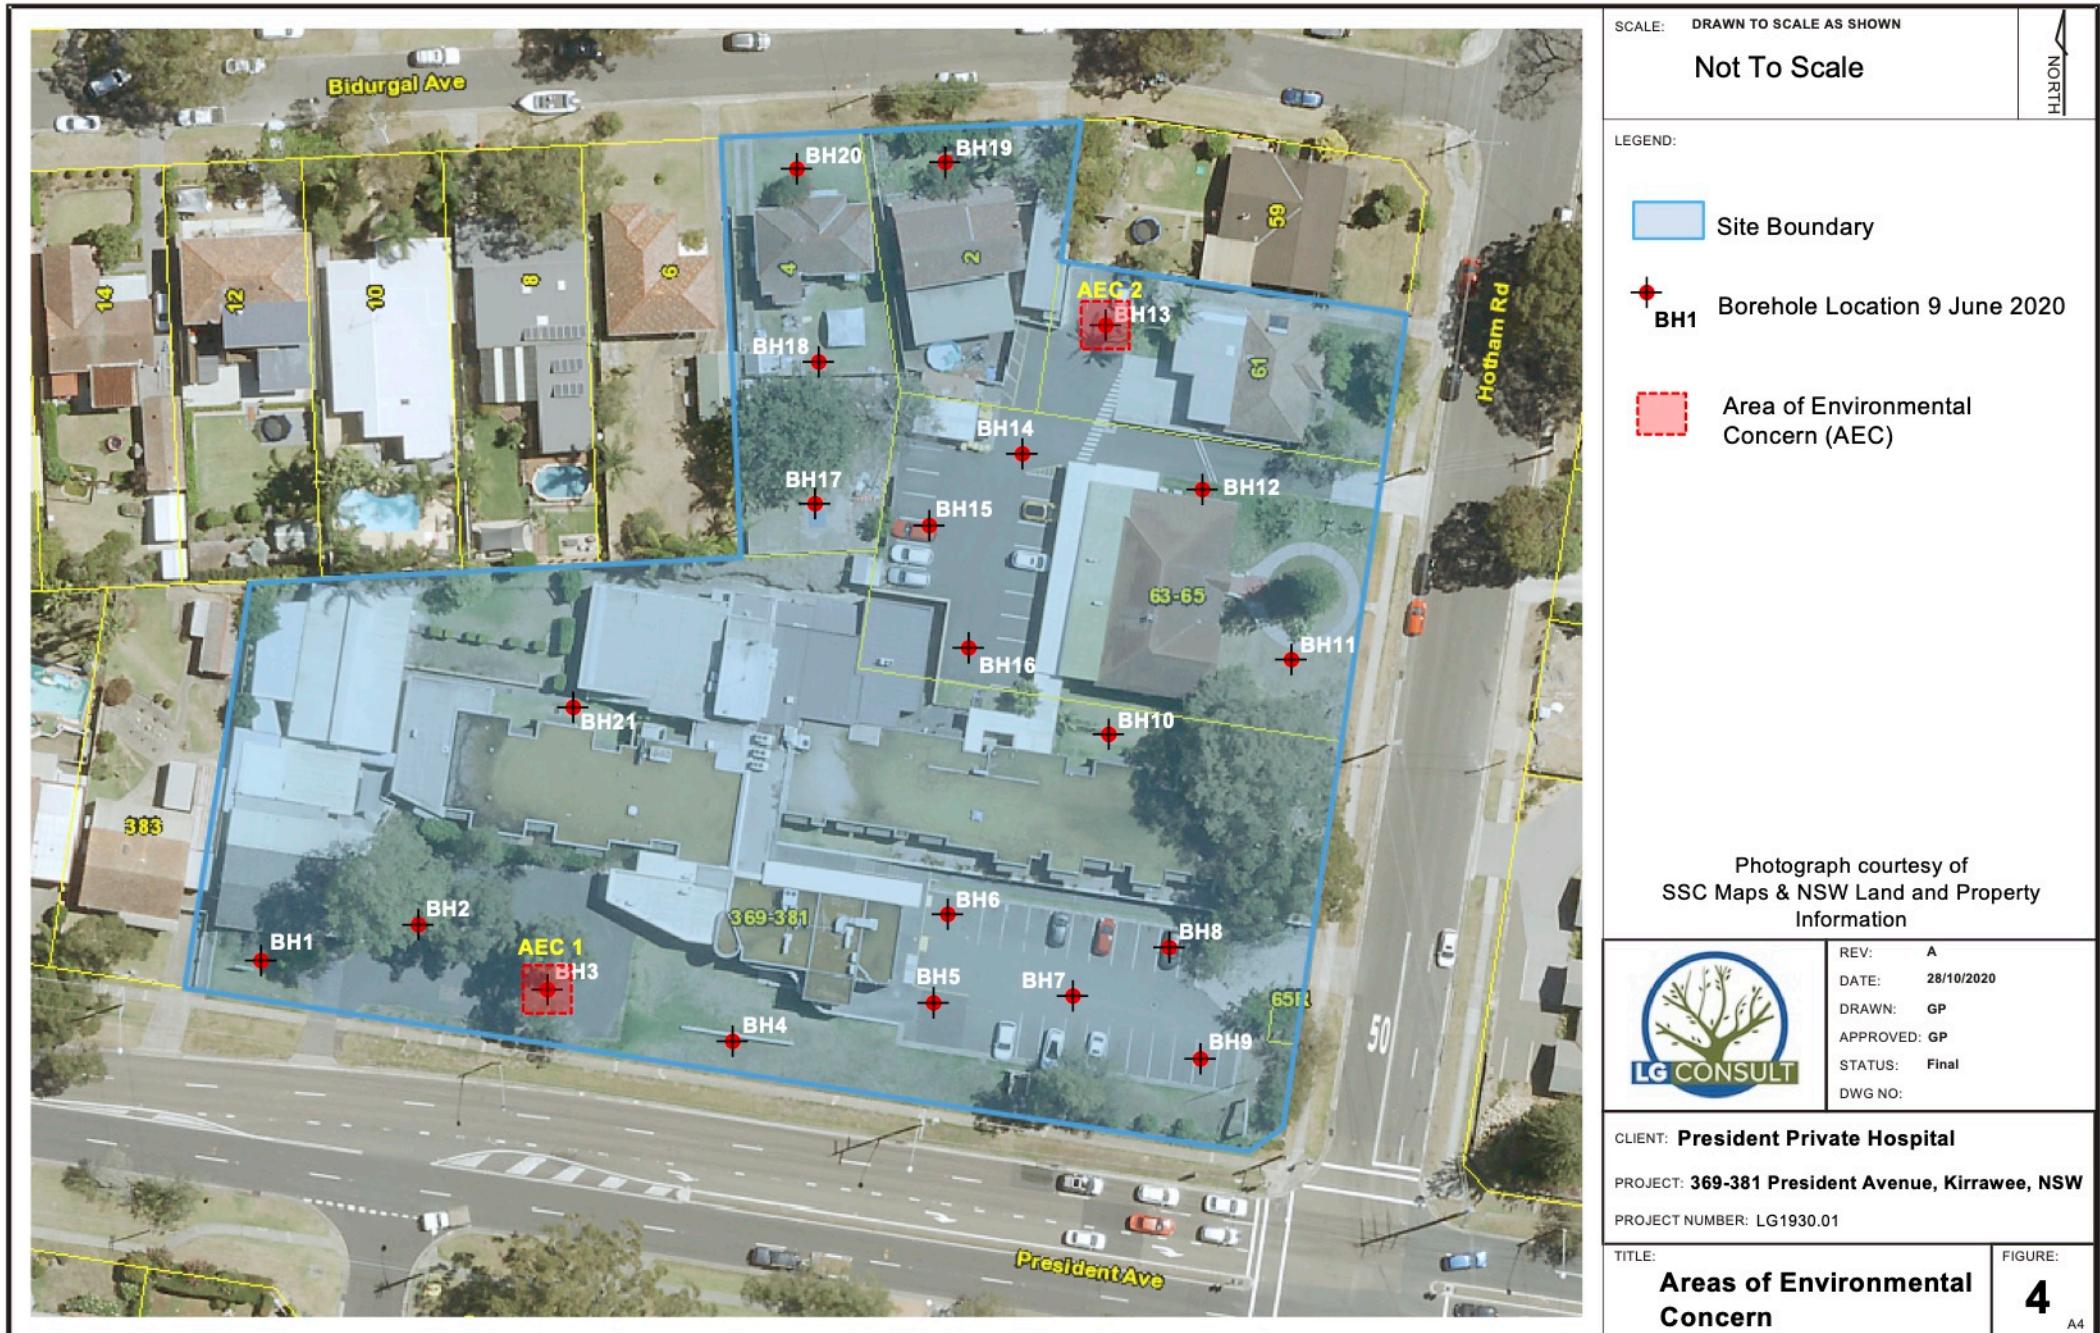
- Excavation and removal of asbestos impacted soils in the following areas of environmental concern (AEC) (refer **Figure 4**):
 - AEC 1 – Excavation and removal of asbestos impacted soils located at and around Asbestos Hotspots BH3/0.1-0.3; and
 - AEC 2 – Excavation and removal of asbestos impacted soils located at and around Asbestos Hotspots BH13/0.1-0.3.
