**ARBORICULTURAL IMPACT ASSESSMENT - DEVELOPMENT OF
NEW PRIMARY SCHOOL GOOGONG NSW - 2021.**

1. INTRODUCTION.

This ARBORICULTURAL IMPACT ASSESSMENT accompanies an Environmental Impact Statement (EIS) pursuant to Part 4 of the Environmental Planning and Assessment Act 1979 (EP&A Act) in support of an application for a State Significant Development (SSD-10326042).

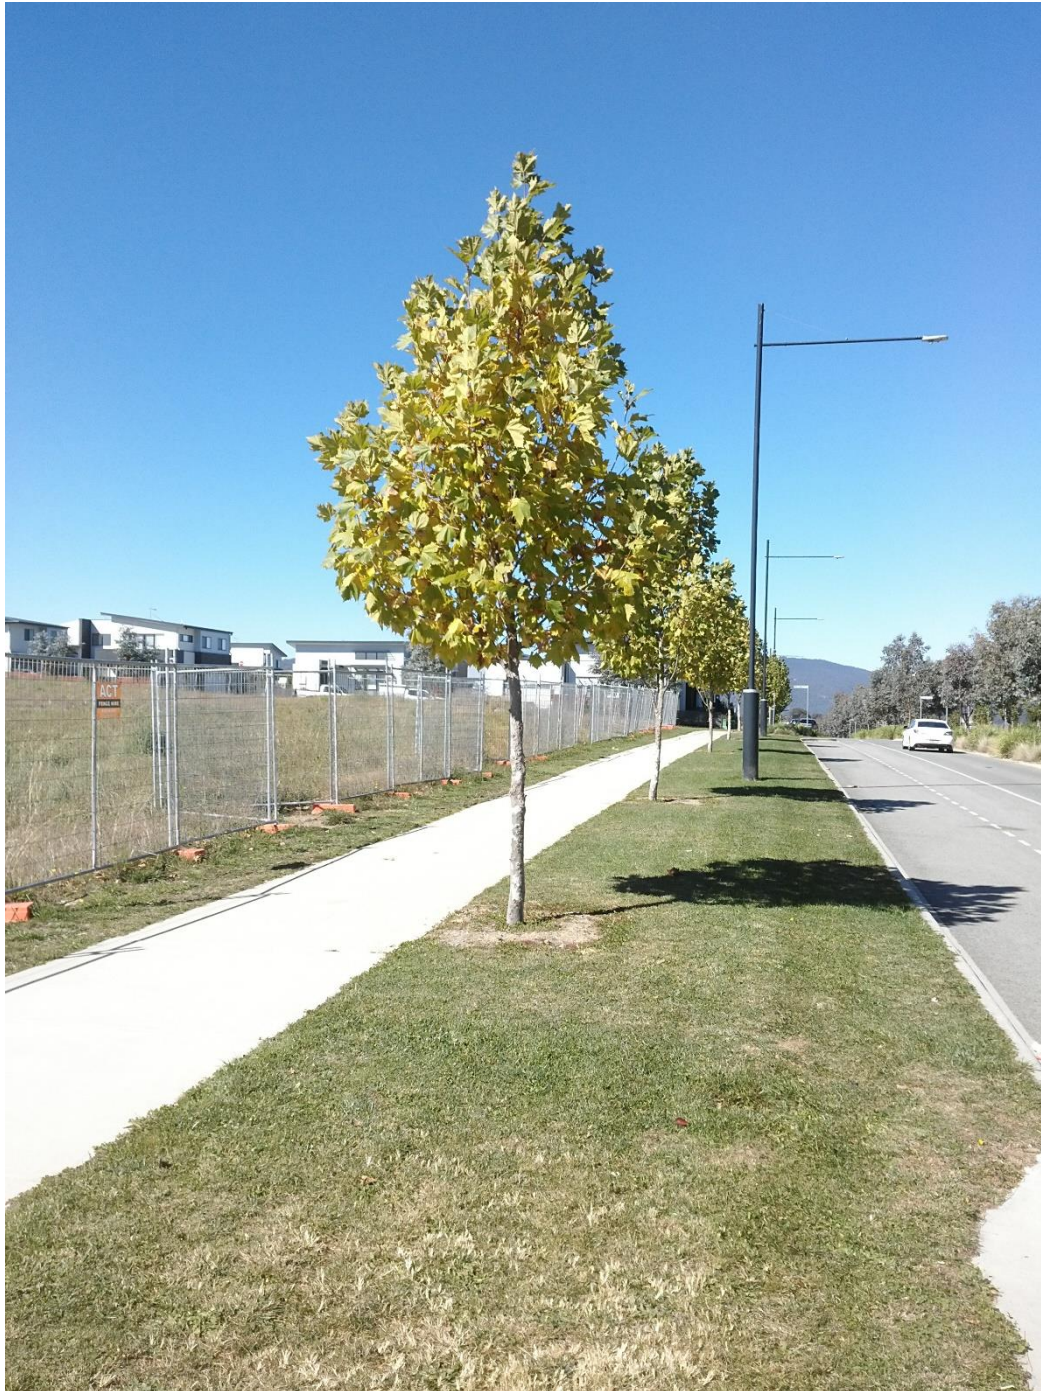
Photo 1 – Street verge of Gorman Drive – South boundary of development.

Young Platanus x acerifolia (Plane Trees) have been established by the local council. The Development site is delineated by the temporary fencing to the left of shot. Part of a line of 12 trees identified as impacted by development.

Table 1 – Identified Trees – Details and Impacts.	
Tree Details	Evaluation Potential Impacts & Recommendations.
<p><u>Council Trees in Gorman Drive.</u> Tree numbers 91, 92, 93, 94, 95, 96, 97, 98, 99, 143 In Sequence from McPhail Way to Wilkins Way</p> <p><u>10 Small <i>Platanus acerifolia</i> (London Plane).</u></p> <p>Species Exotic. Stems 70 to 100mm diameter. Height 6-8 meters. Canopy spread 2-3 meters. Condition and vigour Good to Excellent. Environmental Rating – Very Low. Expected useful life 40 years +.</p> <p>Tree Protection Zone (TPZ) 2m radially based on minimum area for a tree.</p>	<p>Trees present as sound young trees with long life expectancy. Council has invested time and resources to establish these trees to this point and would likely be keen to retain them.</p> <p><u>Recommendation - Retain and protect if possible.</u></p> <ul style="list-style-type: none"> General impacts to the canopy or stem from development – site access - movement/storage of plant and materials. As per supplied drawings the kerb realignment in Gorman Drive will directly impact trees numbered 92, 93, 94, 95, 96, 97, 98, and 99. <p><u>Recommendations.</u></p> <ol style="list-style-type: none"> If these trees are not outside the development fencing then erect fences around each tree so that at least 2m radially is provided for each tree. The kerb realignment is required to come up to the stems of the tree above and the trees will be required to be removed and replaced. <ol style="list-style-type: none"> An impact to the TPZ of 0.5m on the south side only would considered an acceptable impact, however remedial actions will likely be required. IF this is to occur then the trees will require further assessment from Level 5 Arborist to determine specific remedial actions.

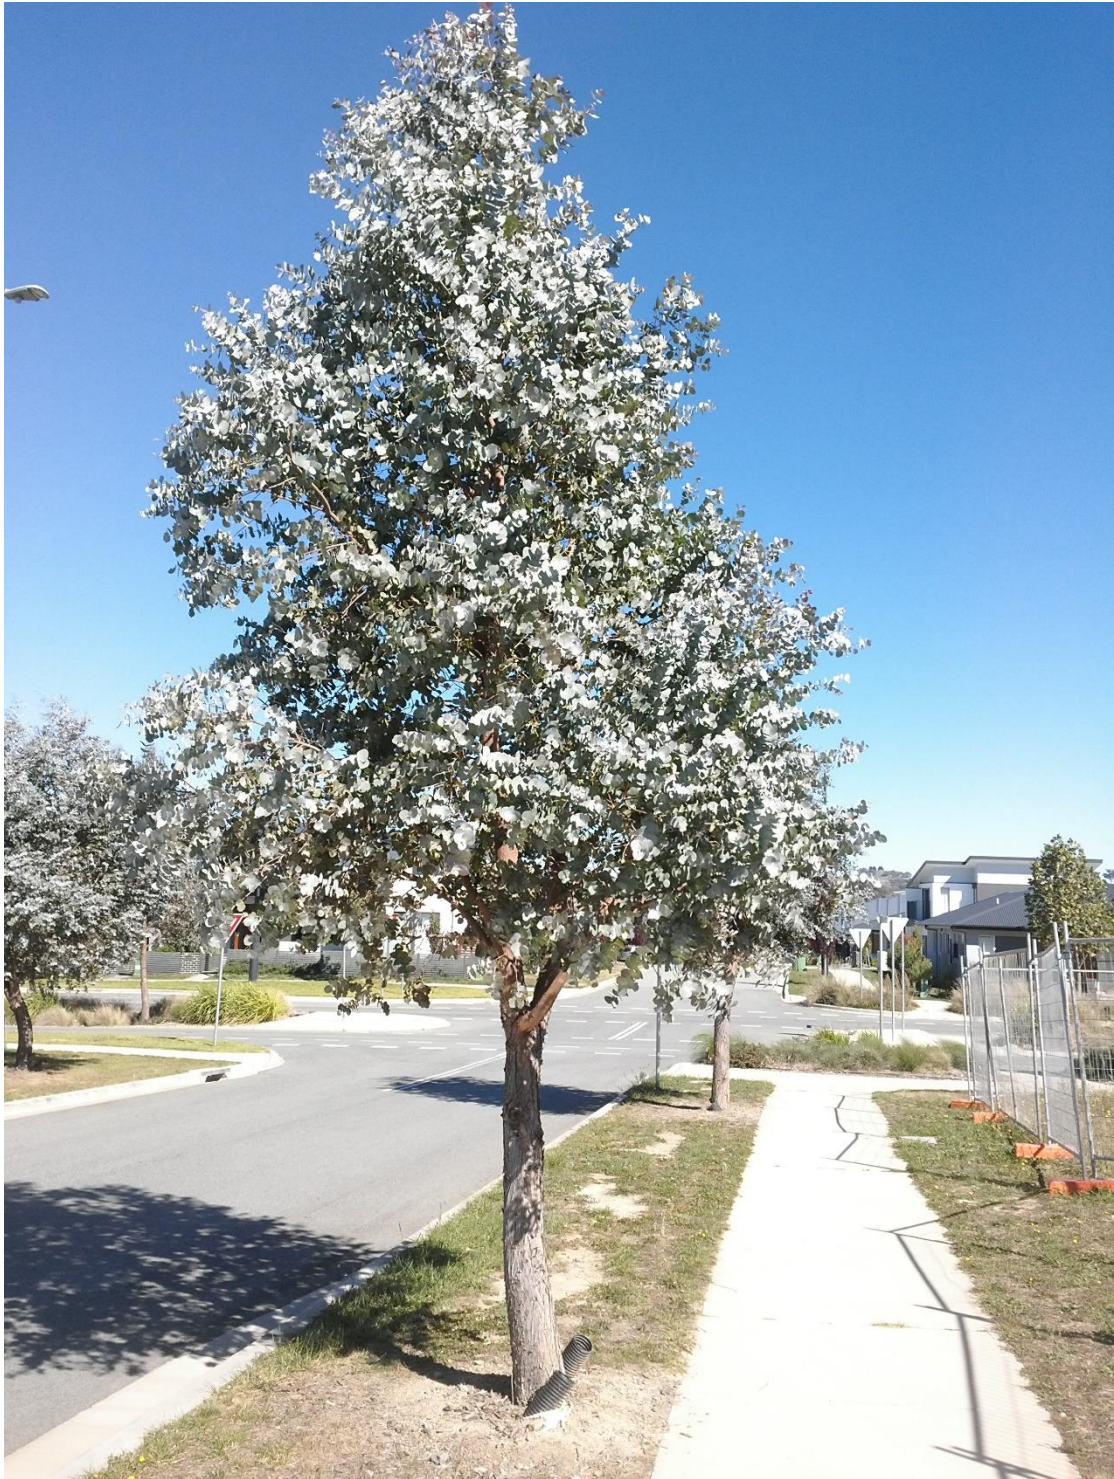
Photo 2 – Street verge of Wilkins Way – East boundary of development.

Young Eucalyptus cinerea (Argyle Apple) have been established by the local council. The Development site is delineated by the temporary fencing to the right of shot. Part of a line of 25 trees identified as potentially impacted by development.

<p><u>Council Trees in Wilkins Way.</u> Tree numbers 34, 35, 41, 42, 43, 44, 45, 46, 47, 48, 49, 50, 51, 52, 53, 55, 57, 70, 79, 25, 29, 33, 40, 54, 64, 62, 24. In sequence from Gorman Drive to Aprasia Avenue.</p> <p><u>25 Small <i>Eucalyptus cinerea</i> (Argyle Apple)</u></p> <p>Species endemic to immediate area. Stem diameters 70mm to 100mm. Heights 3-7 meters, canopy spread 2-3 meters. Trees described as in good to excellent condition and vigour. Environmental Rating – Low. Expected useful life 40 years +.</p> <p>Tree Protection Zone (TPZ) 2m radially based on minimum area for a tree.</p>	<p>Trees present as sound young trees with long life expectancy. Council has invested time and resources to establish these trees to this point and would likely be keen to retain them.</p> <p><u>Recommendation - Retain and protect if possible.</u></p> <ul style="list-style-type: none"> General impacts to the canopy or stem from development – site access movement/storage of plant and materials. <p><u>Recommendations.</u></p> <ol style="list-style-type: none"> If these trees are not outside the development fencing then erect fences around each tree so that at least 2m radially is provided for each tree.

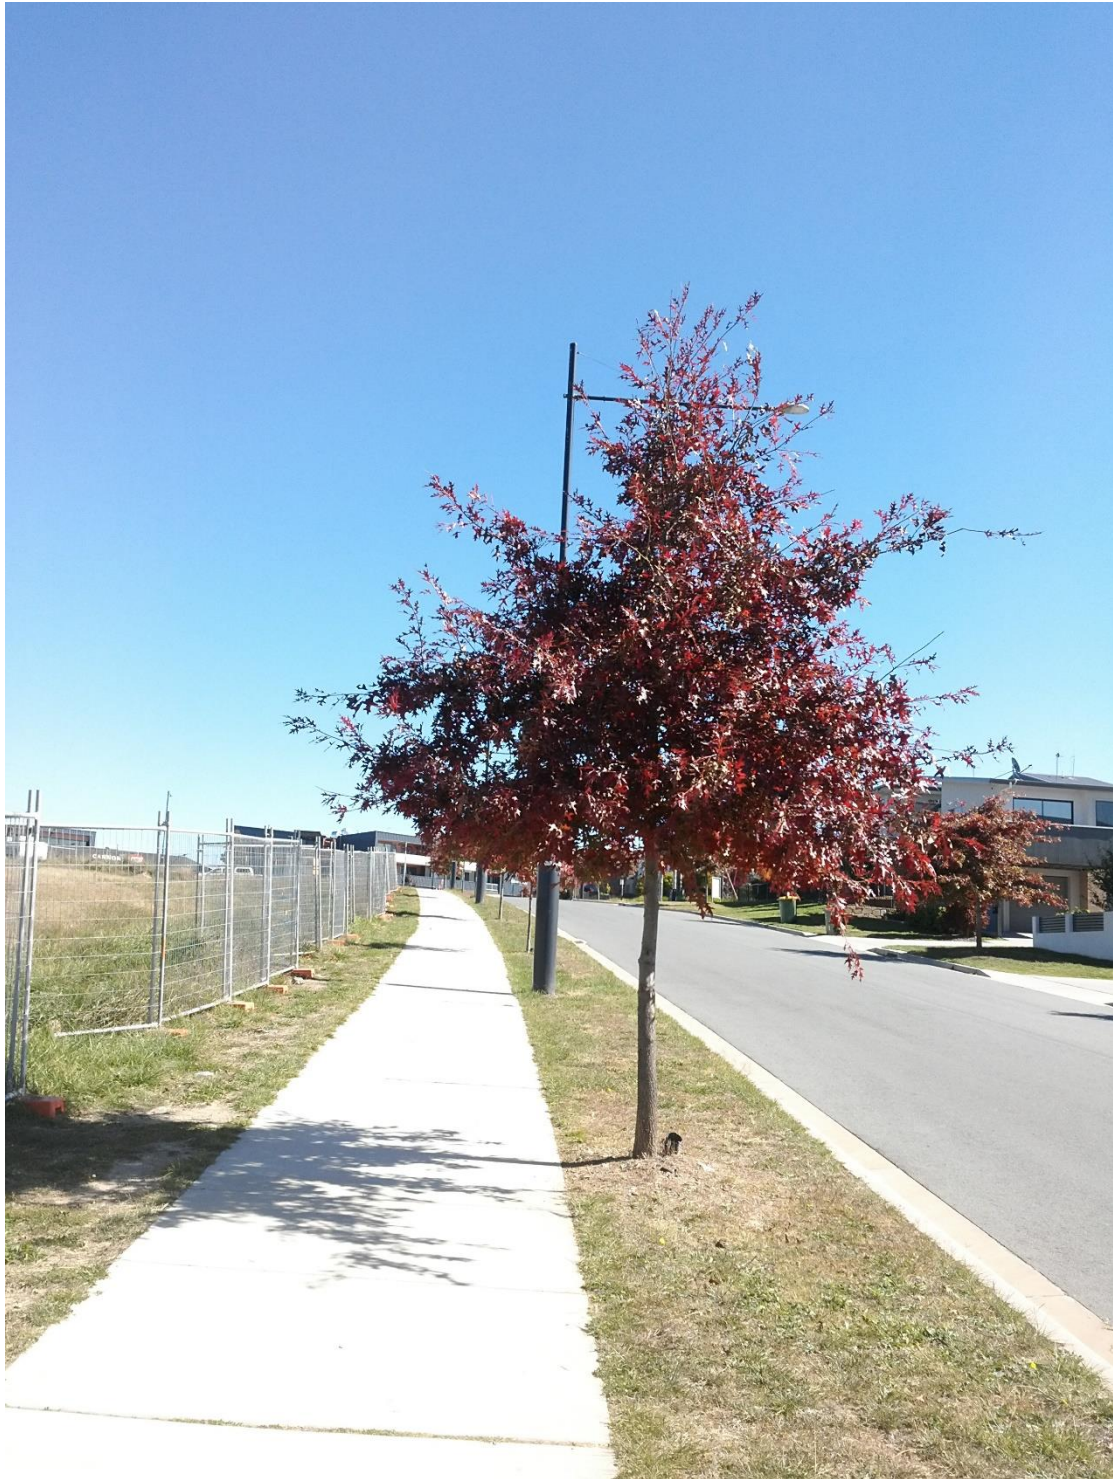
Photo – Street verge of Aprasia Avenue – north boundary of development.
Young Quercus palustris (Pin Oak) have been established by the local council. The Development site is delineated by the temporary fencing to the left of shot. Part of a line of 10 trees identified as impacted by development.

<p><u>Council Trees in Aprasia Way.</u> Tree numbers 12, 8, 5, 4, 3, 19, 18, 17, 11, and 9. In sequence from Wilkins Way to McPhail Way.</p> <p>10 small <i>Quercus palustris</i> (Pin Oak). Exotic Species. Stem diameters 50 to 100mm. Heights 4 to 6m canopy spread 2-3 meters. Condition and vigour good to excellent. Environmental Rating – Very Low. Expected Remaining useful life 40 years +. Tree Protection Zone (TPZ) 2m radially based on minimum area for a tree.</p>	<p>Trees present as sound young trees with long life expectancy. Council has invested time and resources to establish these trees to this point and would likely be keen to retain them.</p> <p><u>Recommendation - Retain and protect if possible.</u></p> <ul style="list-style-type: none"> • General impacts to the canopy or stem from development – site access movement/storage of plant and materials. • As per supplied drawings the kerb realignment in Aprasia Avenue will directly impact trees numbered 8, 5, 4, 3, 19, 18, & 17. • Kerb realignment may impact trees 12 and 11. <p><u>Recommendations.</u></p> <ol style="list-style-type: none"> 4. If the kerb is to be realigned then trees listed above 8, 5, 4, 3, 19, 18, 17, will require removal and replacement. 5. Any trees in the line not to be removed should have fencing erected at least 2m from the stem for protection for impacts to the trees.

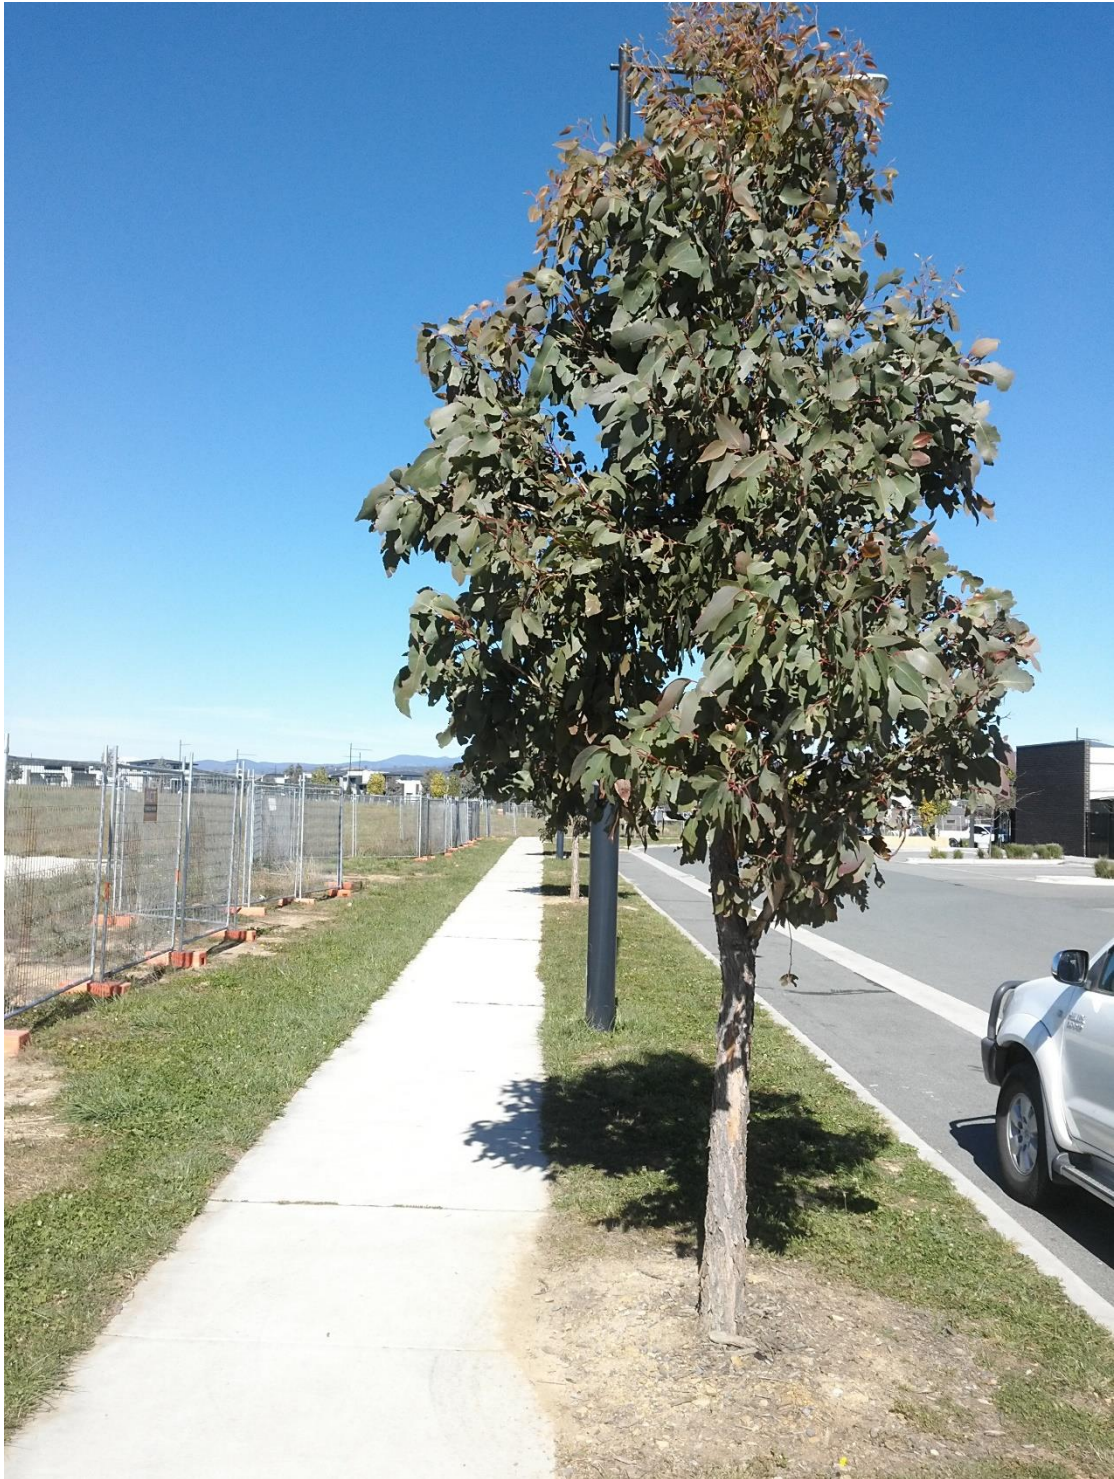
Photo 4 – Street verge of McPhail Way – west boundary of development.

Young Eucalyptus species (not identified to species) have been established by the local council. The Development site is delineated by the temporary fencing to the left of shot. Part of a line of 6 trees identified as potentially impacted by development.

<p><u>Council Trees in McPhail Way.</u> Tree numbers 140, 141, 142, 132, 131, and 128. In sequence from Aprasia Way to Gorman Drive.</p> <p>6 <i>Eucalyptus species</i> (unidentified species)</p> <p>Species may be endemic to immediate area or as a minimum Australian Native. Stem diameters 70mm to 100mm. Heights 3-7 meters, canopy spread 2-3 meters. Trees described as in good to excellent condition and vigour. Environmental Rating – Low. Expected useful life 40 years +. Tree Protection Zone (TPZ) 2m radially based on minimum area for a tree.</p>	<p>Trees present as sound young trees with long life expectancy. Council has invested time and resources to establish these trees to this point and would likely be keen to retain them.</p> <p><u>Recommendation - Retain and protect if possible.</u></p> <ul style="list-style-type: none"> • General impacts to the canopy or stem from development – site access movement/storage of plant and materials. <p><u>Recommendations.</u></p> <ol style="list-style-type: none"> 6. If these trees are not outside the development fencing then erect fences around each tree so that at least 2m radially is provided for each tree.

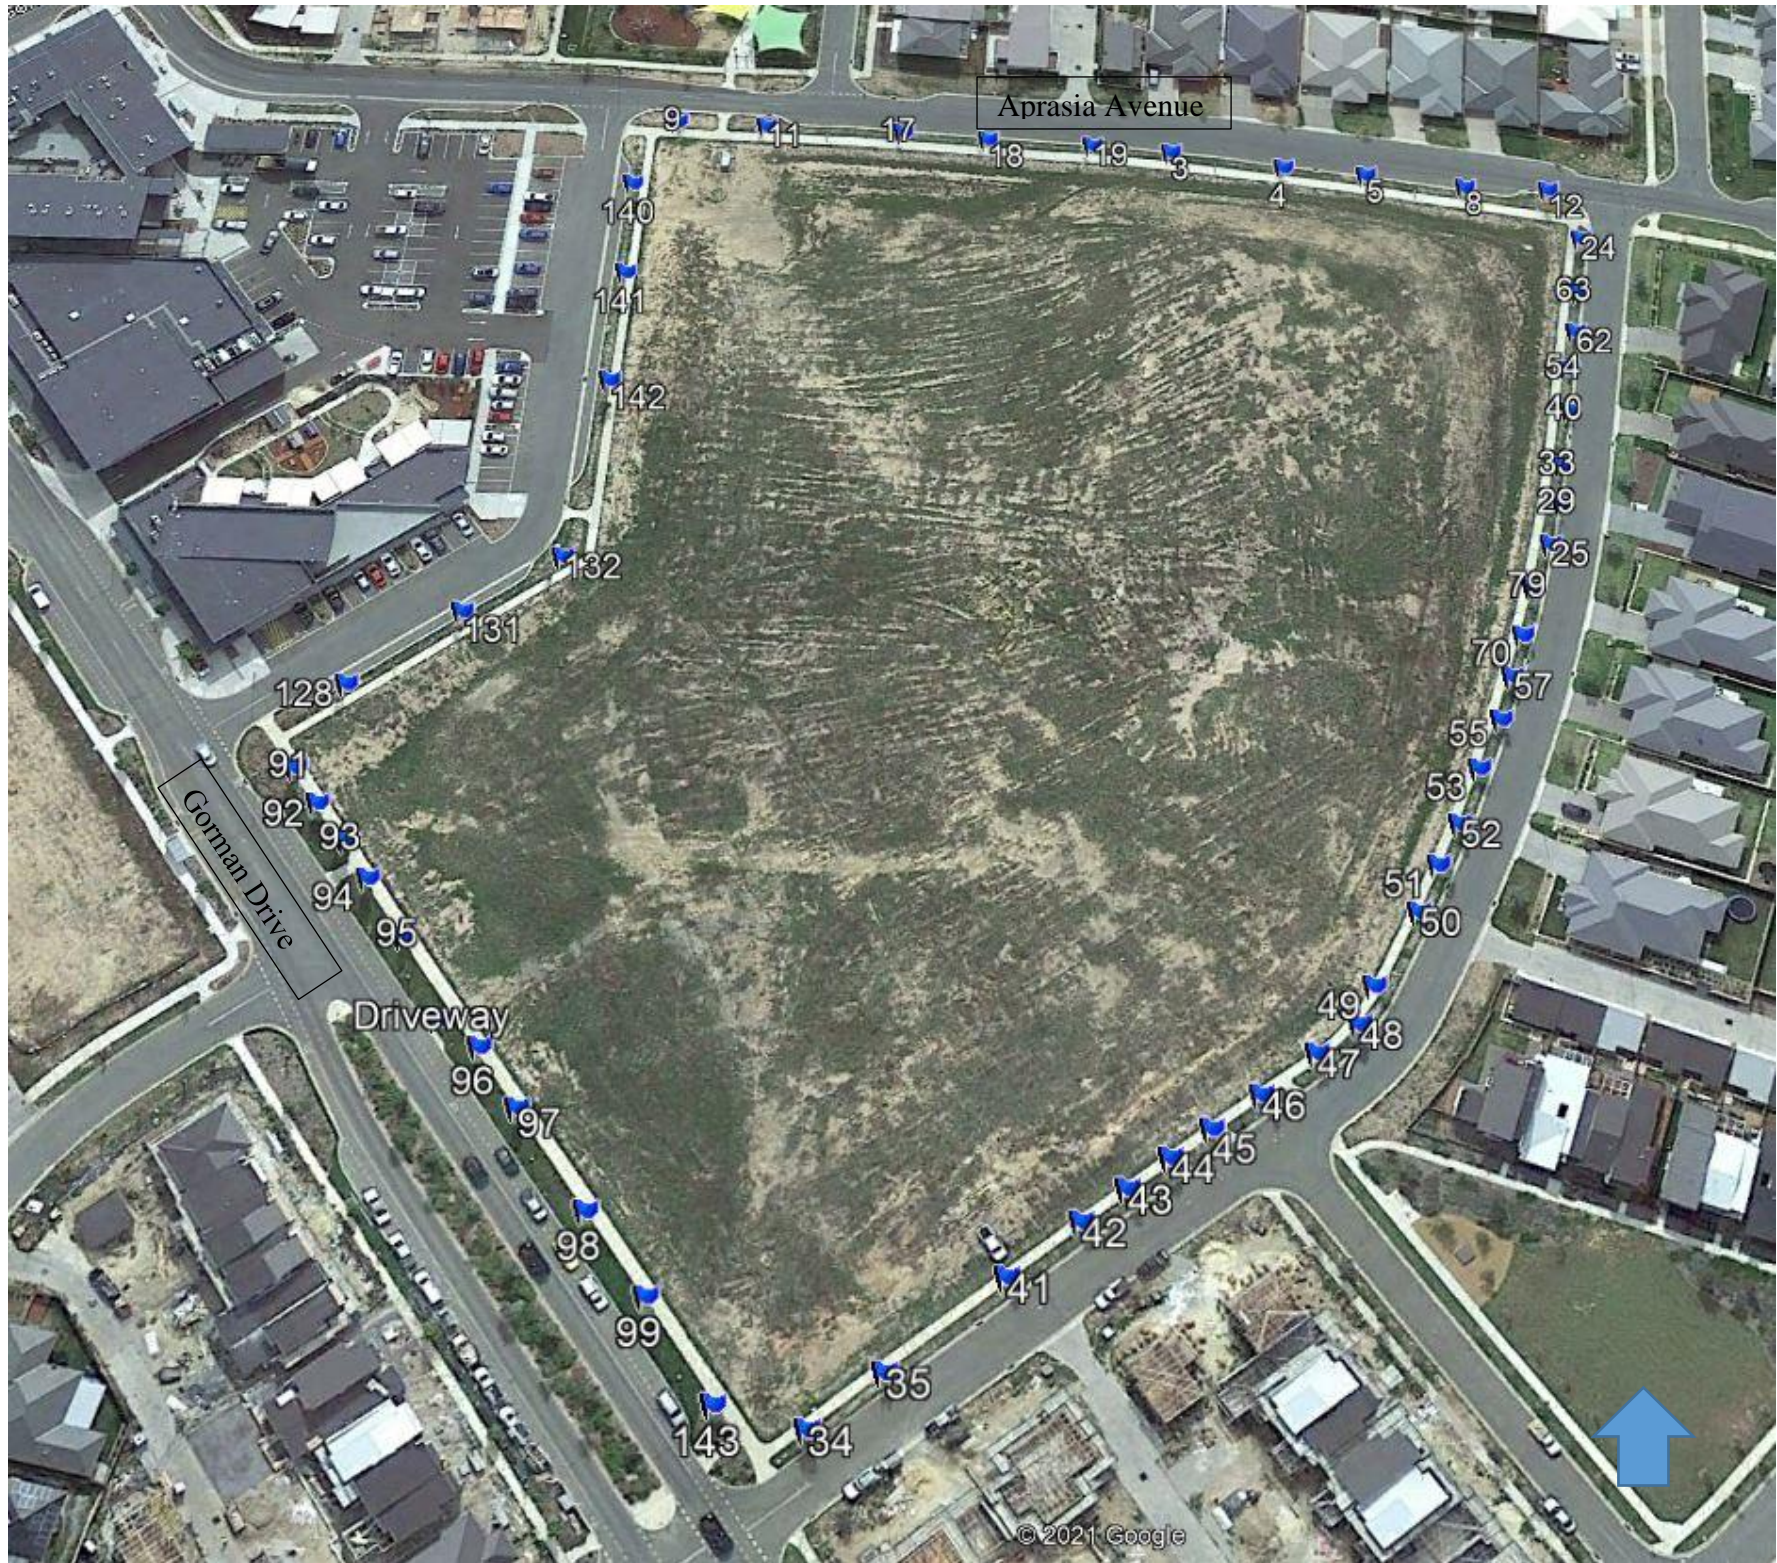
Diagram 2 – Development site bounded by local council street trees.

Tree numbers have been duplicated from the detailed survey plan. Note tree number are not sequential.

All trees have an effective Tree Protection Zone of 2m radially from stems.
