ARBORICULTURAL IMPACT ASSESSMENT TREE PROTECTION SPECIFICATION

Stadium Australia Redevelopment Sydney Olympic Park

Prepared for: INFRASTRUCTURE NSW

21st August 2019
Revision A

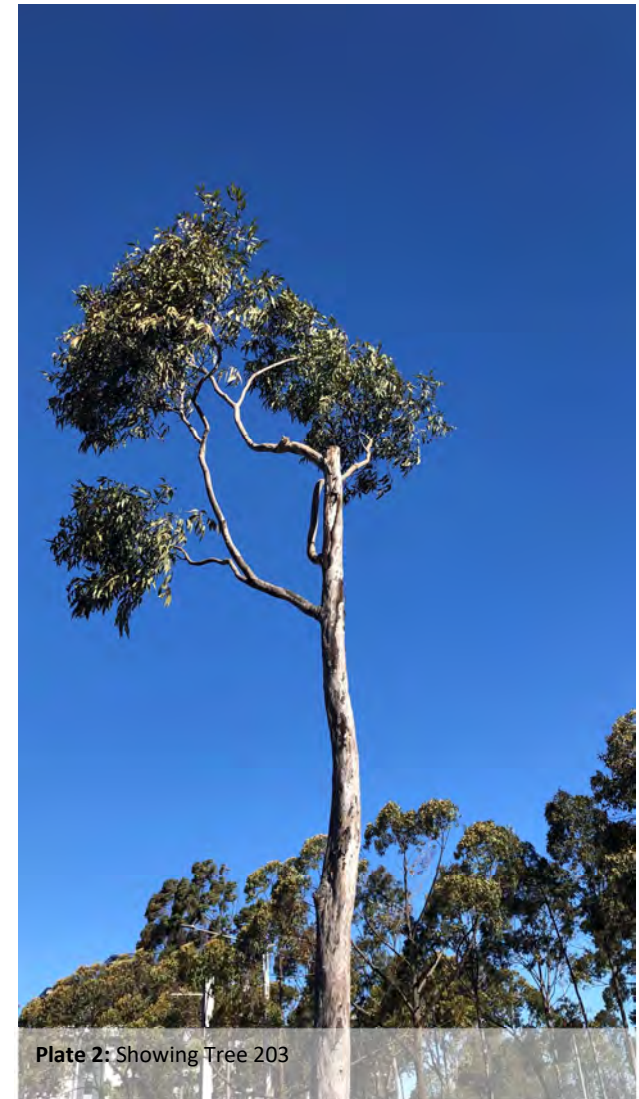
Appendix 4: Plates

- 3.1.3 Tree 203 was identified as *Corymbia maculata* (Spotted Gum) and is in fair health and poor structural condition. The tree has a reduced crown density and its central leader appears to have died back and has been removed. There are also multiple, irregular-shaped wounds on the upper trunk which show limited wound-wood development at the margins. Tree 203 has been allocated a Retention Value of *Priority for Removal* and is recommended for removal irrespective of the proposed development works.

- 3.1.4 The trees should be replaced with advanced-size specimens at the completion of the refurbishment works. New trees should be supplied in accordance with *Australian Standard 2303: Tree Stock for Landscape Use (2015)*.

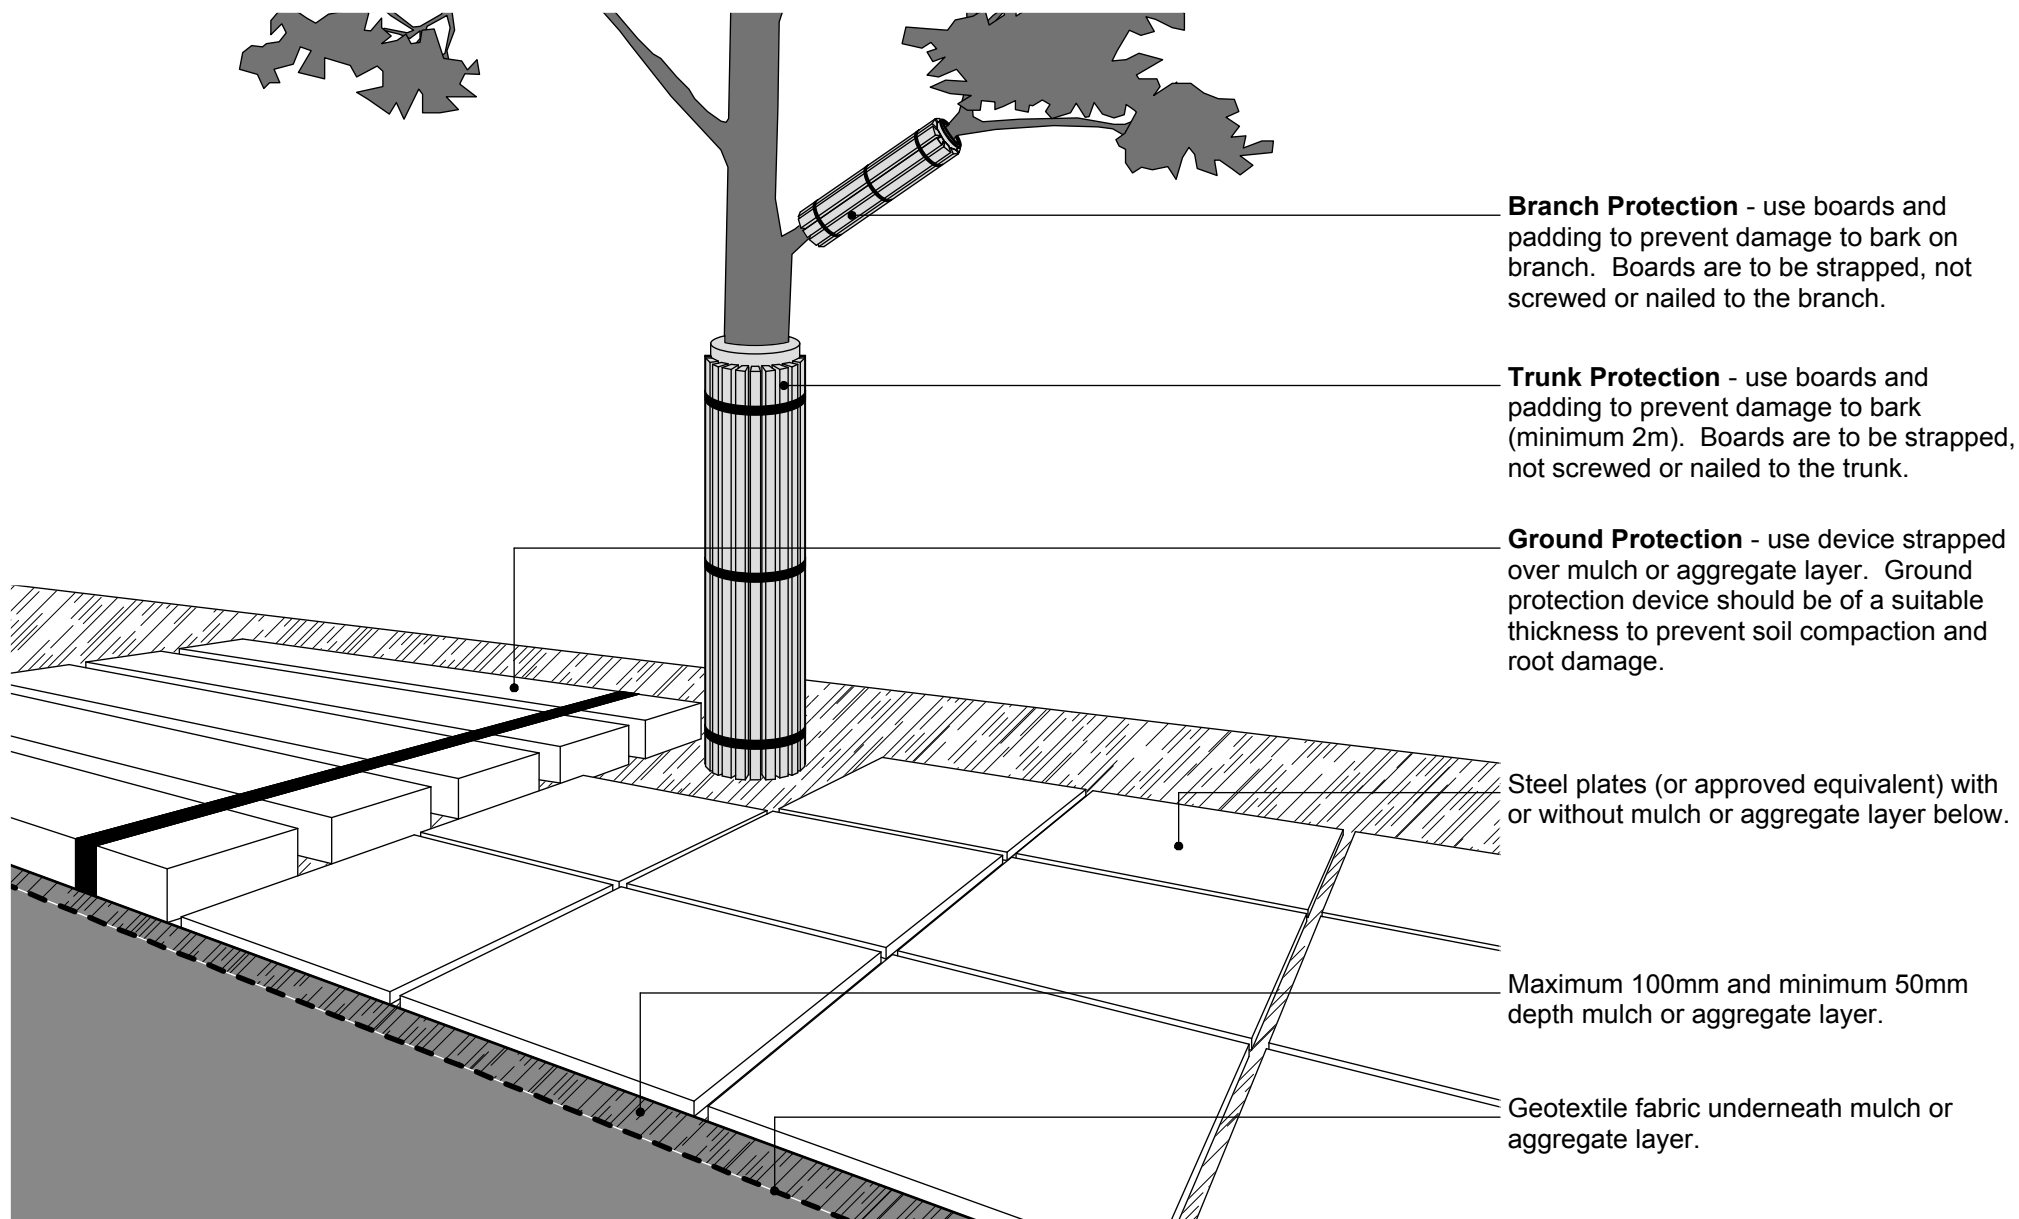
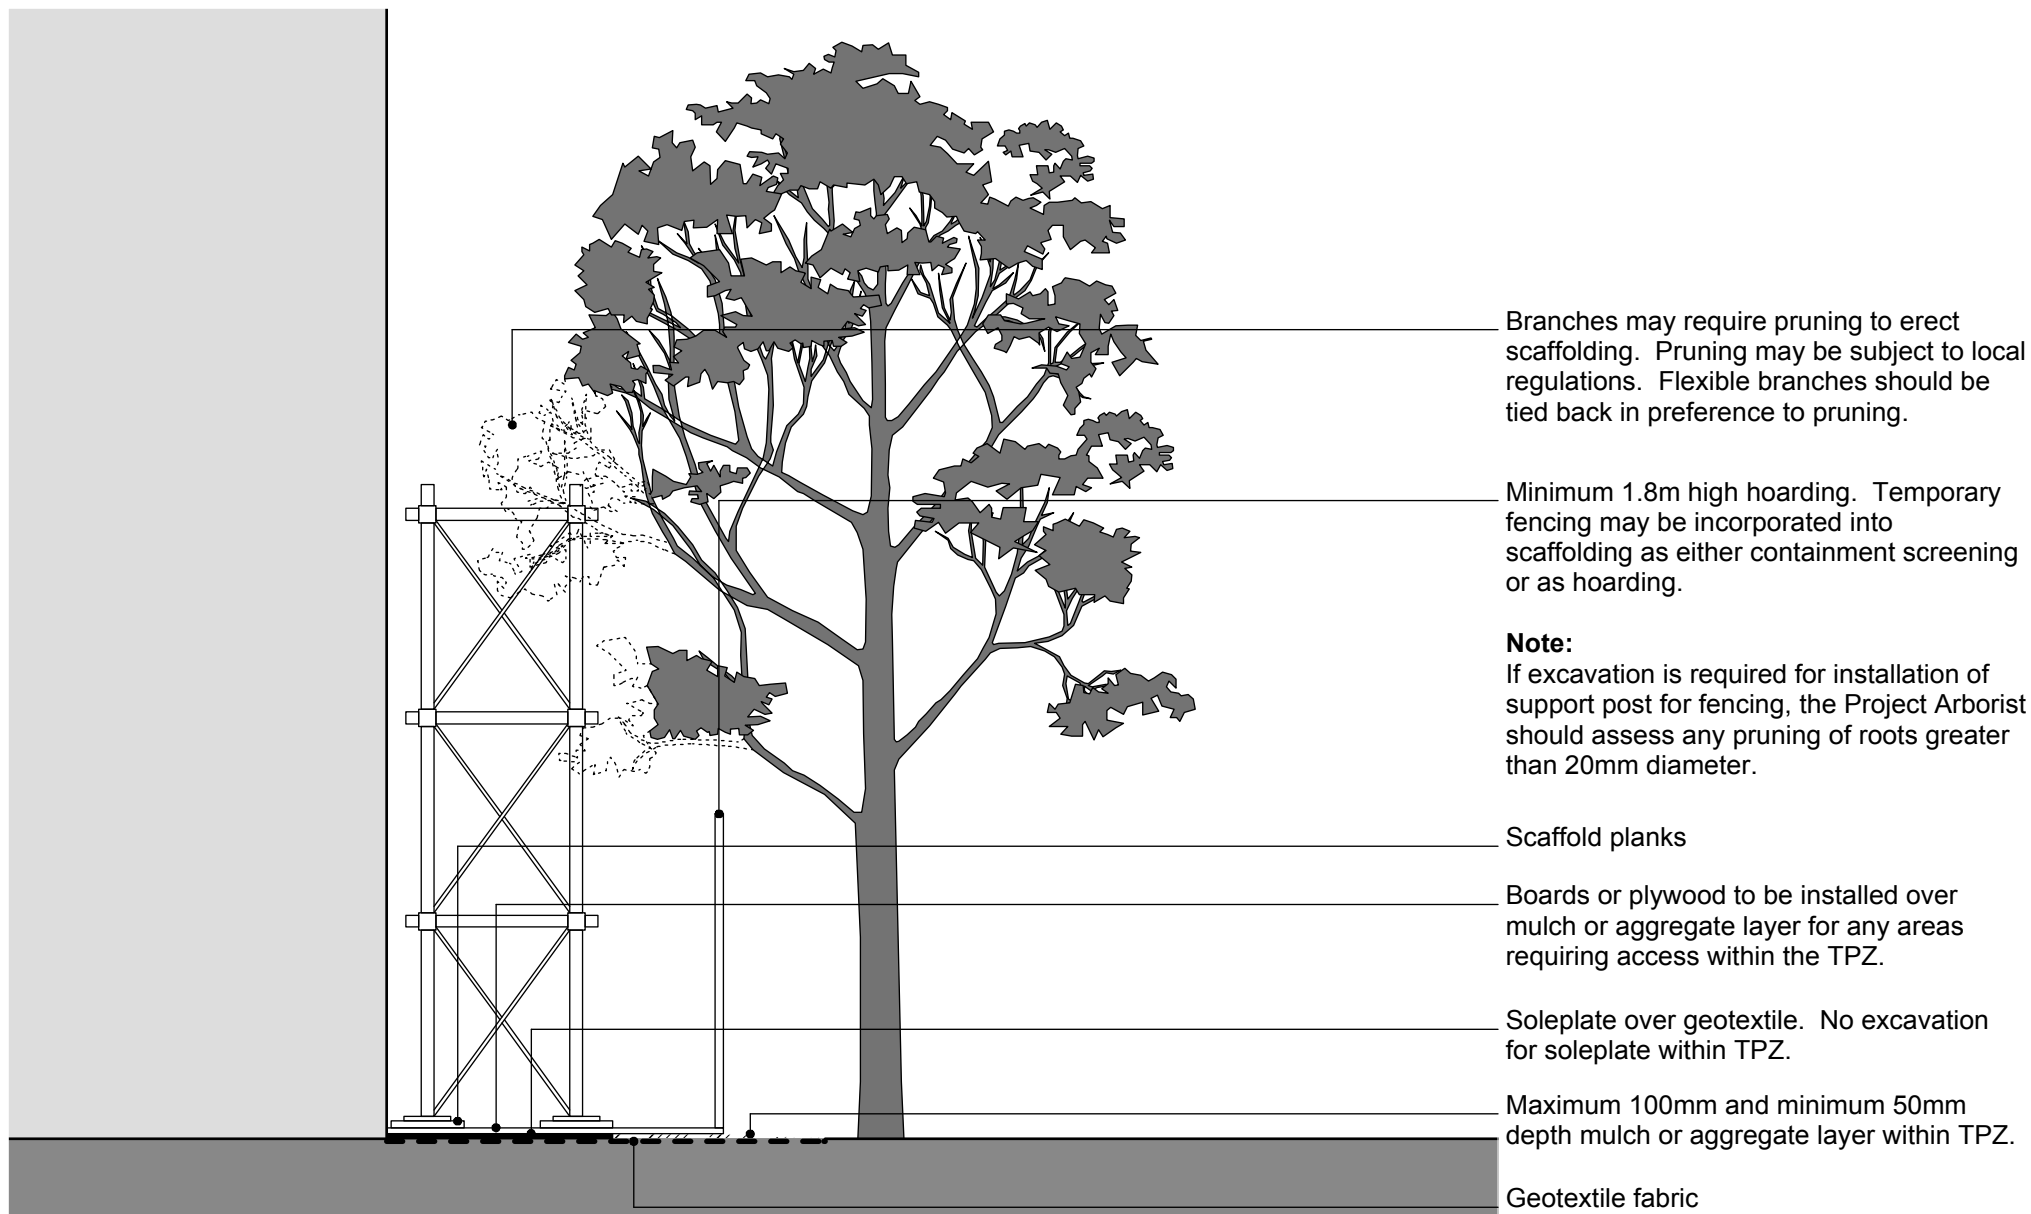
Scaffolding and hoarding shall not be located within a TPZ where possible. Branches may be temporarily pushed or tied back. Scaffolding and hoarding shall be modified and constructed around branches (with appropriate branch protection installed as required) where branches cannot be pushed or tied back without damage. Refer to Typical Tree Protection Details (5) (**Appendix 2**).
