# **Archaeological Report – Subsurface Testing**

**Oxley Solar Farm (SSD 10346)**

July 2022

Project Number: 20-743

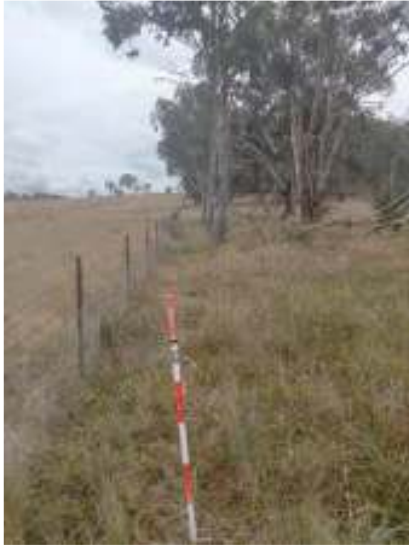
Plate 5 Fenceline demarcating southern extent of the additional northern area showing consistent grass cover with low (20-30%) visibility interspersed by juvenile vegetation.

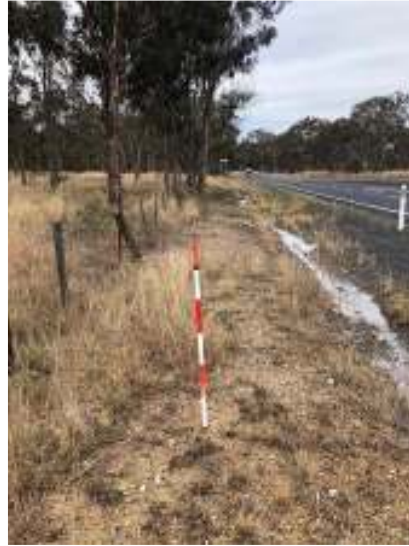
Plate 6 Boundary of the northern extent of additional northern area Grafton Road/Waterfall Way Road shoulder showing heavy disturbance and increased visibility of 30%.

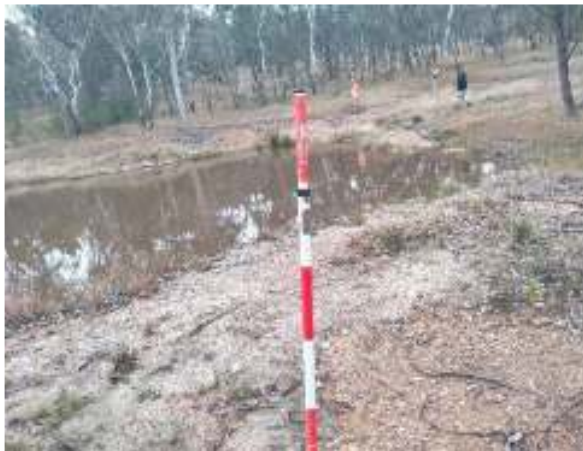
Plate 7 Increased visibility around the perimeter of the dam.

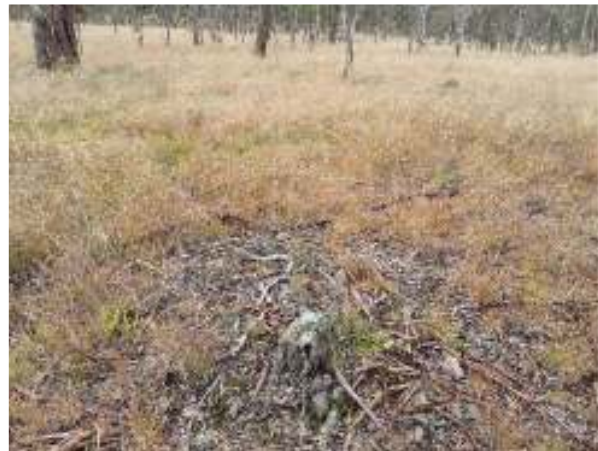
Plate 8 Lower visibility in a consistent grassed and leaf-littered area away from dam and tracks (10-20%).

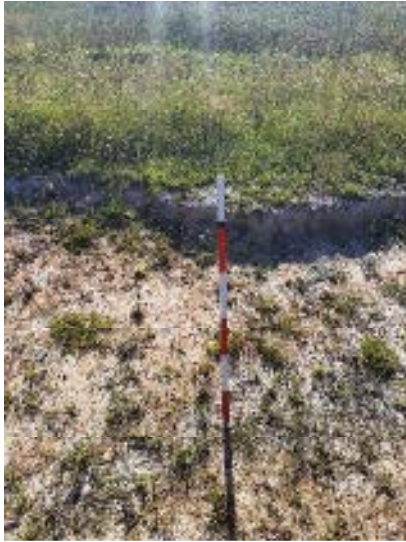
Plate 11 Erosion along drainage line extending from council depot road bridge affording increased visibility.

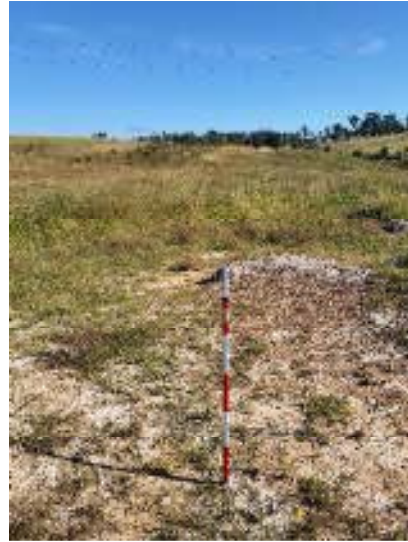
Plate 12 Eroded soils affording increased visibility between drainage line and simple sloped densely grassed/shrubbed area.

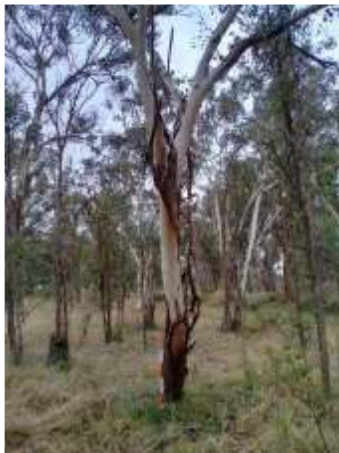
This site consists of a single contemporarily scarred tree assessed as culturally Aboriginal in origin located within a stand of trees, located 560m west of the Gara River and in the crown land area south of Grafton Road and north of the fenceline. The tree is a living, standing, red gum (*Eucalyptus Camaldulensis*) in a moderate condition with a single curved pre-form scar assessed as conforming to the standard scarring morphology accepted for Aboriginal modification (cf. Long 2005). The oval scar faces east, is well formed and is situated on the trunk of the tree. The scar measures 45cm in length by 32cm in width and has a depth of 4cm. The base of the scar is approximately 65cm above the ground. Several contemporary metal axe marks were visible around the perimeter and in the middle of the dry face of the scar. It was noted that some general degradation of the tree and scar was likely due to insect damage. The clean margins of the scar coupled with the contemporary metal axe marks establish the scarring of the tree as recent (Table 5-5).

**Plate 15 Context of Oxley Solar Farm cST1, north of fenceline and south of Grafton Road within a stand of trees.**

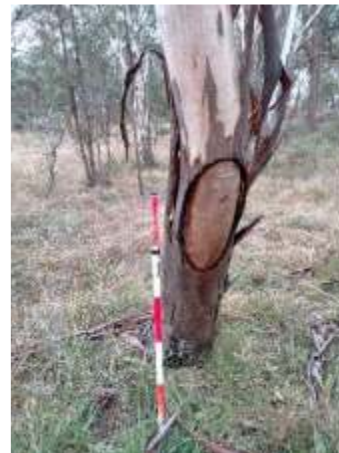
**Plate 16 Close up of scar of Oxley Solar Farm cST1.**

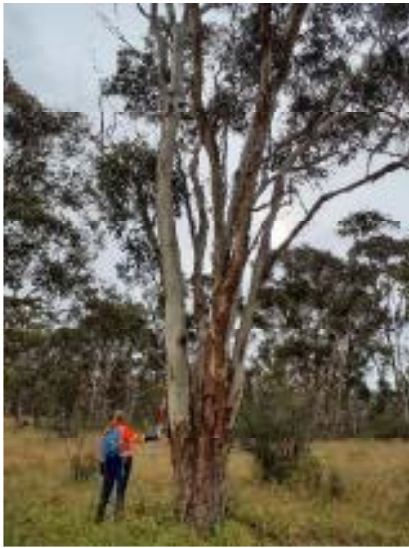
This site consists of a single contemporarily scarred tree assessed as culturally Aboriginal in origin located within a stand of trees, located 580m west of the Gara River and in the crown land area south of Grafton Road and north of the fenceline. The tree is a living, standing, multi-trunked *Eucaplytus* in moderate condition with a single curved pre-form scar assessed as conforming to the standard scarring morphology accepted for Aboriginal modification (cf. Long 2005). The oval scar, faces east, is not well formed but is in good condition. The scar measures 45cm in length by 25cm in width and has a depth of 5cm. The base of the scar is approximately 130cm above the ground. The clean margins of the scar coupled with the contemporary metal axe marks establish the scarring of the tree as recent (Table 5-7).

**Plate 20 Context of Oxley Solar Farm cST3, north of fenceline and south of Grafton Road adjacent to a cleared paddock.**

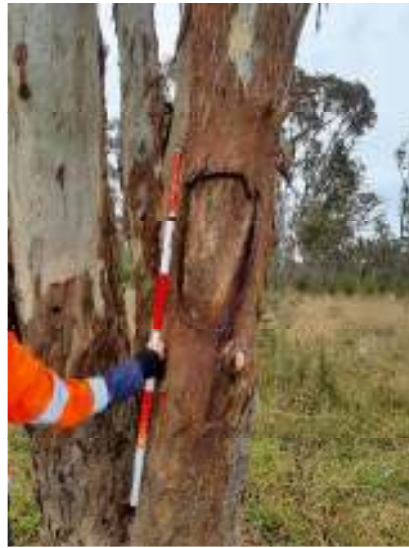
**Plate 21 Close up of scar on Oxley Solar Farm cST3.**

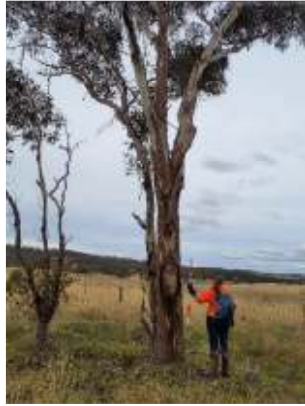
This site consists of a single contemporarily scarred tree assessed as culturally Aboriginal in origin located adjacent to the fence of a cleared paddock, approximately 520m west of the Gara River and in the crown land area south of Grafton Road and north of the fenceline. The tree is a living, standing, *Eucalyptus* in moderate condition with a single curved pre-form scar assessed as conforming to the standard scarring morphology accepted for Aboriginal modification (cf. Long 2005). The oval scar, faces north, is well formed and is in good condition. The scar measures 47cm centimetres in length by 40cm in width and has a depth of 2cm. The base of the scar is approximately 100cm above the ground. Contemporary metal axe marks were visible in the middle of the dry face of the scar. The clean margins of the scar coupled with the contemporary metal axe marks establish the recent scarring of the tree (Table 5-8).

**Plate 22 Context of Oxley Solar Farm cST4, north of fenceline and south of Grafton Road adjacent to the fence of a cleared paddock.**

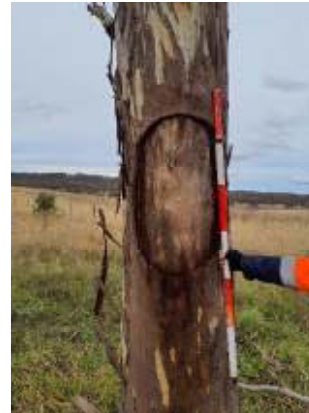
**Plate 23 Close up of scar on Oxley Solar Farm cST4.**

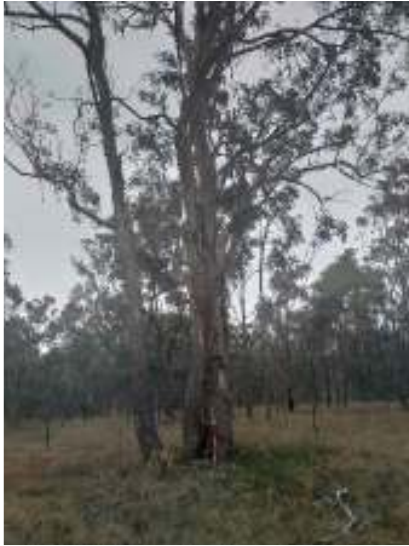
This site consists of a single scarred tree considered to be Aboriginal in origin located within open woodland, bordering the northern side of Waterfall Way located 670 m west of the Gara River. The tree is a living, standing, stringybark in moderate condition with a single curved oval scar assessed as conforming to the standard scarring morphology accepted for Aboriginal modification (cf. Long 2005). The oval scar faces south and is in good condition. The scar measures 50 cm in length by 20 cm in width and has a depth of 1 cm. The base of the scar is approximately 140 cm above the ground. A couple of axe marks were visible along the bottom margin of the scar. It was noted that some general degradation of the tree and scar was likely due to insect damage apparent by the small holes present throughout the dry face of the scar (Table 5-11).

**Plate 27 Context of Oxley Solar Farm ST2 on the northern side of Waterfall Way between fenceline and road.**

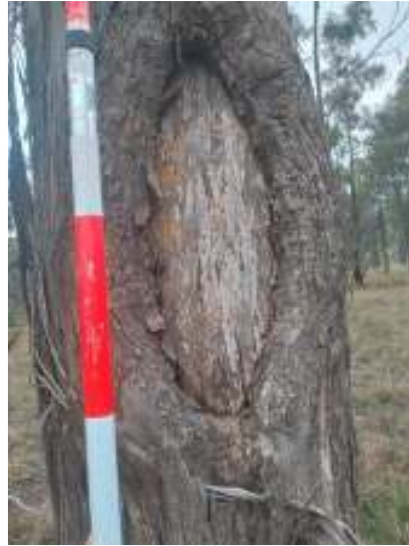
**Plate 28 Close up Oxley Solar Farm ST2 scar.**

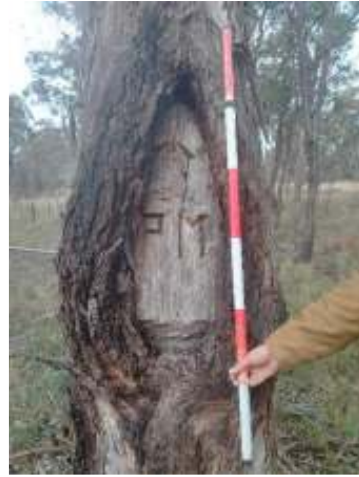
This site consists of a single European scarred tree on the northern side of Grafton Road. The tree is a living, standing, undetermined species of *Eucalyptus* in moderate condition with a single oval-to-triangular shaped scar. The scar is in good condition and located on the west-facing trunk of the tree. The scar measures 75cm in length by 35 cm in width and has a depth of 2 cm. The base of the scar is approximately 80 cm above the ground. Steel hatchet marks are visible towards the base of the scar with an arrow evident at the top of the scar and the letters 'P M' chiselled into the centre of the dry face. The chiselled notation was used to identify permanent survey marks placed along public roads and refer to the circled 'P.M' notation of plans deposited to the Registrar Generals Department (Table 5-12).

**Plate 30 Close up of Oxley Solar Farm SvT1 scar.**

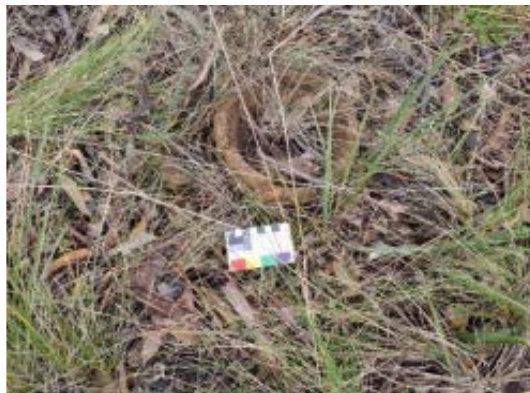
This site consists of an unfired clay and grass bowl on the south side of Grafton Road. The bowl is intact but obscured by grass cover. The clay and grass bowl was situated adjacent to Oxley Solar Farm cST5 and has a radius of approximately 9cm. It was concluded in conversation with senior RAP Bruce Cohen that the clay and grass bowl was likely also a contemporary manifestation of traditional Aboriginal cultural practise by the local group One Connection Disability Services (Table 5-13).

**Plate 31 Close up of Oxley Solar Farm ABG1.**

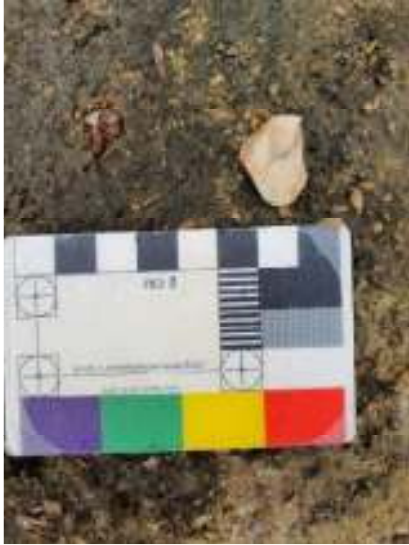
This site is a low-density stone artefact scatter located immediately east of CSt6 within crown land south of Grafton Road and north of the fence line. The site was located on a brown-black sandy loam deposit at the base of a tree, mid-slope and approximately 1 kilometre west of the Gara River. The artefact scatter comprised a silcrete flake and a silcrete flaked piece. Ground surface visibility was reduced to 20% at the base of a tree by leaf litter and humus (Table 5-14).

**Plate 32 Close up of Oxley Solar Farm AS19.**

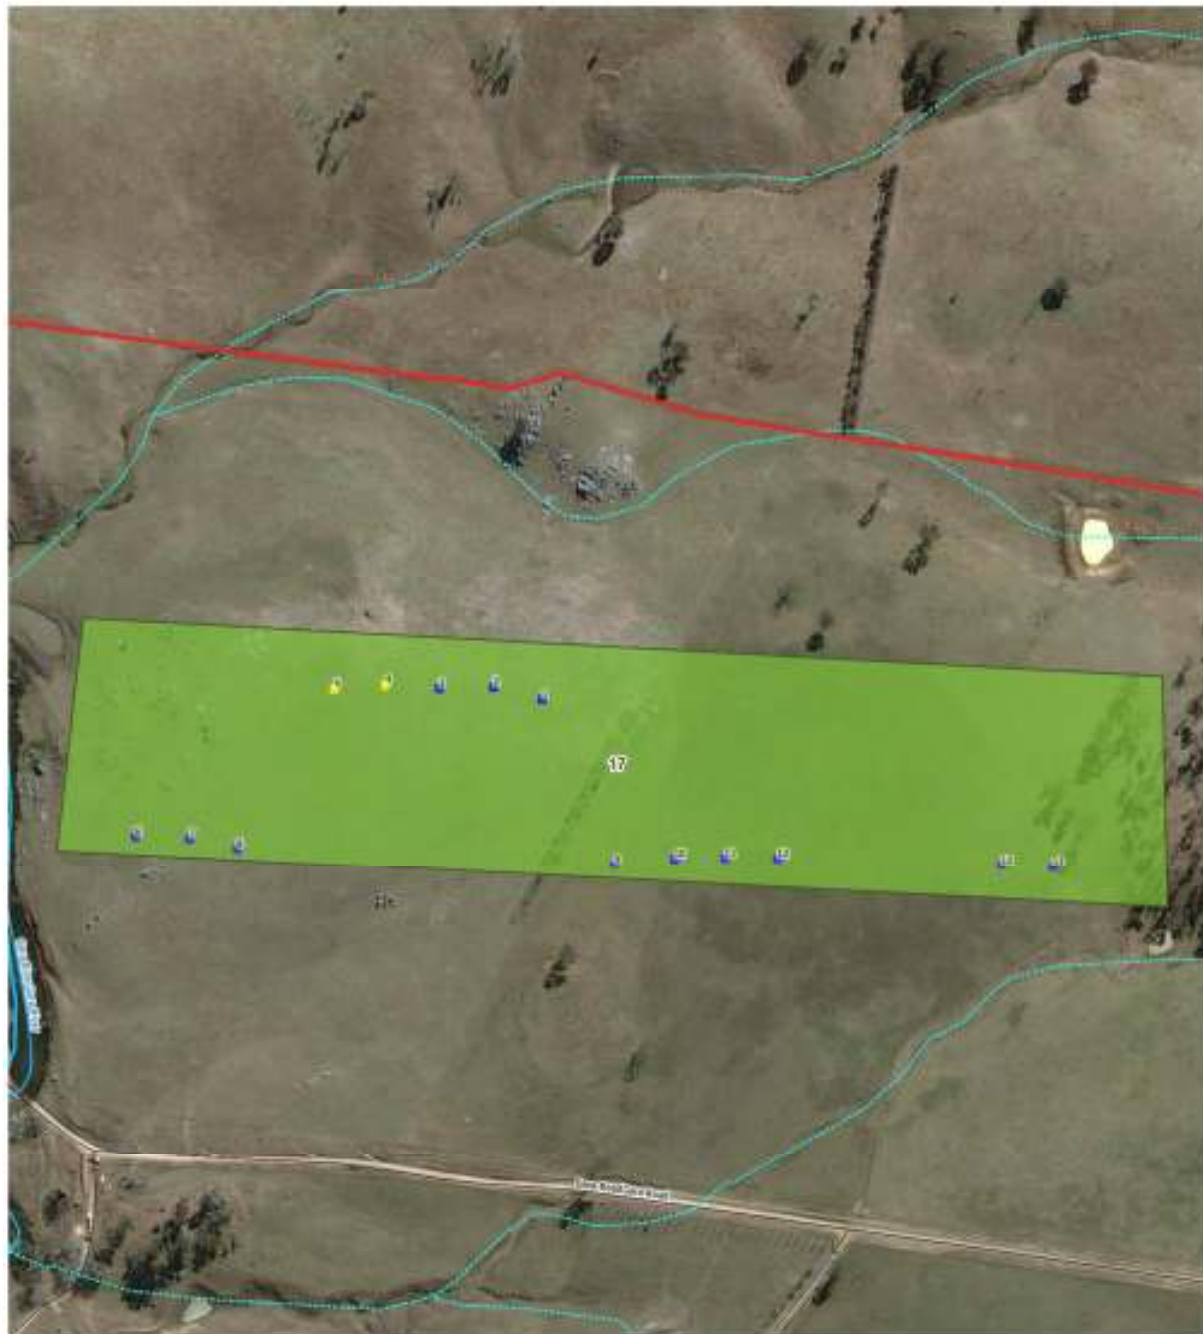
Oxley Solar Farm  
PAD 17 - Test Pit Results

In Pits 1-8, at around 40 cm depth, sticky clay was replaced by a layer of stony material similar to a creek bed. Excavation of test pits continued until the deposit was determined to reach culturally sterile clay, which mostly occurred around 20 cm depth in Pits 9-13 of PAD 17.

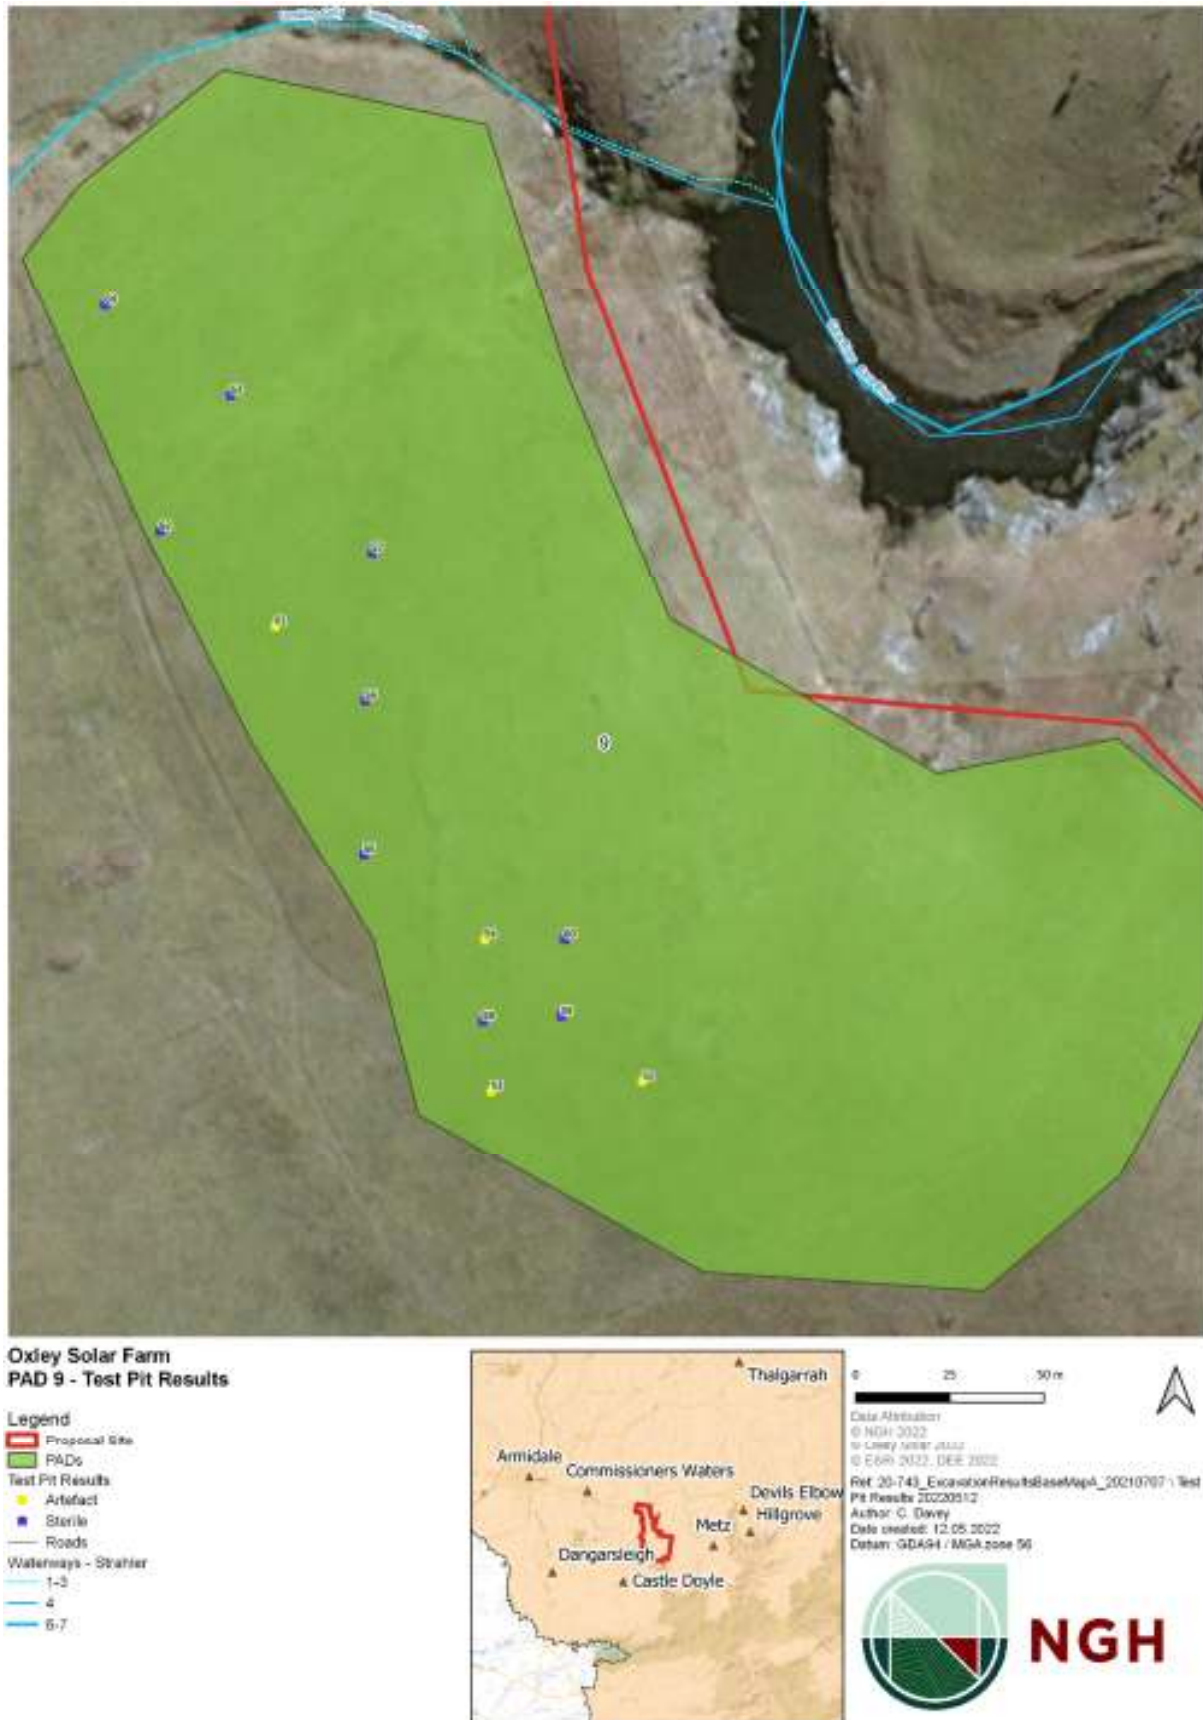
Figure 5-6 Results of testing – PAD 9

Results of test pitting for PAD 9 included artefacts in test pits 52, 53, 54 and 61, fragments of petrified wood in test pits 54, 55 and 62 and natural inclusions of charcoal in TP 52 (Figure 5-6). The subsurface finds from PAD 9 have been recorded as Oxley Solar Farm AS20 (AHIMS 21-4-0321).

PAD 9 is situated to the immediate southwest of the confluence of Gara River and Lambing Gully on a landform characterised as ridgeline/spur (Figure 5-6). Testing was undertaken in the western portion of the PAD, in the areas of highest elevation. The results of the test excavations indicate that shallow deposits of soil are present, overlying culturally sterile clay. Stone artefacts and petrified wood were identified in the soil deposits, particularly to the south west. Results indicate that the landform where test pits 55, 56, 57, 62, 63 and 64 are located has low potential for further archaeological material, whilst the part of the landform to the north and east of Test Pits 52, 53, and 54 have a moderate to low potential for further archaeological material.

On these grounds, further testing must occur to ensure that the potential for this landform to contain archaeological material has been fully explored. The proposed further test pit locations should be situated to the north and east of the area where the highest number of artefacts were identified (Test Pits 52, 53 and 54) and be undertaken before any works involving ground surface disturbance will occur. Further detail on Management Recommendations can be found in Section 10.

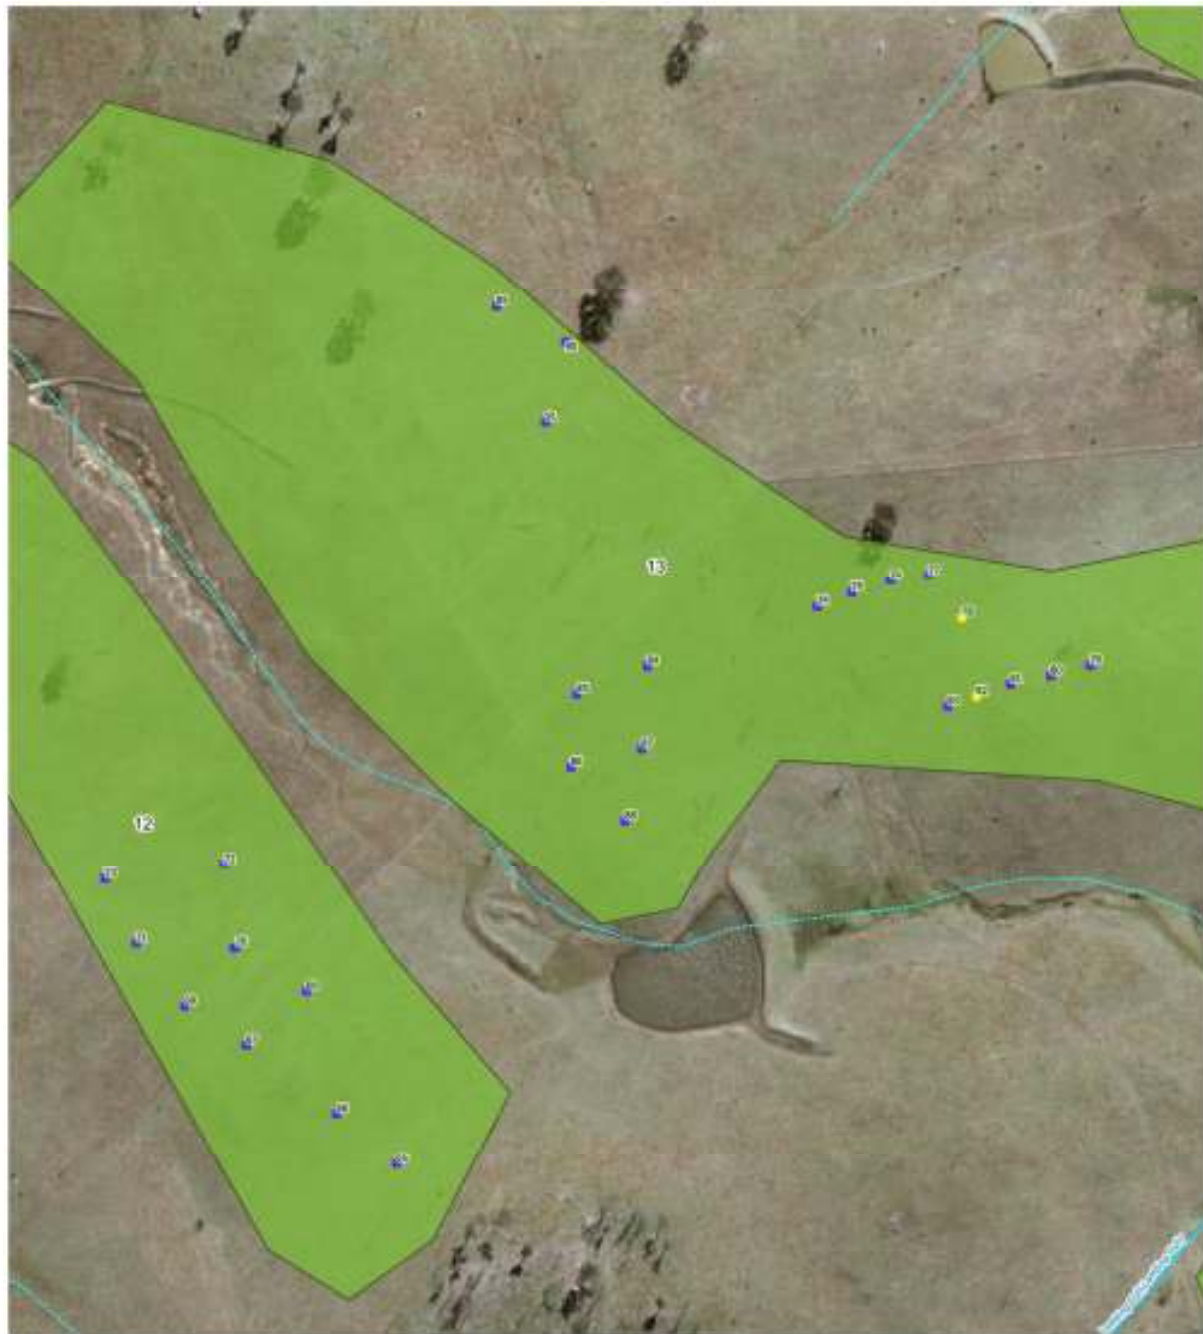
Figure 5-7 Results of testing – PAD 12 and 13

PAD 12 is located on a ridgeline/spur landform north of Lambing Gully and between two first-order drainage lines and dams. The PAD is also directly west of the small exposure north of one of the dams where AS 7 was identified in the original survey (Figure 5-7). Test pitting was conducted in the southern half of the PAD.

Culturally sterile clay was reached at depths between 20 and 25 cm for test pits 69, 67 and 73, at 30 cm for test pits 66 and 68, and at around 15 cm in test pits 71 and 72. The lower elevation of TP71 and TP72 and their closer proximity to the nearby drainage line may account for the increased moisture content and shallower deposit observed in these two test pits.

No test pits in PAD 12 contained artefacts (Figure 5-7).

PAD 13 is located on a southwest facing slope north of Lambing Gully and between two first-order drainage lines approximately 95 m west of Gara River. The PAD is also directly east of a small exposure north of one of the dams where the artefact scatter AS 6 was identified and encompasses the area north of IF 9 (Figure 5-7). Test pitting was focussed on the middle section of the PAD.

The culturally sterile clay layer was reached at depths of 10-20 cm in test pits 74-78, 80 and 89. A stony layer was noted instead of pure natural clay, which was reminiscent of a creek bed for Pit 79 and 81-88 at 10-20cm.

One of these test pits contained two stone artefacts (Pit 82) and one contained one stone artefact (Pit 78) (Figure 5-7). The subsurface finds from this testing area have been recorded as Oxley Solar Farm IF 30.

PAD 13 is situated north of Lambing Gully and between drainage lines feeding into the Gara River located 95 m away. The landform is characterised as a southwest facing slope (Figure 5-7), situated east of artefact scatter AS6 and north of IF9. Test pits were undertaken towards the middle of the PAD, concentrated in the area identified as the development footprint. Results from the 18 test pits indicates that a shallow soil horizon overlies a culturally sterile clay layer in some areas and a stony layer resembling a creek bed in other areas. The soil horizon was approximately 10 – 20 cm deep. Three stone artefacts were recovered from the test pits, indicating there is moderate to low potential for further finds. The two artefact bearing test pits (TP 78 and 82) indicate that further archaeological material may be located in the deposits around this location.

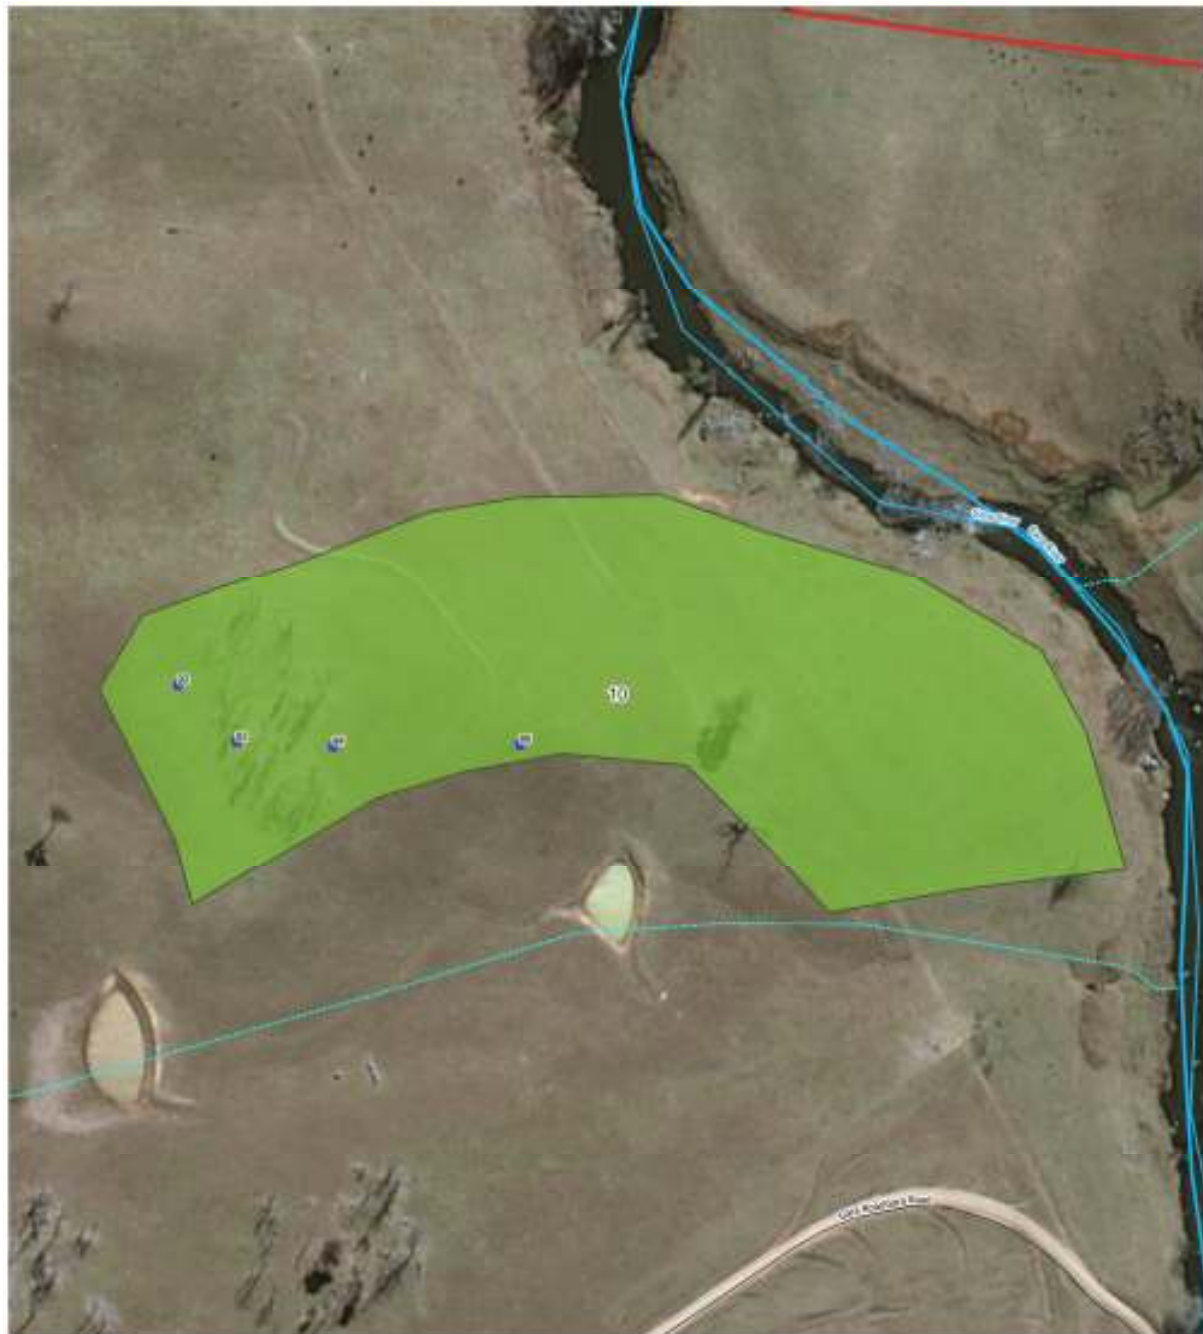
Figure 5-8 Results of testing – PAD 10

PAD 10 is located on a lower slope southwest of the confluence of Gara River and a first-order drainage line. Test pitting was conducted in a small section of the western side of the PAD. That this drainage line formed part of the broader regions watershed was further supported by a notable change in the retention of moisture in the soil compared to the surrounding area. This drainage line extends west with two dams intercepting the drainage alignment and contour banking and swales push away from the dams to the east demonstrating past land modification of the area.

Excavation terminated when either the water table and/or a stony base layer was encountered at depths ranging between 20-50cm. None of the test pits excavated contained artefacts (Figure 5-8).

PAD 10 is situated southwest of the confluence of Gara River and a drainage line on a landform characterised as a lower slope (Figure 5-8). Four test pits were excavated in the south western portion of the PAD and no artefacts were recovered. These results indicate there is a low potential for further archaeological material to be located in this landform where the extension to development footprint is located.

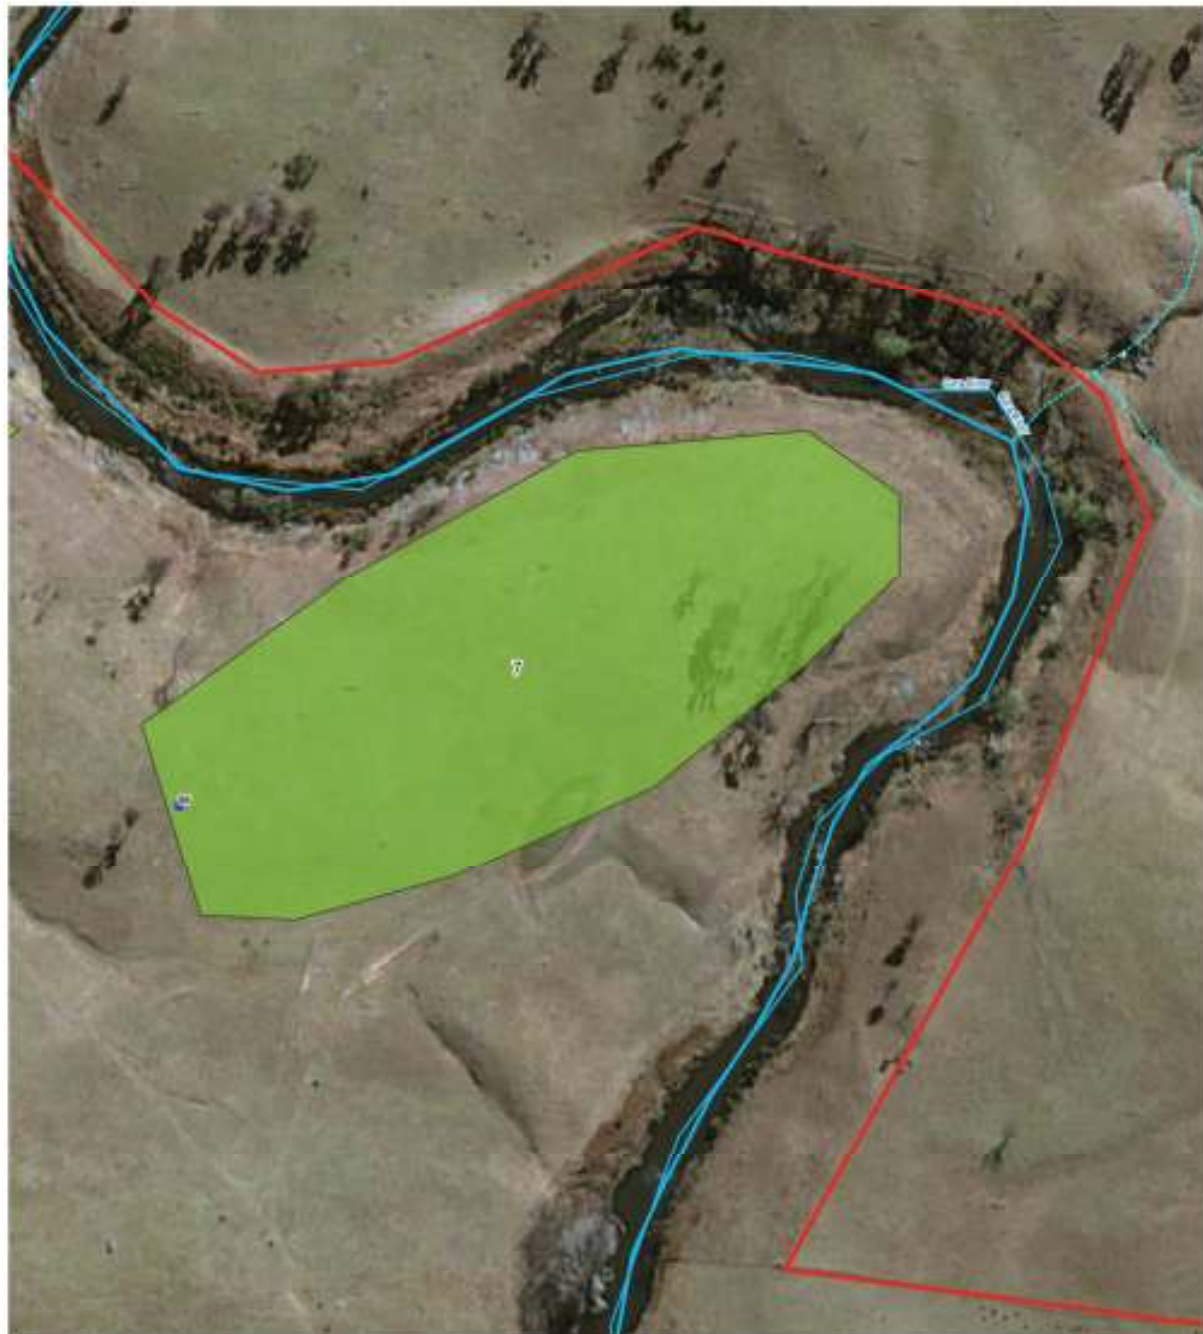
Figure 5-9 Results of testing – PAD 7

Test pit 96 was excavated to a depth of 20 cm with both moisture and ironstone content increasing with depth. No artefacts were recovered from test pit 96 (Figure 5-9).

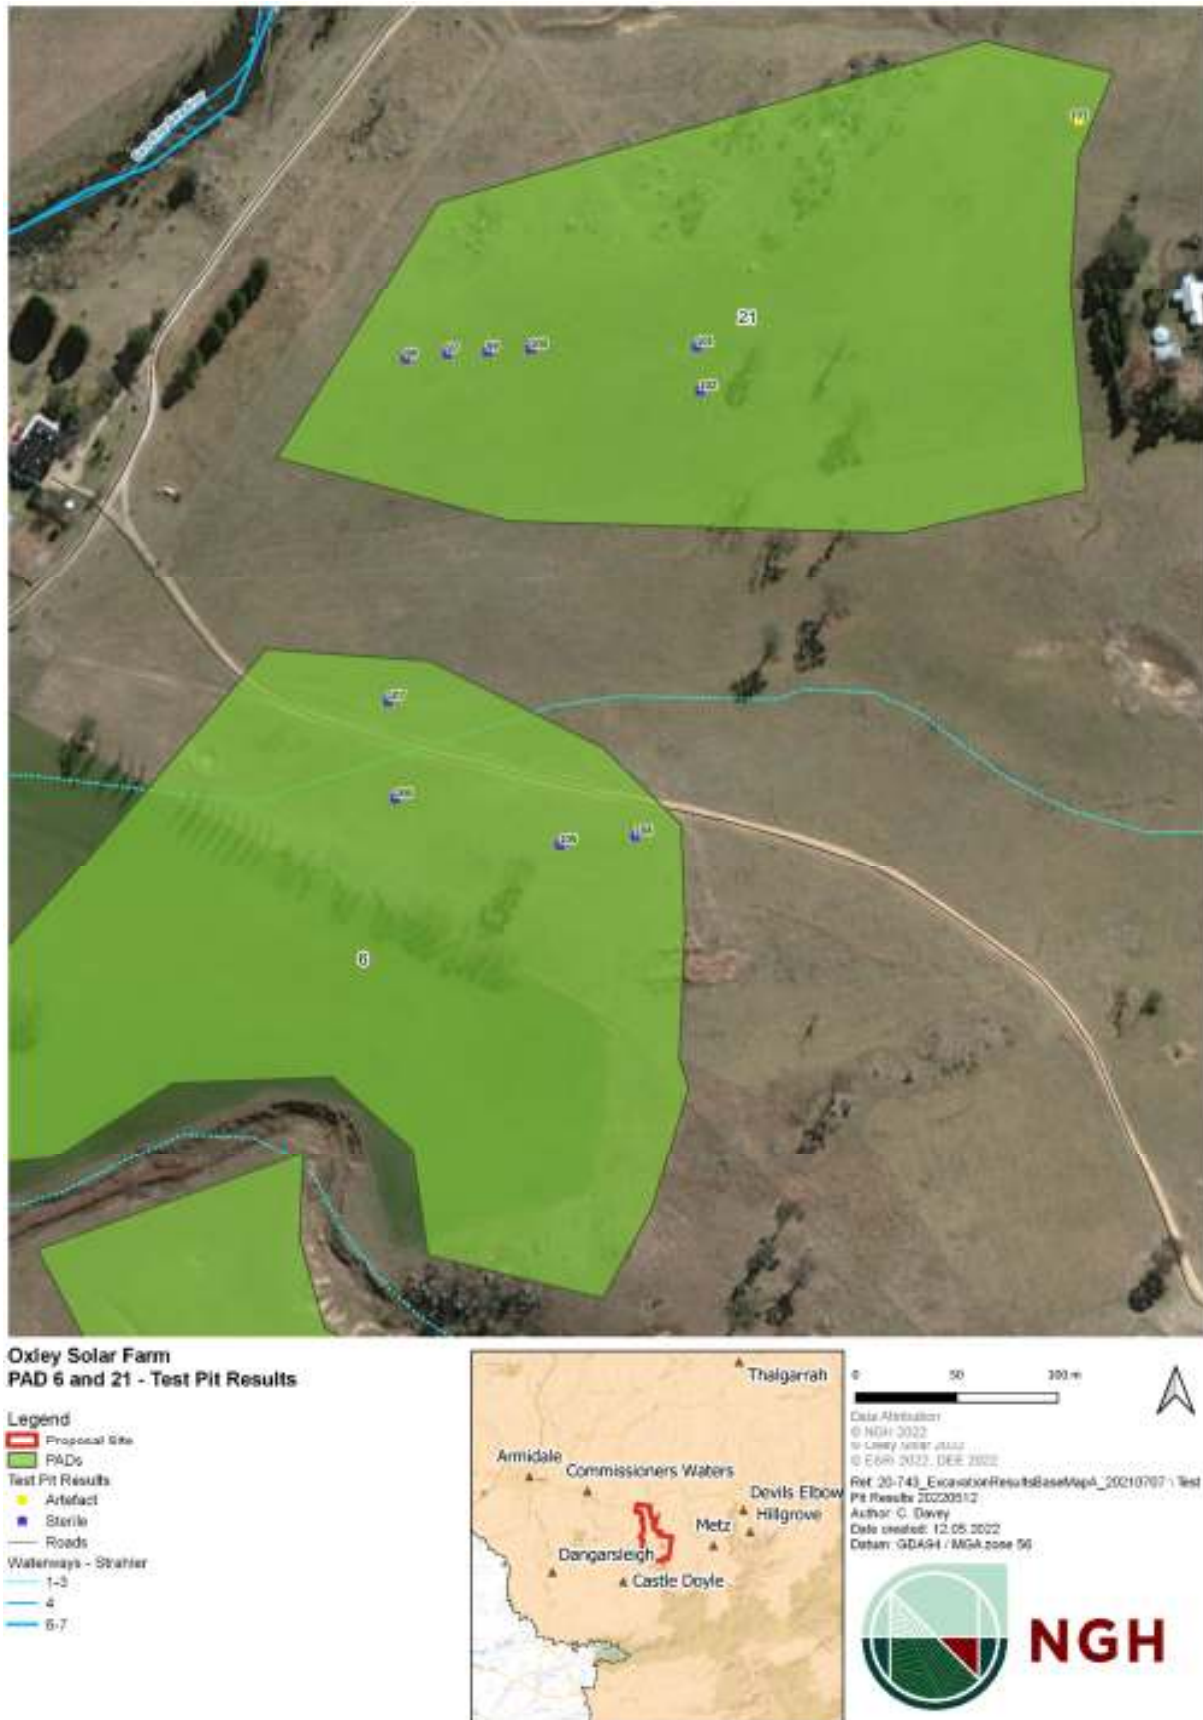
Figure 5-10 Results of testing – PAD 6 and 21

A single artefact from Pit 103 has been recorded as Oxley Solar Farm IF 31 (Figure 5-10).

PAD 6 is located north of Gara Road along an elevated flat area approximately 380 m east of Gara River with a first-order drainage line transecting the testing area. That this drainage line formed part of the broader regions watershed was further supported by a notable change in the retention of moisture in the soil, particularly in Pit 106 and 107, compared to the surrounding area.

Layers of culturally sterile clay or stone were found at depths between 20 and 30 centimetres. The stony layer and increased moisture content evident in test pits 106 and 107 were indicative of their proximity to the nearby first-order drainage line. None of the test pits in PAD 6 were found to contain artefacts (Figure 5-10).

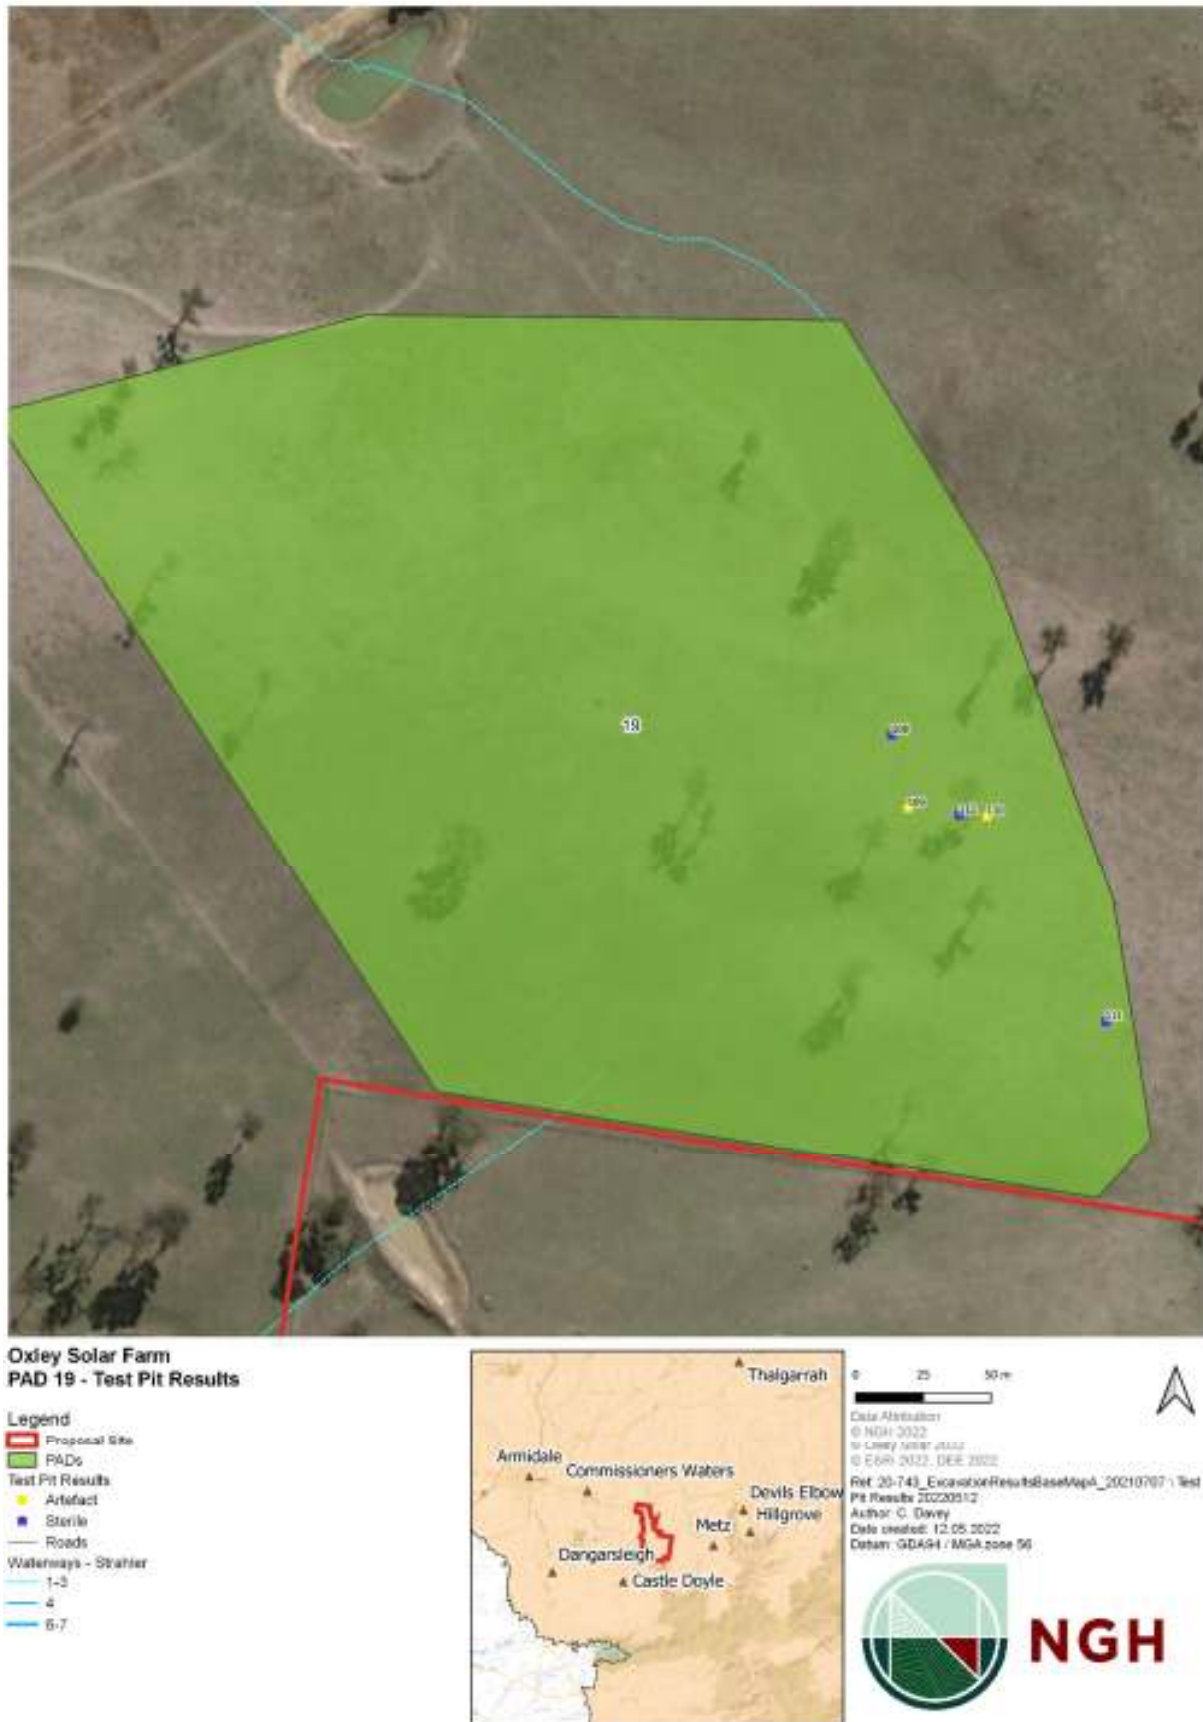
Figure 5-11 Results of testing – PAD 19

Excavation continued until deposits were determined to be culturally sterile, with a layer of clay and ironstone occurring between 27 to 40c m depth in PAD 19.

The two artefacts recovered PAD 19, one each from test pit 109 and test pit 110, have been recorded as Oxley Solar Farm IF 32 and IF 33 (Figure 5-11).

PAD 19 is situated south of the Armidale Metz Track near drainage lines on a landform characterised as elevated (Figure 5-11). Despite evidence of prior significant ground disturbance, previously recorded sites AS14, IF15, IF16, IF17 and CT3 are within proximity of the test pits that were excavated. Results indicate there is a shallow deposit of soil where the two artefacts were recovered from the five test pits, located towards the east of the PAD. The soil horizon overlays a sterile clay and ironstone deposit. These results indicate that whilst there is potential for further archaeological material to be located around the location of TP109 and 110, there is very low potential for further archaeological material to be located in this landform where the extension to the development footprint is proposed.

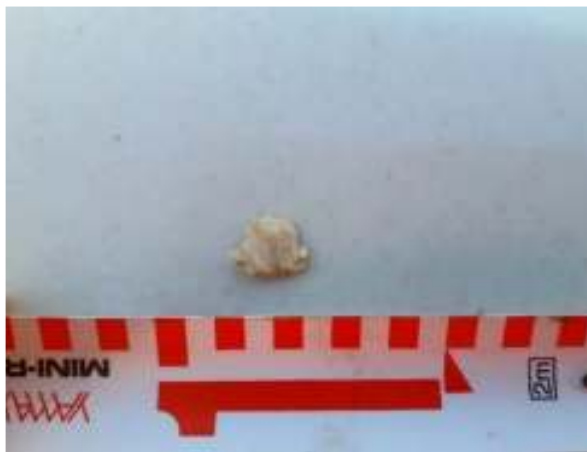
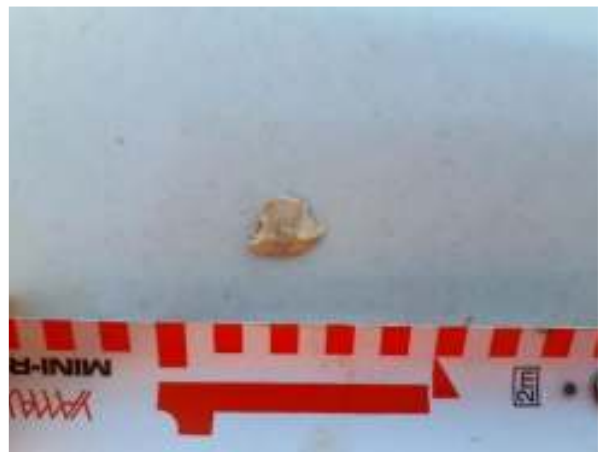
Table 5-17 Photographs of Oxley Solar Farm IF25.

The site was located adjacent to a paddock gate, 60 m north of Gara Road and 90 m from the Gara River and consisted of a pale grey cream silcrete flake in a small exposure with 60% ground surface visibility (Table 5-17).

Plate 53 Close up of Oxley Solar Farm IF25.

Plate 54 Close up of Oxley Solar Farm IF25.

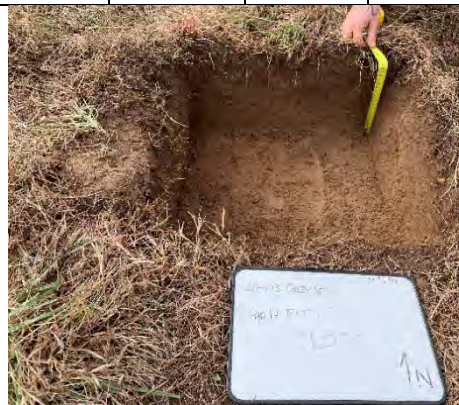
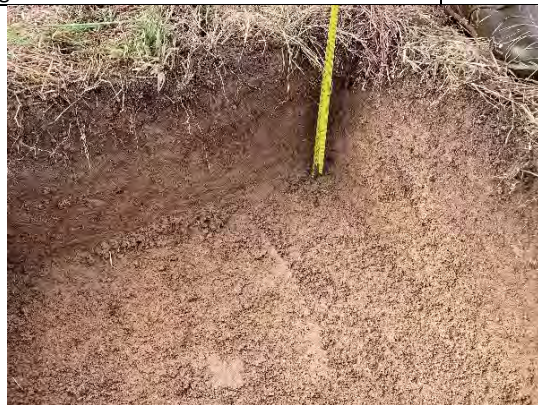
Oxley Solar Farm  
PAD #17  
Pit # 001

PAD	Pit no	Grid Reference (GDA 94 MGA Zone 56)	Spit number	Depth (cm)	Soil Description	Artefacts
17	1	386318, 6616874	1	1-5	Dark humic loamy sand with thick tuft grass inclusions. PH=6.	Nil
			2	5-15	Dark humic loamy sand with thick tuft grass inclusions. Coarse sand gravels and worms throughout. PH 6.5.	Nil
			3	15-25	Quartz grains and pebbles are more prevalent throughout. PH=6.5.	Nil

PAD 17, Pit 1, Spit 3		PAD 17, Pit 1, Spit 3, Northern wall profile

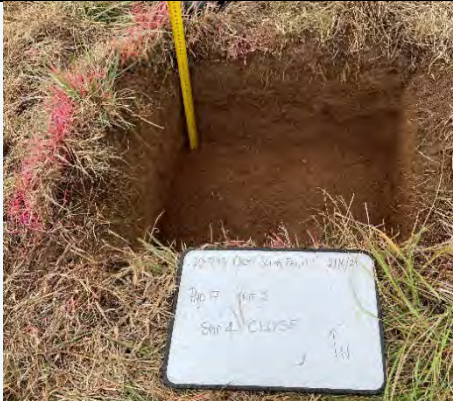
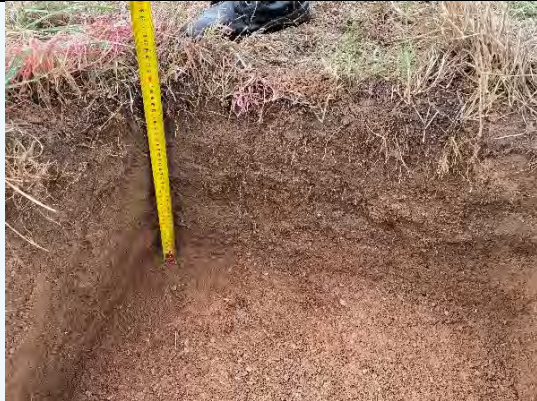
PAD 17, Pit 2, Spit 4				PAD 17, Pit 2, Spit 4, Northern wall profile		
<div><div><div>Oxley Solar Farm PAD #17 Pit # 002</div><div>

17	2	386281, 6616884	1	1-10	Dark humic loamy sand with thick tuft grass as well as insect inclusions. PH=6.	Nil
			2	10-20	Loamy sand with occasional worm and pebble inclusions. Grass roots still present throughout. PH=6.	Nil
			3	20-30	Grassroots decreasing with depth and quartz pebble inclusions increasing with depth. PH=6.	Nil
			4	30-~40	Coarse sand with quartz pebbles and grassroots throughout. PH=6.	Nil

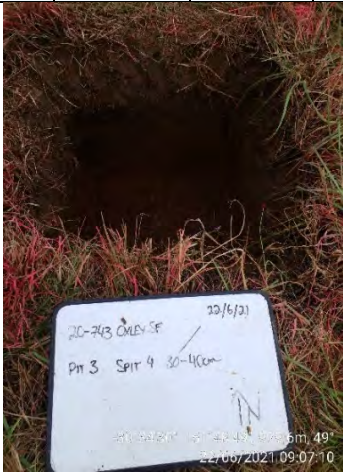
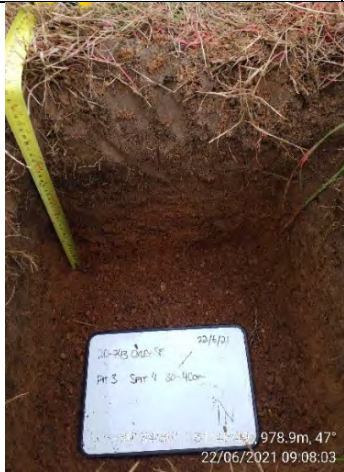
Oxley Solar Farm  
PAD #17  
Pit # 003

2	10-20	Some pebbles are still present throughout (mainly comprising quartz materials). PH=6.	Nil
			3	20-30	More gravel and pebble inclusions are present throughout. More friable textured soils and rootlets are still present protruding through walls.	Nil
			4	30-40	Small quartz pebbles still present with sporadic rootlets also evident. Some occasional insect inclusions. PH=5.5.	Nil

PAD 17, Pit 3, Spit 4			PAD 17, Pit 3, Spit 4, Northern wall profile
