# **Archaeological Report – Subsurface Testing**

**Oxley Solar Farm (SSD 10346)**

July 2022

Project Number: 20-743

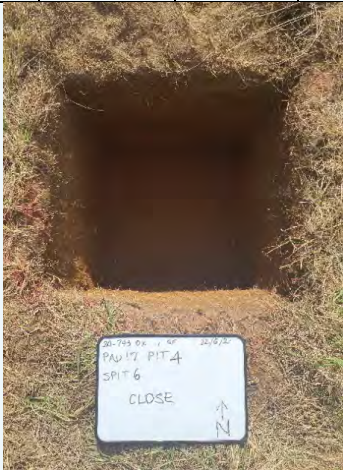
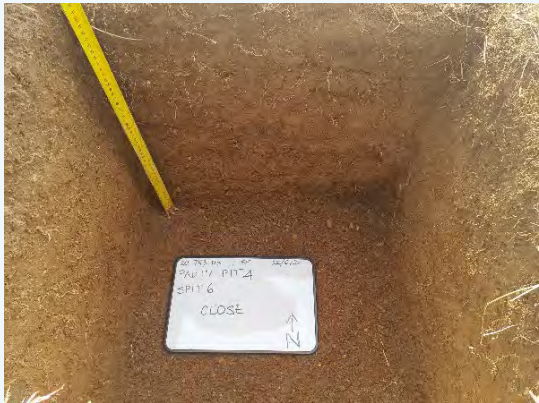
Oxley Solar Farm  
PAD #17  
Pit # 004

17	4	386198, 6616885	1	1-5	Humic loamy sand with coarse grain inclusions. PH=6.	Nil
			2	5-15	Loamy sand with grass-root, pebble and insect inclusions throughout. PH=6.	Nil
			3	15-25	Pebble inclusions decreasing with depth. Loamy sand continued. PH=6.	Nil
			4	25-35	Fewer pebble inclusions again with the occasional worm and grass-root evident. PH=6.5.	Nil
			5	35-45	Continued loamy sand. PH=6.5.	1 artefact, chert flaked piece
			6	45-55	The layer of small quartz pebbles is approximately 2 cm in size. Loamy sand is present but decreasing in friability.	Nil

PAD 17, Pit 4, Spit 6			PAD 17, Pit 4, Spit 6, Northern wall profile

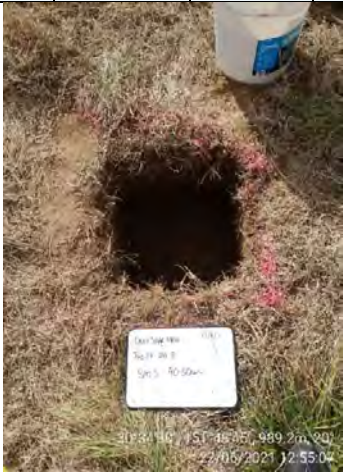
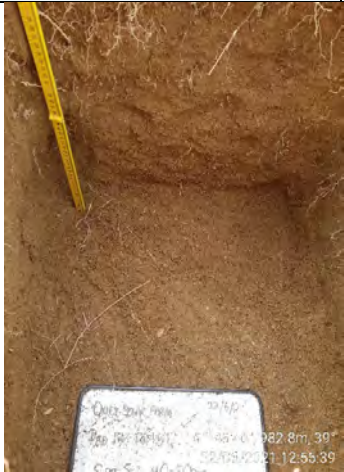
Oxley Solar Farm  
PAD #17  
Pit # 005

17	5	386159, 6616882	1	1-10	Sandy loam with thick tuft grass topsoil.	Nil
			2	10-20	Sandy loam.	Nil
			3	20-30	Small quartz inclusions present throughout. Occasional root and insect inclusions Dry friable sandy loam material.	Nil
			5	30-40	Increased pebble inclusions throughout with the occasional grub are also evident. PH=6.	1 possible artefact.
			5	40-50	Another 10 cm spit was excavated to ensure the below layer was culturally sterile.	Nil

PAD 17, Pit 5, Spit 5			PAD 17, Pit 5, Spit 5, Northern wall profile

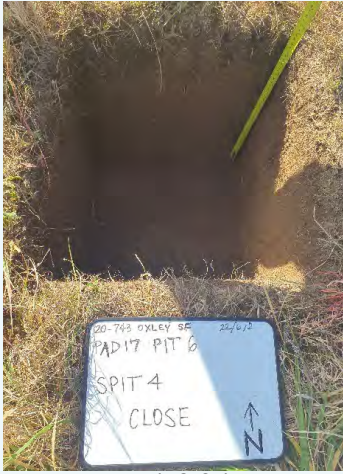
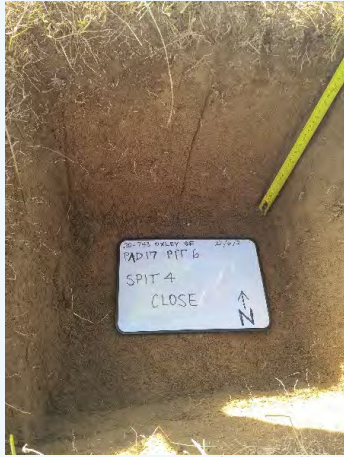
17	6	386008, 6616771	1	1-10	Sandy loam. PH=6.	Nil
			2	10-20	As above.	Nil
			3	20-30	Roots and gravel inclusions towards base of spit.	Nil
			4	30-40	Occasional gravel. Compaction increasing with depth.	Nil

<p>PAD 17, Pit 6, Spit 4</p>

<p>PAD 17, Pit 6, Spit 4, Northern wall profile</p>	
<div> <div> Oxley Solar Farm  PAD #17  Pit # 006 </div> <div>

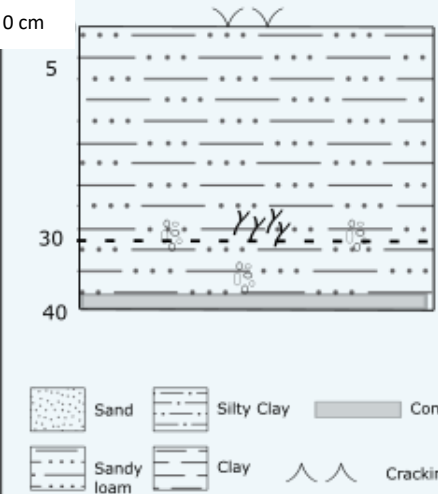
</div> <div> <p>Dark humic sandy loam. roots protruding from wall with the occasional earth worm/grub observed. Dry soil with occasional quartz pebbles towards base.</p> <p>More pebble inclusions. Sandy loam continues but compaction increases with depth.</p> </div> <div>

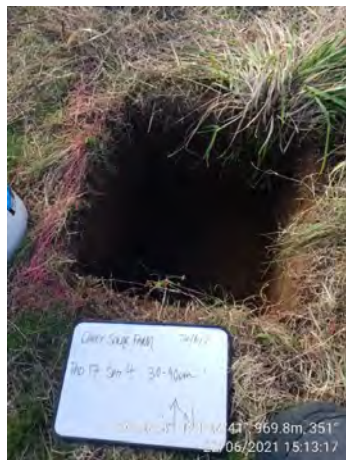
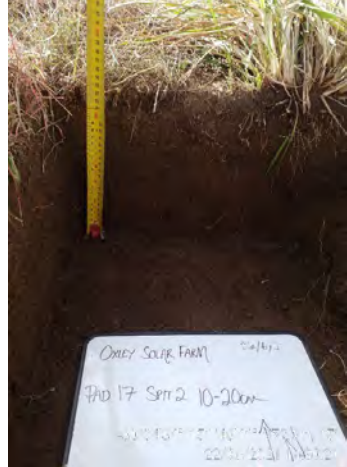
</div> </div>						
17	7	386049, 6616769	1	1-10	Sandy loam. PH=6.	Nil
			2	10-20	Small pebble inclusions throughout as well as the occasional worm. PH=6.	Nil
			3	20-30	Grubs and root inclusion protruding from the wall.	Nil
			4	30-40	Dark humic sandy loam continues with depth. Composition less friable and more compact with depth.	Nil

PAD 17, Pit 7, Spit 4

PAD 17, Pit 7, Spit 2, Northern wall profile			
<div><div><div><div><div>Oxley Solar Farm</div><div>PAD #17</div><div>Pit # 007</div></div><div>

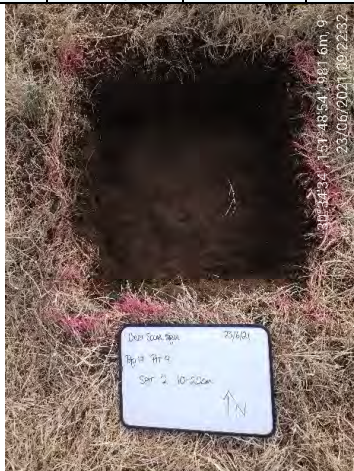
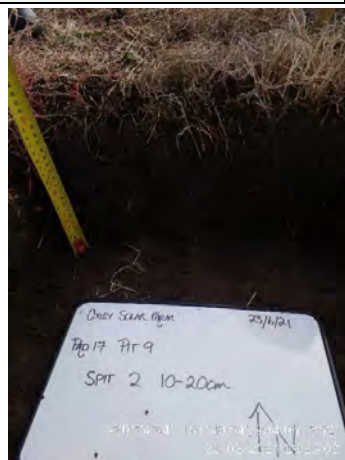
2	10-20	Very sticky black clay with some rootlets and grubs protruding from the wall.	Nil

PAD 17, Pit 9, Spit 2					PAD 17, Pit 9, Spit 2, Northern Wall Profile	
<div><div><div>Oxley Solar Farm PAD #17 Pit # 009</div><div><div>0 cm</div><div>

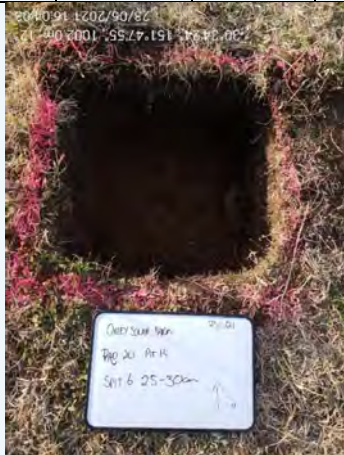
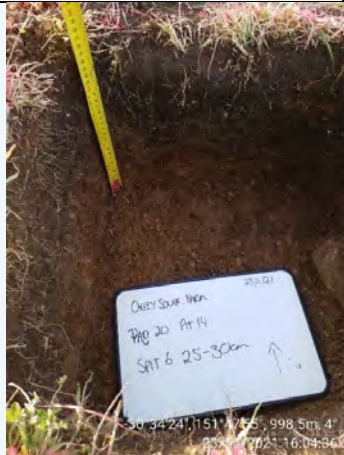
PAD 20, Pit 14, Spit 6.		PAD 20, Pit 14, Spit 6, Northern wall profile.

Grassed topsoil</div></div></div></div>						
20	14	384804, 6617065	1	1-5	Dark humic gritty soil with gravel and pebble inclusions throughout. Sandy loam soil. PH=5.	Nil
			2	5-10	Small charcoal inclusions with gravel and pebbles continuing with depth. Rootlets are now also evident.	Nil

3	10-15	As before.	Nil
			4	15-20	Gravel and pebbles continue but decrease in frequency. Rootlets protruding from the wall.	Nil
			5	20-25	A subtle change to a lighter brown colour. Clay content increasing with depth.	Nil
			6	25-30	Large rock protruding from the west wall. Gravels and pebbles are increasing with depth in density and the occasional rootlet is also evident. Start of consistent clay toward base around the rock.	Nil

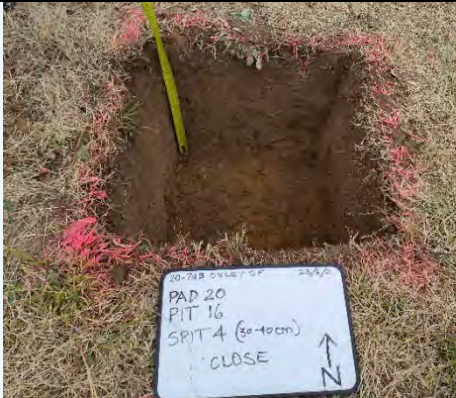
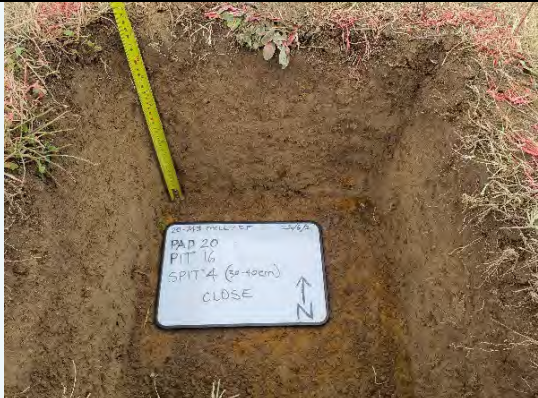
PAD 20, Pit 16, Spit 4.					PAD 20, Pit 16, Spit 4, Northern wall profile.

</div><div>Dark humic brown sandy loam with pebble inclusions.</div><div>Clay content and compactness increasing with depth some pebbles and roots still present.</div></div></div></div>						
20	16	384884, 6617069	1	1-10	Dark brown humic layer down to 2cm. Sandy loam with grass inclusions beneath and some charcoal fragments recovered. PH=6.	Nil
			2	10-20	Brown loamy sandy with light grass-root inclusions. Very small occasional pebbles throughout the soil. PH=6.5.	Nil
			3	20-30	Occasional grass root and pebble inclusions. PH=6.5.	Nil
			4	30-40	Occasional thin tree roots. Large pebbles at the interface of soil and clay. Consistent clay at ~38cm. PH=6.5.	Nil
<div><div>

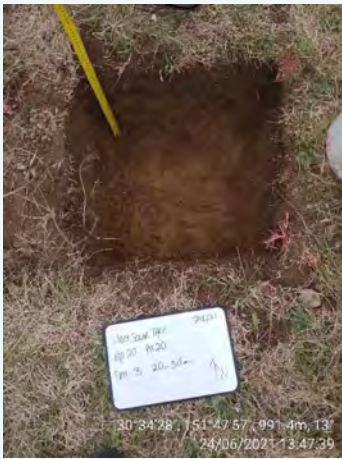
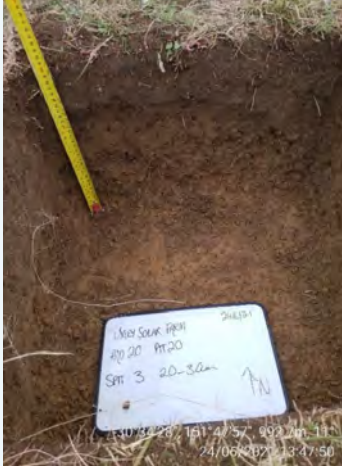
</div></div> <div>PAD 20, Pit 20, Spit 3.</div> <div>PAD 20, Pit 20, Spit 3, Northern wall profile.</div>

</div></div><div>Dark humic brown friable clay with gravel inclusions transitions to yellow hard sticky clay.</div><div><div><div> Sand</div><div> Silty Clay</div><div> Compaction</div><div> Root/Insect</div><div> Gradual Boundary</div><div> Sharp Contact</div><div> Sandy loam</div><div> Clay</div><div> Cracking</div><div> Gravels</div><div> Base of Excavation</div><div> Grassed topsoil</div></div></div></div>						
20	20	384866, 6616935	1	1-10	Dark humic loamy sand with rootlet and insect inclusions. PH=5.	Nil
			2	10-20	Same as above.	Nil
			3	20-30	Loamy sand clay with increased gravel inclusions. Hard clay at 30cm.	Nil
<div><div>

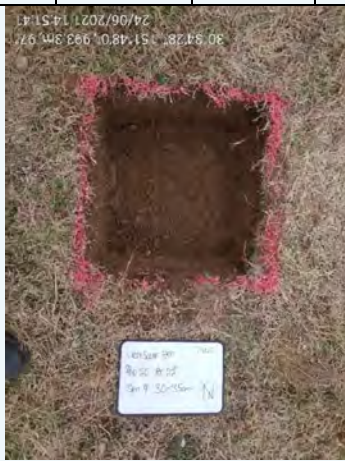
</div><div>PAD 20, Pit 22, Spit 4.</div></div><div><div>

Grassed topsoil</div></div></div></div><div><div>Dark humic sandy loam with thick tuft grass atop. Some gravel observed with depth.</div><div>Compaction, gravel and clay content increasing with depth</div></div></div><div><div>20</div><div><div>22</div><div>384944, 6616934</div><div><div><div>1</div><div>1-10</div><div>Grass and weed cover over shallow loamy sand humic soil ~2cm. Worms and grass-root inclusions throughout. PH=6.5</div><div>Nil</div></div><div><div>2</div><div>10-20</div><div>Lots of roots and gravel. Size of rocks increasing with depth. Grubs throughout. PH=6.5.</div><div>Nil</div></div><div><div>3</div><div>20-30</div><div>As above.</div><div>Nil</div></div><div><div>4</div><div>30-35</div><div>Pockets of clay peeking through at ~32cm. Heavy gravel and rock inclusions with insect burrows in the wall. Sandy clay composition. PH=6.</div><div>Nil</div></div></div></div><div><div><div>

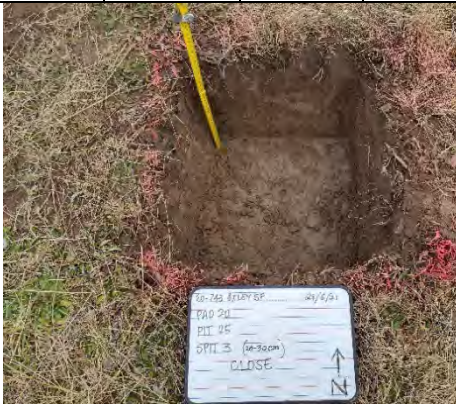
<div>PAD 20, Pit 25, Spit 3.</div></div>			
		<div>

Grassed topsoil</div></div></div></div>						
20	25	385065, 6616934	1	1-10	Very grassy and compact with some grass root and worm inclusions. Loamy sand. PH=6.	Nil

2	10-20	Loamy sand. Few sporadic roots. PH=6.5.	Nil
			3	20-30	Soil starting to get muddy. One earthworm inclusion. Increased moisture content turning the soil to mud. PH=6.5.	Nil
			<div>

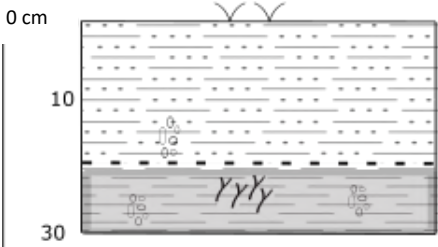
PAD	Pit no	Grid Reference (GDA 94 MGA Zone 56)	Spit number	Depth (cm)	Soil Description	Artefacts
<div><div><div>Oxley Solar Farm PAD #20 Pit # 027</div><div><div><div><div><div><div>0 cm</div><div>10</div><div>30</div></div><div>

</div><div>Dark humic sandy loam.</div><div>Pebble, insect and root inclusions. Clay pockets at top of spit transition to a consistent clay base.</div></div><div><div><div><div><div><div>

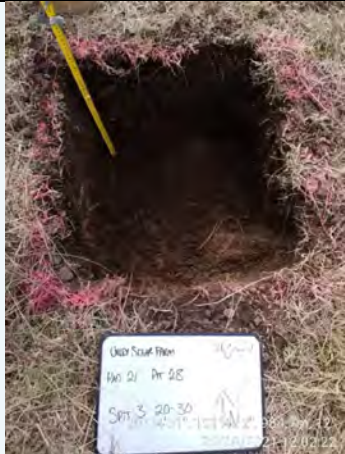
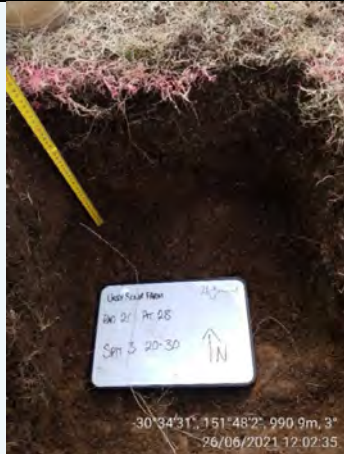
PAD 20, Pit 28, Spit 3.		PAD 20, Pit 28, Spit 3, Northern wall profile.

Grassed topsoil</div></div></div></div></div></div></div></div></div></div></div>						
20	28	384996, 6616844	1	1-10	Loamy sand with lots of ironstone inclusions towards the base. PH=5.	Nil

2	10-20	Loamy sand with gravel to medium-sized rock inclusions.	Nil
			3	20-30	Loamy gritty soil with heaps of small and large ironstone rocks. Sporadic root inclusions towards base and protruding from wall. Clay pockets at ~28cm and clay based at 30cm.	Nil

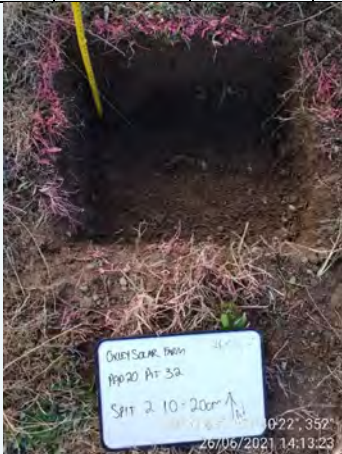
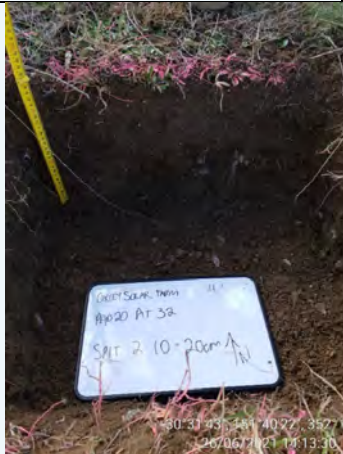
PAD 20, Pit 32A, Spit 2.		PAD 20, Pit 32A, Spit 2, Northern wall profile.

PAD	Pit no	Grid Reference (GDA 94 MGA Zone 56)	Spit number	Depth (cm)	Soil Description	Artefacts
<div><div>Oxley Solar Farm PAD #20 Pit # 031</div><div><div><div><div><div><div>0 cm</div><div>10</div><div>20</div></div><div></div><div><div>Dark brown sandy loam. Thick tuft grass and roots throughout. Earth worms evident.</div><div>Dark brown sticky clay. Ocasional rootlets throughout. Compactness increasing with depth.</div></div></div></div><div><div><div><div> Sand</div><div> Silty Clay</div><div> Compaction</div><div> Root/Insect</div><div> Gradual Boundary</div><div> Sharp Contact</div><div> Sandy loam</div><div> Clay</div><div> Cracking</div><div> Gravels</div><div> Base of Excavation</div><div> Grassed topsoil</div></div></div></div></div></div></div>						
20	32A	385144, 6616758	1	1-10	Loam sand is very gritty. Large quantity of stone and small quartz pebbles. Roots protruding from the base of spit and sides of all four walls.	Nil

2	10-20	As above.	Nil
			3	20-30	Soil transitioning into silty clay with a large quantity of stone and pebbles. Few earthworms and roots protruding out of the walls of the pit. Clay at ~30cm.	Nil

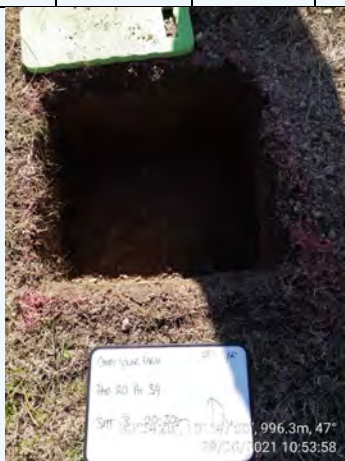
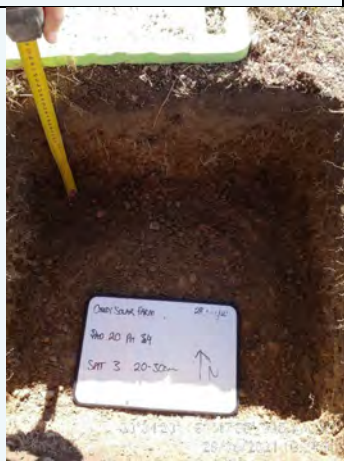
</div></div> <div>PAD 20, Pit 34, Spit 3.</div> <div>PAD 20, Pit 34 Spit 3, Northern wall profile.</div>

Grassed topsoil</div></div><div><p>Sandy loam topsoil with thick tuft grass atop</p><p>Pockets of clay at 20 transition to consistent clay base at 29. Compactness increasing with depth and occasional gravels throughout.</p></div></div></div></div></div></div>						
20	34	384802, 6617180	1	1-10	Occasional grubs in dark humic sandy loam with lots of gravel inclusions. PH=5.	Nil

2	10-20	Gravel inclusions increasing with depth. Loamy sand. PH=5.	Nil
			3	20-30	Consistent gravel inclusions, rootlets protruding from walls.	Nil
			<div><div>

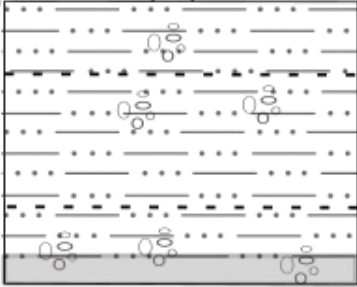
PAD	Pit no	Grid Reference (GDA 94 MGA Zone 56)	Spit number	Depth (cm)	Soil Description	Artefacts
<div><div><div>Oxley Solar Farm PAD #20 Pit # 035</div><div><div><div>0 cm</div><div>10</div><div>30</div><div>40</div></div><div>

</div></div><div><div>Dark humic brown sandy loam with occasional gravel inclusions</div><div>Gravel size and density increasing with depth. Lots of gravel observed throughout.</div><div>Hard gravel based with episodic sandy loam with frequent clay pockets.</div></div><div><div><div> Sand</div><div> Silty Clay</div><div> Compaction</div><div> Root/Insect</div><div> Gradual Boundary</div><div> Grassed topsoil</div><div> Sandy loam</div><div> Clay</div><div> Cracking</div><div> Gravels</div><div> Base of Excavation</div><div> Sharp Contact</div></div></div></div></div>						
20	36	384883, 6617180	1	1-10	Moist dark grey, brown clayey silt with very high gravel content (30%) and pebbles up to 150mm in size. Friable to compact composition. Gravel include quartz, mudstone, basalt and silcrete materials. Grassroots and worms included. Fairly undisturbed apart from compactness due to livestock trampling. PH=6.5	One possible (unlikely) artefact.

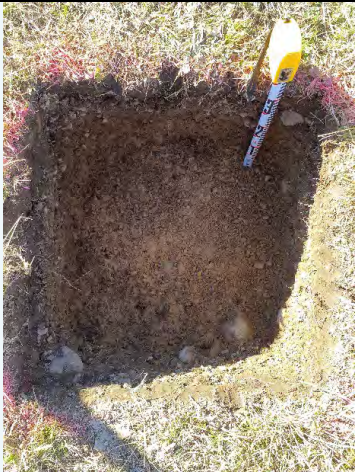
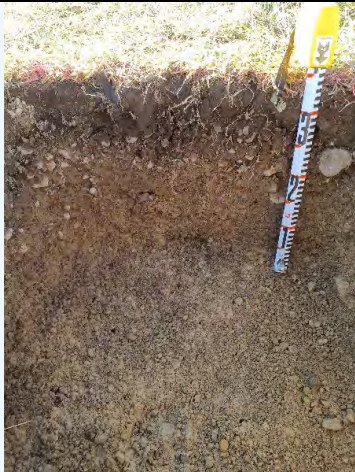
PAD 20, Pit 36, Spit 4.			PAD 20, Pit 36, Spit 4, Northern wall profile.

2	10-20	Sandy clay with a transition to loam with very high gravel and pebble content. Friable with few root inclusions,	Several possible (unlikely) materials were collected.
			3	20-30	Transition to greyer, pale sandy silty clay with mottling throughout.	Nil
			4	30-40	As above. PH=7.	Nil

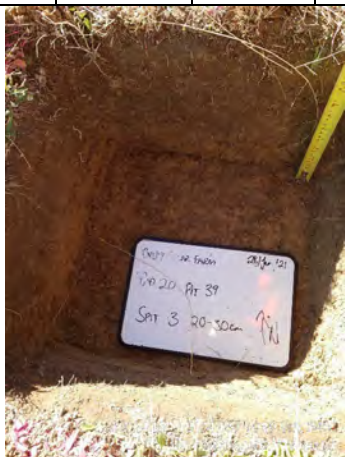
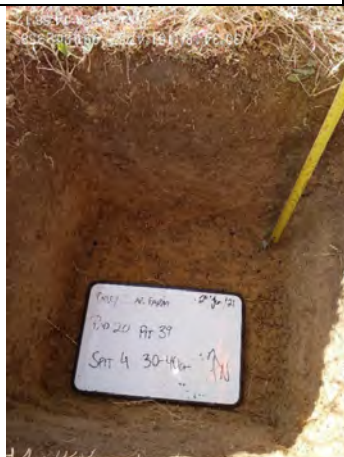
PAD 20, Pit 39, Spit 3.		PAD 20, Pit 39, Spit 4, Northern Wall profile.

</div></div><div><p>Dark humic brown sandy loam with thick tuft grass atop. Occasional charcoal throughout.</p><p>Occasional gravels and transition from sandy loam to silty sandy clay. Moisture content increasing with depth.</p><p>Ironstone throughout with consistent clay base at 40.</p></div></div>						
20	39	384874, 6617247	1	1-10	Thick tuft grass inclusions atop dark humic sandy loam.	Nil
			2	10-20	Moisture content increasing with depth. Occasional roots throughout the dark humic sandy loam.	Nil
			3	20-30	Increased moisture again with one or two gravels amongst the sandy loam.	Nil
			4	30-40	Ironstone inclusions at ~35cm. Pockets of clay at 38cm. Stop at 40cm for a consistent clay base. PH=6.5.	Nil

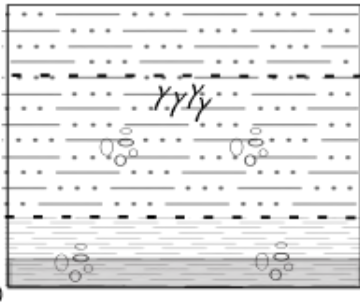
PAD	Pit no	Grid Reference (GDA 94 MGA Zone 56)	Spit number	Depth (cm)	Soil Description	Artefacts
<div><div>Oxley Solar Farm PAD #20 Pit # 039</div><div><div>0 cm</div><div>

</div><div>Dark humic brown sandy loam with thick tuft grass atop.</div><div>Occasional gravels and moisture content increasing with depth.</div><div>Ironstone throughout at 35cm with occasional gravel and consistent clay base at 40.</div><div><div><div>

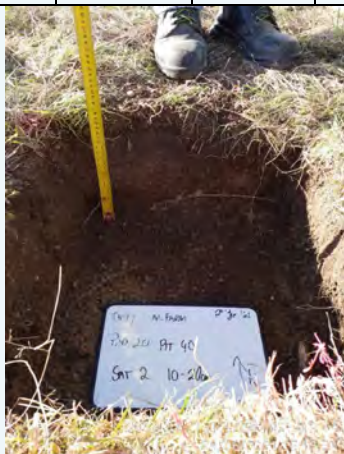
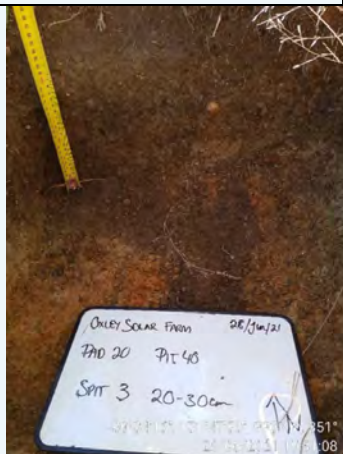
PAD 20, Pit 40, Spit 2.		PAD 20, Pit 40, Spit 3, Northern wall profile.

Grassed topsoil</div></div></div></div></div>						
20	40	384877, 6617289	1	1-10	Occasional pebbles, amongst thick tuft grass and sandy loam soils. A slight depression in landform is evident.	Nil

2	10-20	Gravel content increasing with depth.	Nil
			3	20-30	Clay pockets at ~28cm. Large root in the southeast corner. Pebbles are consistent with the occasional ironstone inclusions evident. Clay at 30cm. PH=6.5.	Nil

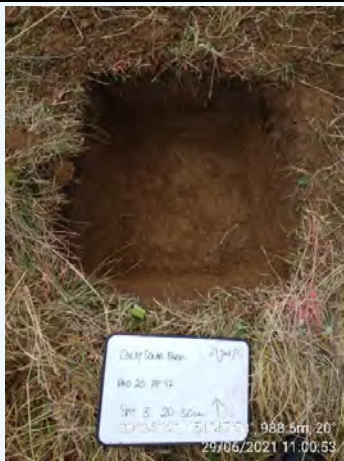
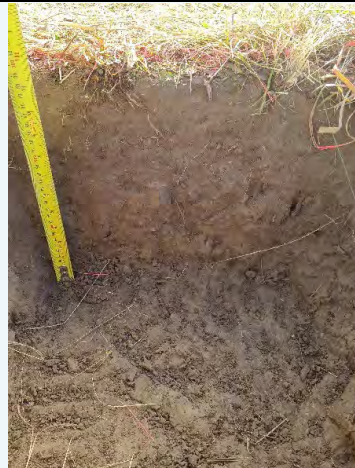
Grassed topsoil</div></div></div></div></div>						
20	42	384880, 6617370	1	1-10	Occasional grub, one or two pebbles, thick tuft grass with a top layer of dark humic sandy loam.	Nil

2	10-20	Transition to clayey dark brown silty loam.	Nil
			3	20-30	Transition to sticky dark brown clay. PH=5.	Nil

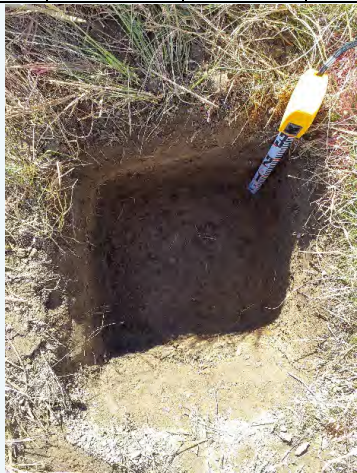
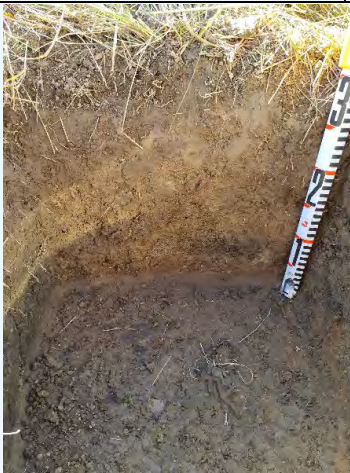
PAD 20, Pit 44, Spit 3.			PAD 20, Pit 44, Spit 3, Northern wall profile.

Grassed topsoil</div></div></div></div></div>						
20	44	384877, 6617451	1	1-10	Soft dark brown damp topsoil with grass-root inclusions throughout.	Nil
			2	10-20	As above with a transition to sticky clay. Some stone ironstone and shale inclusions throughout.	Nil

3	20-30	Sticky dark grey-brown clay with nodules of hard orange, brown clay and ironstone. Some quartz and shale inclusions up to 50mm in size (5%).	Nil

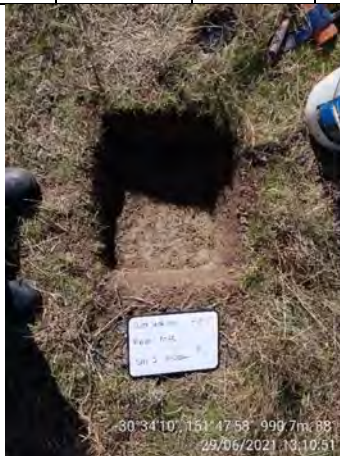
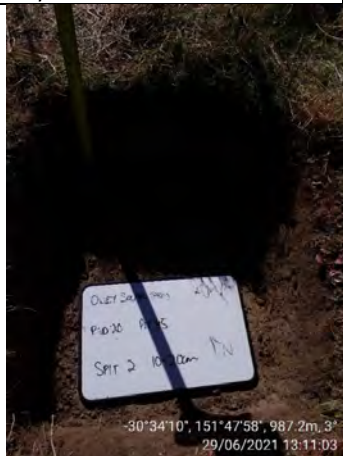
PAD 20, Pit 45, Spit 2.		PAD 20, Pit 45, Spit 2, Northern wall profile.

Grassed topsoil</div></div></div></div>						
20	45	384876, 6617492	1	1-10	Dark humic grey loamy sand.	Nil

2	10-20	Transition to greyish sandy loam with pebbles and then yellow clay from ~15cm.	nil

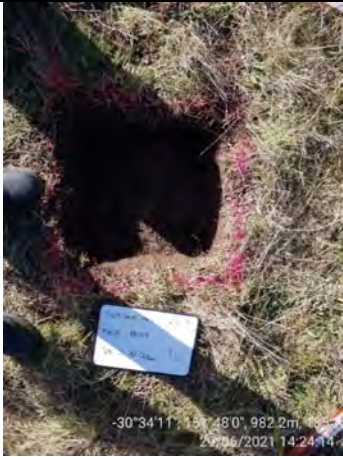
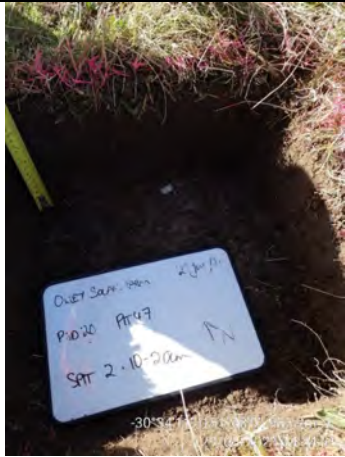
PAD 20, Pit 47, Spit 2.		PAD 20, Pit 47, Spit 2, Northern wall profile.

</div> </div> <div> <div> 0 cm 10 20 </div> <div> </div> <div> Dark humic sandy loam with grass roots.   Dark brown clayey silt transition to pale brown clay with ironstone inclusions and orange mottling throughout </div> </div> <div> <div> </div> </div>						
20	47	384943, 6617456	1	1-10	Loamy sand with <5cm cobble inclusions.	Nil
			2	10-20	Pockets of yellow-orange clay at 17cm. Grey clay base with those pockets at 20cm with some medium-sized gravels throughout.	Nil

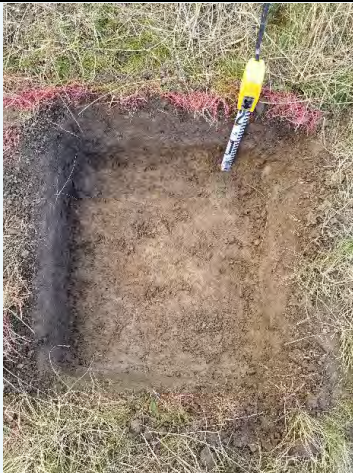
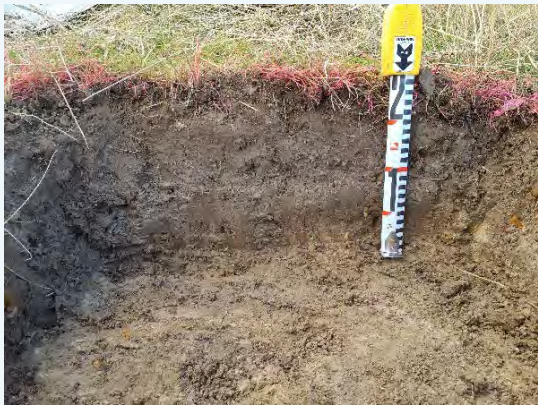
PAD 20, Pit 48, Spit 2.		PAD 20, Pit 48, Spit 2, Northern wall profile.

20	48	384940, 6617417	1	1-10	Dark grey, brown clayey silt	Nil
			2	10-20	Transition to pale grey clay with orangey-brown clay and ironstone inclusions. PH=6.	Nil

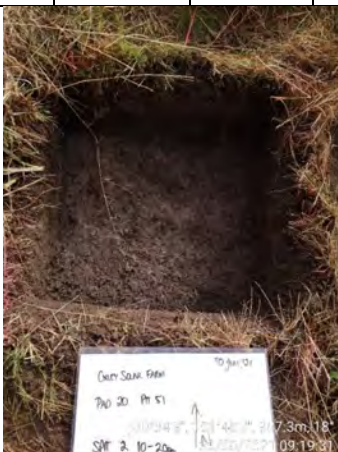
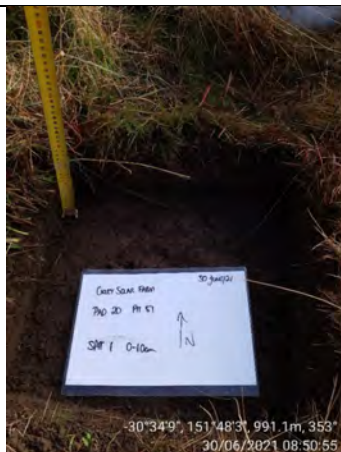
20	51	385010, 6617507	1	1-10	Thick tuft grass atop humic black sandy loam. PH=5.	Nil
			2	10-20	Grey clay base appearing at 18cm and consistent by 20cm. Occasional angular pebbles with no artefact diagnostics.	Nil

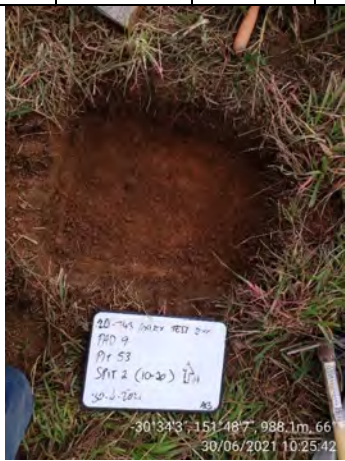
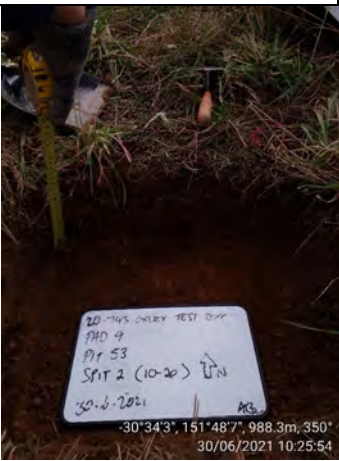
PAD 9, Pit 53, Spit 2.		PAD 9, Pit 53, Spit 2, Northern wall profile.

Grassed topsoil</div></div></div>						
9	53	385111, 6617699	1	1-10	Dark grey, brown silt with quartz pebble inclusions (8%), up to 20mm in size.	2 artefacts (1 quartz broken flake and 1 silcrete flake)
			2	10-20	A few grubs and lots of gravel. Reddish soil. Clay at 20cm.	Nil

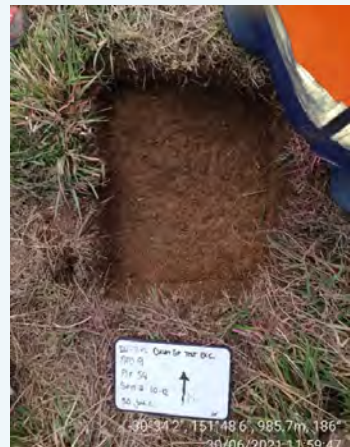
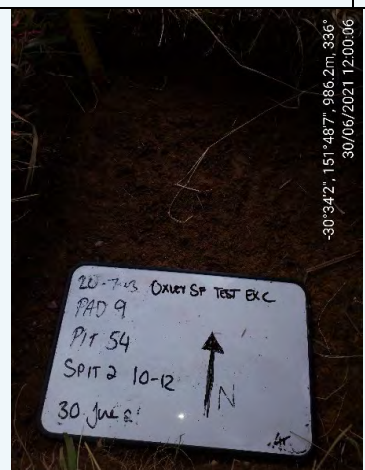
PAD 9, Pit 54, Spit 2.		PAD 9, Pit 54, Spit 2, Northern Wall profile.

Grassed topsoil</div></div></div></div><div><div>Dark grey brown silt with quartz inclusions and two artefacts</div><div>Red clayey soil with grubs and gravel throughout.</div></div></div></div>						
9	54	385109, 6617739	1	1-10	Dark grey, brown silt with significant amounts of petrified wood fragments (10-20%). Quartz pebble and rootlet inclusions.	Nil
			2	10-20	Transition to grey, brown mottled clay.	Some possible artefacts found, quartz/petrified wood.

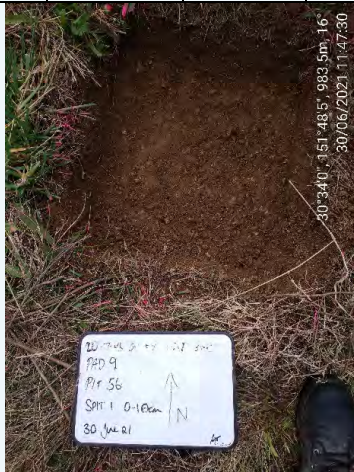
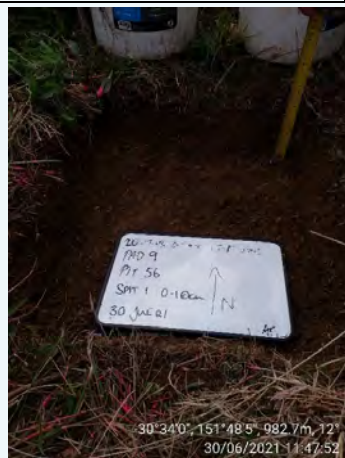
Sharp Contact</div></div></div></div></div> <div><div>9</div><div>56</div><div>385078, 6617802</div><div>1</div><div>1-10</div><div>Sandy loam quickly transition to hard clay base. With insect and gravel inclusions throughout.</div><div>Nil</div></div> <div><div>

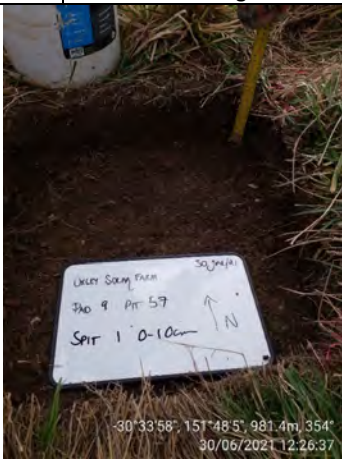
</p>						
9	57	385079, 6617842	1	1-10	Sandy loam quickly transition to hard clay base. With insect and gravel inclusions throughout.	Nil

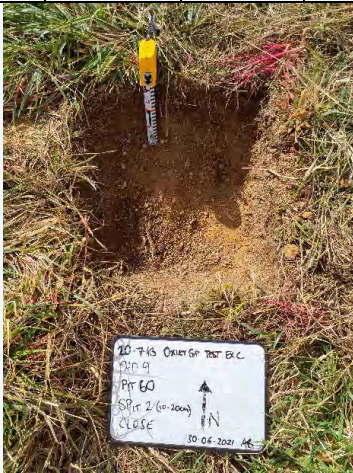
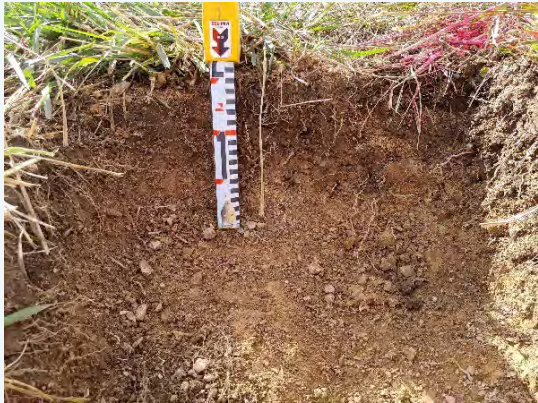
PAD 9, Pit 60, Spit 2.			PAD 9, Pit 60, Spit 2, Northern wall profile.

Grassed topsoil</div></div></div></div>						
9	60	385131, 6617739	1	1-10	Sandy loam with occasional worms throughout. Thick grey clay at 12cm.	Nil
			2	10-20	Consistent clay base 13cm onwards.	Nil

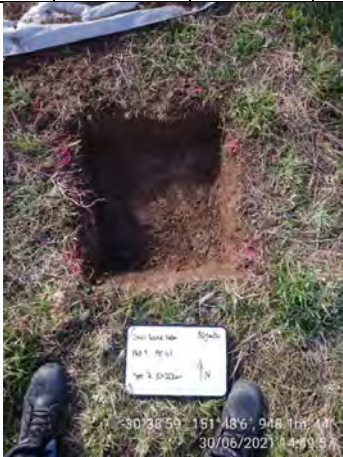
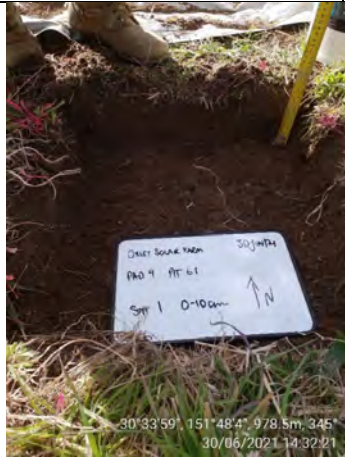
Grassed topsoil </p>						
9	61	385054, 6617822	1	1-10	Dark humic sandy loam with pockets of grey clay.	3 possible artefacts.
			2	10-20	Consistent grey clay base at 20cm. Occasional angular rocks with depth but nothing artefactual	Nil

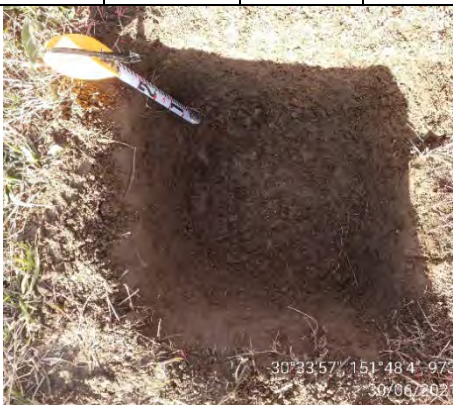
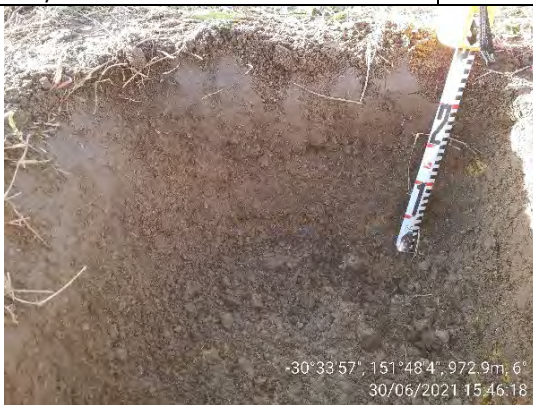
PAD 9, Pit 63, Spit 3.			PAD 9, Pit 63, Spit 3, Northern wall profile.

Grassed topsoil</div></div></div></div></div>						
9	63	385042, 6617883	1	1-10	Dak grey, brown clayey loam with roots and inclusions of rock and quartz up to 30mm in size up to 5%.	Nil
			2	10-20	Continuation of above. High content of gravel/pebbles with angular sandstone inclusions up to 100mm in size, 20%.	Nil

3	20-30	Transitioning into darker grey, brown with orange clay nodules. PH=6.5.	Nil

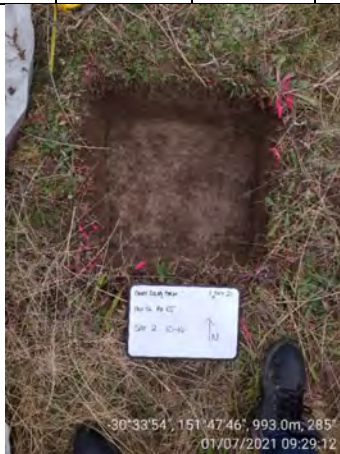
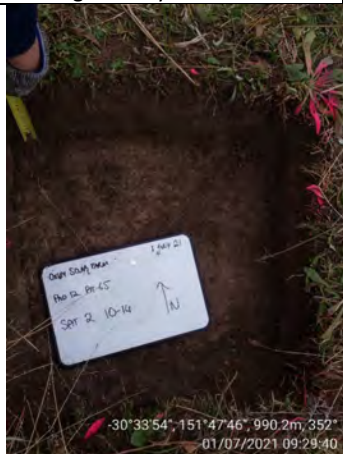
</div></div> <div><div>PAD 12, Pit 65, Spit 2.</div><div>PAD 12, Pit 65, Spit 2, Northern wall profile.</div></div>

Grassed topsoil</div></div></div> <div><div>9</div><div>65</div><div>384562, 6617980</div><div><div>1</div><div>2</div></div><div><div>1-10</div><div>10-15</div></div><div><div>Thick tuft grass atop dark humic sandy loam.</div><div>Pockets of yellow clay at 12cm which continues with depth. Consistent great clay base at 14cm.</div></div><div>Nil</div><div>Nil</div></div> <div><div>

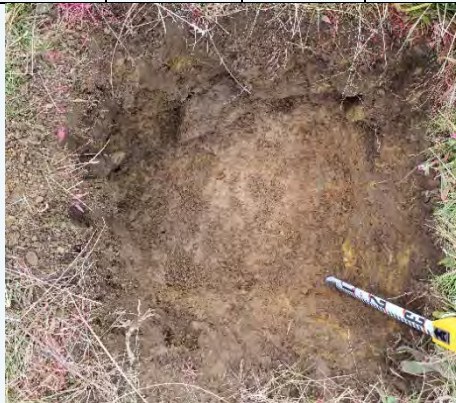
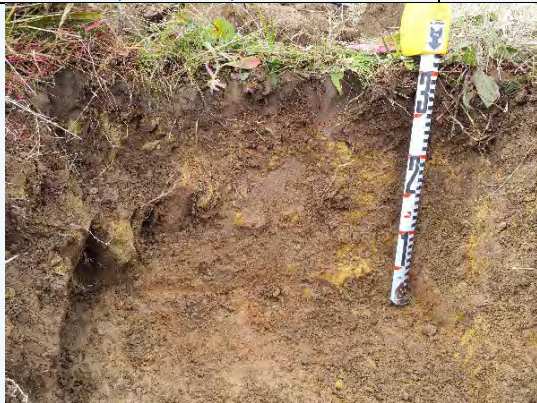
PAD 12, Pit 66, Spit 6.		PAD 12, Pit 66, Spit 6, Northern wall profile.

Grassed topsoil</div></div></div></div>						
12	66	384530, 6618007	1	1-5	Large angular rocks within orangey brown clayey silt. Root and worm inclusions throughout. Decomposing sandstone also noted throughout up to 20cm in size.	Nil

2	5-10	As above. PH=6.5.	Nil
			3	10-15	Ad above.	Nil
			4	15-20	As above. Transitions to pale grey, brown clay.	Nil
			5	20-25	Clay mottling orange, brown with grey shaley nodules.	Nil
			6	25-30	Transition to sticky brown clay.	Nil

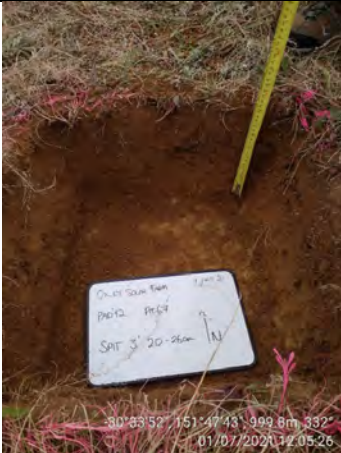
PAD 12, Pit 67, Spit 3.

Grassed topsoil</div></div></div></div></div>						
12	67	384482, 6618043	1	1-10	A couple of grubs observed, lots of gravel, light brown sandy loam.	Nil

2	10-20	Larger angular rock (5-10cm).	Nil
			3	20-25	Yellow cream clay base layer with some gravels atop.	Nil

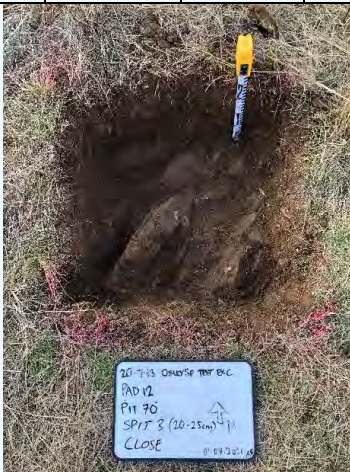
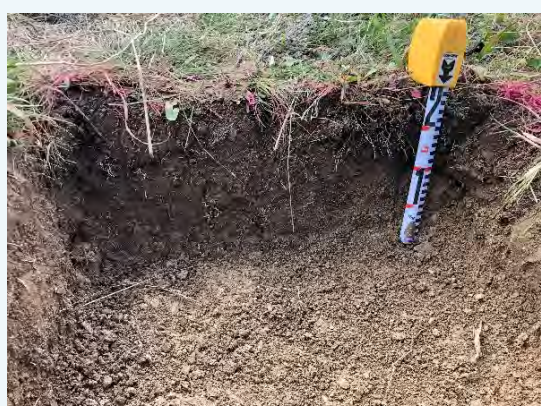
PAD 12, Pit 68, Spit 3.	PAD12, Pit 68, Spit 3, Northern wall profile.

</div><div><div>Light brown sandy loam with occasional grubs and large angular rocks (5-10cm) observed towards lower end of spit.</div><div>Yellow cream clay base later with some gravels throughout.</div></div></div><div><div><div><div> Sand</div><div> Silty Clay</div><div> Compaction</div><div> Root/Insect</div><div> Gradual Boundary</div><div> Sharp Contact</div><div> Sandy loam</div><div> Clay</div><div> Cracking</div><div> Gravels</div><div> Base of Excavation</div><div> Grassed topsoil</div></div></div></div></div>						
12	68	384514, 6618072	1	1-10	Dark grey, brown clayey silt with 10% sandstone inclusions (up to 5cm in size). PH=6.	Nil
			2	10-20	As above but less than 5% stone.	Nil

3	20-30	Transition to paler grey, brown sticky clay with minor orange mottling. PH=7.	Nil

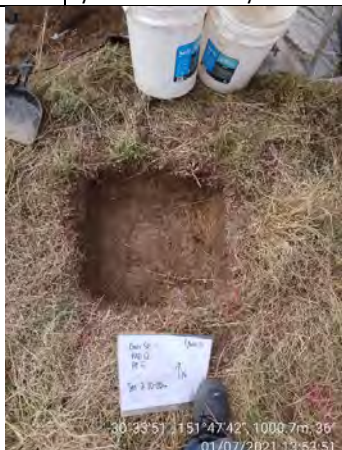
</div><div>PAD12. Pit 69. Spit 2.</div></div></div>

Grassed topsoil</div></div></div></div><div><div>12</div><div>69</div><div>384449, 6618064</div><div><div>1</div><div>2</div></div><div><div>1-10</div><div>10-20</div></div><div><div>Dark humic sandy loam with occasional gravels.</div><div>Yellow pockets of clay at 11cm and consistent yellow brown clay base at 20cm.</div></div><div>Nil</div><div>Nil</div></div><div>

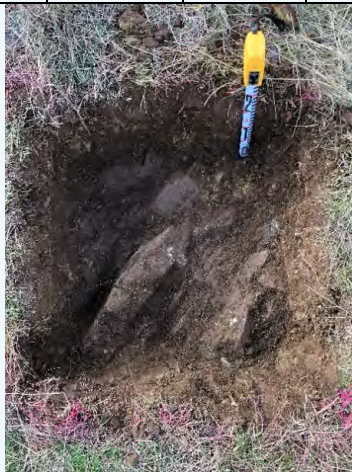
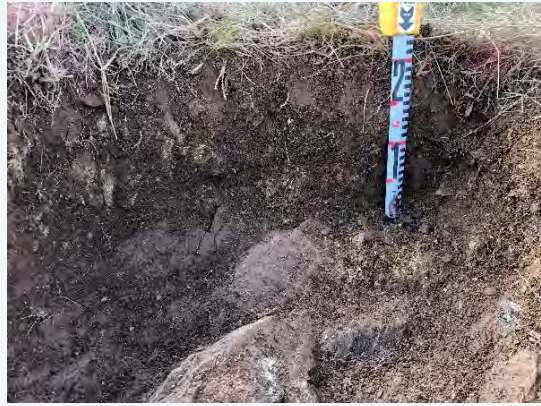
</div></div><div><div>PAD 12, Pit 70, Spit 3.</div><div>PAD 12, Pit 70, Spit 3, Northern wall profile.</div></div></div></div> </

Grassed topsoil</div></div></div></div></div><div><div>12</div><div><div>70</div><div>384477, 6618095</div><div><div>1</div><div>2</div><div>3</div></div><div><div>1-10</div><div>10-20</div><div>20-25</div></div><div><div>Dark grey, brown clayey silt with 40% inclusions of angular sandstone up to 10cm in size.</div><div>As above.</div><div>Sandstone boulders evident throughout base.</div></div><div>Nil</div><div>Nil</div><div>Nil</div></div><div><div>

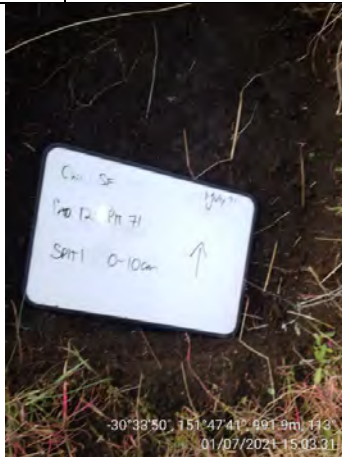
PAD 12, Pit 71, Spit 2.

Grassed topsoil</div></div></div></div>						
12	71	384424, 6618097	1	1-10	Sandy loam with clay inclusions. Clay content increasing with depth.	Nil
			2	10-15	Larger medium sized rocks throughout. Fairly sticky compact clay transitions to a hard clay base.	Nil

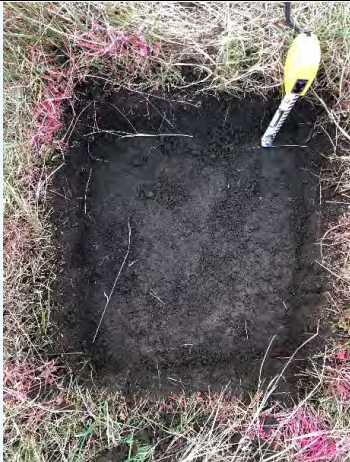
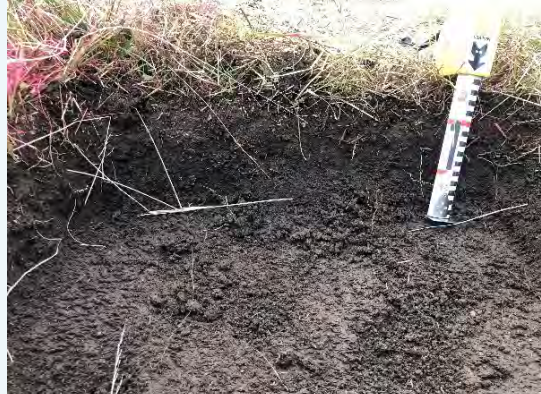
PAD 12, Pit 72, Spit 2.			PAD 12, Pit 72, Spit 2, Northern wall profile.

Grassed topsoil</div></div></div></div></div></div>						
12	72	384470, 6618139	1	1-10	Grass and roots atop a dark brown to black silty clay. Compact and damp, ‘flood mud’ from drainage line. PH=6.	Nil

2	10-15	As above. Compact and sticky.	Nil

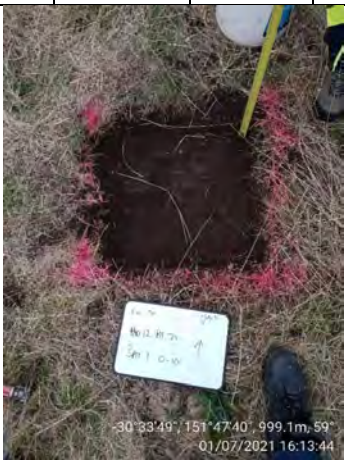
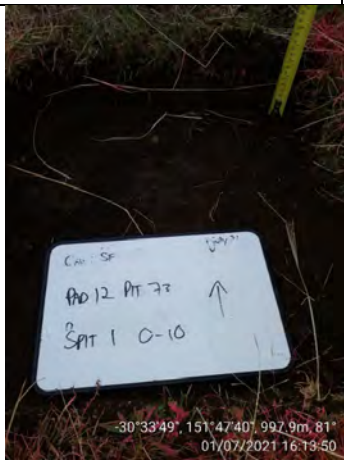
Grassed topsoil </p>						
12	73	384407, 6618132	1	1-10	Black humic silty clayey loam beneath thick tuft grass with occasional pebbles.	Nil
			2	10-20	Dark humic black soil with clay content increasing with depth and large rock inclusions throughout.	Nil

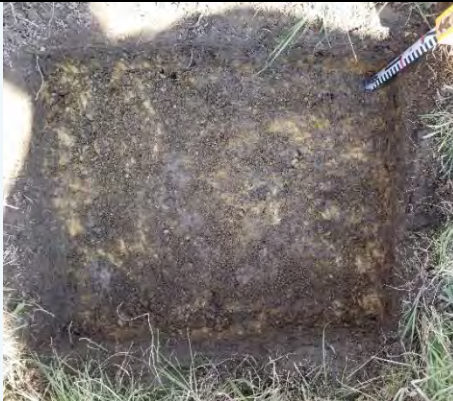
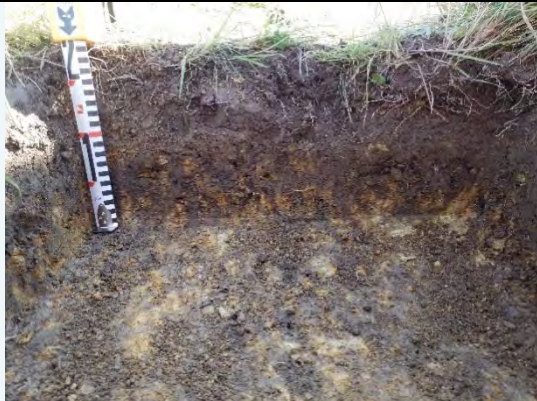
</div></div>			
			<div><div>PAD 13, Pit 74, Spit 4.</div><div>PAD 13, Pit 74, Spit 4, Northern wall profile.</div></div>

2	5-10	As above but transitioning to orange mottled clay (only 1% base) very sticky.	Nil
			3	10-15	Continue as above with orange mottling from decomposing sandstone observed.	Nil
			4	15-20	As above, 100% decomposing stone.	Nil
			<div><div>

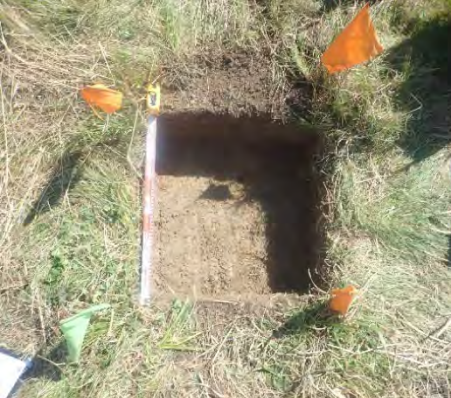
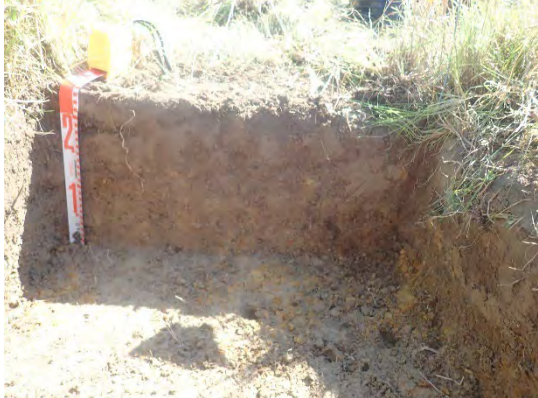
PAD 13, Pit 75, Spit 2.		PAD 13, Pit 75, Spit 2, Northern wall profile.

Grassed topsoil</div></div></div></div>						
13	75	384804, 6618283	1	1-10	Grassy topsoil but soft soil due to frost. Sporadic roots.	Nil.

2	10-20	Sporadic roots protruding from all walls with some worms throughout. Moist soil with degrading ironstone throughout. Some insects throughout.	Nil.

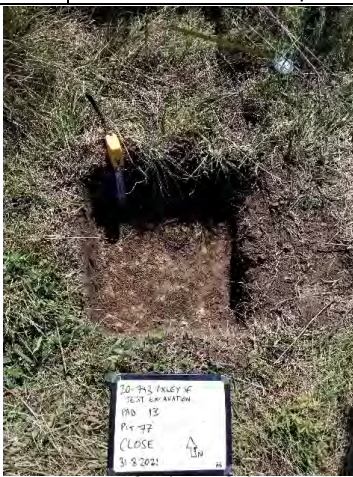
PAD 13, Pit 77, Spit 1.

Grassed topsoil </div> </div> </div>						
13	77	384845, 6618293	1	1-10	Dark grey, brown clayey loam with small gravel inclusions (5%) <5mm. Some grass roots <5%, <3mm thick. Fine gavel. One large piece of stone - friable/claystone. Transitions to some orange mottling and then clay base with decomposing sandstone at base of spit.	Nil

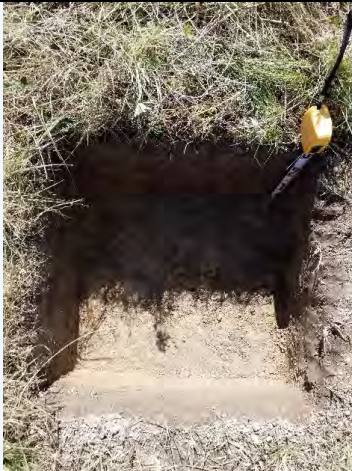
<div>PAD 13, Pit 78, Spit 3</div>

2	10-20	As above.	1 possible artefact.
			3	20-30	Compacted and degraded soil/sandstone. One jasper rock (non-artefactual), loamy clay transitions to clay with few pebbles.	Nil

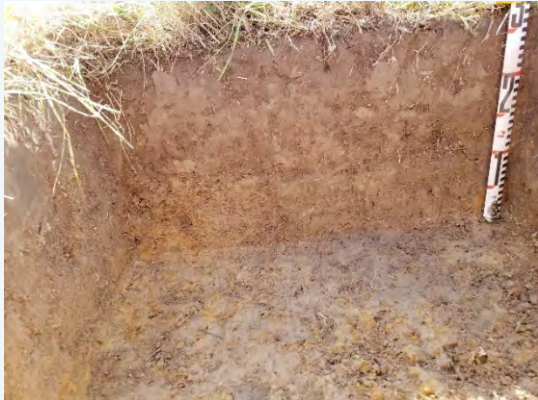
<div>PAD 13, Pit 78, Spit 3, Northern wall profile</div>			
13	79	384930, 6618245	1	1-10	Fine grained clayey loam with dark brown to brown soil. Very high rock content (40%), up to 10cm in size with breakable claystone nodule inclusions.	Nil.
			2	10-20	Transition into yellow claystone, very breakable, to continue digging would be quarrying.	Nil.

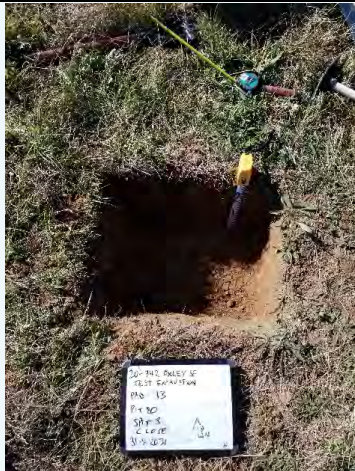
<p>PAD 13, Pit 80, Spit 3</p>

2	10-20	Brown fine grained clayey silt appearance of orange mottled clay/ grey clay and decomposed soils at approximately 15cm depth.	Nil
			3	20-30	At approximately 25cm appearance of some of the decomposed claystone.	Nil

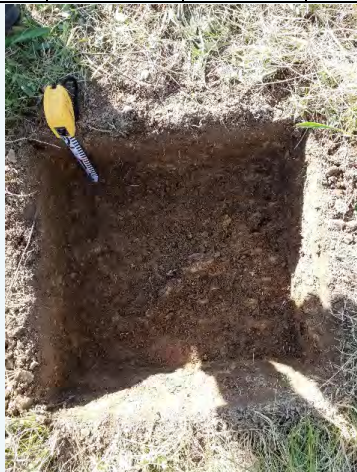
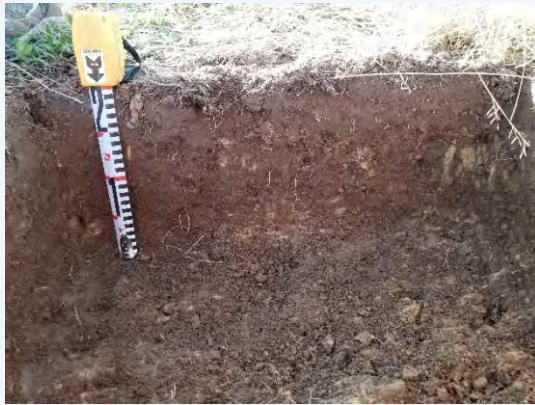
PAD 13, Pit 82, Spit 2		PAD 13, Pit 82, Spit 2, Northern wall profile

Grassed topsoil</div></div></div></div></div>						
13	82	384870, 6618228	1	1-10	Loamy soil with roots protruding. Starting to hit of lot of hard rock.	2 artefacts, basalt flake and quartz flake.
			2	10-20	Loamy sand, lot of pebbles. Starting to get cloggy around the 15cm mark. Few roots protruding towards the base of spit, lots of rocks at base.	Nil

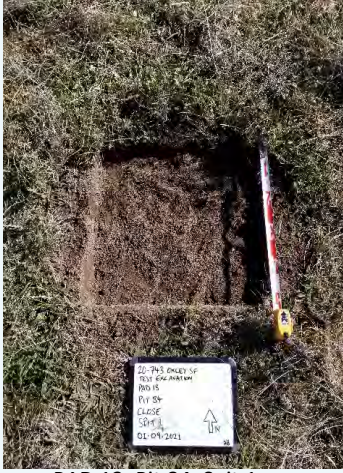
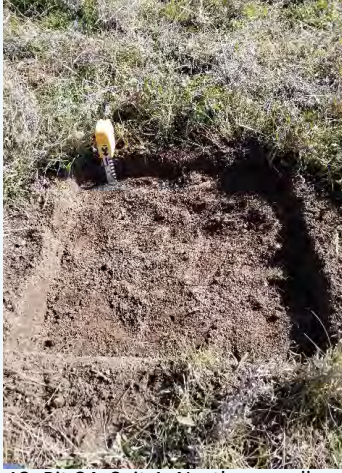
PAD 13, Pit 84, Spit 1.				PAD 13, Pit 84, Spit 1, Northern wall profile.

Grassed topsoil </div> </div>						
13	84	384695, 6618244	1	1-5	Brown loamy topsoil and then onto degrading sandstone.	Nil

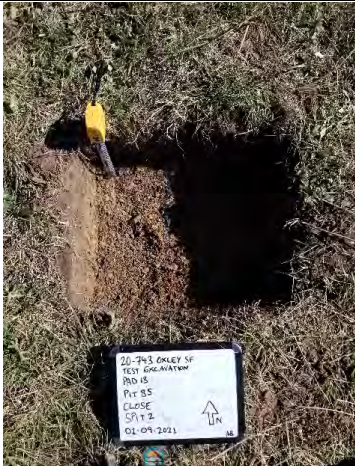
<div>PAD 13, Pit 85, Spit 2.</div></div><div><div>

</div><div>Grassed topsoil</div></div></div></div><div><div>13</div><div><div>85</div><div>384658, 6618230</div></div><div><div>1</div><div>1-10</div><div>Dark grey, brown sticky clayey loam. Very damp with 1% inclusions of decomposed sandstone/claystone (&lt;20mm in size).</div><div>Nil</div></div><div><div>2</div><div>10-20</div><div>From approximately 10cm appearance of orange yellow decomposing sandstone increasing with depth. At approximately 20cm about 80% of content is decomposing sandstone and claystone.</div><div>Nil</div></div></div><div><div>

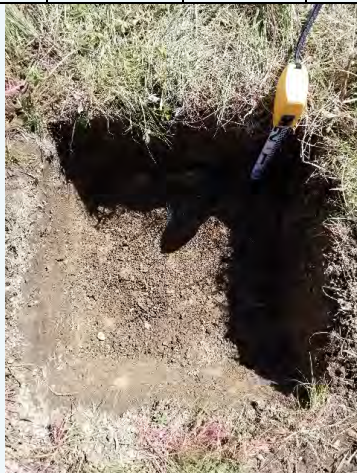
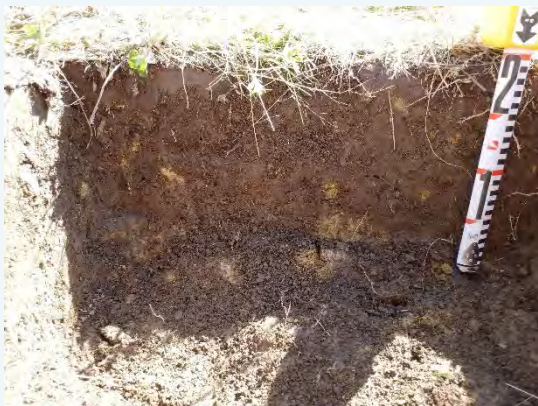
PAD 13, Pit 86, Spit 2				PAD 13, Pit 86, Spit 2, Northern wall profile

</div><div><div>Dark grey brown sticky clayey loam. Very damp with 1% inclusions of decomposed sandstone/claystone (&lt;20mm in size).</div><div>From approximately 10cm appearance of orange yellow decomposing sandstone increasing with depth. At 20cm about 80% of content is decomposing sandstone and claystone.</div></div></div></div>						
13	86	384655, 6618191	1	1-10	Topsoil dark grey, brown clay silty loam	Nil
			2	10-20	As per pit 85.	Nil

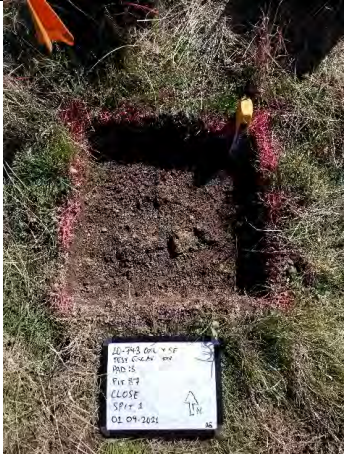
<p>PAD 13, Pit 87, Spit 1</p>

Grassed topsoil </p>						
13	87	384692, 6618201	1	1-10	Loamy top soil with worms, grass roots and carrots throughout. Soil getting moist and then onto degraded sandstone.	Nil

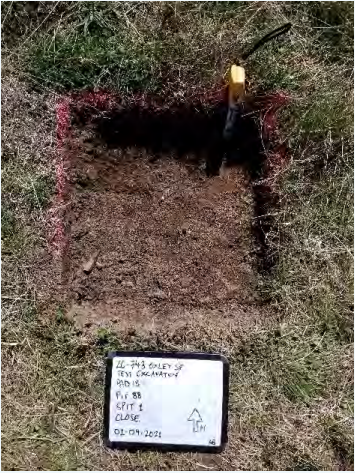
<p>PAD 13, Pit 88, Spit 1.</p>

Gravels    — Base of Excavation    ∨ ∨ Grassed topsoil </p>						
13	88	384683, 6618163	1	1-10	Removal of grass, brown loamy topsoil, worms, degraded sandstone, grass roots	Nil
