# **Archaeological Report – Subsurface Testing**

**Oxley Solar Farm (SSD 10346)**

July 2022

Project Number: 20-743

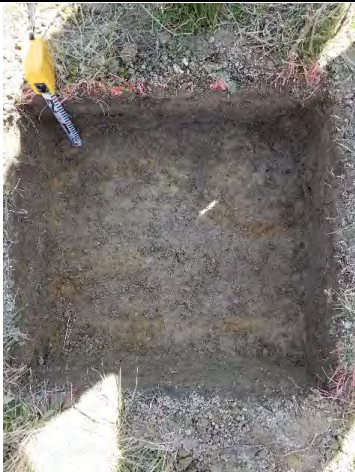
PAD 13, Pit 89, Spit 2

Grassed topsoil</div></div></div></div></div>						
13	89	384615, 6618435	1	1-10	Fine grained grey brown clayey loam to clayey silt. Grass roots <2mm, <1% worms throughout. No stone inclusions.	Nil
			2	10-20	At approximately 15-18cm, hit sticky grey, orange mottled clay with no stone inclusions.	nil

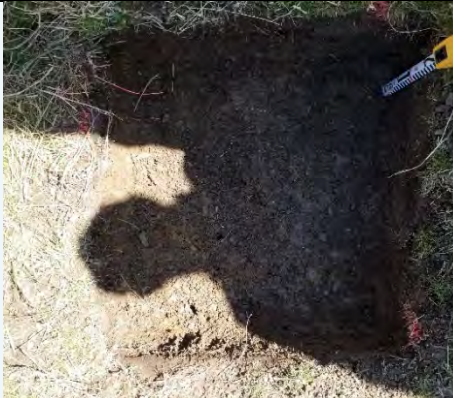
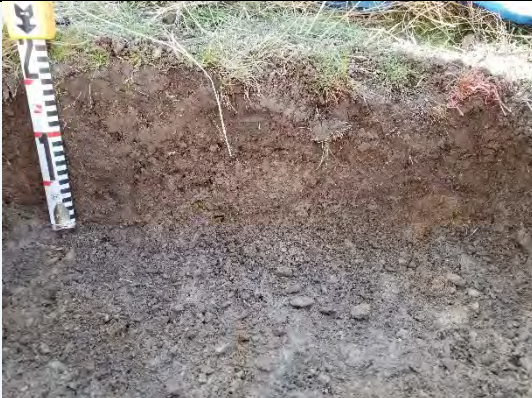
PAD 13, Pit 90, Spit 2					PAD 13, Pit 90, Spit 2, Northern wall profile

Grassed topsoil</div></div></div>						
13	90	384652, 6618416	1	1-10	Clayey dark grey, brown loam transitions into clayey silt. Roots 5%, less than 2mm in size. Transition to crumbly decomposing sandstone. Four some rounded pieces of basalt.	Nil
			2	10-18	Decomposing sandstone as per pits to the south.	Nil

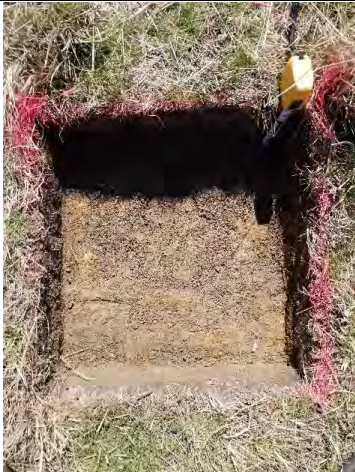
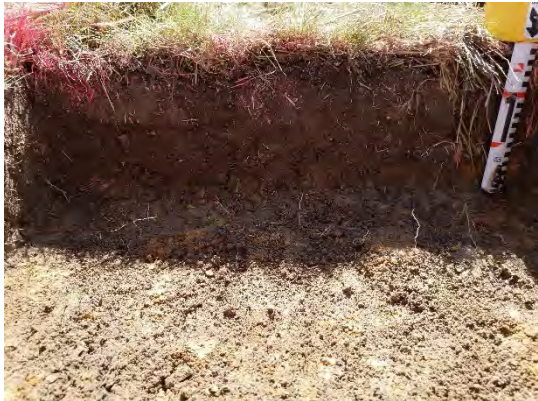
PAD 13, Pit 91, Spit 2			PAD 13, Pit 91, Spit 2, Northern wall profile

Grassed topsoil</div></div></div></div>						
13	91	384641, 6618374	1	1-10	Brownish grey loam with some clay present throughout. Worms, grubs, beetles and bits of stone.	Nil

2	10-20	As above. Coming down onto a clay mixed base.	Nil.

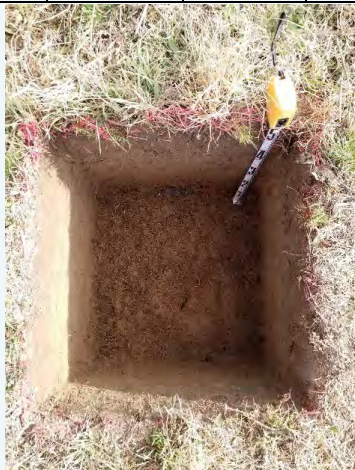
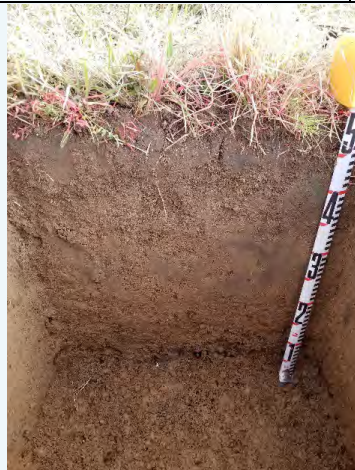
PAD 10, Pit 92, Spit 5		PAD 10, Pit 92, Spit 5

5	40-50	Ironstone more prevalent especially at base quite moist, larger ironstone pieces determined to constitute base of spit.	Nil

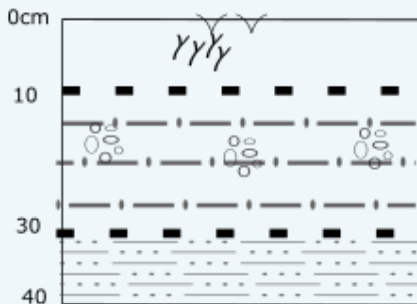
</div><div><div>Sandy silt dark brown loam with no stone inclusions in top layer but roots etc present &lt;2%.</div><div>Transition to pale brown sandy silt with one possible mudstone pebble approximately 5cm in size at approximately 15cm. High moisture.</div><div>Moisture content increasing to become mud, pale brown sandy silt.</div></div><div><div><div>

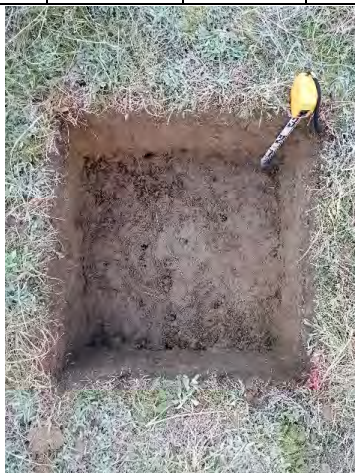
</div> <div>PAD 10, Pit 95, Spit 3</div>				<div>

2	10-20	As above, and then transitioning to pale brown coarse-grained sand and regular small river pebbles.	Nil
			3	20-30	As above, moisture content increasing, Ironstone or decomposing granite appearing at about 25cm, orange/dark brown.	Nil.
	<div>

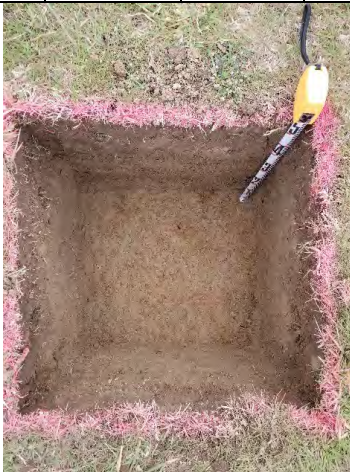
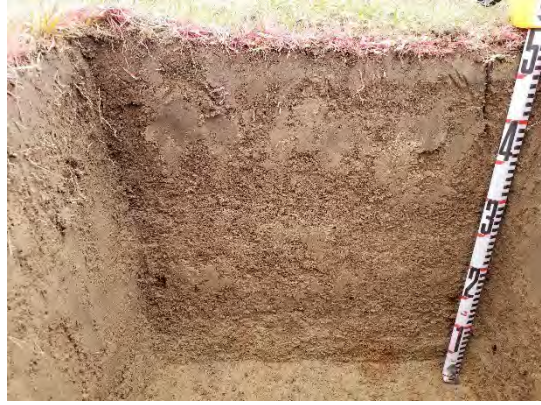
<p>PAD 21, Pit 97, Spit 1</p>

Grassed topsoil</div></div></div></div>						
21	97	385944, 6616229	1	1-10	Sandy soil with worm and grass inclusions, gritty in texture. Soil is moist.	Nil
			2	10-20	Sandy gritty loam with the same context as above.	Nil
			3	20-30	As above. Signs of ironstone.	Nil
			4	30-40	Very moist. As above.	Nil

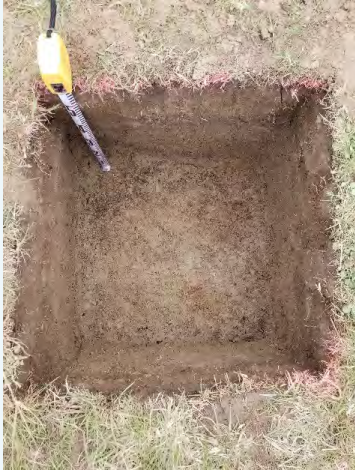
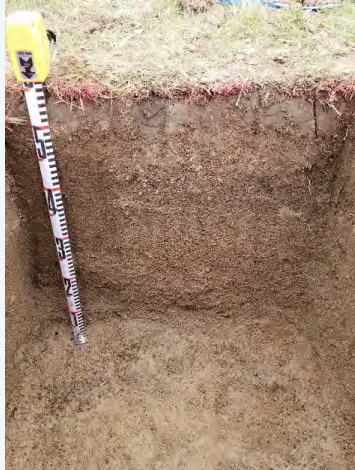
PAD 21, Pit 98, Spit 6.		PAD 21, Pit 98, Spit 6, Northern wall profile.

3	20-30	As above.	Nil
			4	30-40	As above.	Nil
			5	40-50	As above but with appearance of some pieces of ironstone and mottle orange clay (<55%).	Nil
			6	50-60	Increasing ironstone and fine gravel or very coarse sand plus patches of mottled clay.	Nil

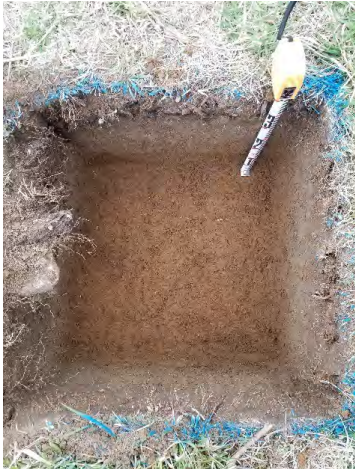
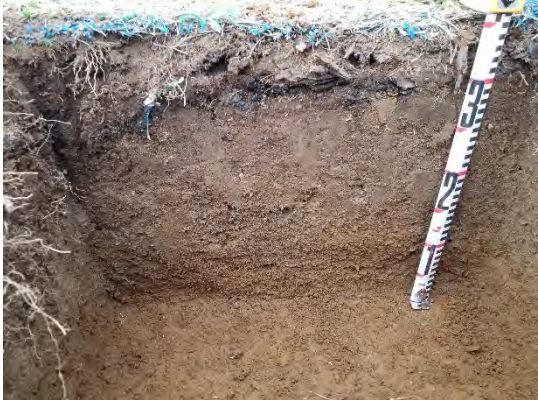
PAD 21, Pit 103, Spit 4.			PAD 21, Pit 103, Spit 4, Northern wall profile.

3	20-30	Light brown sandy soil, gritty, small to medium quartz inclusions, worms, soil colour change from light brown to orange brownish in colour.	Nil
			4	30-40	Orange, brown sandy soil which transitions into clay. PH=6.5	Nil

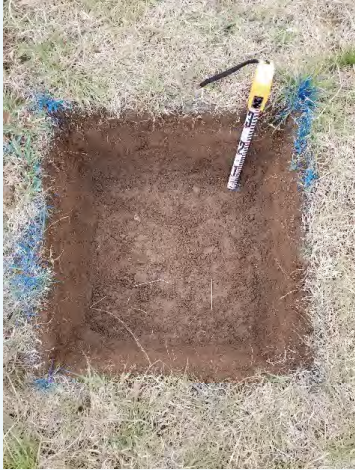
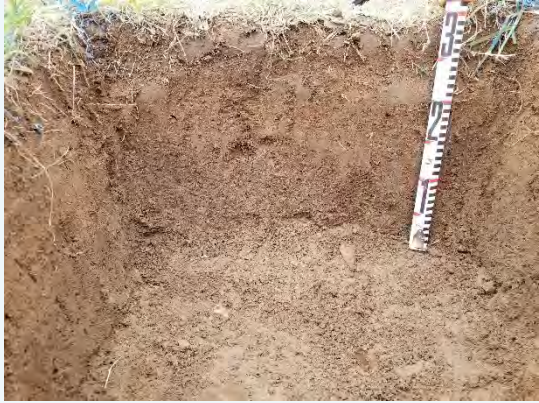
PAD 6, Pit 104, Spit 6.			PAD 6, Pit 104, Spit 6.

6	104	386037, 6615991	1	1-5	Coarse grained silty clayey sand, dark brown.	Nil
			2	5-10	As above.	Nil
			3	10-15	As above.	Nil
			4	15-20	As above.	Nil
			5	20-25	Change to grey, brown clayey sand with river pebbles and cobbles throughout (50% up to 10cm in size).	Nil
			6	25-30	As above, hard cobbles increase to 80%.	Nil

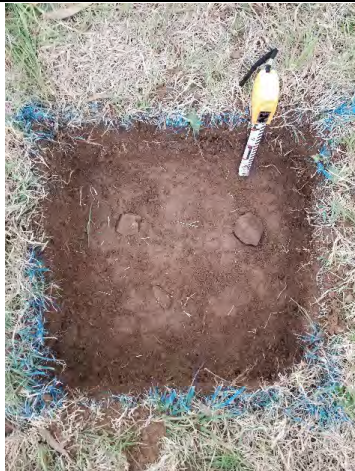
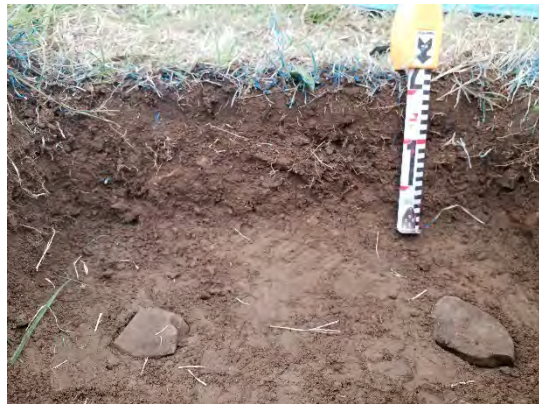
PAD 6, Pit 105, Spit 2.					PAD 6, Pit 105, Spit 2, Northern wall profile.	
<div><div><div><div><div>Oxley Solar Farm</div><div>PAD #6</div><div>Pit # 105</div></div><div><div><div>0cm</div><div>

6	105	386000, 6615987	1	1-10	Rocky from the onset, same as spit 3 of pit 104.	Nil
			2	10-20	Lots of rocks towards base of spit.	Nil

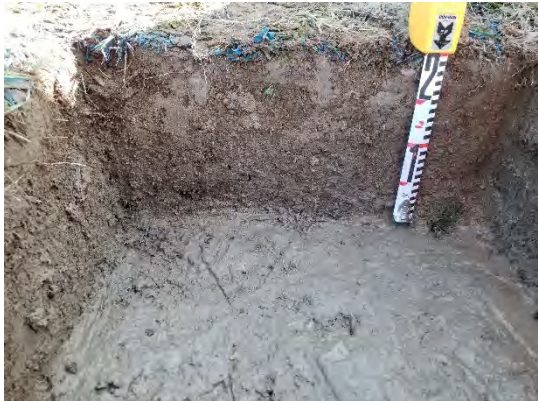
<p>PAD 6, Pit 107, Spit 2, Northern wall profile.</p>
<div> <p><b>Oxley Solar Farm</b> PAD #6 Pit # 107</p>

<p>Topsoil dark brown moist loam with roots and clayey silt with one cobble inclusion. Hit water table so pit terminated.</p> <div> <div>  Sand  Clayey loam  Compaction </div> <div>  Sandy loam  Clay  Cracking </div> <div>  Root/Insect  Gravels </div> <div>  Gradual Boundary  Base of Excavation </div> <div>  Sharp Contact  Grassed topsoil </div> </div> </div>						
19	108	386402, 6614954	1	1-10	Topsoil dark brown medium coarse grained sandy silty loam with grass root inclusions. PH=6.	Nil.
			2	10-20	As above, some small stone pebble inclusions (<2%, <2mm).	Nil.
			3	20-30	Transition to orange, brown clay with high ironstone content. PH=6.5.	Nil.

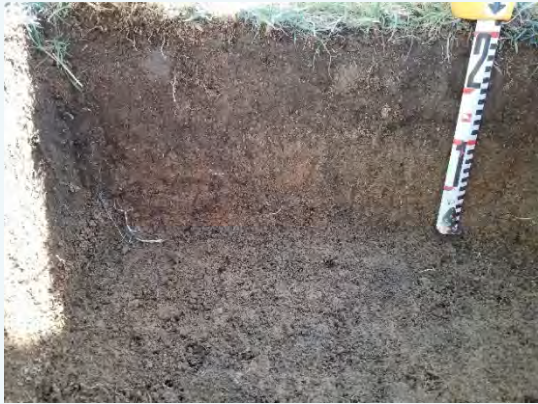
<p>PAD 19, Pit 108, Spit 4, Northern wall profile</p>	
<div style="display: flex; justify-content: space-between; align-items: flex-start;"> <div style="width: 40%;"> <p><b>Oxley Solar Farm</b> <b>PAD #19</b> <b>Pit # 108</b></p>

</div> <div style="width: 55%;"> <p style="text-align: right;">↑ N</p> <p>Topsoil dark brown moist loam with roots.</p> <p>Transition to orange brown clay with ironstone content. Ironstone content increases with depth</p> </div> </div>						
19	109	386408, 6614927	1	1-10	Dark brown loamy soil, grass roots, change in soil colour for spit 2. PH=6.	Nil.
			2	10-20	Appears to be a furrow in the middle of the spit, soil context is gritty with ironstone inclusions. PH=6.5.	Nil.
			3	20-27	As above.	Nil.

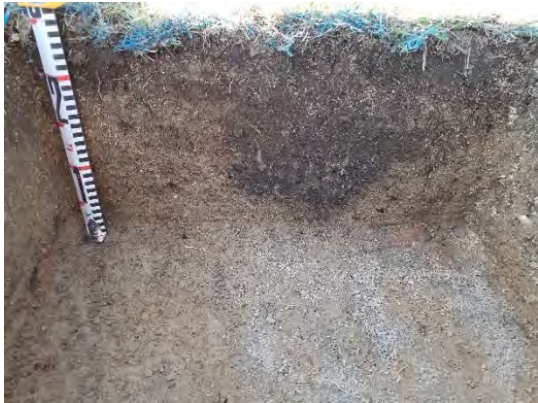
<p>PAD 19, Pit 109, Spit 3, Northern wall profile</p>
<p><b>Oxley Solar Farm</b> <b>PAD #19</b> <b>Pit # 109</b></p> <p>0cm</p>

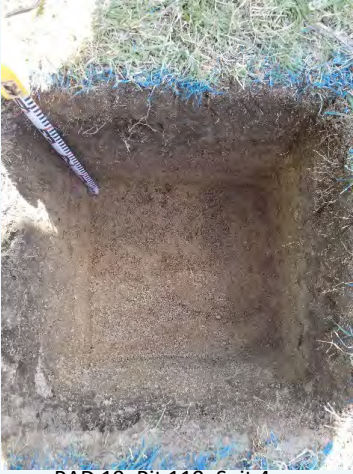
<p>PAD 19, Pit 110, Spit 4</p>

3	20-30	As above, transition to orangey brown silty sand with flecks of charcoal (<1%). PH=6.5.	Nil.
			4	30-40	As above increasing stone inclusions (2%, <2mm). At approximately 34-38cm hit sticky mottled orange, brown clay. PH=6.5.	Nil.

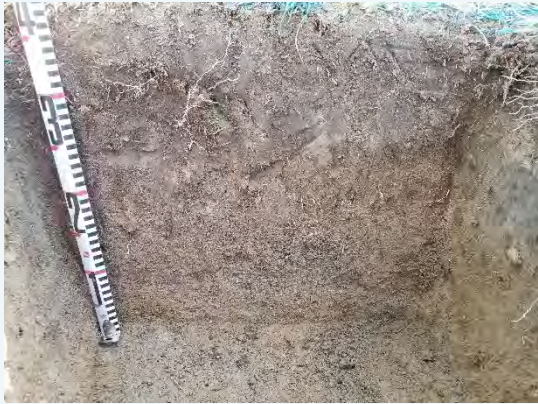
<p>PAD 19, Pit 110, Spit 4, Northern wall profile</p>	
<div> <div> Oxley Solar Farm  PAD #19  Pit # 110 </div> <div>

<p>0cm</p> <p>35</p> <p>40</p> </div> <div> <p>Medium brown coarse grained sandy silty loam, transitions to orange brown with depth and a few charcoal inclusions towards base of spit.</p> <p>Increasing stone inclusions. Sticky mottled orange brown clay at 34 -38cm.</p> </div> <div> <div>  Sand  Clayey loam  Compaction  Root/Insect  Gradual Boundary  Sharp Contact </div> <div>  Sandy loam  Clay  Cracking  Gravels  Base of Excavation  Grassed topsoil </div> </div> </div>						
19	111	386481, 6614848	1	1-10	Removal of grass, light brown soil, worms, grass roots, soil is loamy.	Nil.
			2	10-15	Soil context is a light brown loam with ironstone and grass root inclusions. Onto ironstone bed at the base of the spit.	Nil.
