Oxley Solar Farm

Soil Impact Assessment

October 2022

Project Number: 21-393

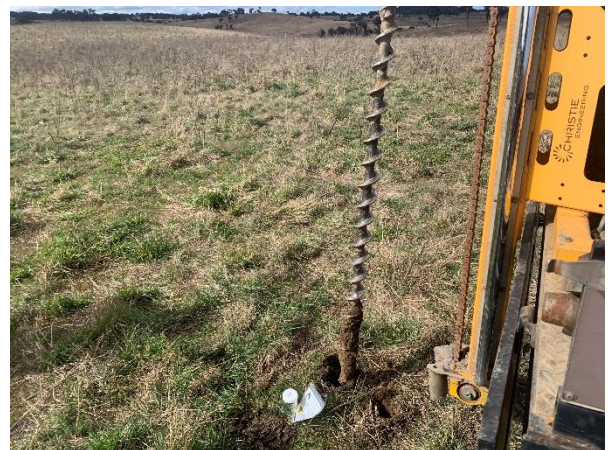
Image 5 BH04

The maximum borehole sampling depth was to 1.0 m Below Ground Level (BGL). Shallow bedrock (sandstone/siltstone) was encountered in borehole locations located in areas higher in the landscape. In some instances, borehole depth was terminated as shallow as 0.4mBGL (BH04).

- Lot 5 DP253346 (BH01, BH03, BH04, BH05, BH09, BH10, BH11, BH12): Bedrock was encountered at shallow depths, ranging from 0.4mBGL in BH04 and 0.5mBGL in BH01. Silty/sandy clay, loose with low plasticity was observed in both boreholes on top of bedrock. Hard clay with low plasticity and gravels were observed in BH05. BH09 observed sandy clays with high plasticity, whereas BH10 and BH11 observed loose sandy clays on top of a gravelly clay with high plasticity. BH12 observed a water layer at 0.1mBGL within a soft clayey sand layer trapped on top of a hard gravel band layer at 0.7mBGL.
