Report on
Preliminary Geotechnical Investigation

Multi-Trades and Digital Technology Hub
See Street, Meadowbank TAFE

Prepared for
The Technical and Further Education Commission

Project 86469.05
October 2019

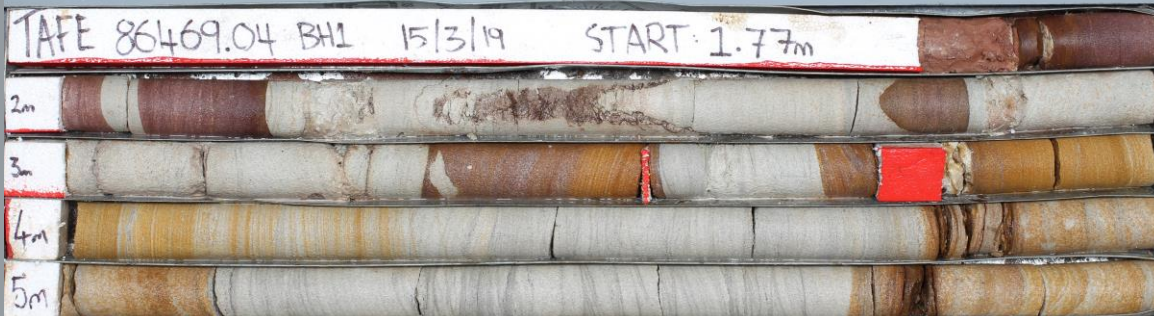
Project No: 86469.04
BH ID: BH1
Depth: 1.77-6.00m
Core Box No.: 1/3

1.6				
	1.87	SANDSTONE: extremely low strength then high strength, moderately then slightly weathered, fractured, red-brown, orange and grey, medium to coarse grained sandstone with some extremely low strength bands		C	1.77		PL(A) = 0.57

1.87				
					1.96				
					2.95		PL(A) = 0.73		
					3.52				
	3.8				3.95		PL(A) = 0.55		
	4.3	SANDSTONE: high strength, fresh and slightly weathered, fractured and slightly fractured, orange and pale-grey, medium to coarse grained sandstone with some indistinct siltstone laminations		C	4.95		PL(A) = 1.71

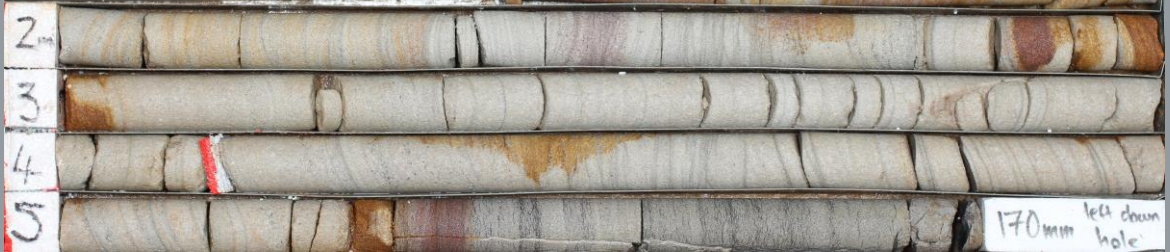
TAFE 86469.04 BHS 17/3/19 START 1.4m BOX 1

1.4	SANDSTONE: high strength, moderately to slightly weathered, slightly fractured to unbroken, pale grey and brown, fine to medium grained sandstone with some high strength ironstained bands			1.38 1.4		PL(A) = 1.61			
	2				1.95		PL(A) = 1.61			
	3	3.05m: becomes fresh stained		C	2.9		PL(A) = 0.96			
	4				3.7		PL(A) = 1.64		Gravel Machine slotted PVC screen

4.15					
	5			C	4.8		PL(A) = 1.15			
	5.26	SANDSTONE: high strength, fresh, slightly fractured, grey, fine to medium grained sandstone with some carbonaceous laminations			5.15		PL(A) = 1.26	20-03-19		
	6	Bore discontinued at 6.0m - Target depth			6.0				End cap	
	7									
	8									
	9

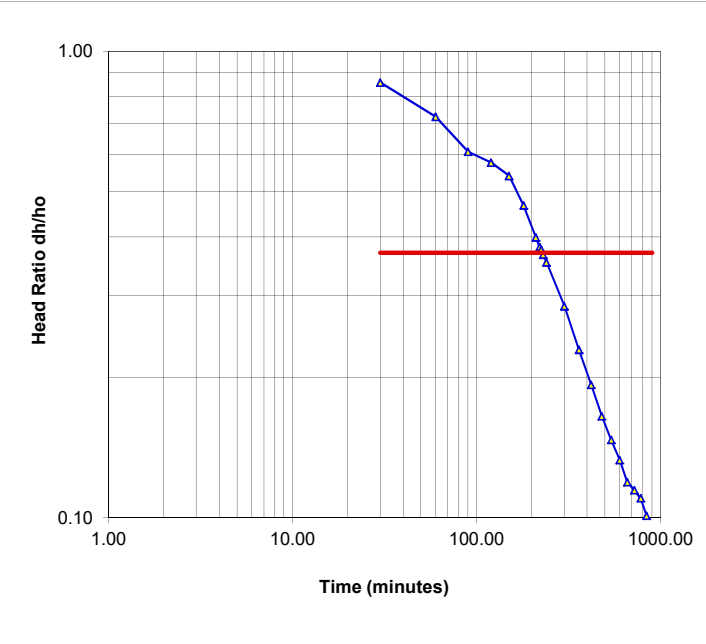
Permeability Testing - Rising Head Test Report

Client: TAFE NSW Project: Multi-Trades & Digital Technology Hub Location: P Block Car park, See St, Meadowbank	Project No: 86469.05 Test date: 20-Sep-19 Tested by: AT																																																																																																
Test Location Description: BH1 Material type: Sandstone	Test No. BH1 Easting: 323562 m Northing: 6256839 m Surface Level: 22.5 m AHD																																																																																																
Details of Well Installation Well casing diameter (2r) 50 mm Well screen diameter (2R) 76 mm Length of well screen (Le) 10.7 m Depth to water before test 7.82 m Depth to water at start of test 10 m																																																																																																	
Test Results <table border="1" style="width: 100%; border-collapse: collapse; margin-top: 10px;"> <thead> <tr> <th>Time (min)</th> <th>Depth (m)</th> <th>Change in Head: δH (m)</th> <th>$\delta H/H_0$</th> </tr> </thead> <tbody> <tr><td>0.00</td><td>10</td><td>2.18</td><td>1.000</td></tr> <tr><td>30.00</td><td>9.69</td><td>1.87</td><td>0.858</td></tr> <tr><td>60.00</td><td>9.4</td><td>1.58</td><td>0.725</td></tr> <tr><td>90.00</td><td>9.15</td><td>1.33</td><td>0.610</td></tr> <tr><td>120.00</td><td>9.08</td><td>1.26</td><td>0.578</td></tr> <tr><td>150.00</td><td>9</td><td>1.18</td><td>0.541</td></tr> <tr><td>180.00</td><td>8.84</td><td>1.02</td><td>0.468</td></tr> <tr><td>210.00</td><td>8.69</td><td>0.87</td><td>0.399</td></tr> <tr><td>220.00</td><td>8.65</td><td>0.83</td><td>0.381</td></tr> <tr><td>225.00</td><td>8.64</td><td>0.82</td><td>0.376</td></tr> <tr><td>230.00</td><td>8.62</td><td>0.80</td><td>0.367</td></tr> <tr><td>240.00</td><td>8.59</td><td>0.77</td><td>0.353</td></tr> <tr><td>300.00</td><td>8.44</td><td>0.62</td><td>0.284</td></tr> <tr><td>360.00</td><td>8.32</td><td>0.50</td><td>0.229</td></tr> <tr><td>420.00</td><td>8.24</td><td>0.42</td><td>0.193</td></tr> <tr><td>480.00</td><td>8.18</td><td>0.36</td><td>0.165</td></tr> <tr><td>540.00</td><td>8.14</td><td>0.32</td><td>0.147</td></tr> <tr><td>600.00</td><td>8.11</td><td>0.29</td><td>0.133</td></tr> <tr><td>660.00</td><td>8.08</td><td>0.26</td><td>0.119</td></tr> <tr><td>720.00</td><td>8.07</td><td>0.25</td><td>0.115</td></tr> <tr><td>780.00</td><td>8.06</td><td>0.24</td><td>0.110</td></tr> <tr><td>840.00</td><td>8.04</td><td>0.22</td><td>0.101</td></tr> <tr><td>900.00</td><td>8.03</td><td>0.21</td><td>0.096</td></tr> </tbody> </table> <div style="margin-top: 20px;">

<div style="text-align: right; margin-top: 10px;"> To = 227 mins 13620 secs </div> </div>		Time (min)	Depth (m)	Change in Head: δH (m)	$\delta H/H_0$	0.00	10	2.18	1.000	30.00	9.69	1.87	0.858	60.00	9.4	1.58	0.725	90.00	9.15	1.33	0.610	120.00	9.08	1.26	0.578	150.00	9	1.18	0.541	180.00	8.84	1.02	0.468	210.00	8.69	0.87	0.399	220.00	8.65	0.83	0.381	225.00	8.64	0.82	0.376	230.00	8.62	0.80	0.367	240.00	8.59	0.77	0.353	300.00	8.44	0.62	0.284	360.00	8.32	0.50	0.229	420.00	8.24	0.42	0.193	480.00	8.18	0.36	0.165	540.00	8.14	0.32	0.147	600.00	8.11	0.29	0.133	660.00	8.08	0.26	0.119	720.00	8.07	0.25	0.115	780.00	8.06	0.24	0.110	840.00	8.04	0.22	0.101	900.00	8.03	0.21	0.096
