Report on
Remediation Action Plan

Proposed Multi-Trades and Digital Technology Hub
See Street, Meadowbank

Prepared for
TAFE NSW

Project 86469.10
September 2019

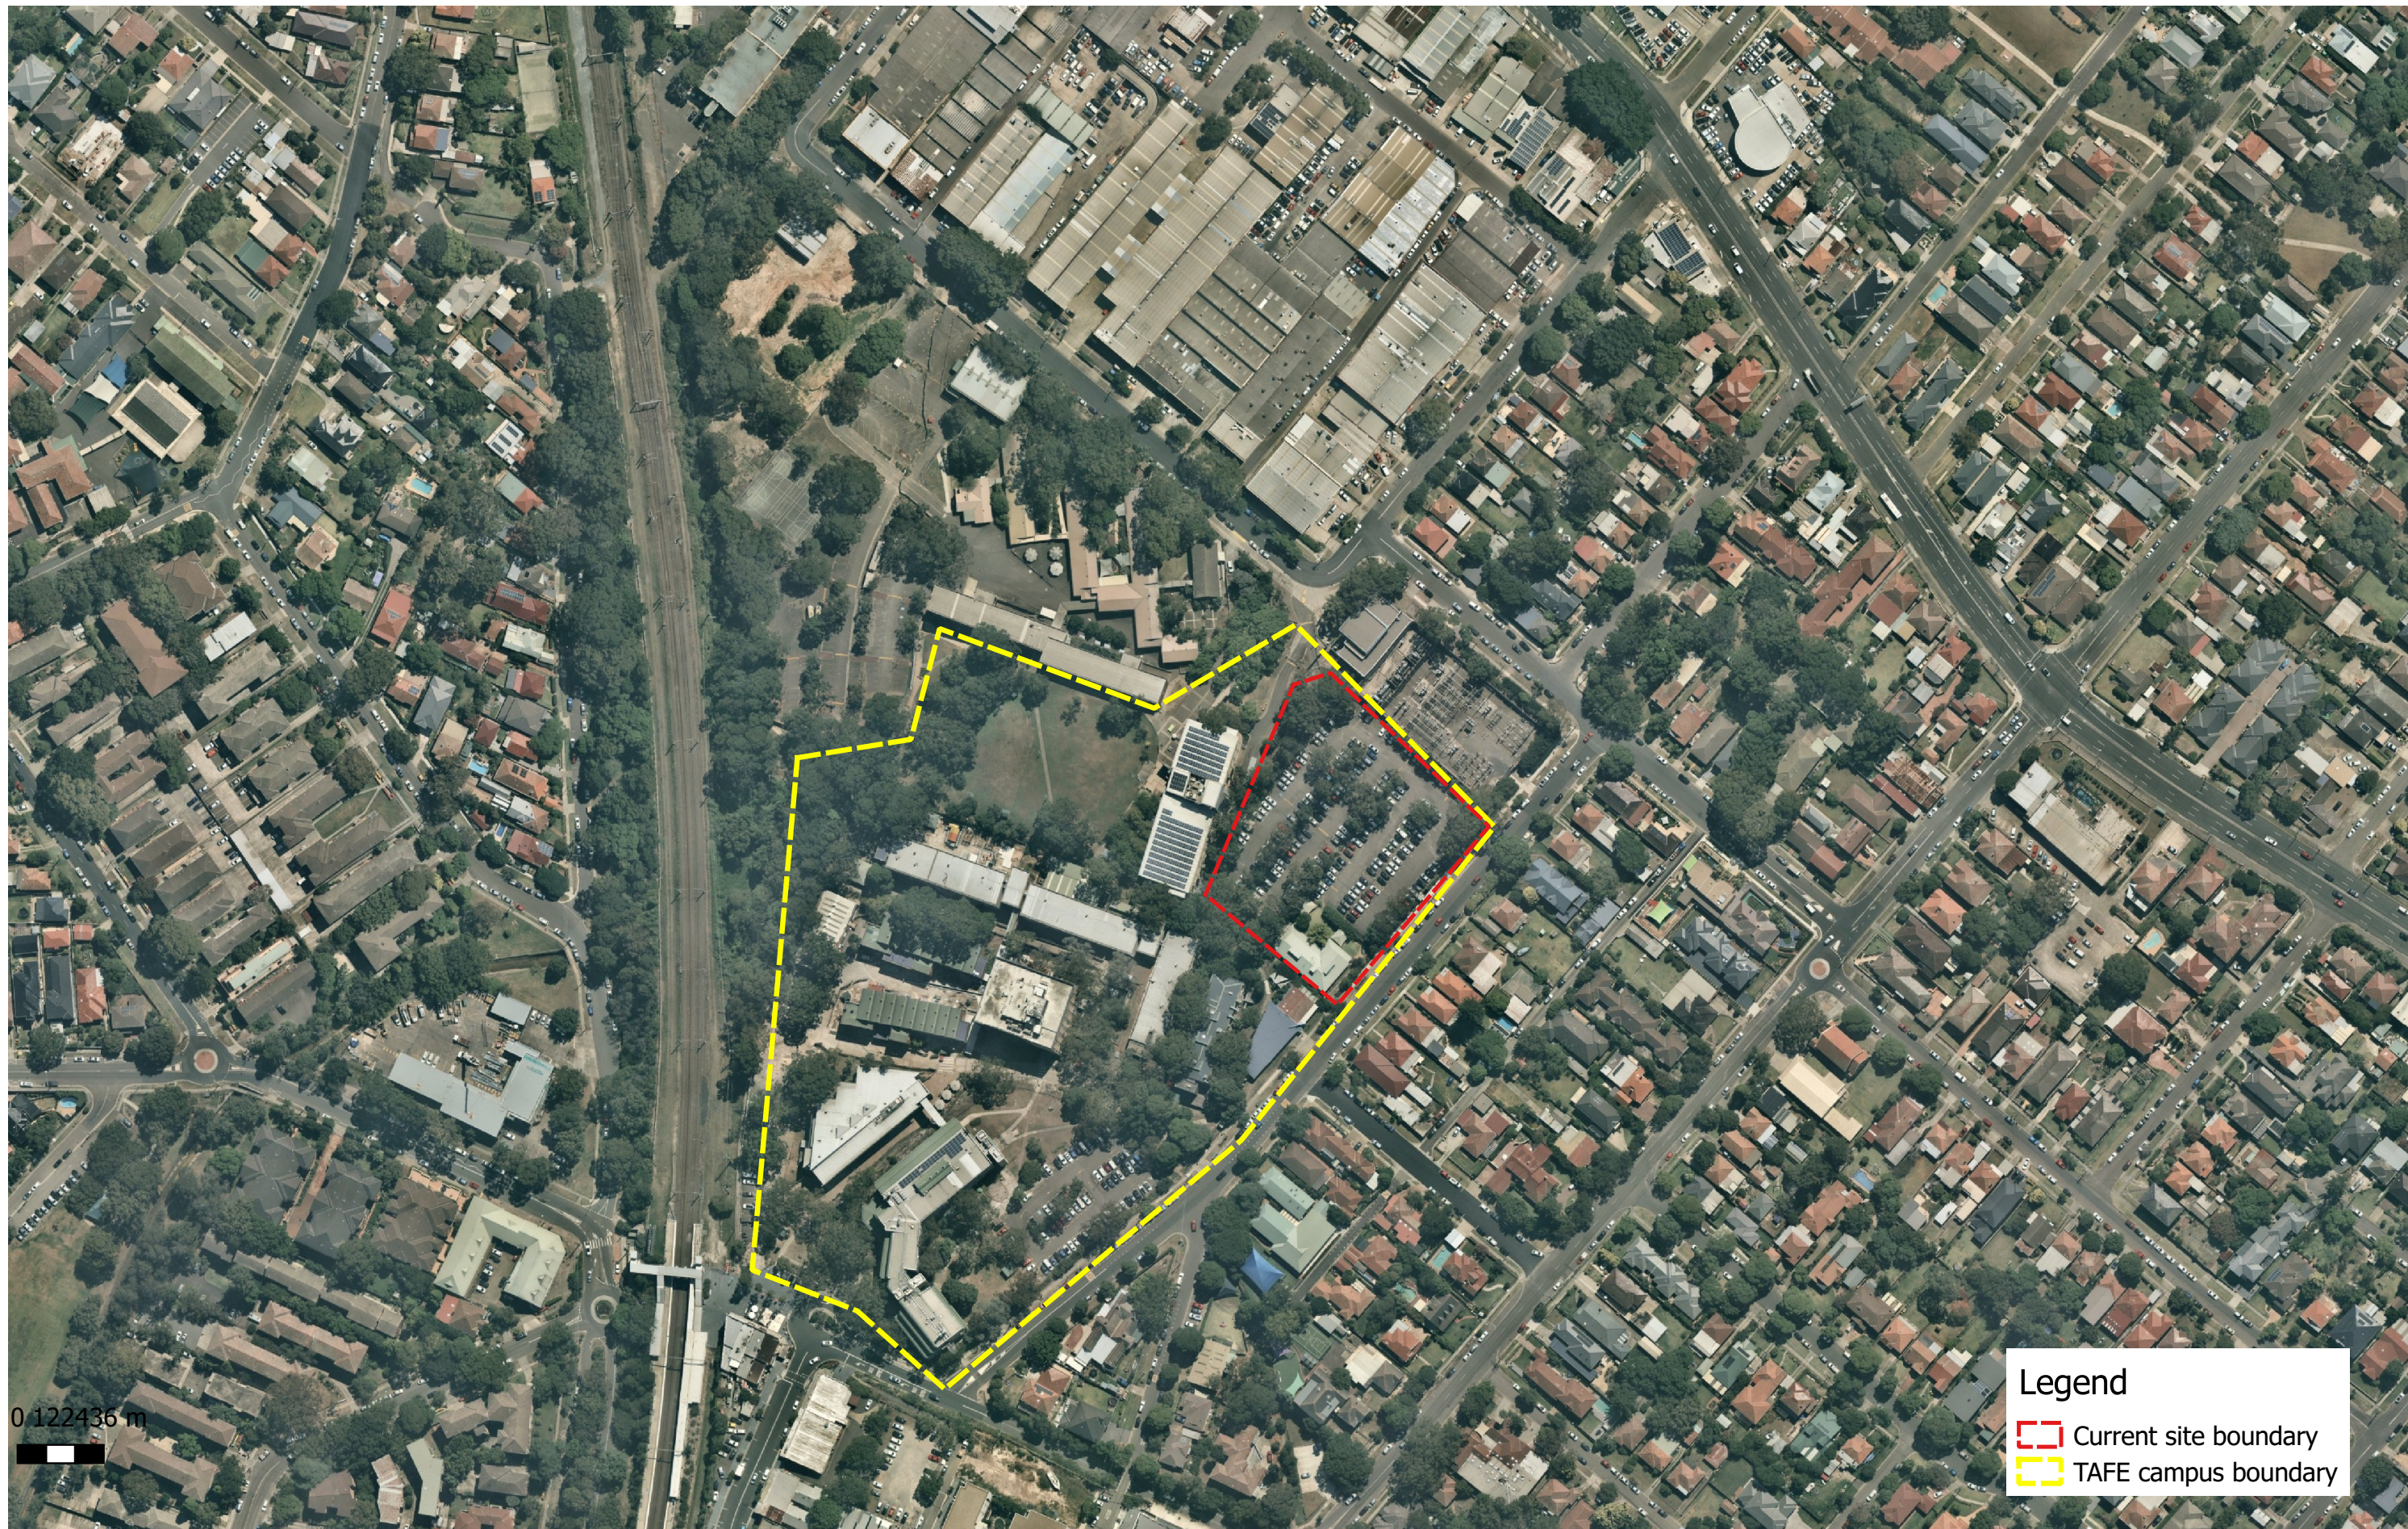
- Current site boundary
- TAFE campus boundary

This report presents a remediation action plan (RAP) prepared for the proposed multi-trades and digital technology hub (the site), located in the north eastern portion of TAFE NSW Meadowbank Campus, See Street, Meadowbank. The proposed development relates to an approximately 0.8 ha area within the larger Meadowbank TAFE campus. The site boundary of the proposed development is shown on Drawing 1 of Appendix A.

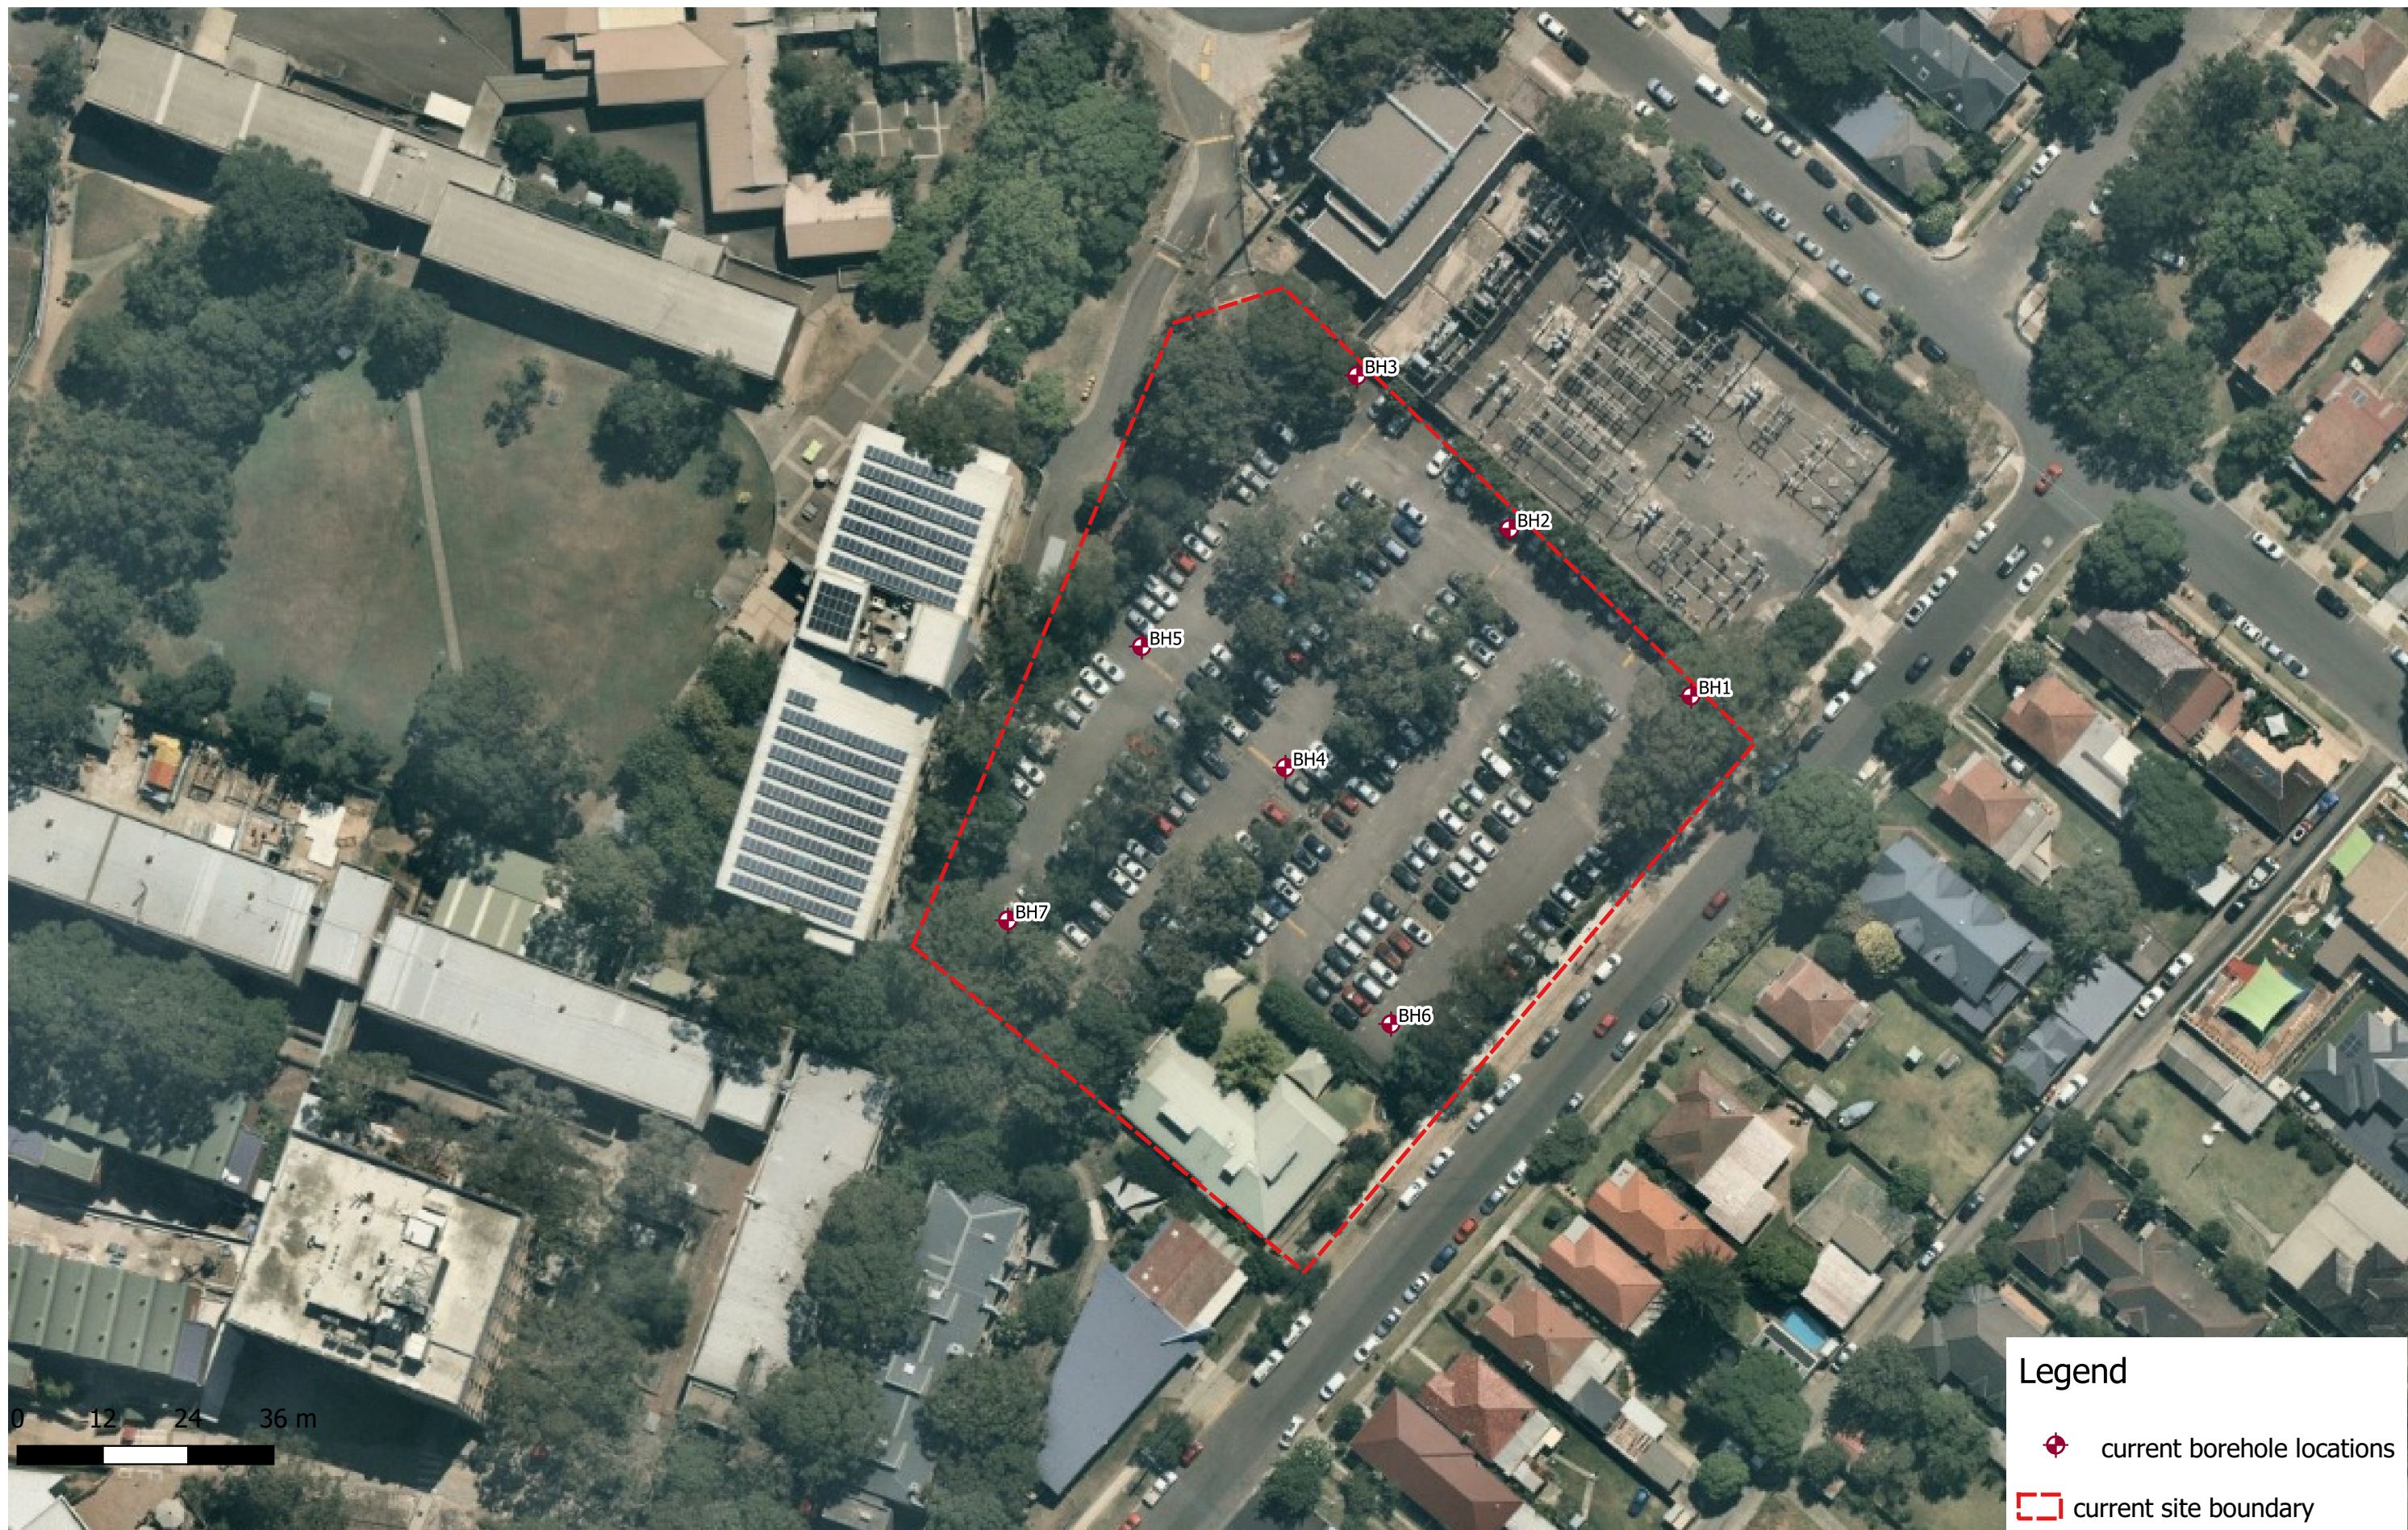
- (F) EASEMENT FOR ELECTRICITY PURPOSES 6.045 & 11.095 WIDE (T399040)
 (G) EASEMENT FOR DRAINAGE PURPOSES 2.5 WIDE (S464491)
 (H) EASEMENT FOR ELECTRICITY AND OTHER PURPOSES
 (J) RIGHT OF CARRIAGE WAY 6, 8 & VAR WIDTH

- Construction of a new, six-storey multi-trades and digital technology hub with basement carpark; and
- Construction of a new, internal road covering the footprint of the existing Ausgrid easement. The location of the Ausgrid easement is presented on Drawing 3 of Appendix A.
