**REPORT TO
HEALTH INFRASTRUCTURE**

**ON
GEOTECHNICAL INVESTIGATION**

**FOR
PROPOSED STAGE 2 REDEVELOPMENT,
PAEDIATRIC SERVICES BUILDING (PSB)**

**AT
THE CHILDREN'S HOSPITAL AT WESTMEAD,
HAWKESBURY ROAD, WESTMEAD, NSW**

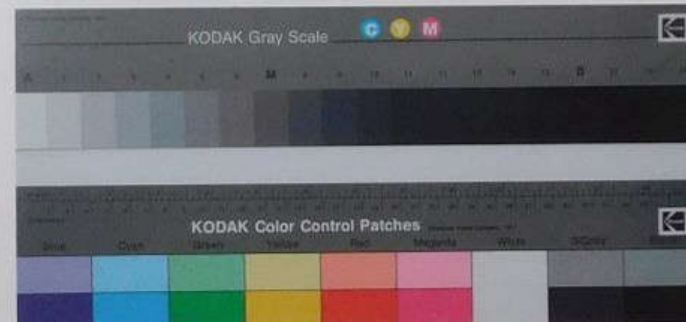
Job No: 33303BT
Borehole No: BH1
Depth: 7.3m - 10.0m

33303BT, BH1, CORING STARTS AT: 7.3m

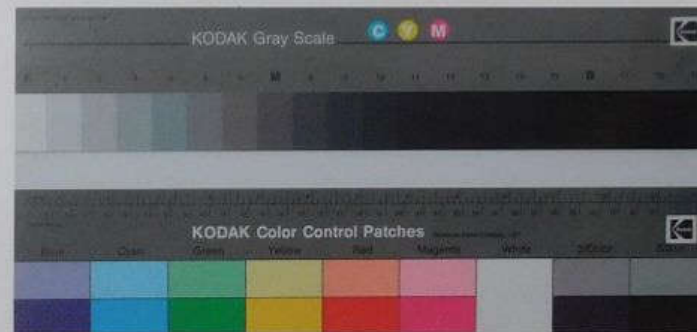
Job No: 33303BT
Borehole No: BH2
Depth: 8.47m - 11.00m

33303BT WESTMEAD BH2 START CORING AT 8.47m

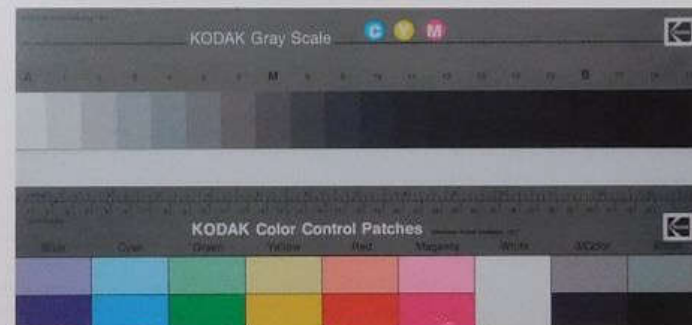
Job No: 33303BT
Borehole No: BH3
Depth: 9.3m - 12.0m

33303BT, BH3, CORING STARTS AT: 9.3m

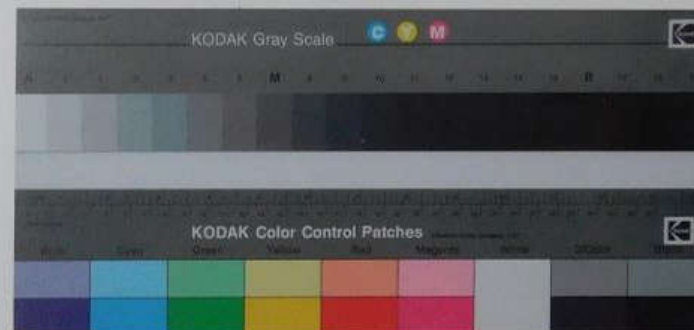
33303BT, BH4, CORING STARTS AT: 7.6m

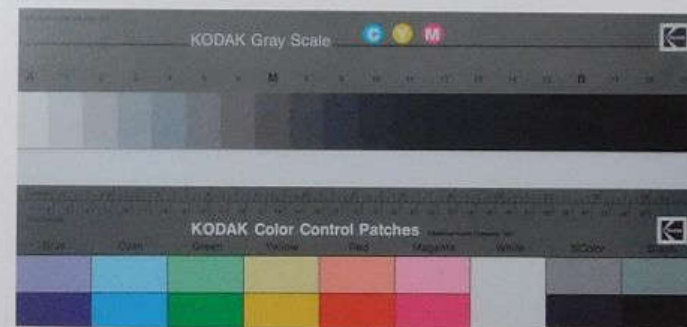
Job No: 33303BT
Borehole No: BH5
Depth: 7.1m - 10.0m

33303BT. BH5. CORING STARTS AT: 7.1 m

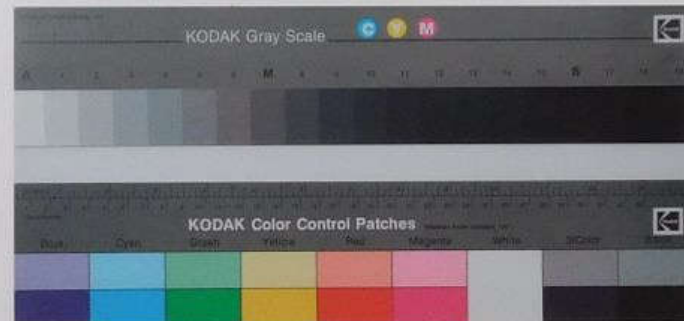
33303BT WESTMEAD BH6 START CORING AT 7.39m

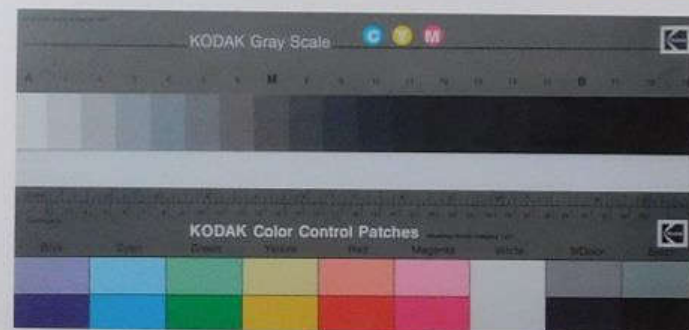
Job No: 33303BT
Borehole No: BH 7
Depth: 4.27m - 7.0m

33303BT WESTMEAD BH7 START CORING AT 4.27m

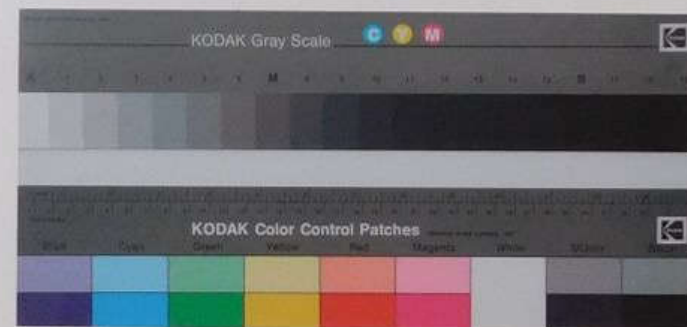
33303BT WESTMEAD BH8 START CORING AT 4.21m
