Remedial Action Plan

The Children's Hospital at Westmead
Stage 2 Redevelopment,
Paediatric Services Building (PSB)
Redbank Road,
Westmead NSW

9 February 2021

56200/133,598 (Rev C)

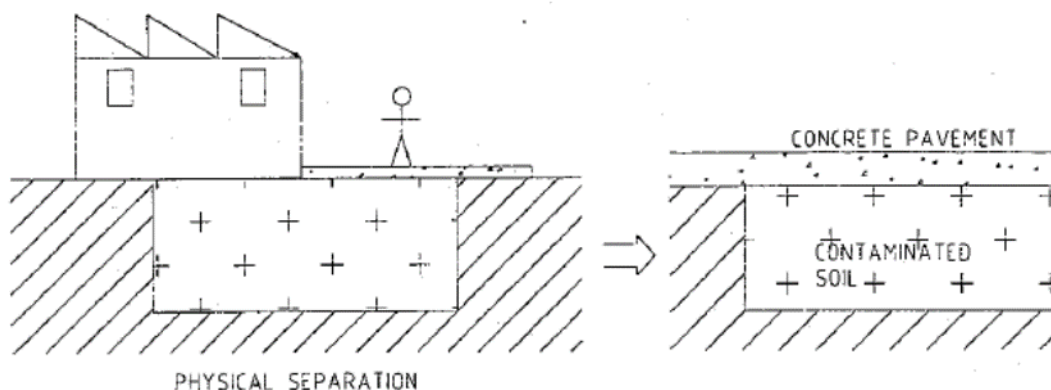
- A minimum soil cover thickness of 0.3 m in turfed areas, 0.5 m in mass planting/shallow landscaped areas and 0.6 m in tree pit zones which is underlain by a “marker layer” in unpaved areas, i.e., parks, gardens and green open spaces etc.; or
- Permanent concrete floor/ground/wall slabs or asphaltic concrete surfaced pavements and underlain by a “marker layer”, i.e., underlying buildings, roads, pathways; or
- Top (concrete) of pile foundations (no marker layer required for below pile foundations).

A conceptual sketch, sourced from ANZECC 1999¹⁵, is shown following:

The marker layer shall consist of a bright orange coloured non-woven polyester continuous filament or PET (such as nonwoven geotextiles) or similar with a minimum density of approximately 150 grams per square metre (or equivalent). The marker layer must:

- Be easily recognisable within soils (i.e., bright orange in colour);
- Be durable as a long term marker layer (i.e., > 150 grams per square metre); and
- Maintain integrity during remedial/civil works such as capping layer insulation and road/building construction.

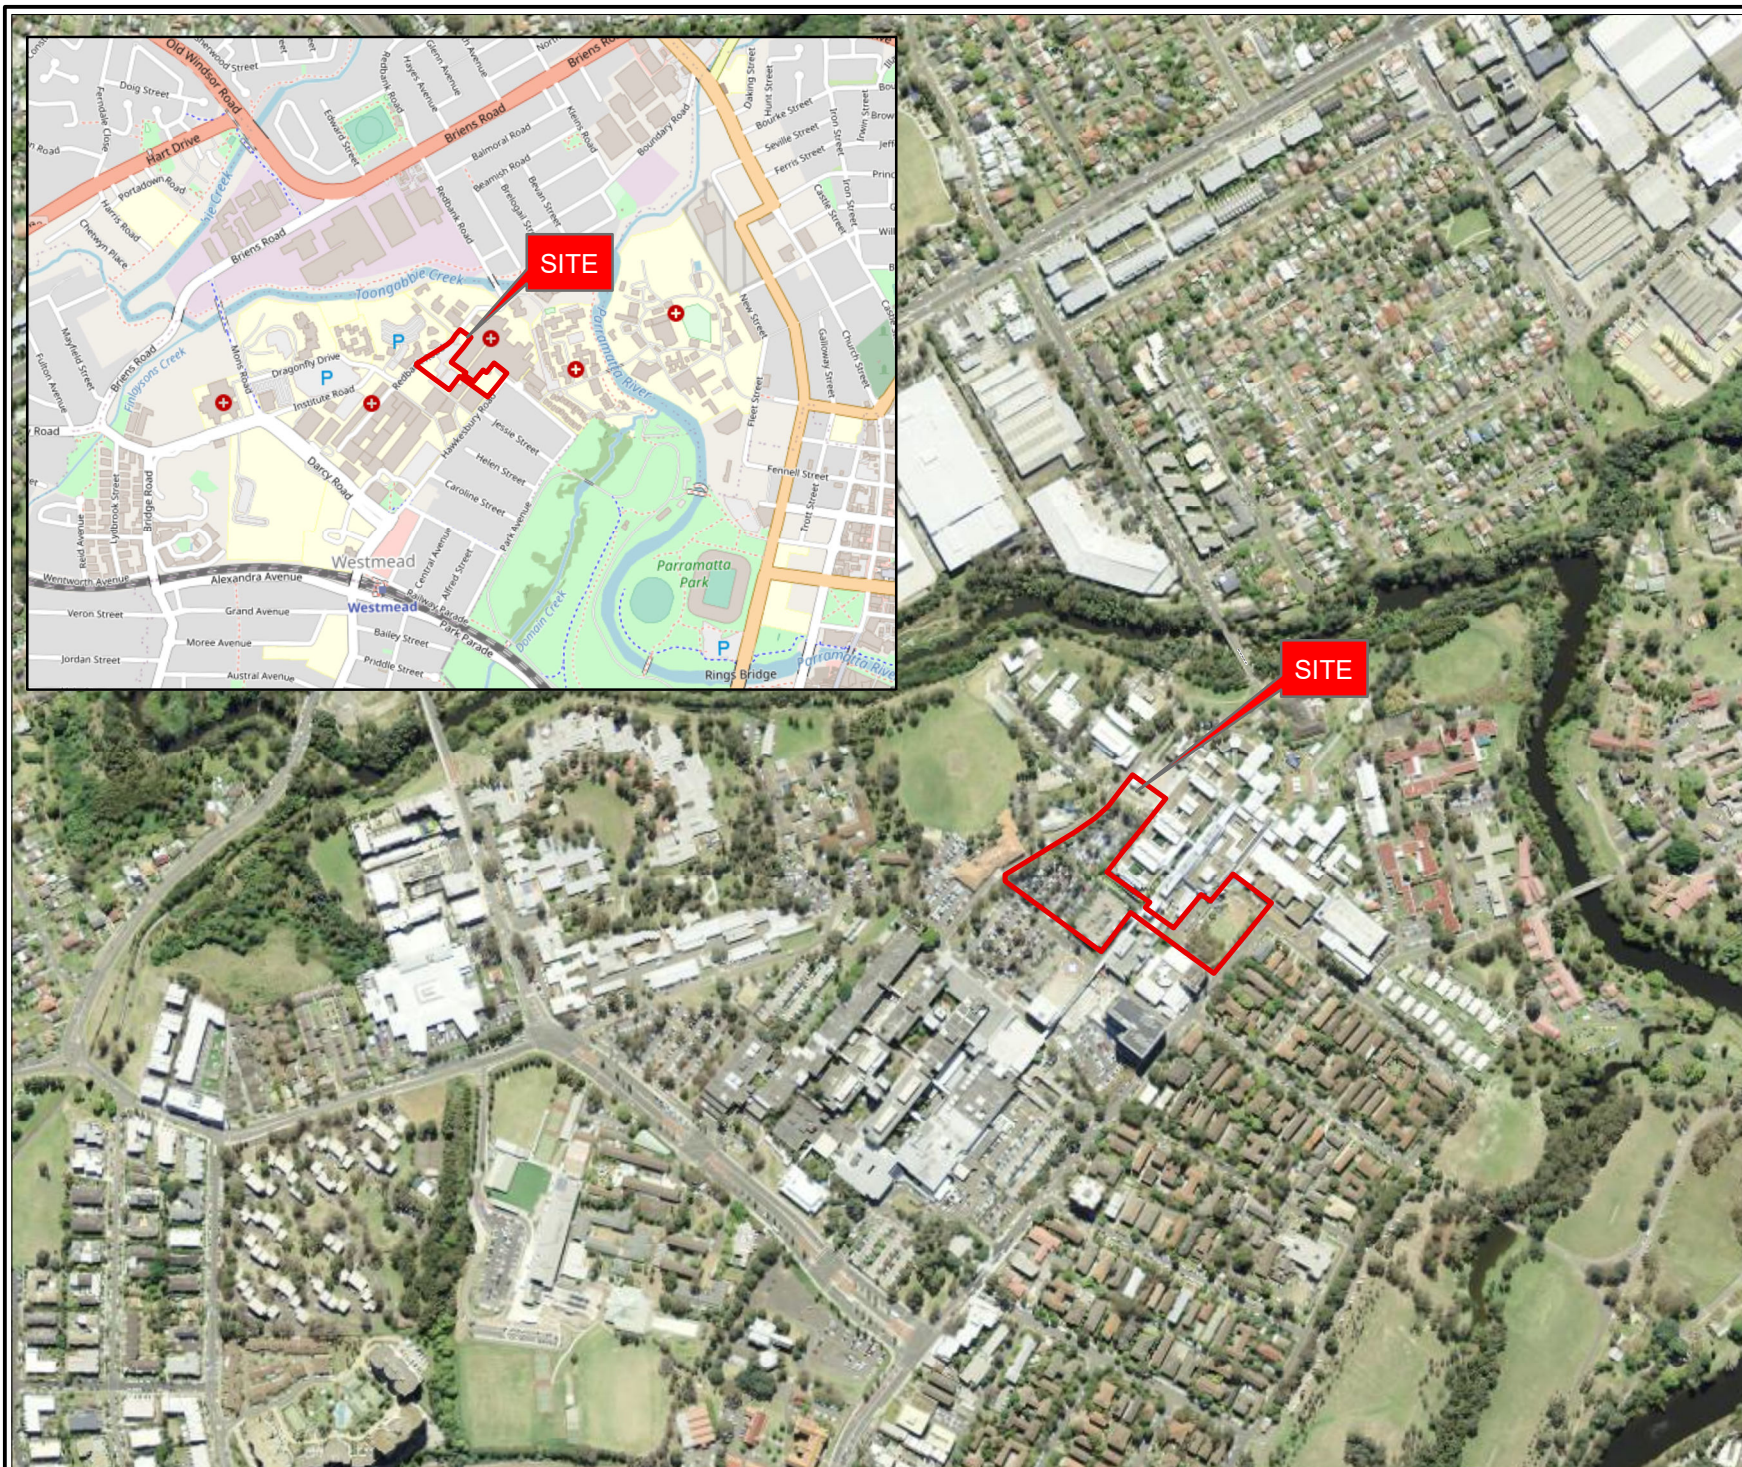
FIGURE 1

SITE LOCATION

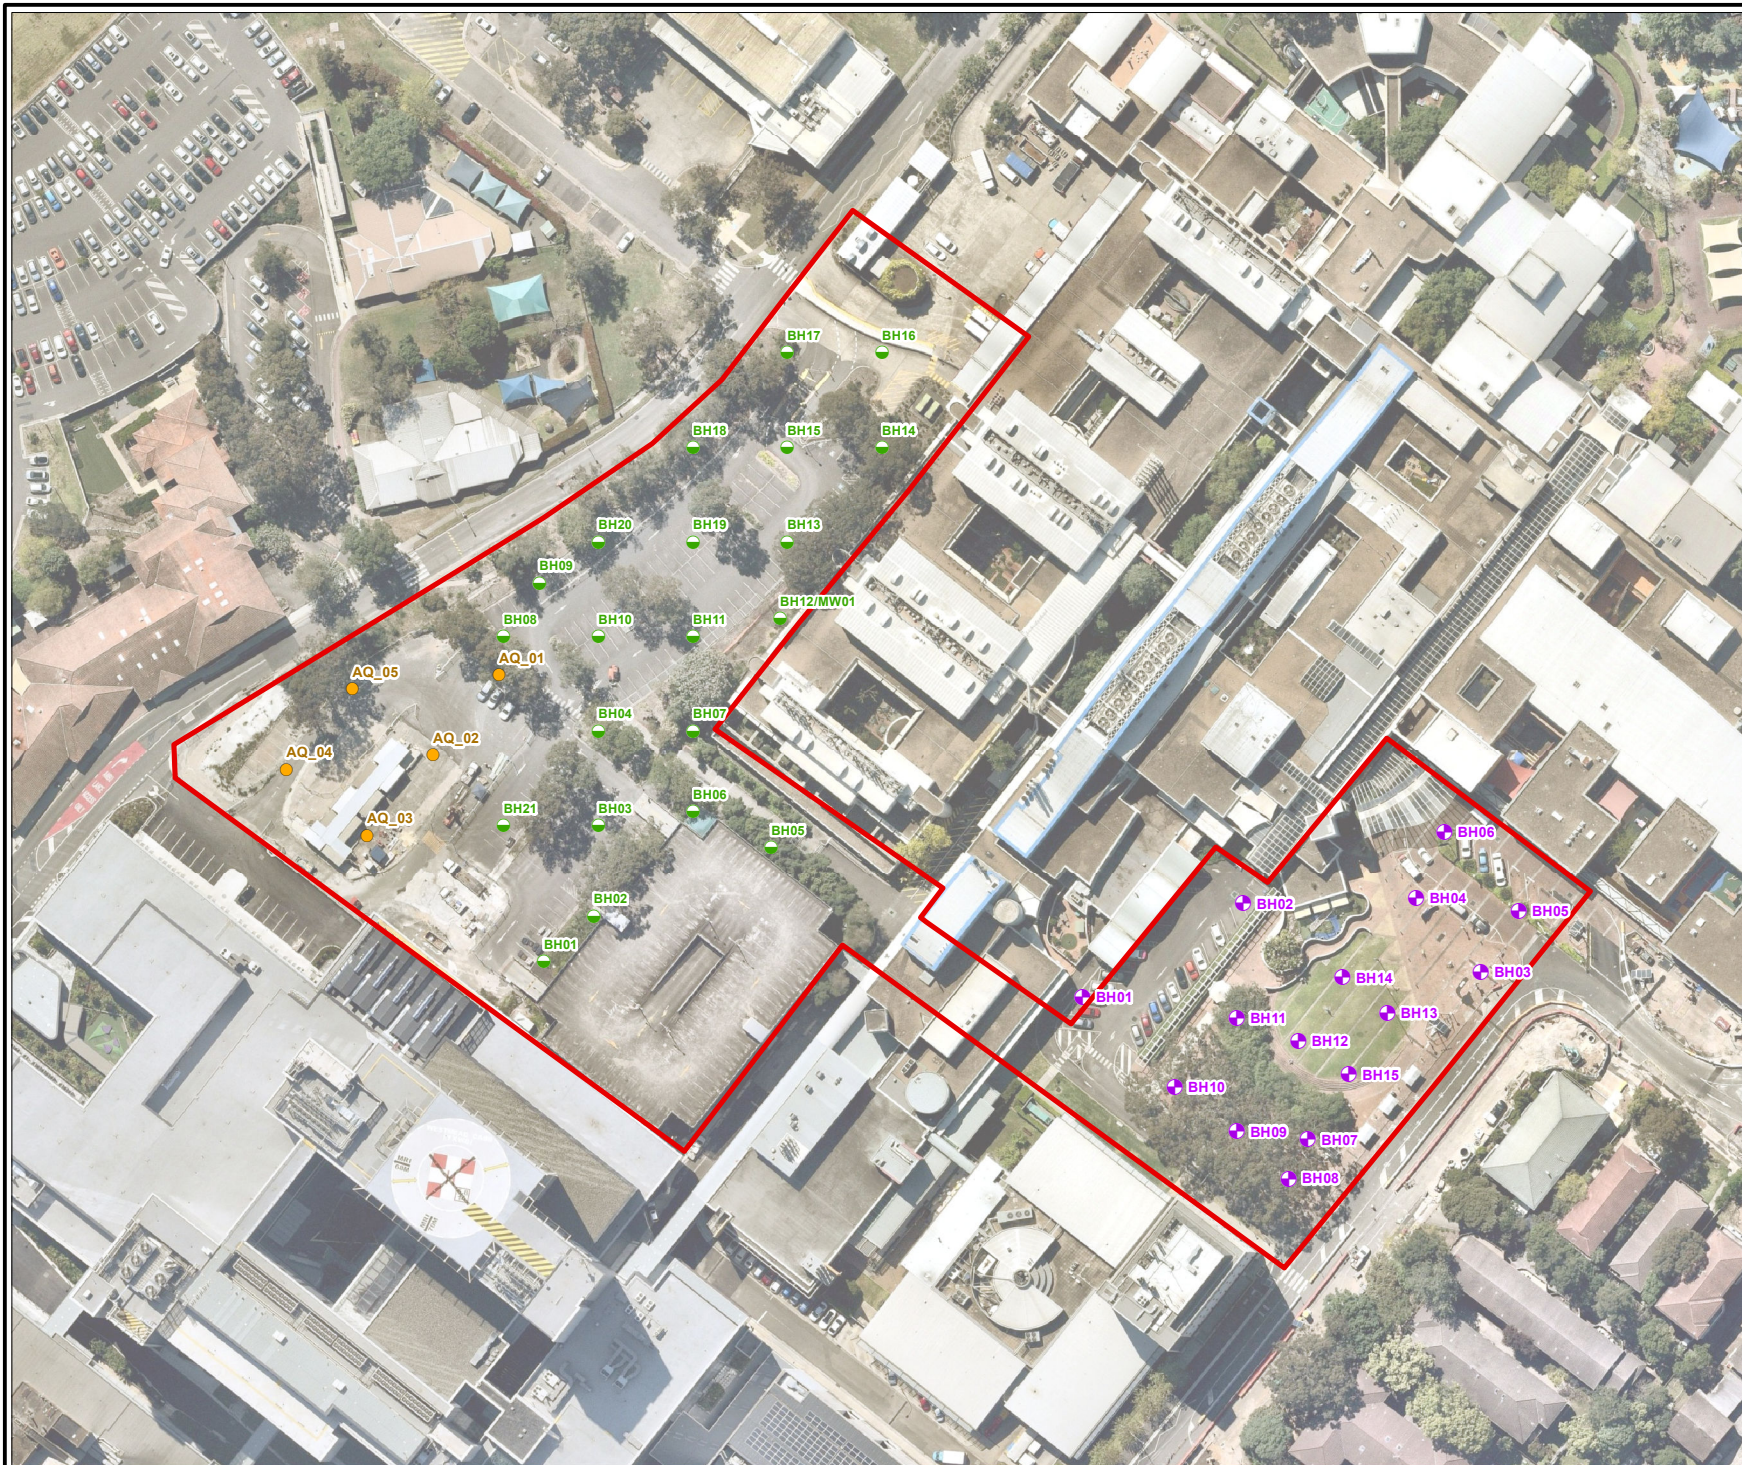
FIGURE 3

HISTORICAL SAMPLE LOCATIONS

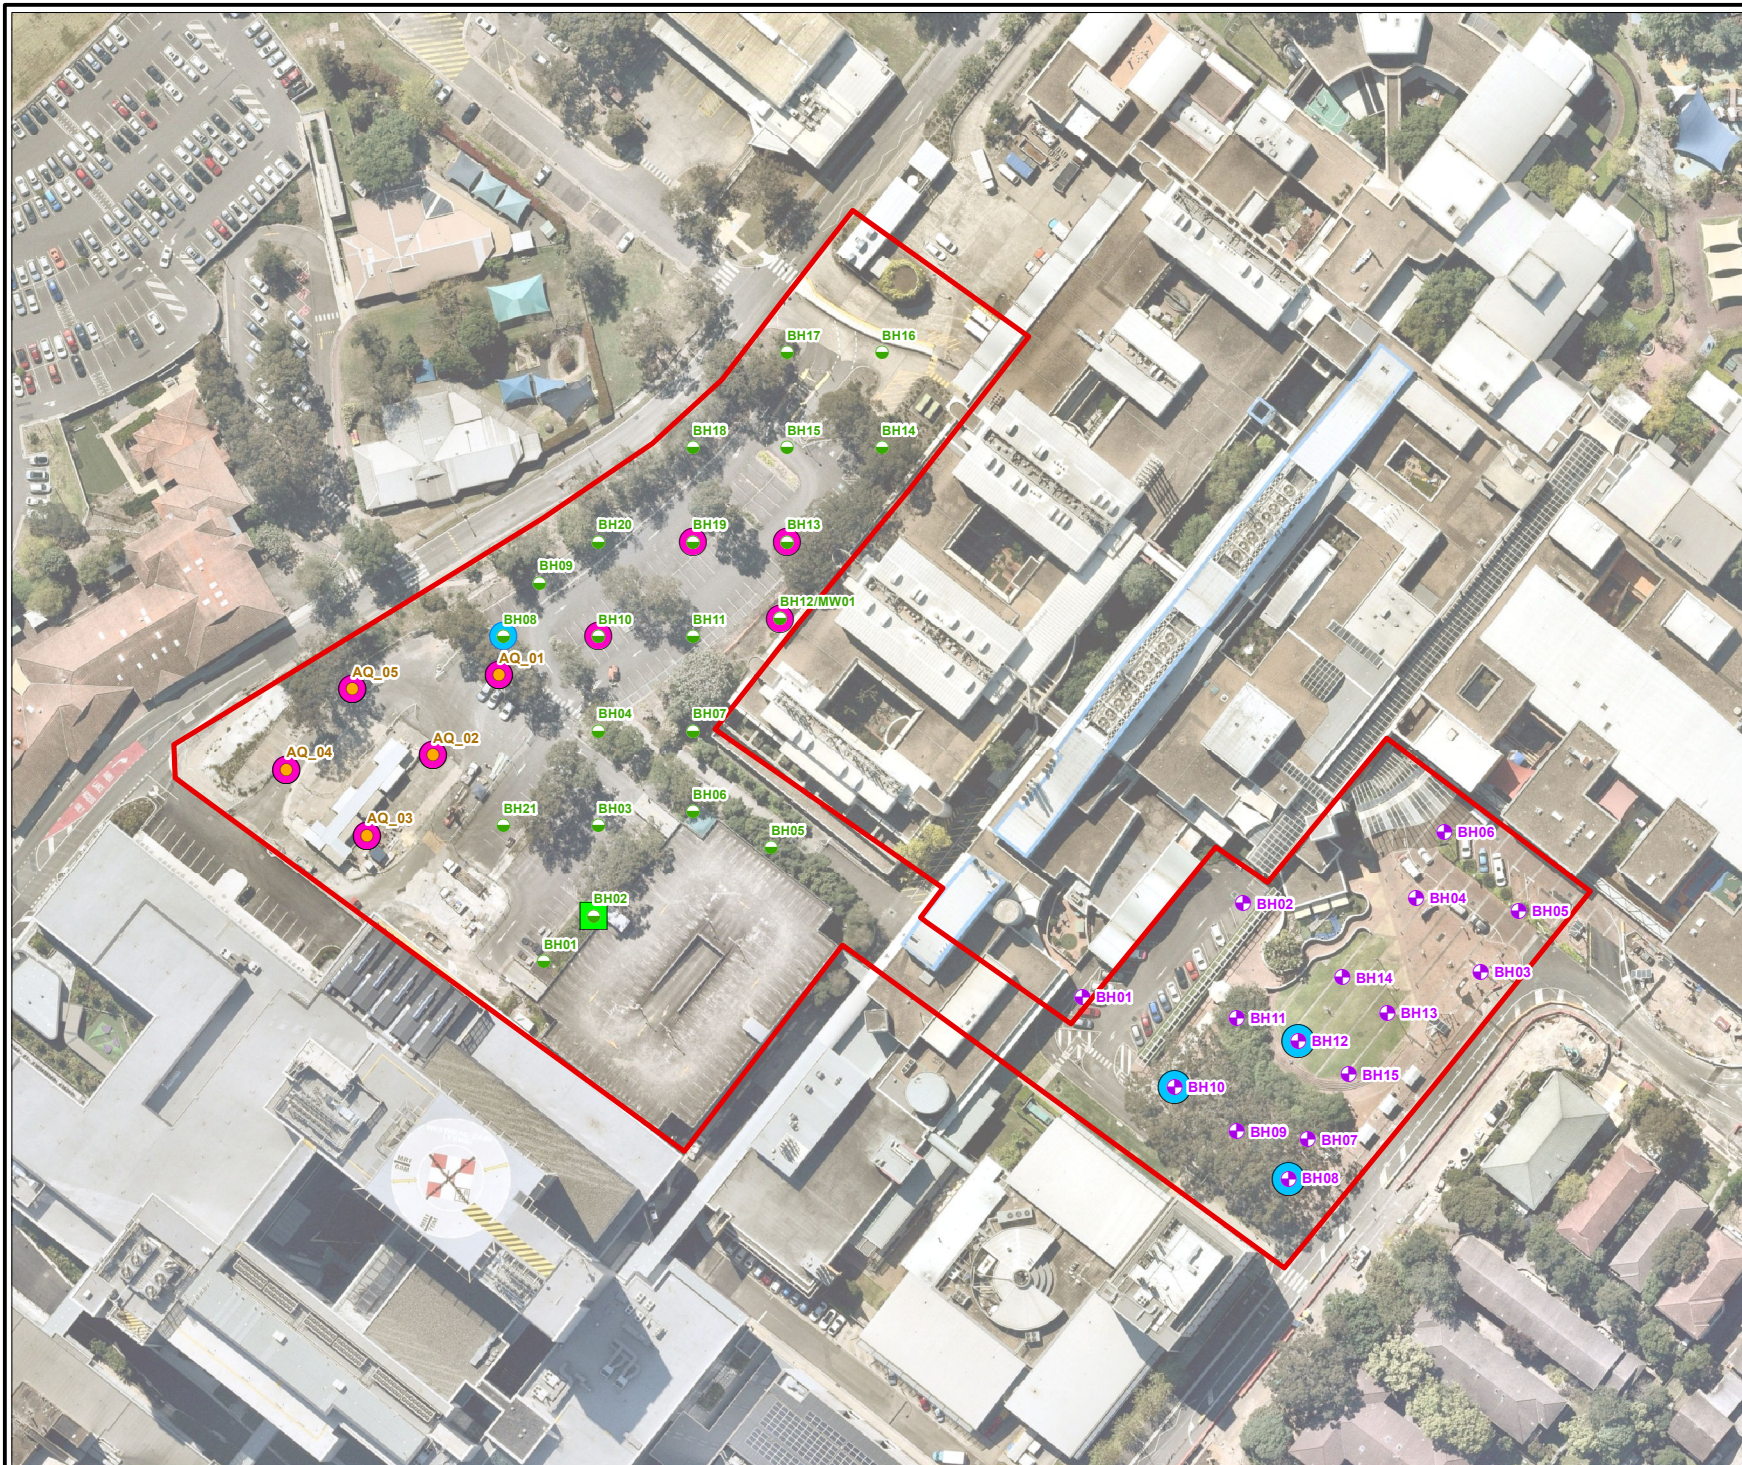
FIGURE 4A

ASBESTOS DETECTIONS

JBS&G (2019) reported that visible ACM fragments were observed and/or detected above the adopted site criterion at 2 sample locations (out of 26) in the fill profile ranging from ground surface level to 4.3 m bgs during field quantification.

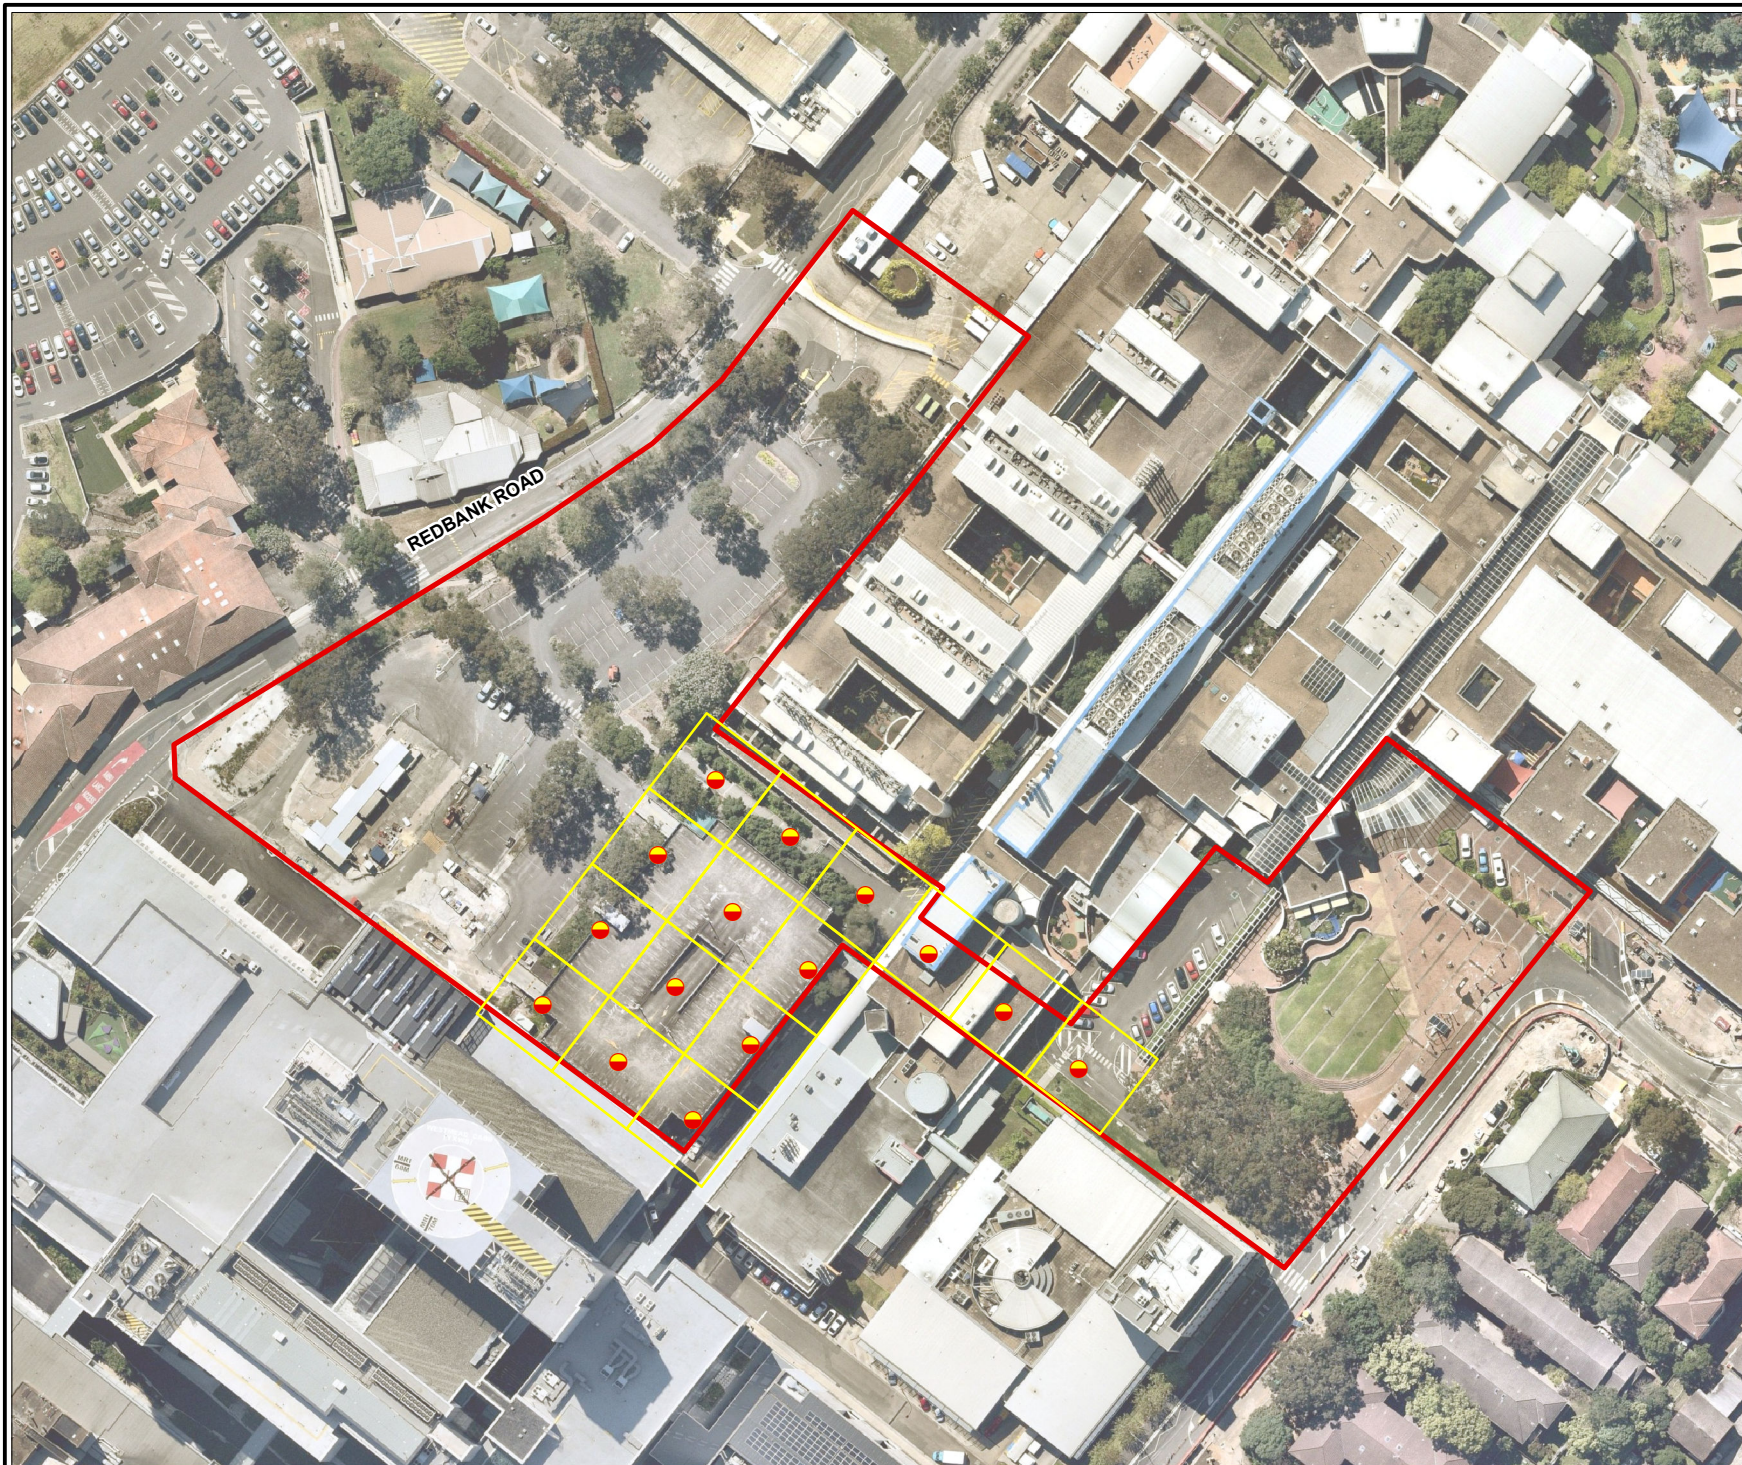
FIGURE 5

DATA GAP ASSESSMENT

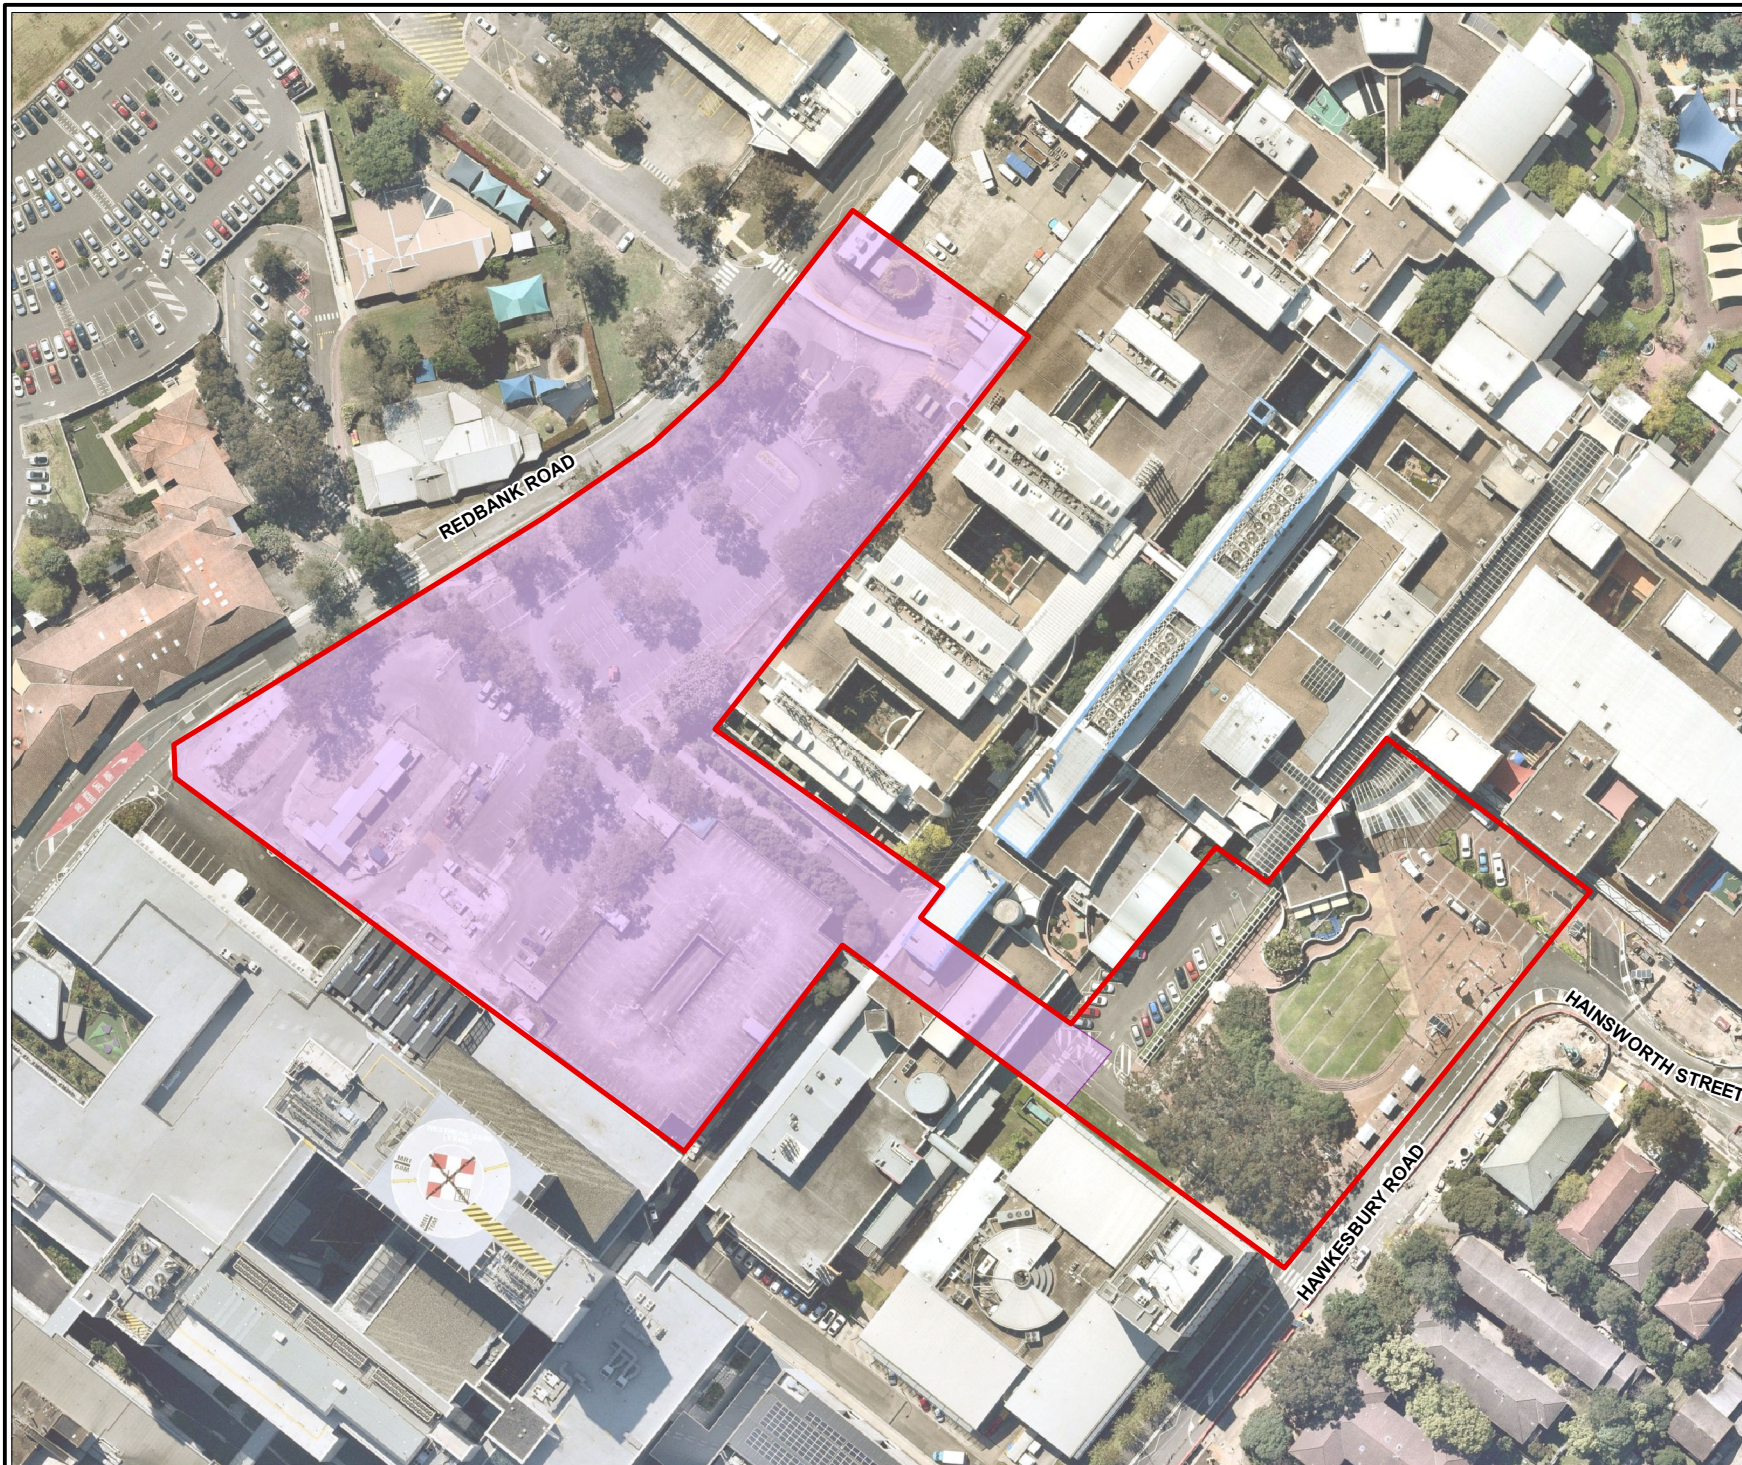
- Approximate Site Boundary
- Extent of required marker and capping layer

Soils underlying the multi-level car park area and adjacent areas in the southern portion of the site have not been assessed due to access limitations. It is presumed that the asbestos impacted fill will extend beneath these areas, with soils requiring further assessment as per the sampling regime in **Table 9.2**. Proposed sampling locations will be completed on a 20 m grid, consistent with the sampling density in JBS&G 2019, across these areas prior to the implementation of remediation works proposed herein, with approximate locations detailed on **Figure 5**.

The data gap of the assessment of soils underlying the car park and adjacent areas in the southern portion has been incorporated within the RAP and are to be addressed during the validation works and are shown on **Figure 5**.

Soil validation sampling for asbestos and chemical constituents will be conducted by the Remediation Consultant under the car park footprint and adjacent areas in the southern portion. An approximate 20 m grid sampling density will be applied (refer **Figure 5**), with sample locations targeting identified areas of concern. The sample locations will comprise both chemical constituent sampling and asbestos quantification sampling. If gross soil contamination observed following the removal of the slab or during boreholes, consideration to additional sample locations will be given. All results will be compared to the adopted site soil validation criteria as presented in **Table 9.3**.
