## **Bush Fire**

### **Assessment Report**

## **BUSHFIRE ASSESSMENT REPORT**

### **ALTERATIONS AND ADDITIONS TO EXISTING SCHOOL**

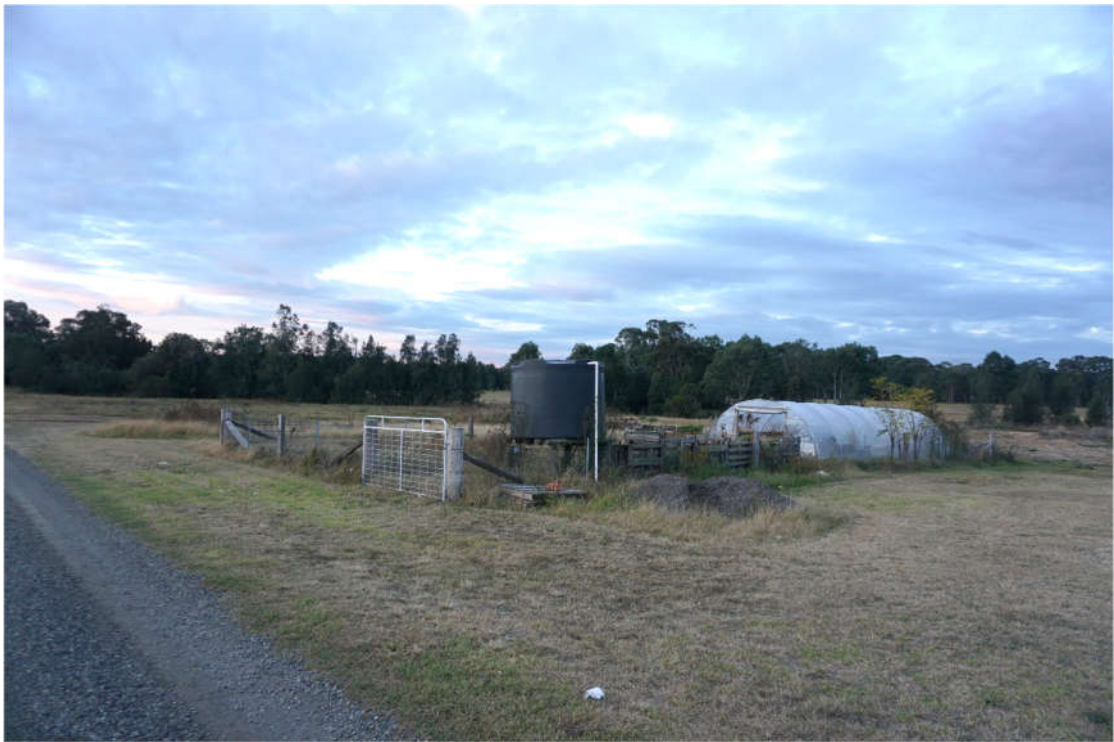
PHOTOGRAPH 1 – PROPOSED AQUATIC CENTRE LOCATION

View of the location of the proposed aquatic centre looking east. The existing greenhouse will be demolished and the unmanaged grassland surrounding the building shall be maintained.

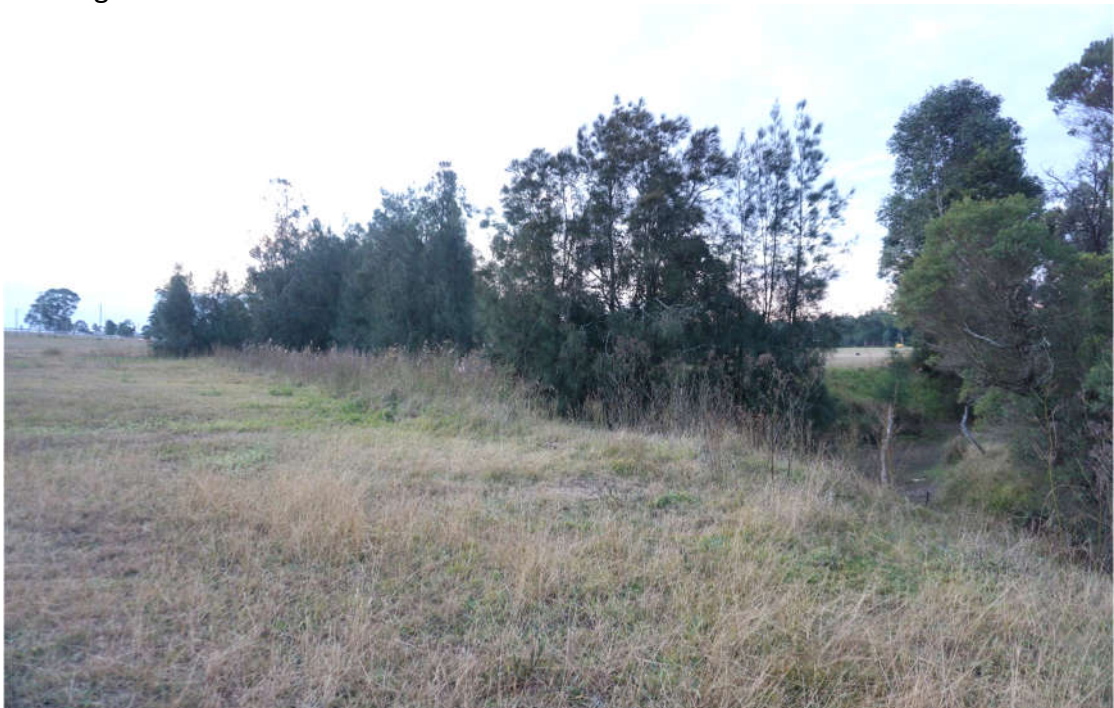
PHOTOGRAPH 2 – NARROW BAND OF TREES LOCATED EAST OF ACQUATIC CENTRE

View of low threat vegetation located east of the aquatic centre. The vegetation is a thin band of casuarinas that offer a reduced vegetative threat to the proposed buildings and open structures. The ecological constraints analysis identifies a 20 metre riparian buffer to be located around the mapped waterway.

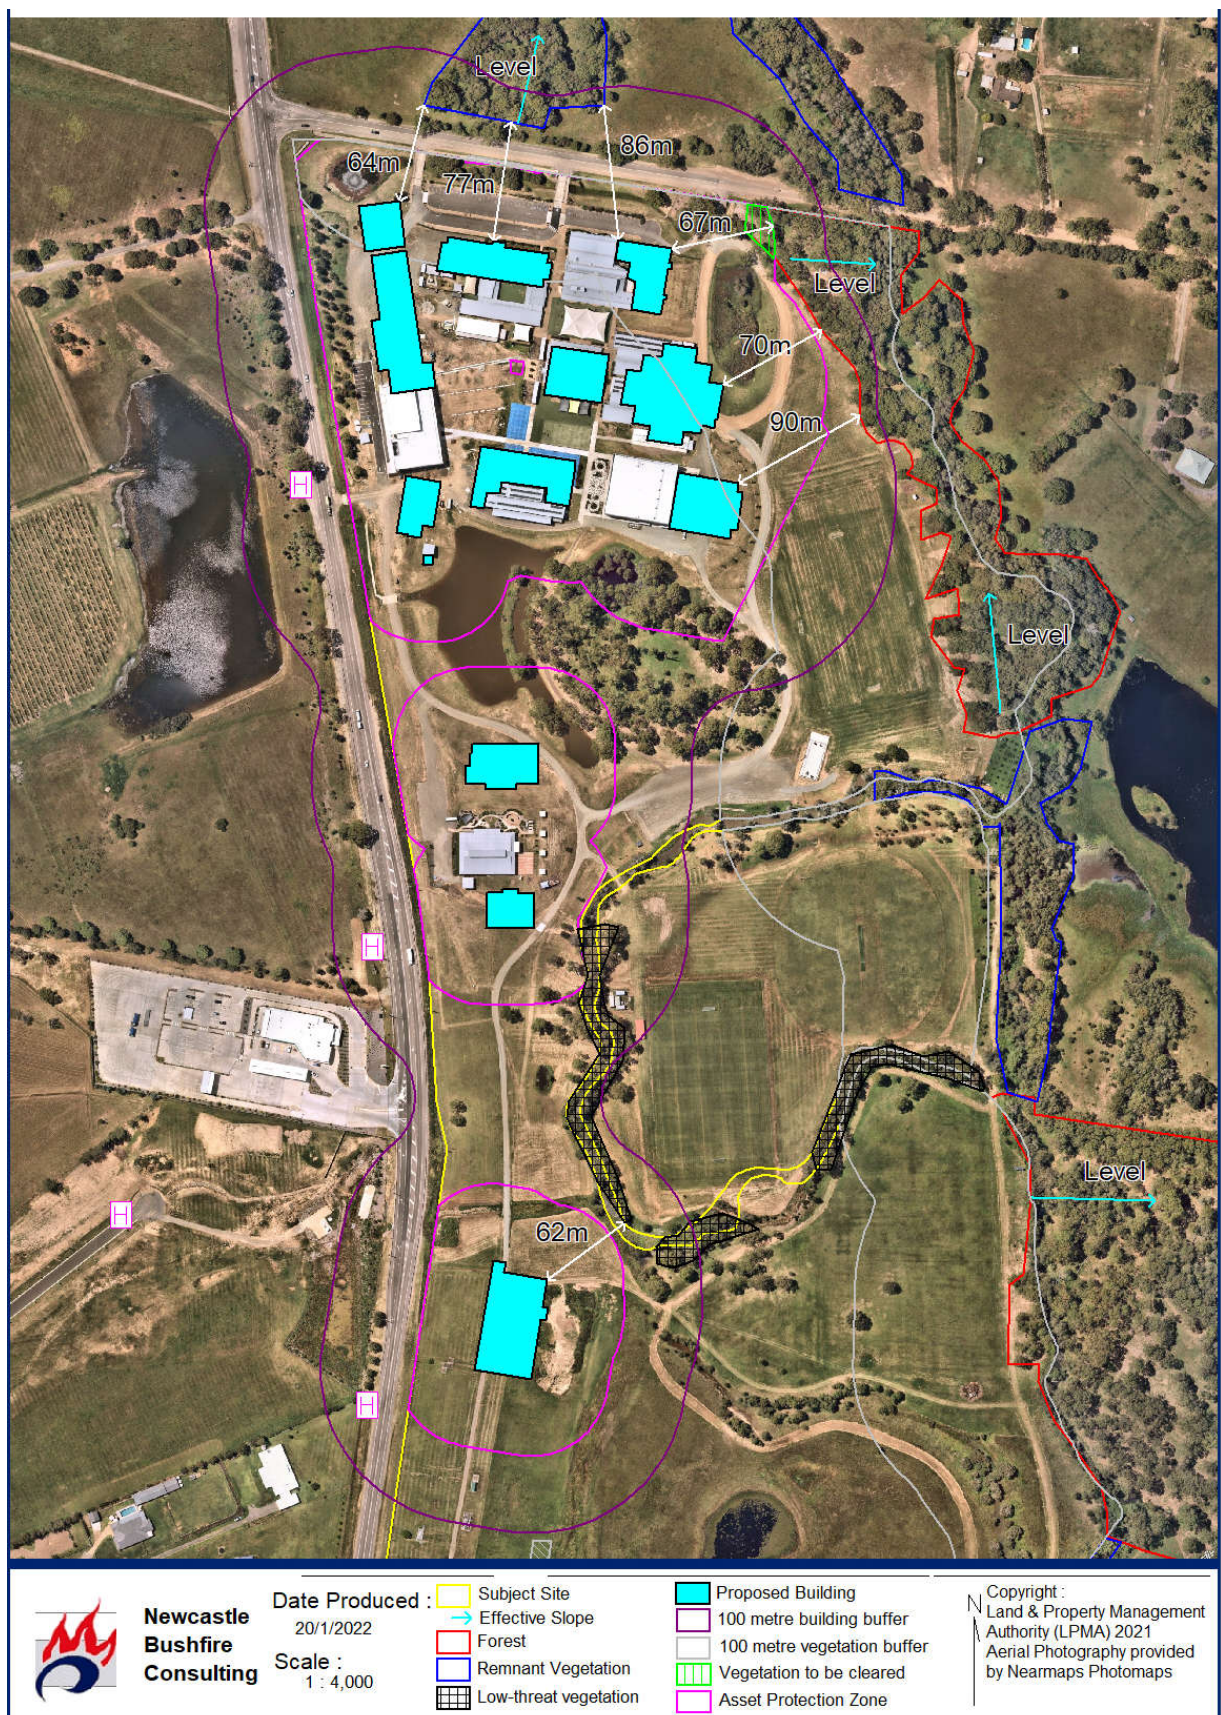
FIGURE 1 – SITE CONSTRAINTS MAP

Primary Vegetation Structures have been identified in Figure 1 and 2 – Site Constraints Map and separation distances shown in Table 2 – Bushfire Attack Assessment.

Effective Slopes have been identified in Figure 1 and 2 – Site Constraints Map and slope ranges are shown in Table 2 – Bushfire Threat Assessment.

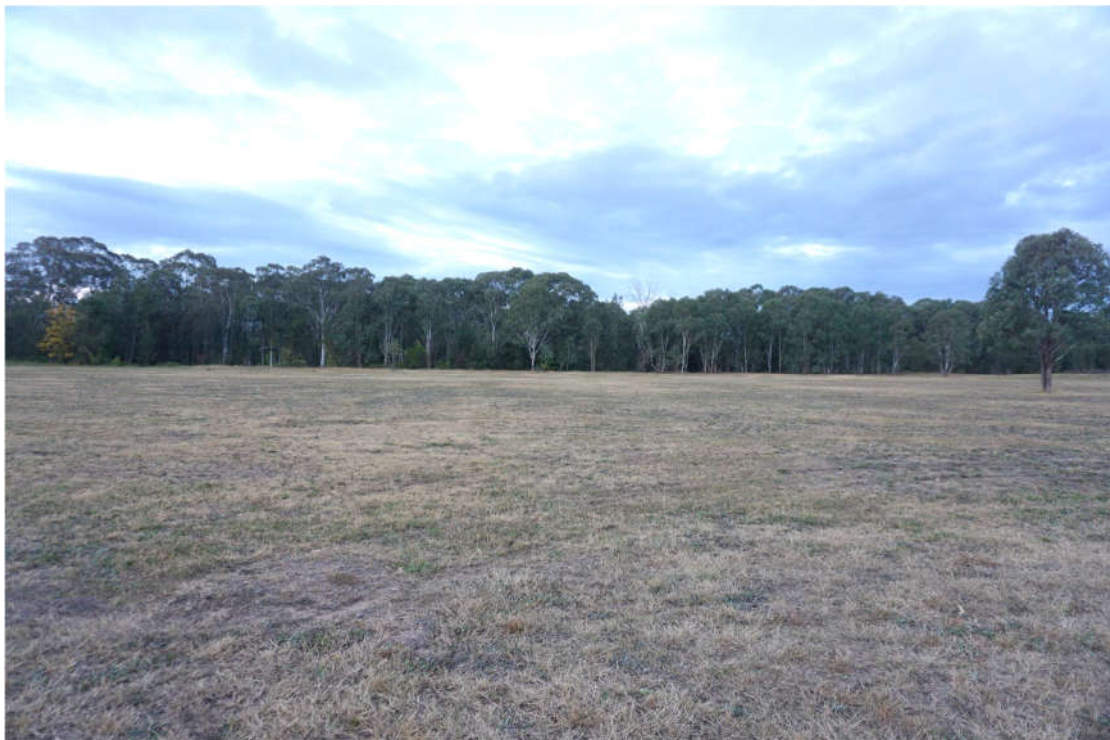
**PHOTOGRAPH 3 – MANAGEMENT EAST OF LOW-THREAT RIPARIAN CORRIDOR**

View of managed fields located east of the low-threat riparian corridor. Forest can be seen in the distance, with the majority of the open fields presently being mechanically managed grass. The forest is dominated by eucalypts in the upper stratum with an understorey of native shrubs and grasses. Black Creek runs along the eastern boundary of the site.
