Albion Park Quarry Extraction Area Stage 7 Extension

Historic Heritage Assessment

Biosis Pty Ltd

August 2021

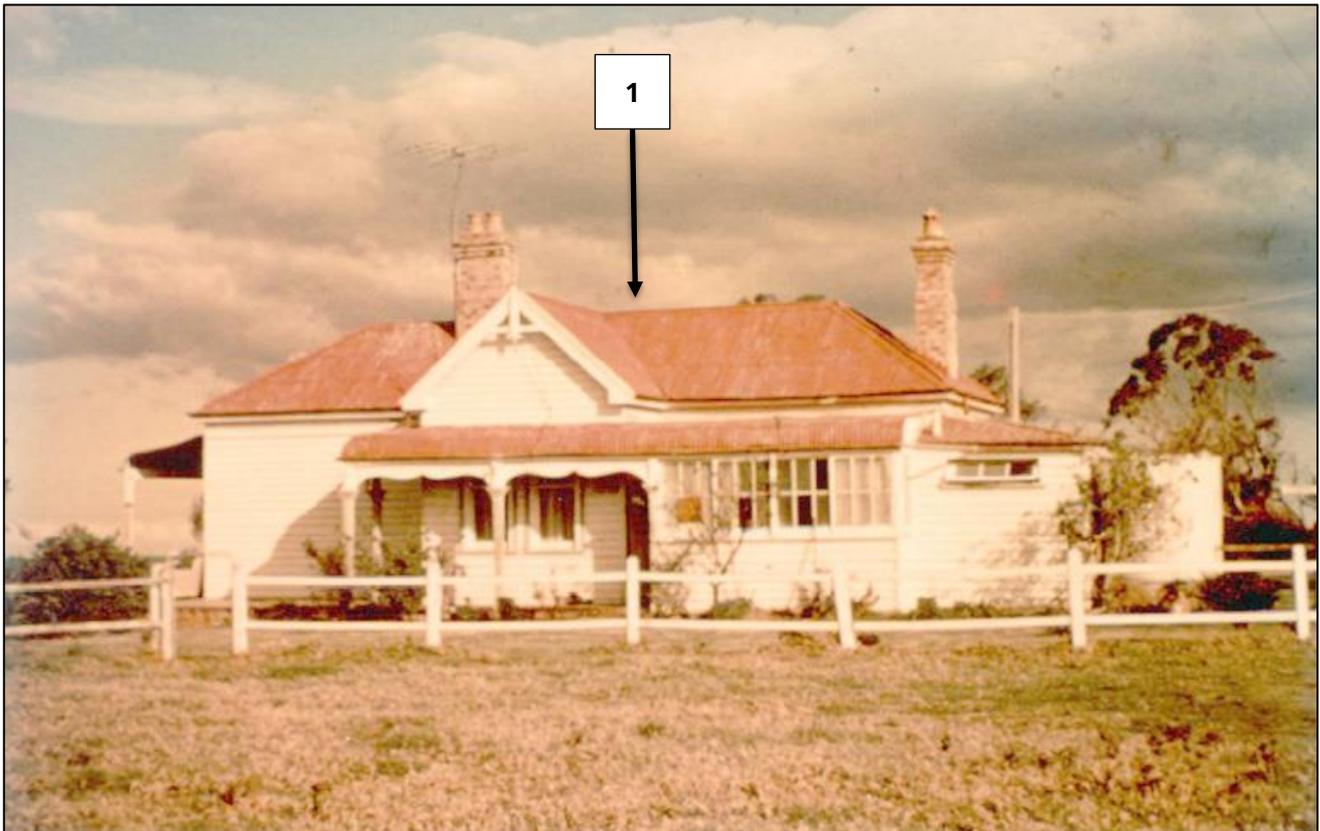
Photo 1 A photograph of the main house [1], Belmont, taken in 1964 (Source: Shellharbour Library)

It is believed the main house [1] at Belmont was built around this time, being a weatherboard dwelling constructed in a Victorian and Edwardian style with a hipped corrugated iron roof with gables, a bullnose verandah, decorative valance and finial chimneys (**Photo 1**). There are also a series of stone walls [2], which are believed to date to c.1912.²⁶ It is believed the main house [1] was built in two stages, represented by a symmetrical northern section (Victorian) and the asymmetrical southern end (Edwardian).²⁷ A 1929 entry in the Shellharbour Building Register 1923-1951 may belong the McDonalds of Belmont. It records a 'Milkroom etc.' valued at £40 under S. N. McDonald within the Oak Flats Estate; it is possible that this may be a record for future owner Samuel Richards McDonald of Belmont which was incorrectly assigned to the Oak Flats Estate, as they were situated in close proximity to one another. However, the accuracy of this assumption this cannot be confirmed.²⁸ Samuel Hercules McDonald leased Lot 6 to John McDonald and Richard McDonald, farmers from Albion Park, in February 1930, which expired in October 1937. In the same year, the property was transferred to Mary Jane McDonald, wife of Samuel Hercules McDonald.²⁹

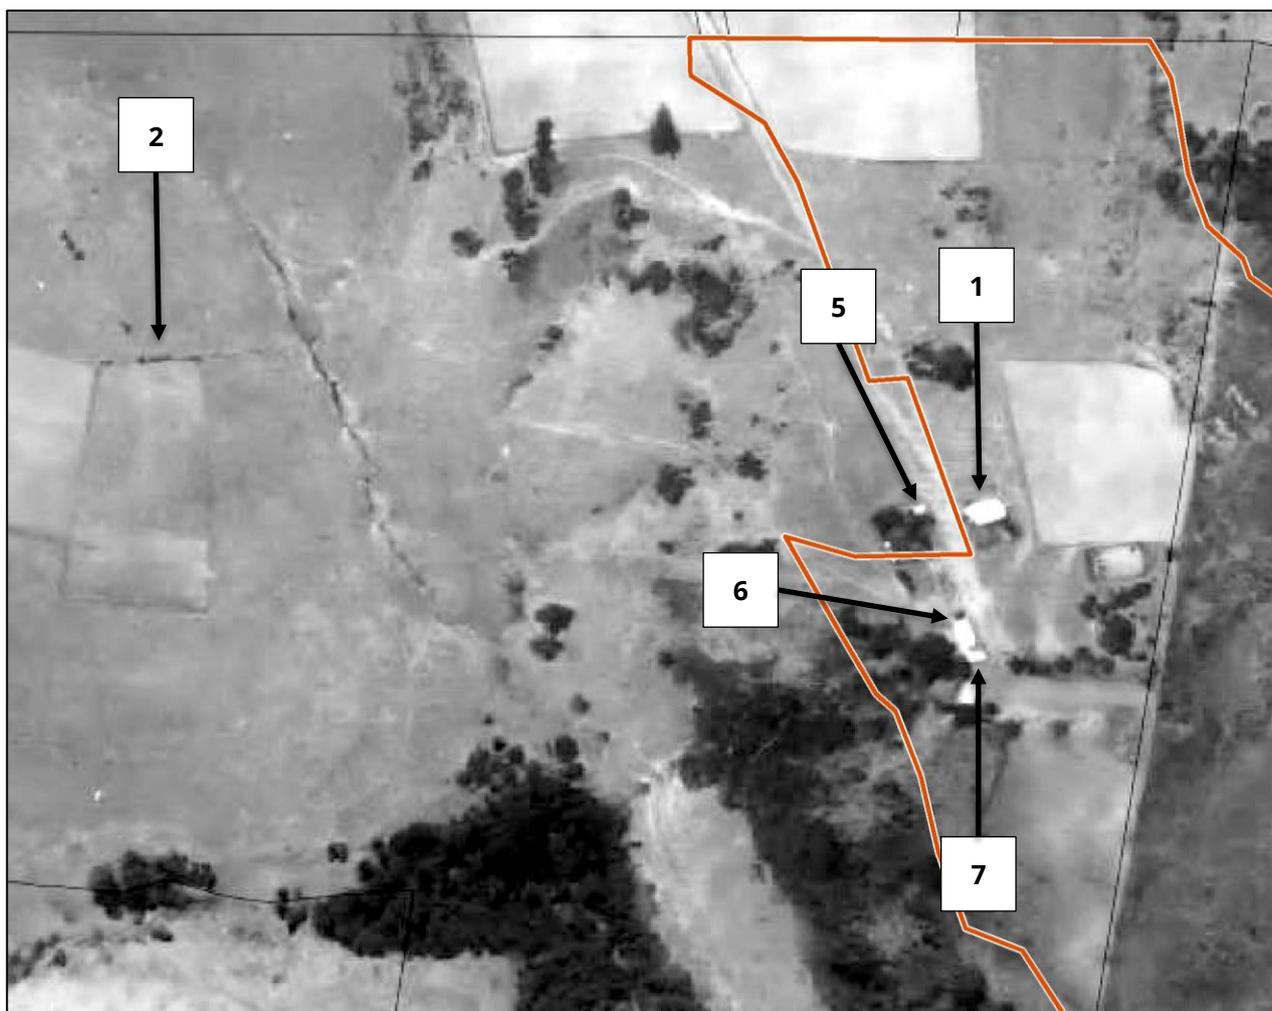
Photo 2 A 1948 aerial photograph of the study area, showing the main house [1], stone walls [2], and three other structures [5] [6] [7] (Source: Shellharbour Council)

In December 1948, John Henry Bill McDonald and Samuel Richard McDonald became the owners of the property.³³ Aerial photographs from the same year show the level of development and site use at this time (**Photo 2**). The main house [1], stone walls [2] and several other buildings [5] [6] [7] are visible. It is not possible to confirm which of these may be the farm building [3] or silage pit [4].

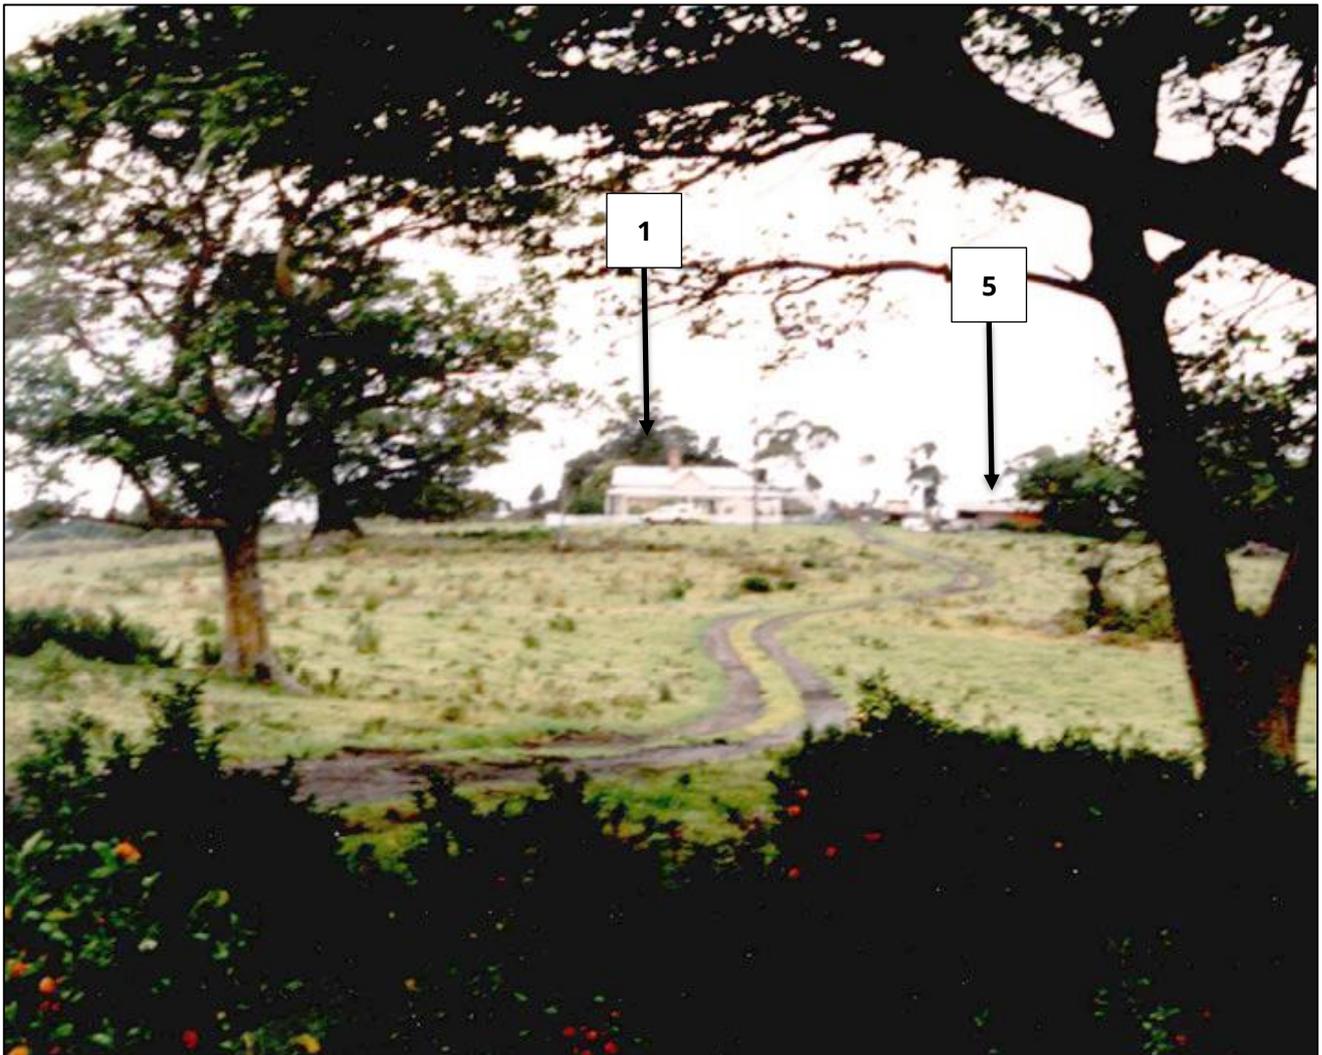
Photo 4 View of the main house [1] and garage [5] from near the driveway, showing vehicles near the structures, 1964 (Source: Shellharbour Library)

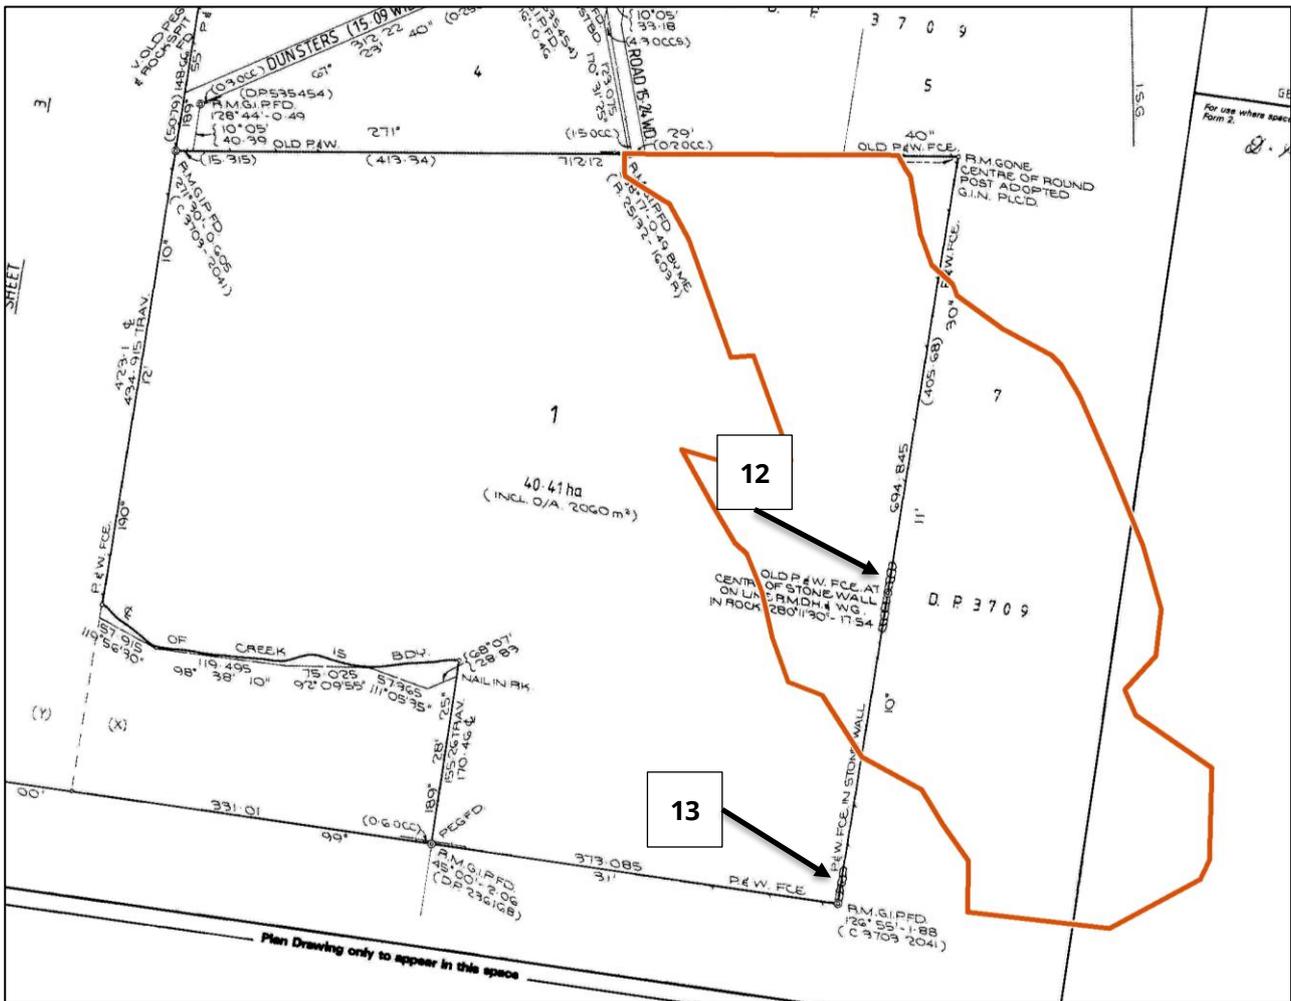
Plate 4 A 1996 subdivision plan of the study area, showing the presence of further stone walls [12] [13] (Source: NSW Land Registry Services, DP 858245)

In 1985, Doris Lucy Cody acquired the property from the Crown. A further subdivision took place between this purchase and 1996, but it has not been possible to obtain the plan for this change. The most recent subdivision took place in 1996, which established the property's current configuration. The subdivision plan notes the presence of further stone walls [12] [13] on the eastern boundary of the study area (**Plate 4**).³⁶

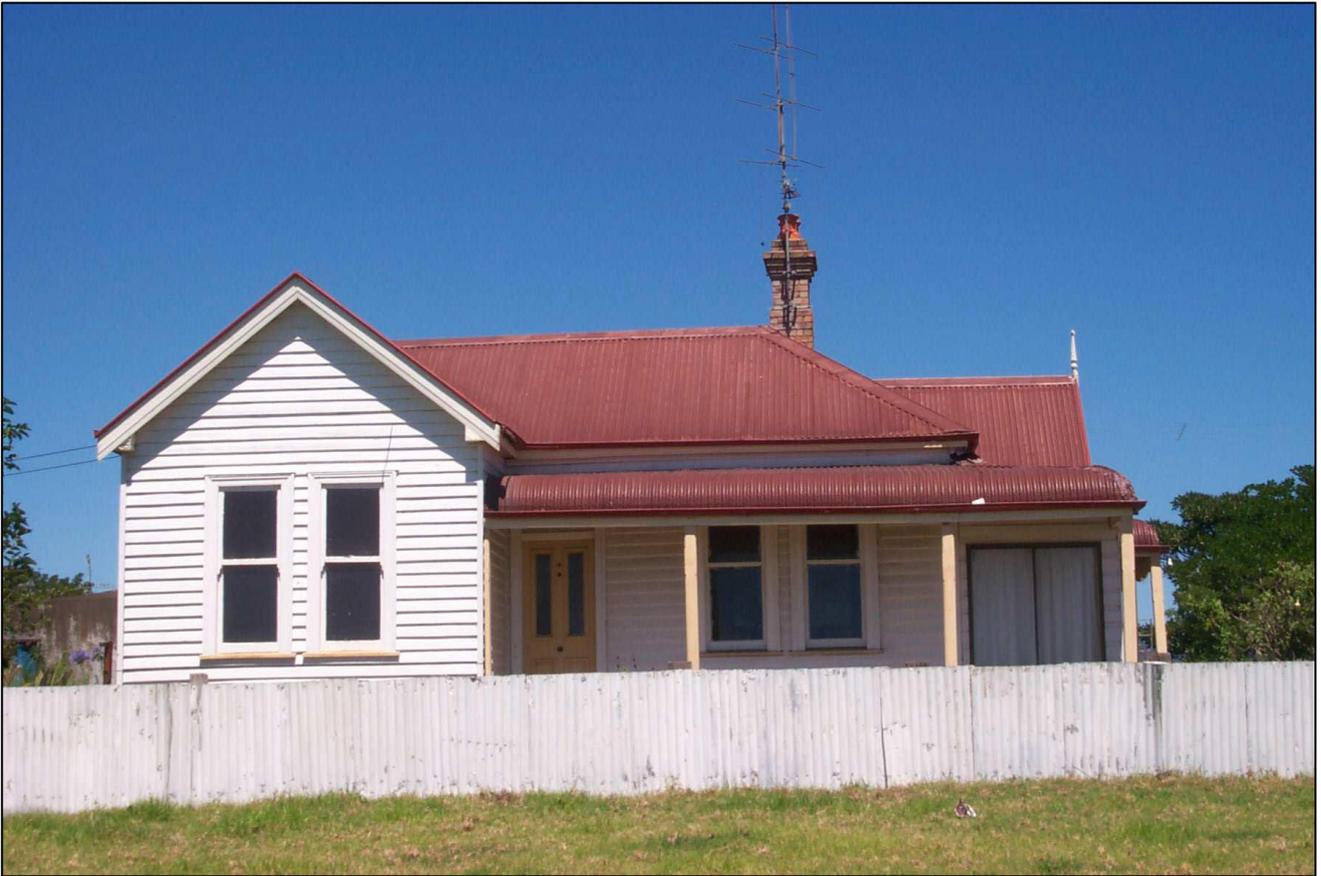
Photo 5 The Belmont main house [1], in 2004 (Source: Shellharbour Heritage Inventory Sheet for Belmont, Dry Stone Walls, Figs and Coral Tree Ave)

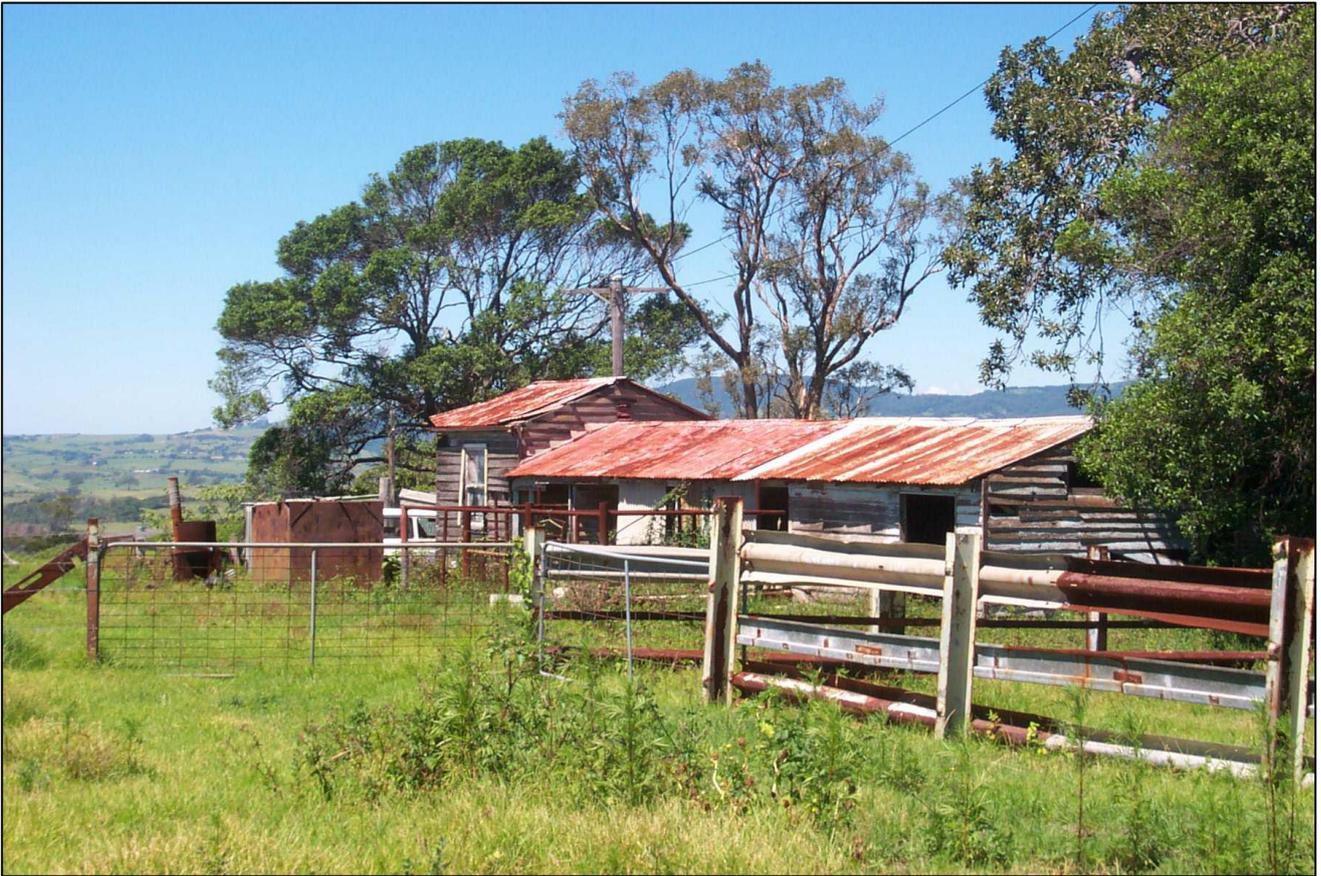
Photo 6 The dairy and bails [6] within the Belmont Estate in 2004 (Source: Shellharbour Heritage Inventory Sheet for Belmont, Dry Stone Walls, Figs and Coral Tree Ave)

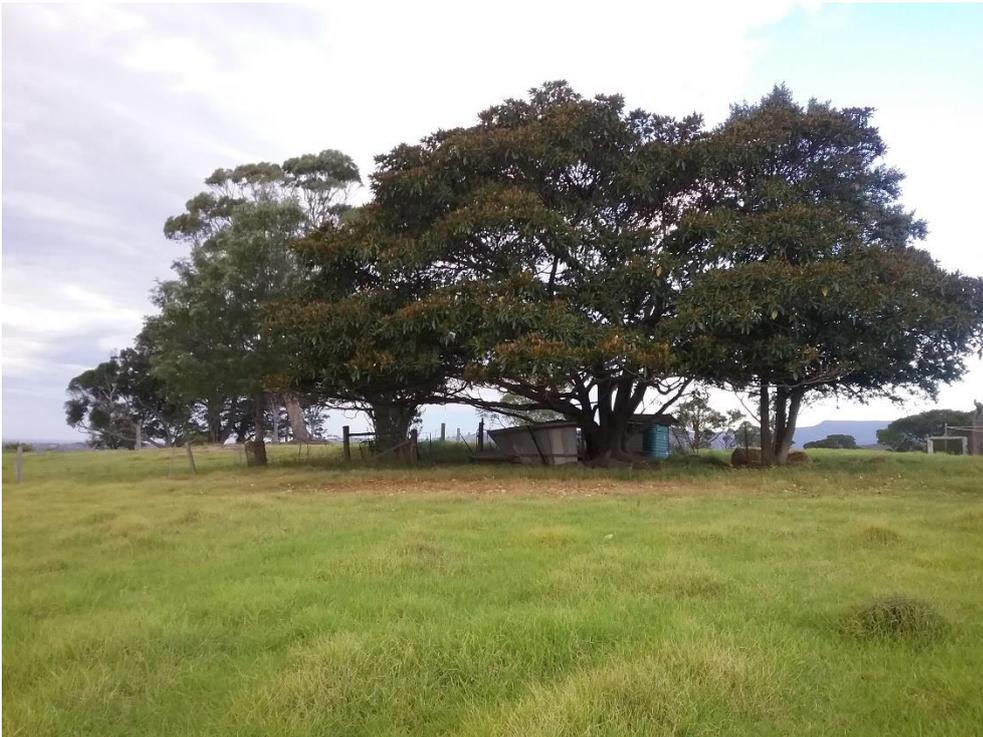
Photo 8 View of vegetation, informal farm structures and fencing near the Belmont main house [1] and building complex

The study area was likely cleared around or before the time of the Dunster's lease. This relict evolved landscape has been heavily modified for dairying and agriculture, with internal and external boundaries formed by a variety of timber, stone and wire fencelines, and by modified and natural vegetation **Photo 8**. Within this landscape is a complex of domestic, farming-related structures and occupational areas (**Photo 9**, **Photo 10** and **Photo 11**), an island of structures amongst pastoral lands, situated on a prominent ridgeline with views to coastal residential areas and the sea (**Photo 12**). To the west of the study area is a large quarry site (**Photo 13**).

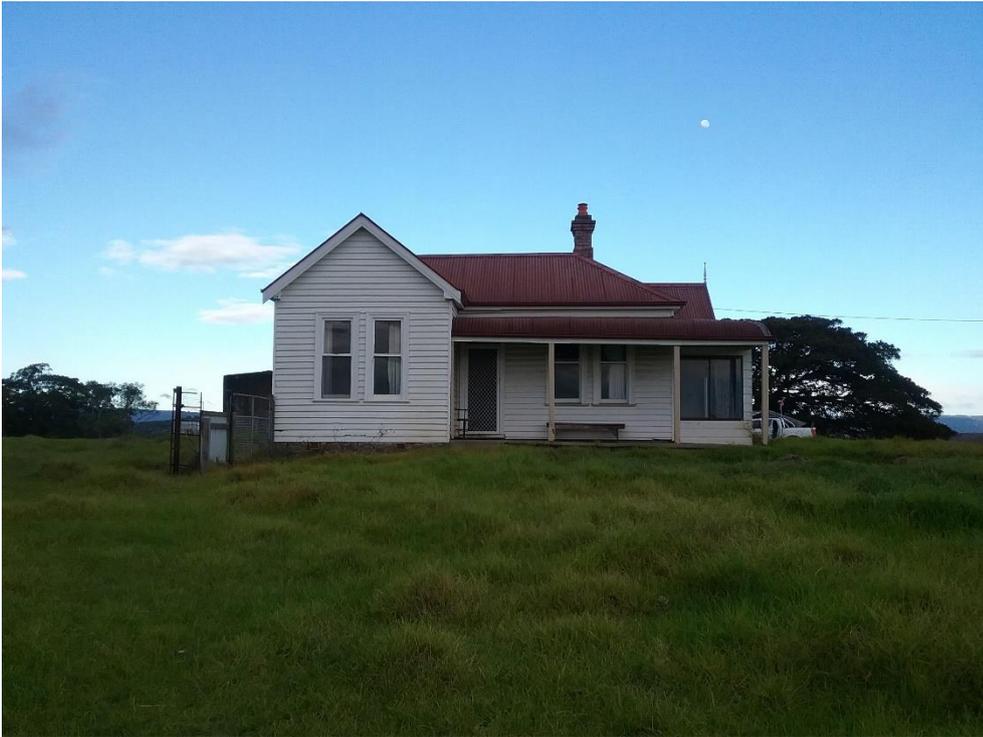
Photo 9 Eastern-facing facade of the Belmont main house [1], facing west

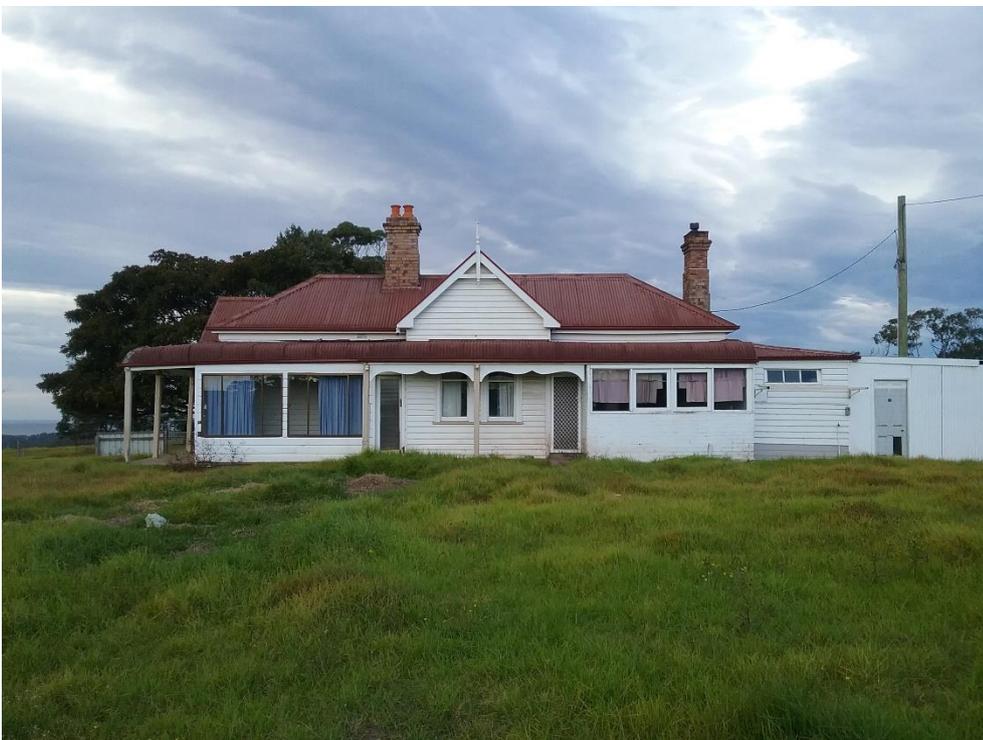
Photo 10 View of the northern facade of Belmont main house [1], facing south

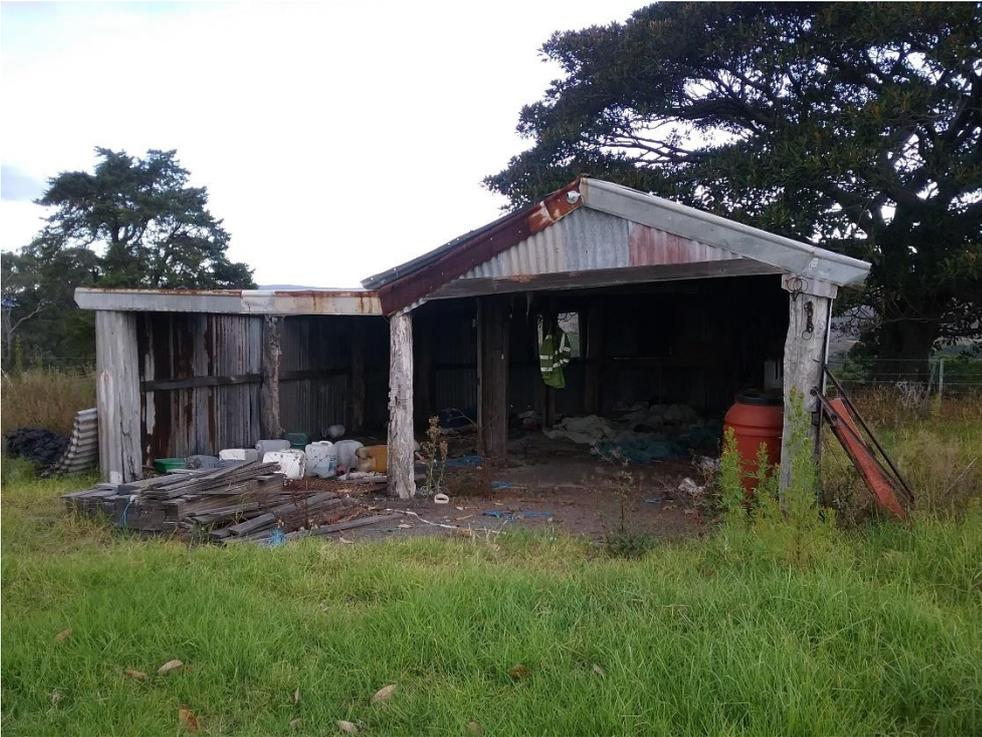
Photo 11 View of the garage [5] in its current state, facing west

The garage/storage shed [5] consists of timber posts and beams, with corrugated iron and plastic sheeting used for the roof, and some metal flashings (**Photo 11**). The garage is located north-west of Belmont main house [1] on the opposite side of the driveway track. It is possible the floor surface is compacted dirt, but this cannot be confirmed due to low visibility. It appears to be in a derelict state, and is used as an informal storage space for materials and rubbish.

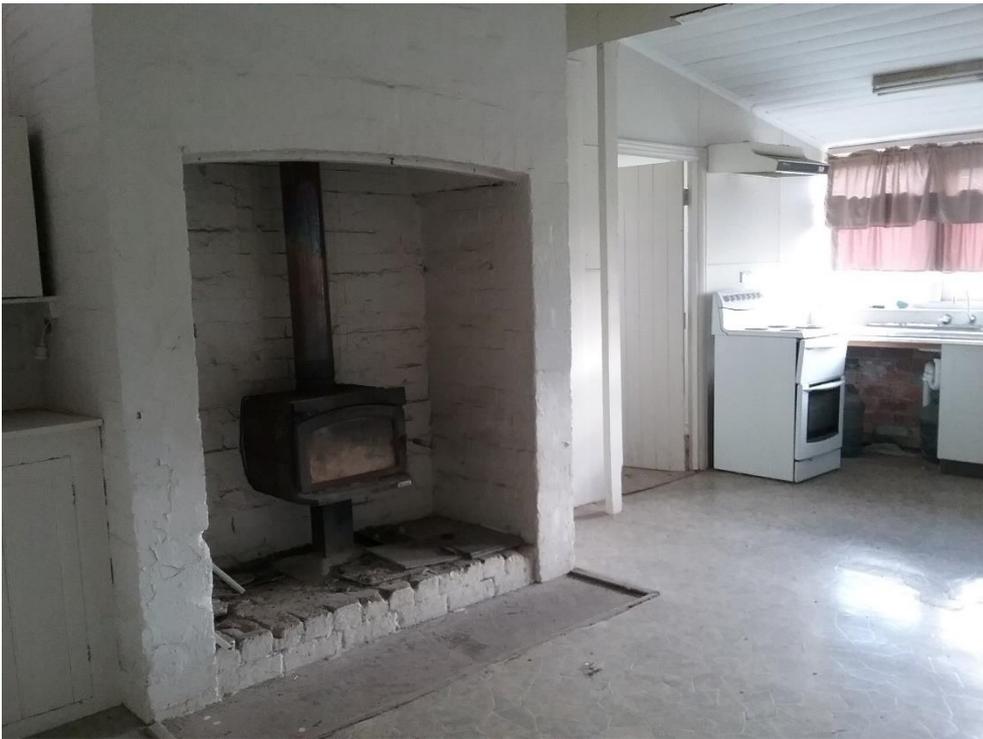
Belmont main house [1] is largely constructed of timber and weatherboard paneling, and also features corrugated iron roofing, two brick chimneys with associated fireplaces and hearths, brick footings and more recent extensions constructed of brick, timber and fibro sheeting (**Photo 14**, **Photo 15** and **Photo 16**). Concrete water tanks are also situated adjacent to the house, with a drain pipe collecting rainwater from the roof. Belmont main house remained occupied until 2003, and is said to have remained in good condition at the time of the vacation of the occupant. In addition to the inspection undertaken by Biosis, a dilapidation survey (see **Appendix 1** Dilapidation Survey Report) was undertaken by Design 5 Architects in April 2018⁴² and a structural integrity report by KF Williams and Associates Pty Ltd in November 2018 (see **Appendix 3**

Photo 14 Kitchen space, Belmont main house

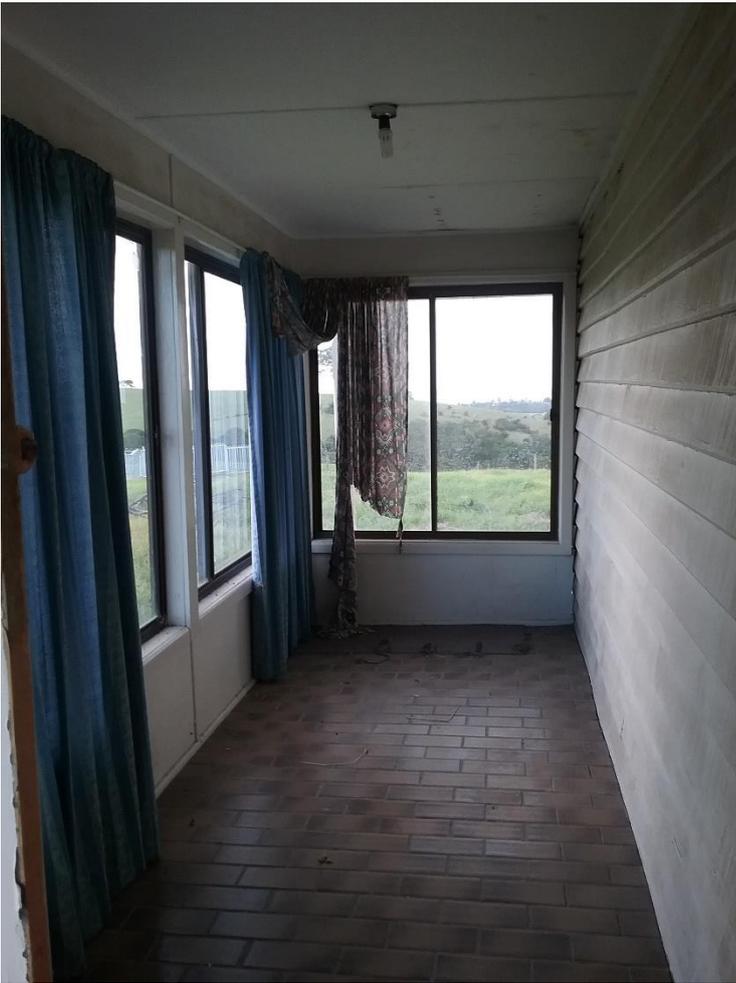
Photo 15 Closed-in porch, Belmont main house

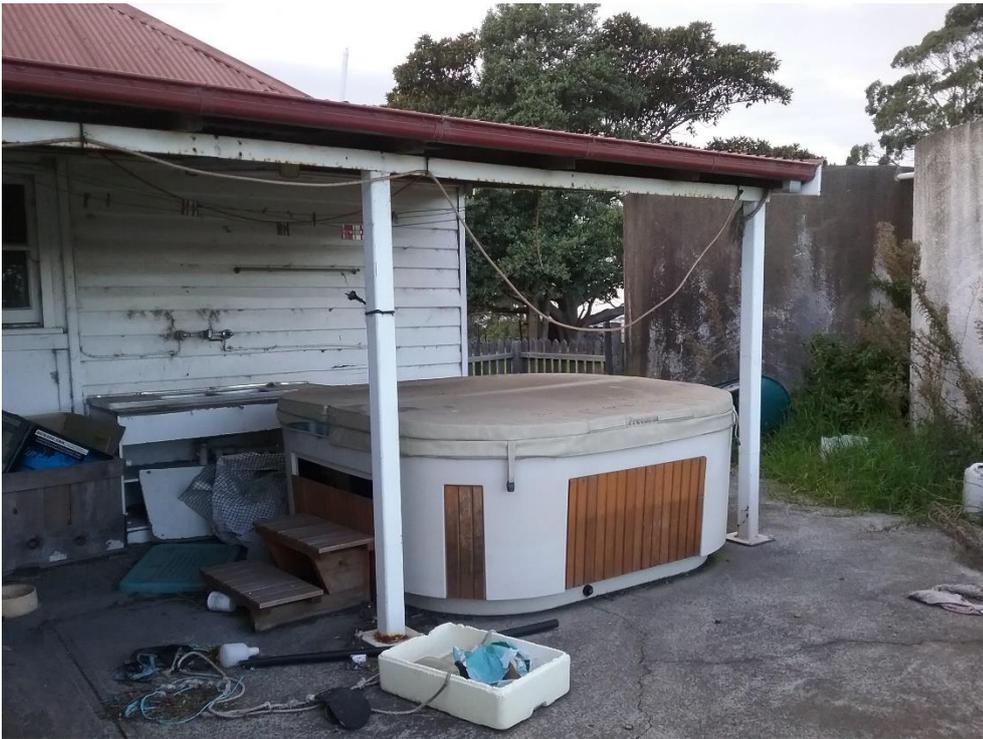
Photographs from both surveys indicate that visually the building is in relatively fair condition, with some areas in poorer condition, such as the south-western patio area. However, several areas were noted for areas of visual damage, including:

Photo 16 South-western patio area, Belmont main house

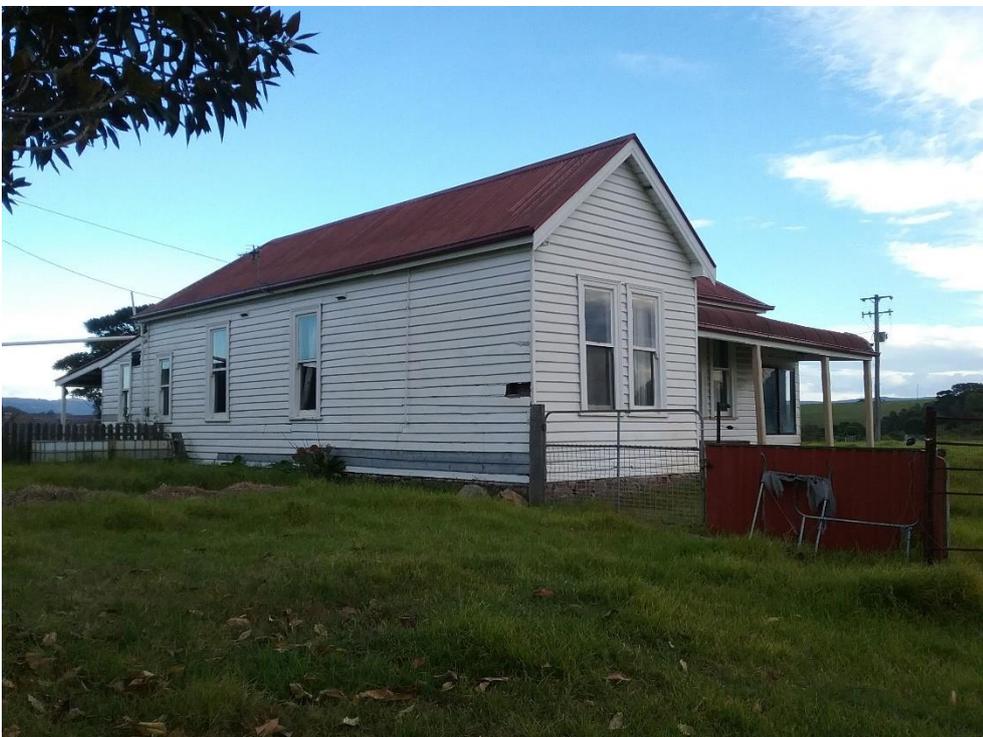
Photo 17 Damaged timber weatherboard in north-eastern part of Belmont main house

- Damaged timber weatherboard cladding and brick base wall on the south-eastern corner and east-southern wall of the building (**Photo 17**).
- A spliced verandah post on the norther-eastern corner of the verandah (**Photo 18**).
- Cracks in plasterboard in the eastern corner of space SG.2.
- Damage to ceiling timber lining boards in space SG.1 (hallway).
- Damaged or broken door in the northern elevation of SG.8.

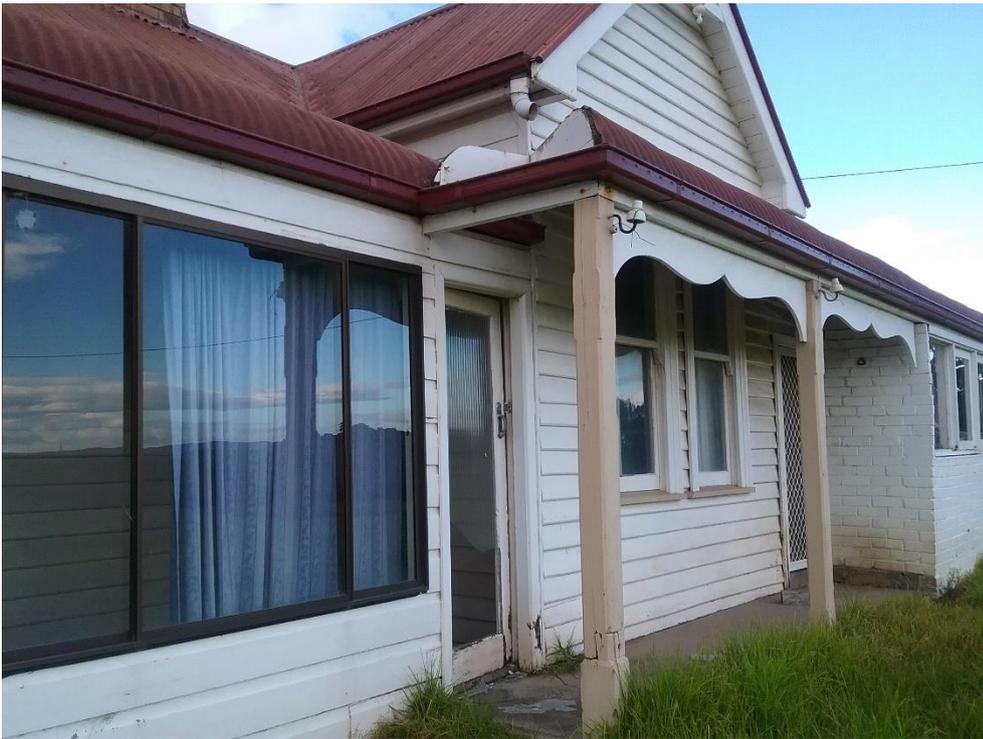
Photo 18 Spliced verandah post on northern verandah area, Belmont main house

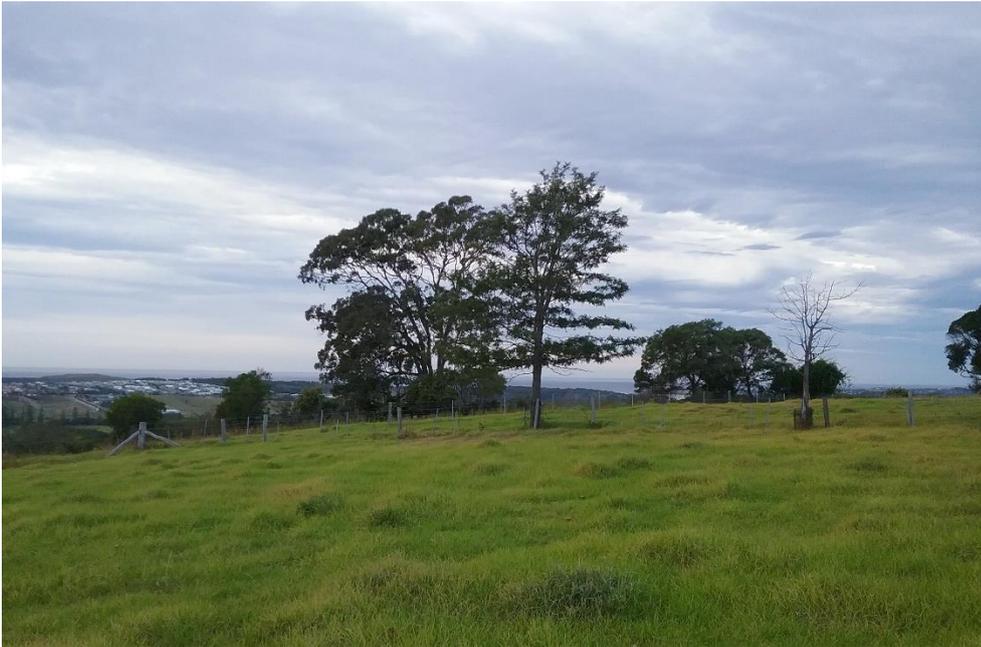
Photo 19 Example of post and wire fencing present within the study area

A number of fences and gates of various ages were present, and were constructed of timber posts, metal wire and frames (**Photo 19**), as well as more modern welded mesh fencing. These items were generally in a fair condition. Several informal outbuildings were also visible, and appear to consist of timber frames and metal and plastic corrugated sheeting (**Photo 8**). These items appear to be in poor condition. A modern electricity pole was also present north of Belmont main house adjacent to the driveway. There are also a number of Moreton Bay fig trees within the vicinity of Belmont house. The two largest ones are in poor condition and appear to be in various stages of dying. The coral tree avenue has previously been removed as part of the Stage 1 – 6 quarrying activities.

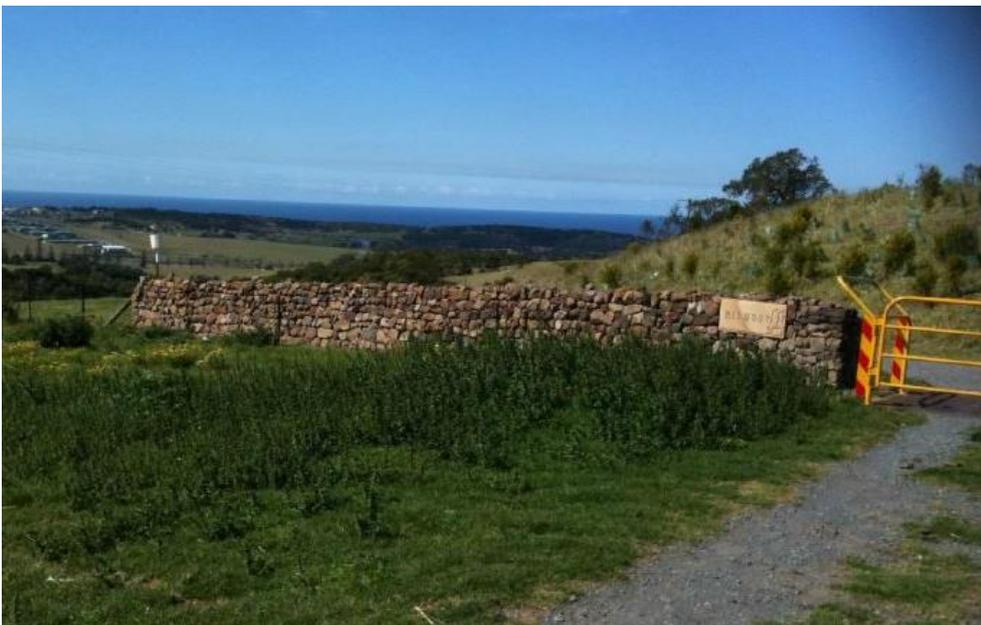
Photo 20 Reconstructed dry stone walls at the entrance to Belmont (Source: Albion Park Quarry Heritage Management Plan)

Under development consents 466-11-2003 and 467-11-2003, dry stone walls A and B were reconstructed at the entrance to the Cleary Bros Belmont property, allowing the structures to retain their original associations with the area and placing them in public view (**Photo 20**). The salvage and reconstruction of the structures was undertaken by an experienced and accredited dry stone waller following regional styles in accordance with the *Albion Park Quarry Heritage Management Plan* (Cleary Bros (Bombo) Pty Ltd 2017).

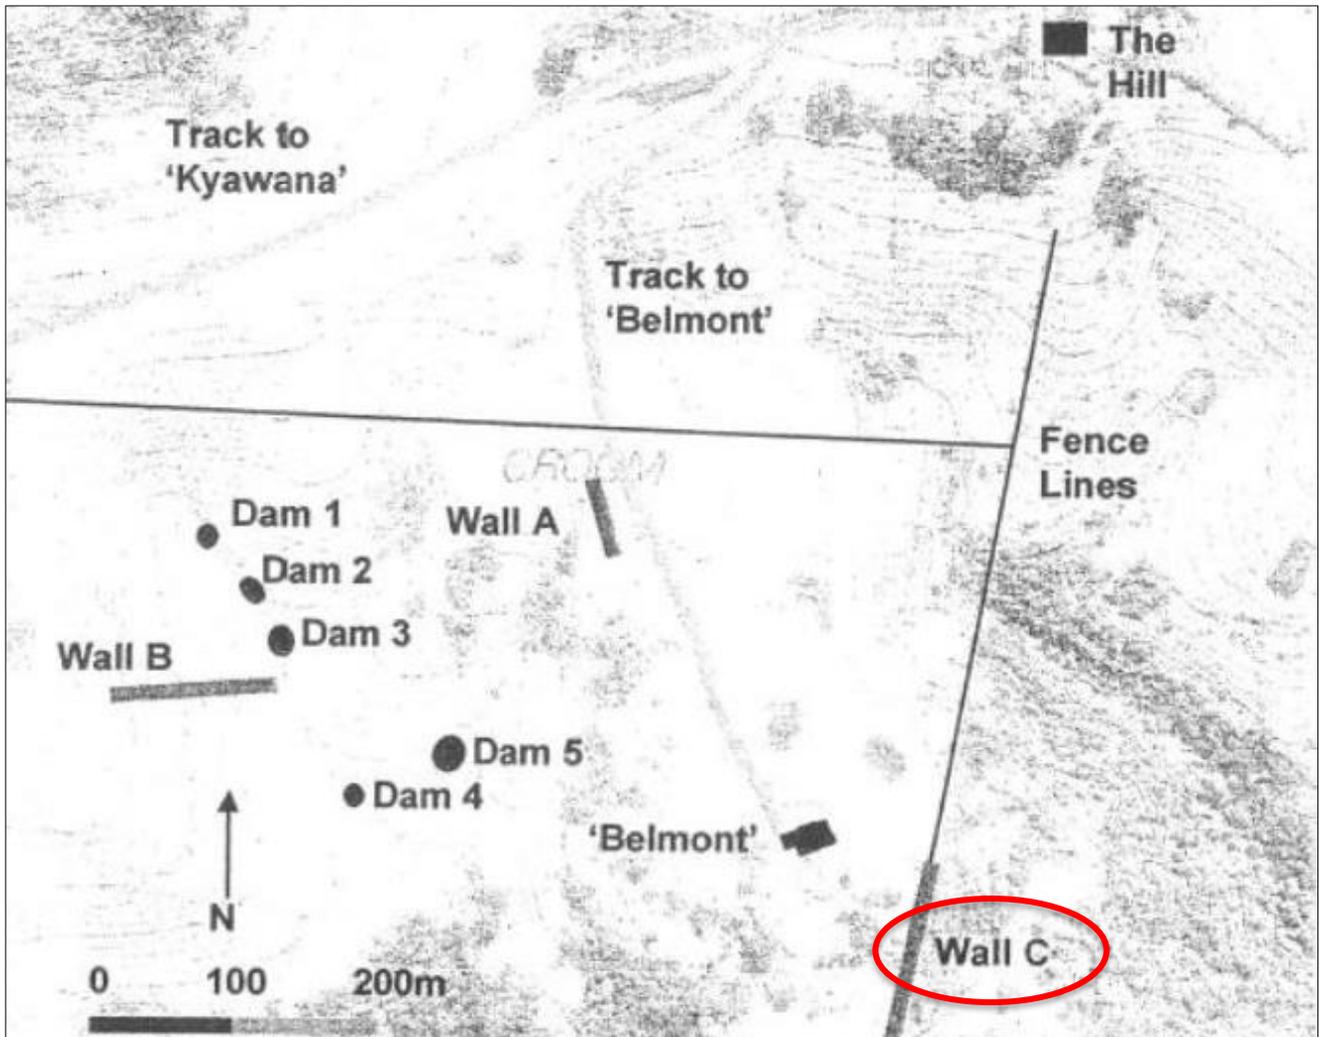
Plate 5 Location of dry stone wall C within the study area (Source: Albion Park Quarry Heritage Management Plan)

Dry stone wall C [12] is located within the study area (**Plate 5**) and during the physical inspection of the study area, a further dry stone wall (D) [14] was located (Photo **21** and **Figure 4**). Both dry stone walls are in a deteriorating condition with vegetation invasion present and evidence of slumping and bellying.

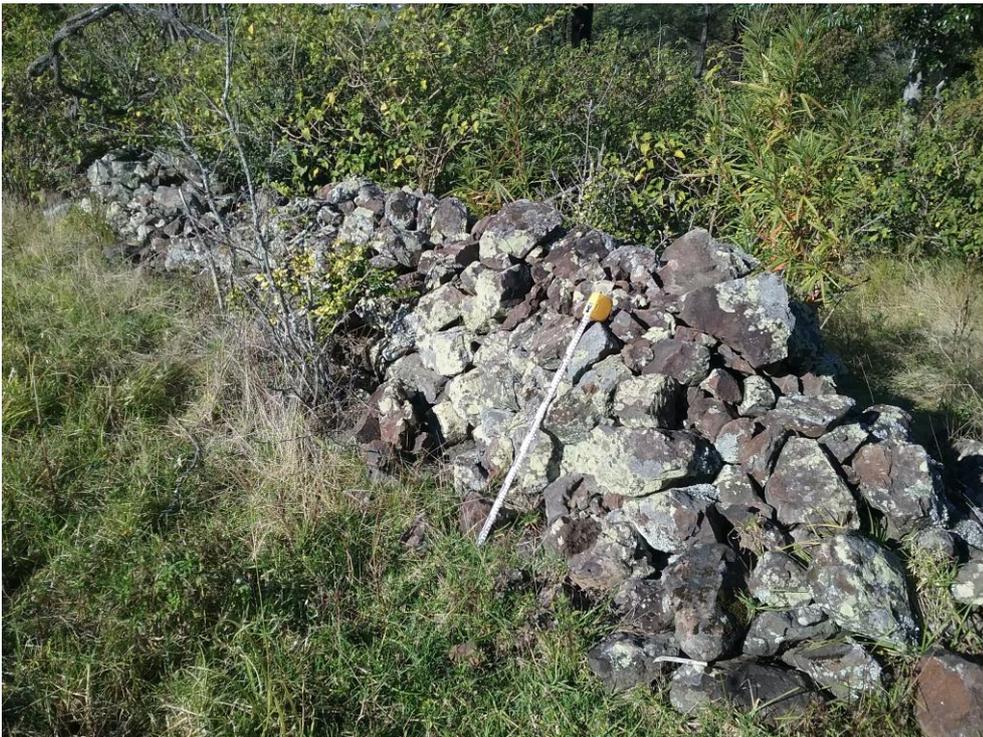
Photo 21 Dry stone wall D [14] located during the physical inspection
