Albion Park Quarry Extraction Area Stage 7 Extension

Historic Heritage Assessment

Biosis Pty Ltd

August 2021

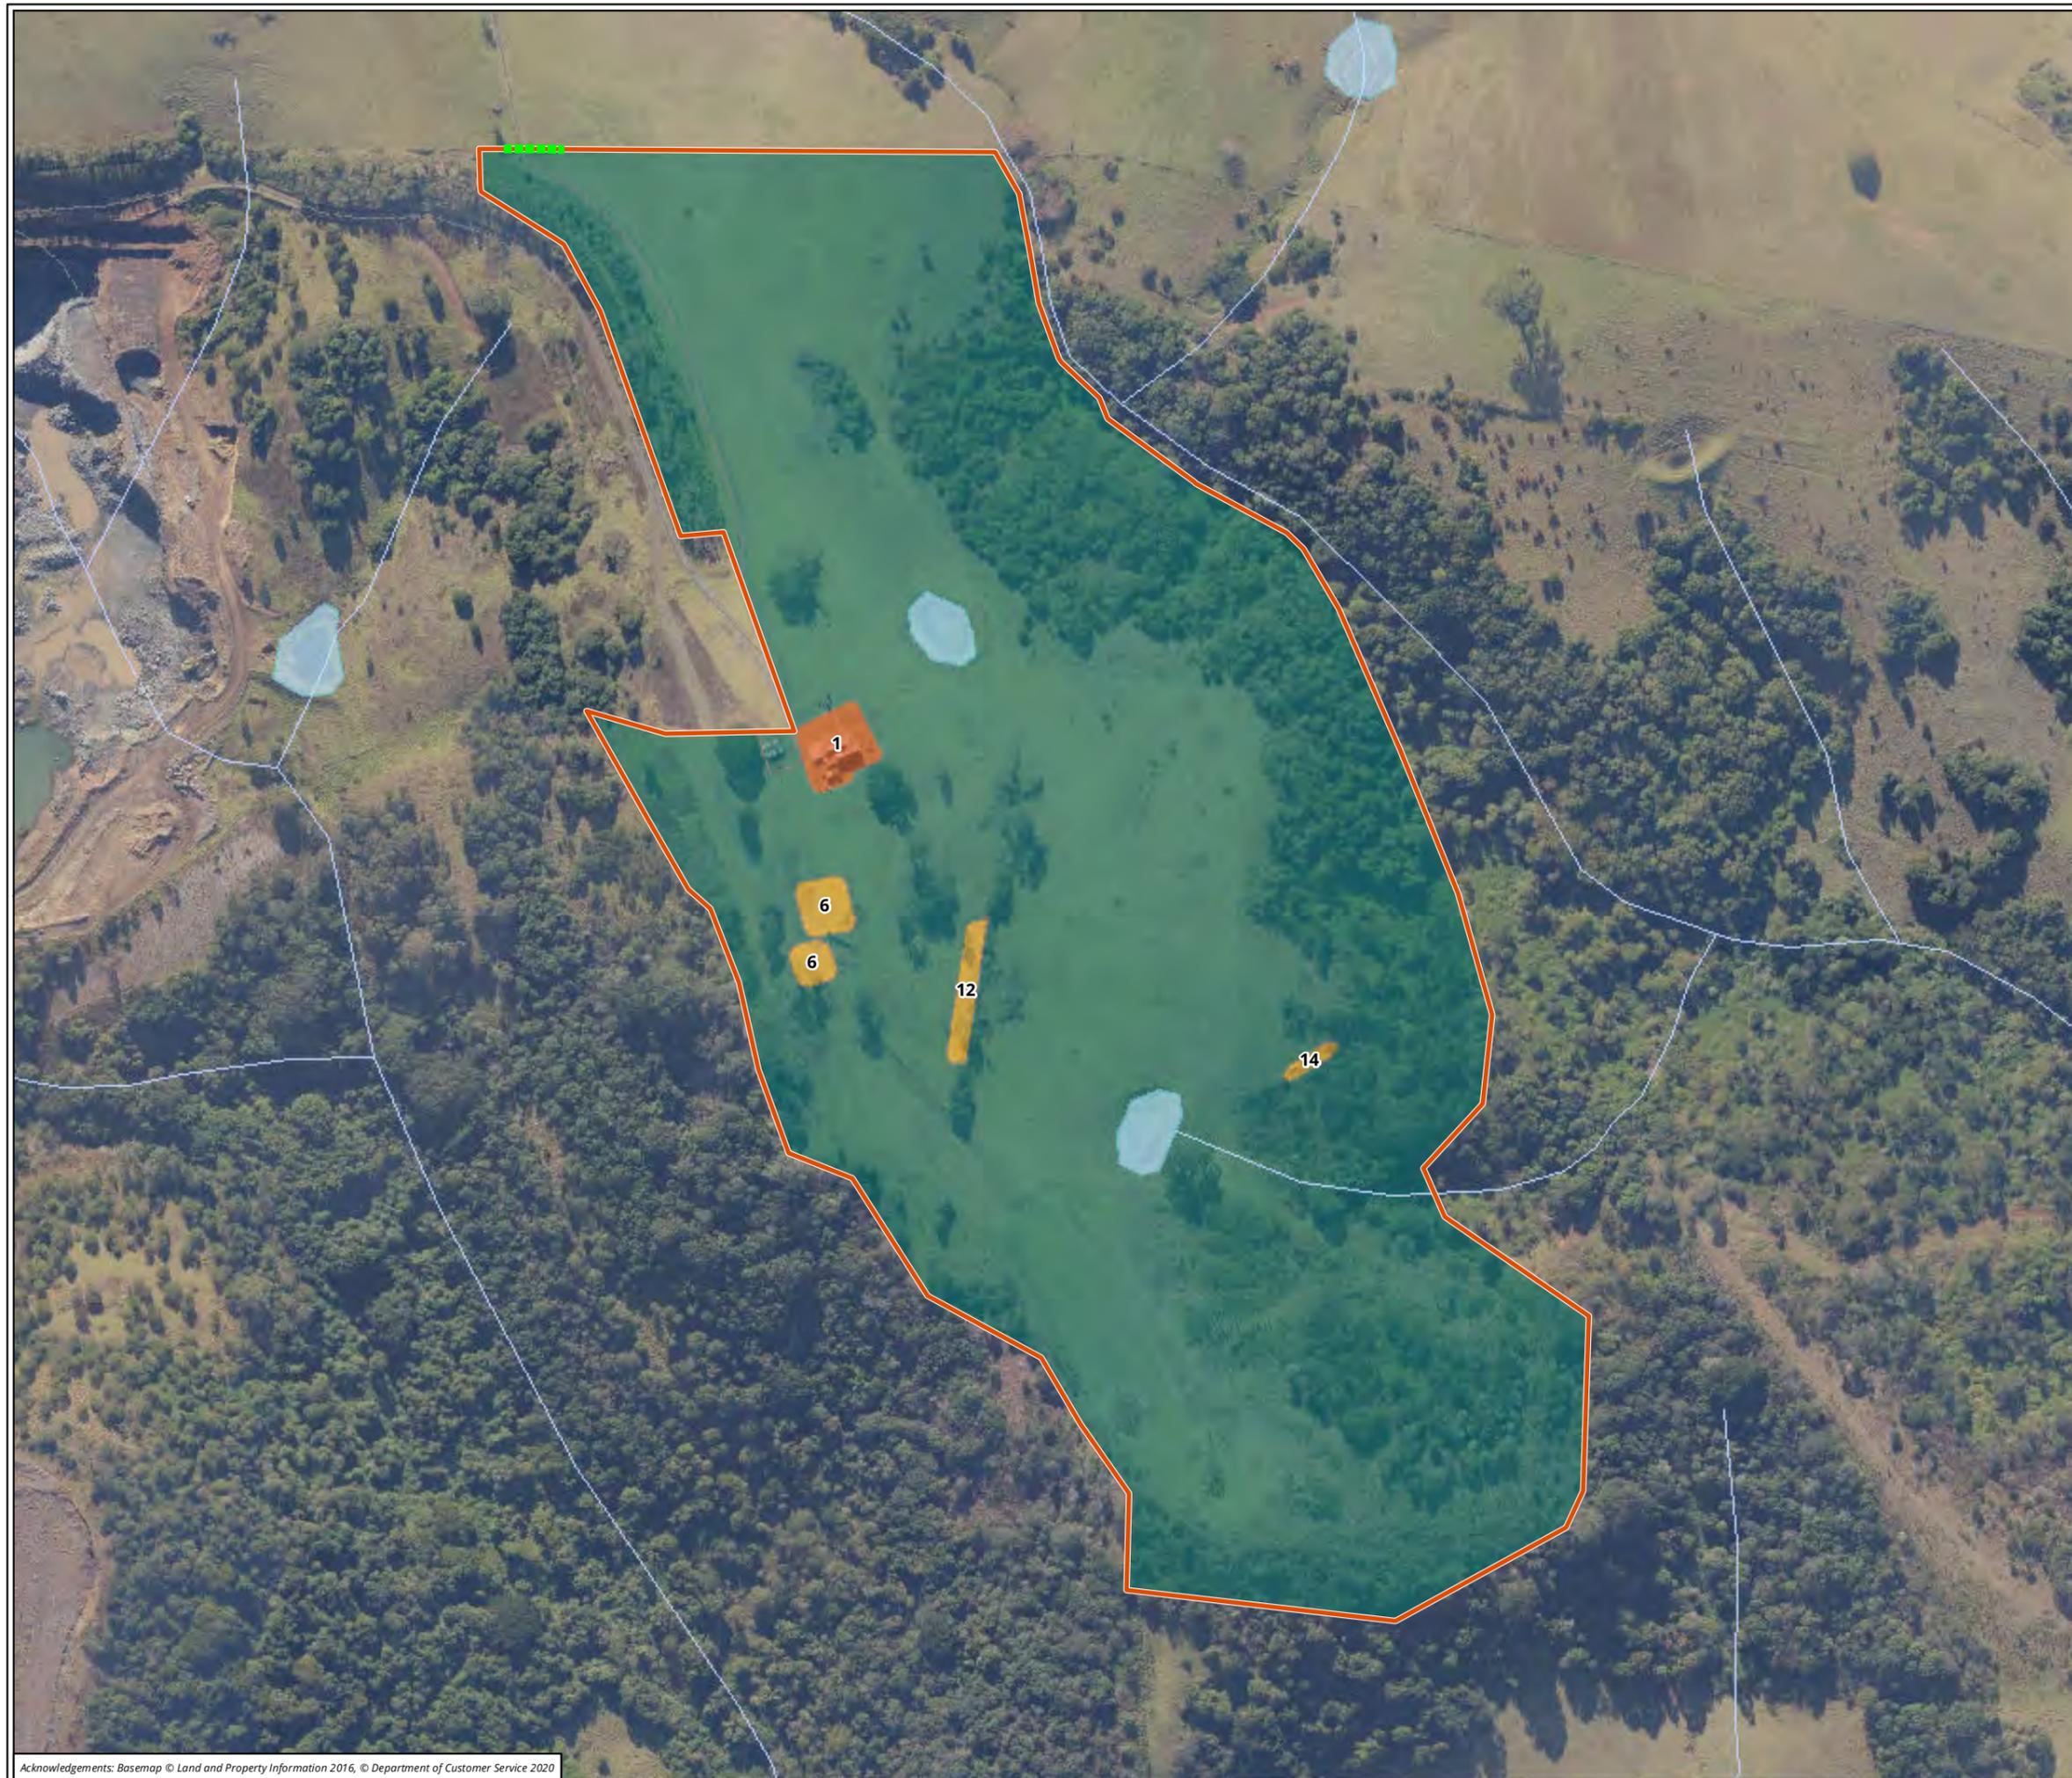
Figure 4 Assessment of archaeological potential

Designation	Description	Probable feature(s)	Possible construction date	Archaeological potential
1	Belmont main house	Building footings or foundations, cut and fill deposits, secondary deposits (rubbish pits, cesspits, cisterns, privies), underfloor occupation deposits, yard surfaces, fencing post holes, remains of timber posts and fencing wire.	c.1900	High
2	Stone walls A and B	Wall foundations, associated cut and fill deposits.	c.1912	Nil – removed and reconstructed
3	Farm building	Building footings or foundations, fencing or structural postholes and associated remnant timber posts, cut and fill deposits, compacted floor surfaces, artefact scatters.	Pre-1949	Low – location unknown
4	Silo pit	Timber and metal structural remains, cut and fill deposits, postholes, organic	Pre-1949	Low – location unknown

There are several areas of high and moderate archaeological potential within the study area. The main house [1] and its immediate vicinity is considered to hold high archaeological potential. These areas may contain building footings or foundations, cut and fill deposits, secondary deposits (rubbish pits, cesspits, cisterns, privies), underfloor occupation deposits, yard surfaces, fencing post holes, and remains of timber posts and fencing wire. Should archaeological resources be present, they would be valuable in responding to research questions relating to the domestic and working lives of late 19th and early 20th century dairy farmer families and dairy farming practices in the Shellharbour region. Those areas considered to hold moderate archaeological potential include the location of the former bails and dairy building [6] and stone walls [12] [14]. Archaeological material may be in the form of building footings or foundations, fencing or structural postholes and associated remnant timber posts, cut and fill deposits, compacted floor surfaces, artefact scatters, rubbish pits, yard surfaces, wall foundations and associated cut and fill deposits. Should archaeological material be present in these locations, they may contribute to knowledge of dairy farming methods and practices within the Shellharbour region. The remainder of the study area is considered to have low archaeological potential.

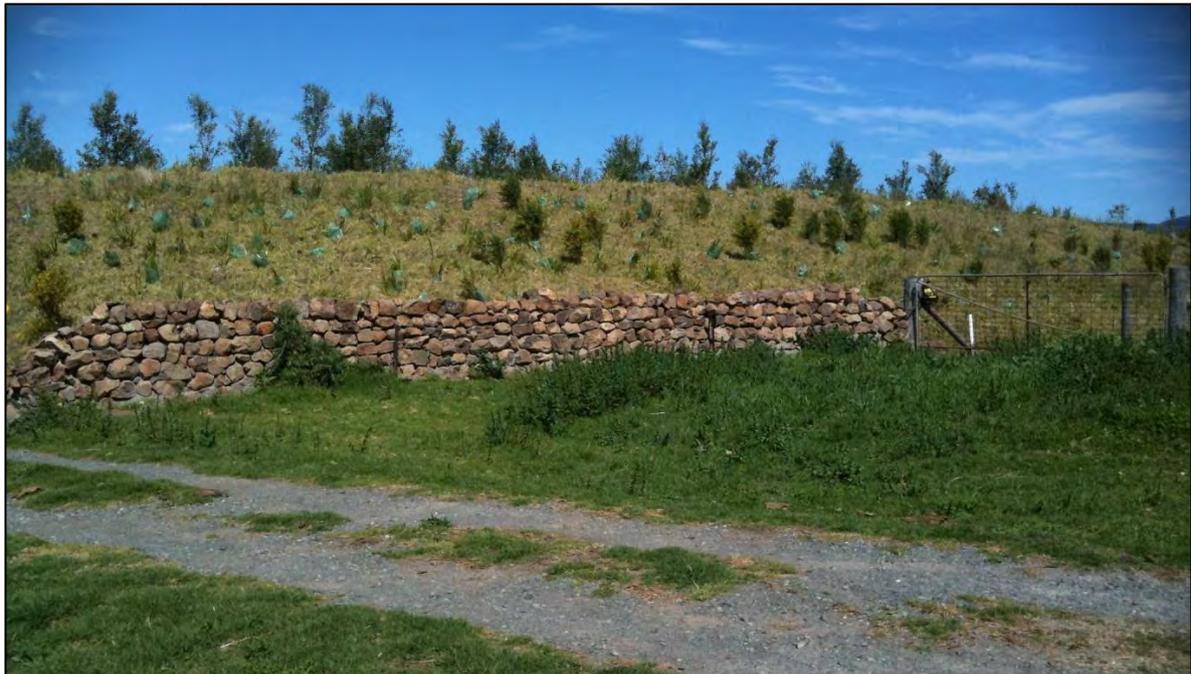
Figure 6 – Reconstructed dry stone wall adjacent to the Belmont entrance in 2010.

Dry stone walls A and B have been reconstructed at the entrance to the Cleary Bros 'Belmont' property, allowing the structures to retain their original associations with the area and placing them in public view (see Figure 6). Two photographs of the reconstructed walls are included below.

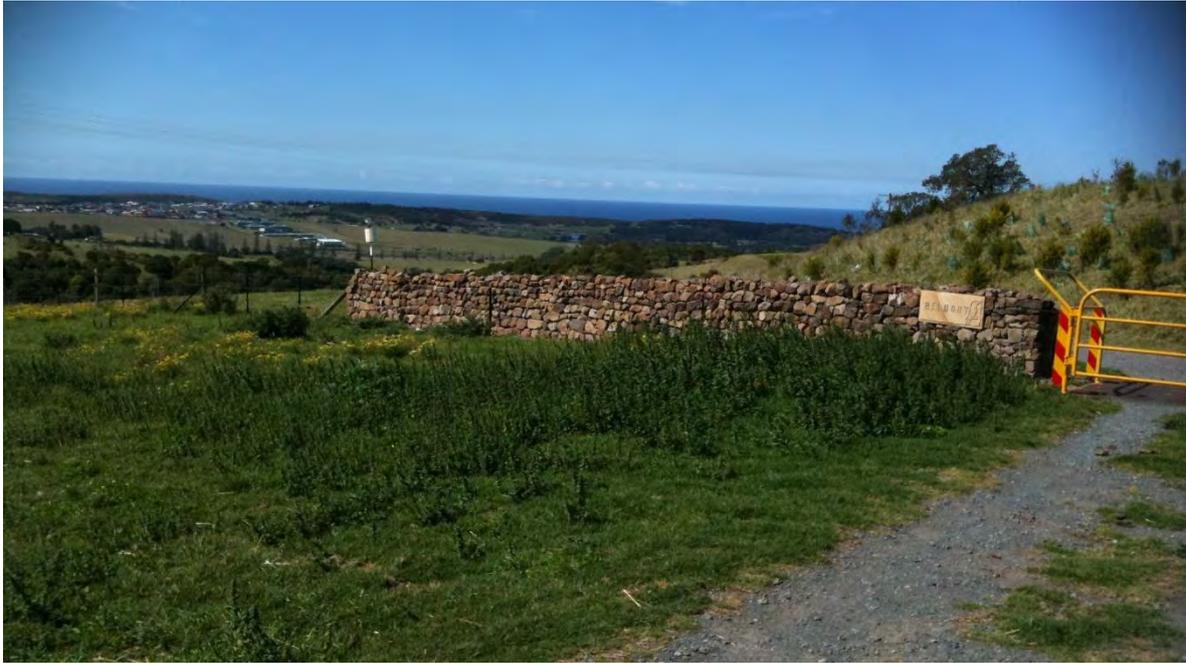
Figure 7 – Reconstructed dry stone wall adjacent to the Belmont entrance in 2010.
