Report on  
Geotechnical Investigation

Trinity Grammar School  
113-119 Prospect Road, Summer Hill

Prepared for  
Bloompark Consulting Pty Ltd

Project 86861.00  
October 2019

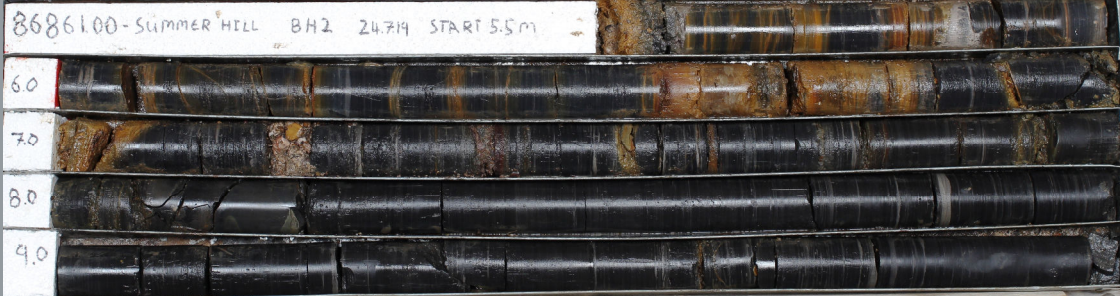
Project No: 86861.00  
BH ID: BH 2  
Depth: 5.50 - 10.00 m  
Core Box No.: 1

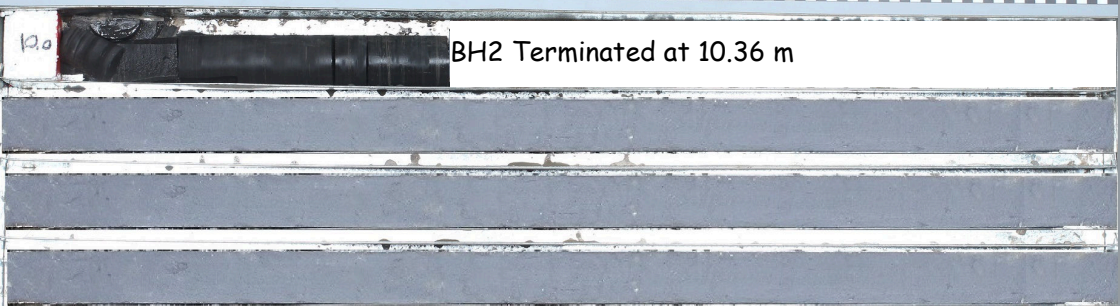
Project No: 86861.00  
BH ID: BH 2  
Depth: 10.00 - 10.36 m  
Core Box No.: 2

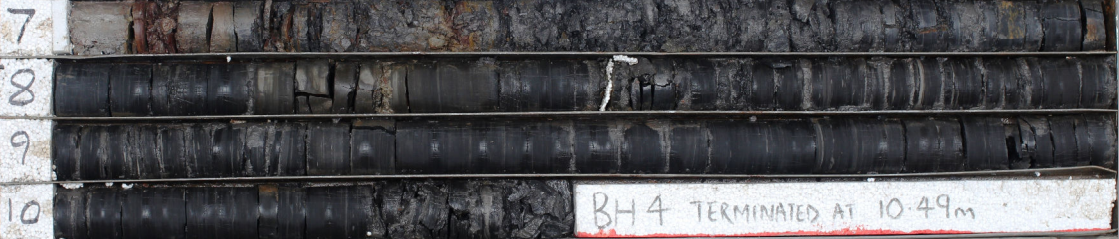
7.03 - 10.49m

86861.00 SUMMER HILL 15/07/19 BH4 START AT 7.03m

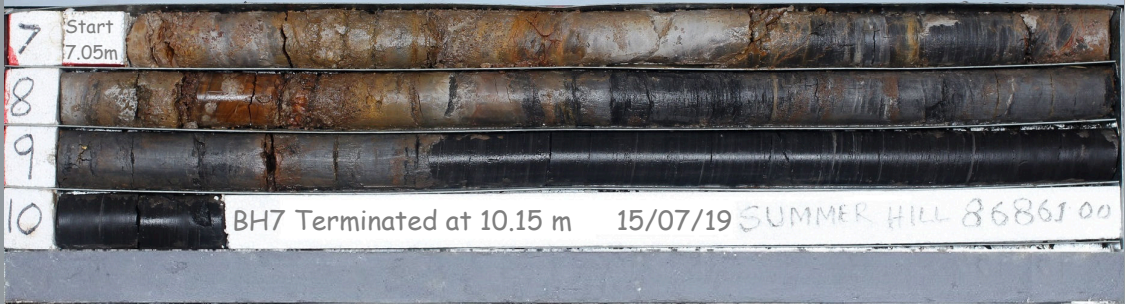
7.05 - 10.15m

Project No: 86861.00  
BH ID: BH7  
Depth: 7.05 - 10.15 M  
Core Box No.: 1

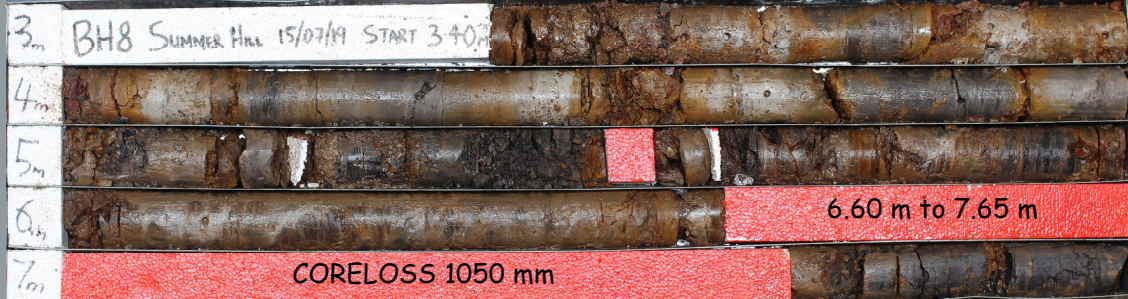
3.40 - 8.00m

Project No: 86861.00  
BH ID: BH 8  
Depth: 3.40 - 8.00 m  
Core Box No.: 1

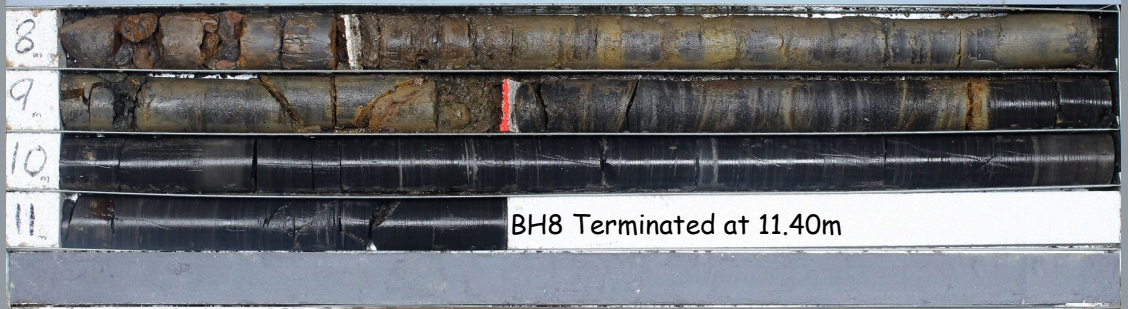
8.00 - 11.40m

Project No: 86861.00  
BH ID: BH 8  
Depth: 8.00 - 11.40 m  
Core Box No.: 2

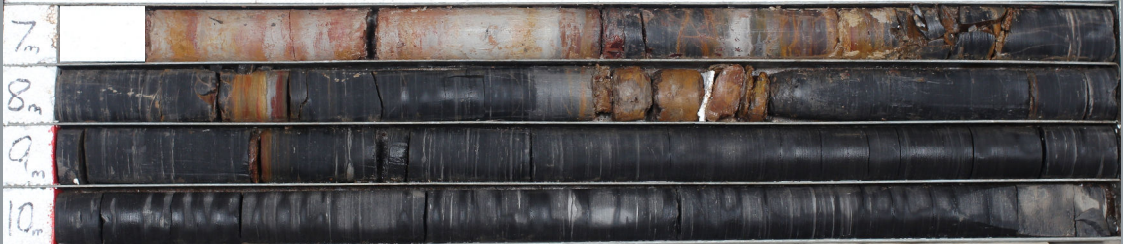
7.08 – 11.00 m

SUMMER HILL 86861.00 BH 9 START: 7.08 M

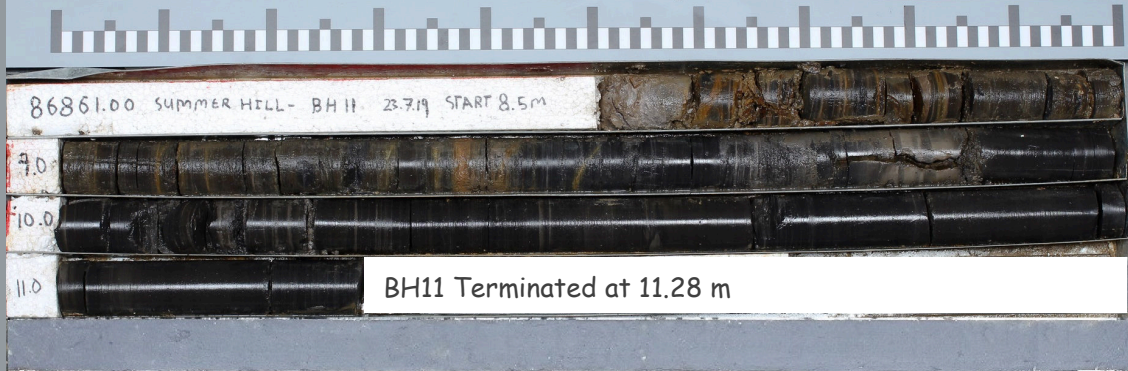
Project No: 86861.00  
BH ID: BH 11  
Depth: 8.50 - 11.28 m  
Core Box No.: 1
