Report on Preliminary Site Investigation (Contamination)

Trinity Grammar School 113 – 119 Prospect Road, Summer Hill

> Prepared for Trinity Grammar School

> > Project 86861.00 October 2019

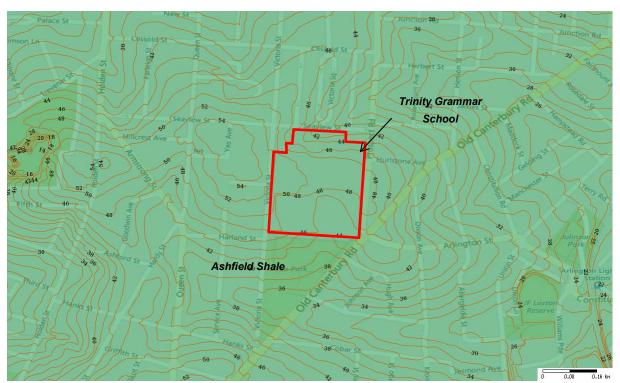
The Sydney 1:100 000 Geological Series Sheet indicates that the site is underlain by Ashfield Shale which typically comprises a residual clay profile overlying variably weathered dark grey shale, laminite and siltstone. An extract from the geological map overlain by 2 m surface contours is shown in Figure 1.

Figure 1: Extract from geological map overlain by 2 m surface contours

The topography of the site suggests that regional groundwater is likely to flow in either a northerly or southerly direction. Groundwater in this geology is typically of poor quality (i.e. saline / high dissolved salts) and low yield and is not considered to be a high value potential resource.

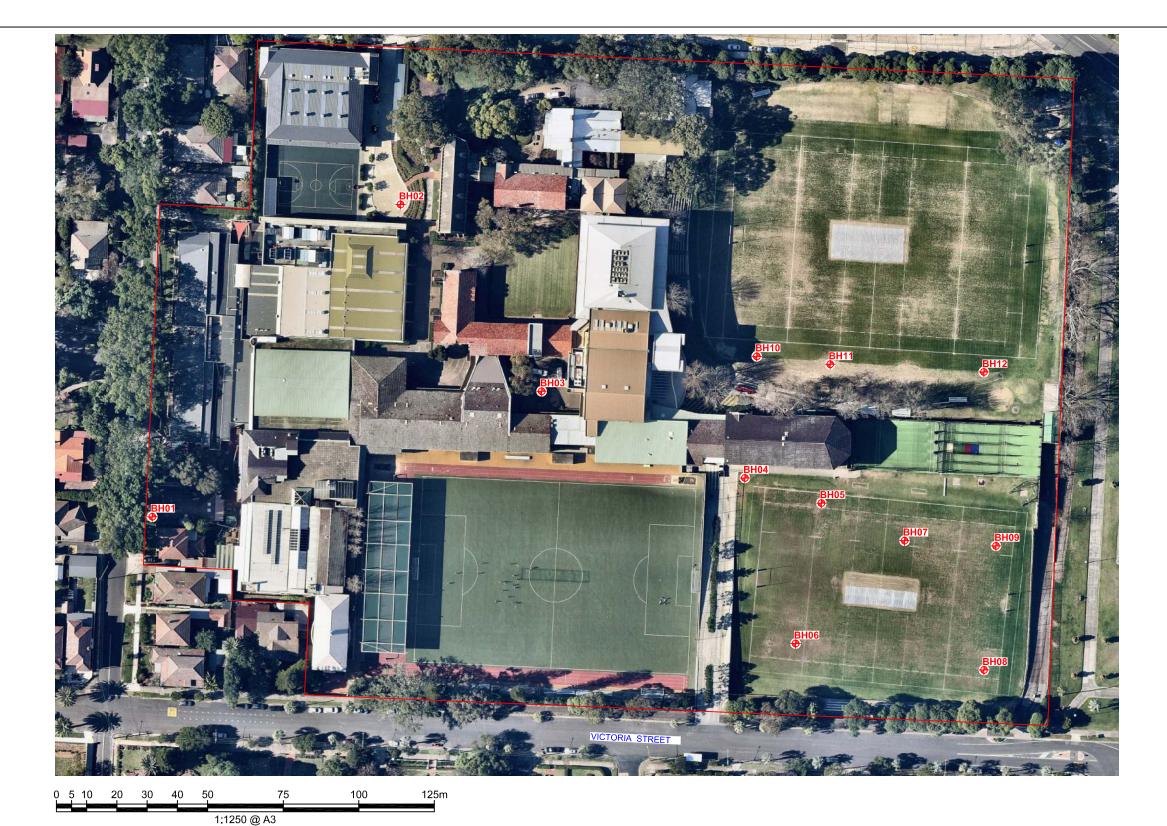
PROJECT No:	86861.00	
)	DRAWING No:	C1	
	REVISION:	0

Locality Plan

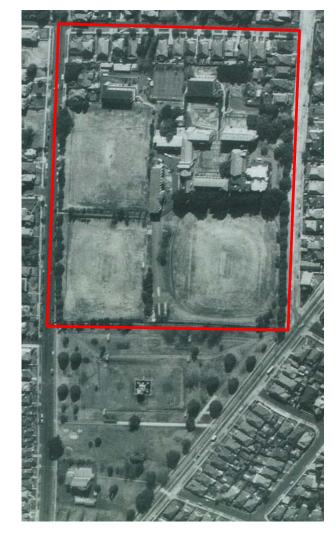
PROJECT No:	86861.00
PLATE No:	2
REVISION:	0

Historical Aerial Photographs	
Trinity Grammar School	
113-119 Prospect Road, Summer Hill

The 1961 photograph shows additional buildings in the north-eastern area of the site. The 1970 photograph shows additional buildings in the northern and central portions. The vegetation along the site boundaries is more pronounced. The 1978 photograph shows similar conditions.

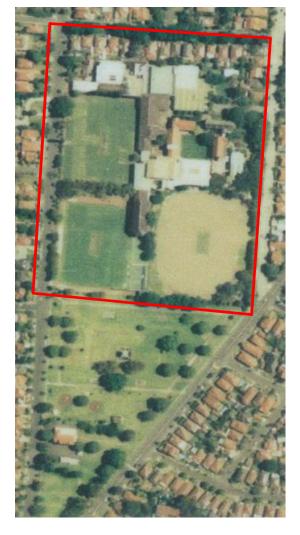
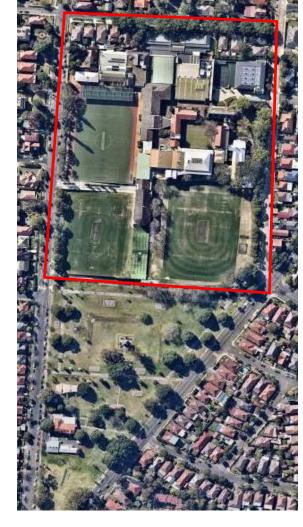
CLIENT:	Trinity Grammar School	Historical Aerial P
OFFICE:	Sydney	Trinity Grammar S
DATE:	25 Sep 2019	113-119 Prospect
