**REPORT TO
SUTHERLAND SHIRE COUNCIL
C/- NBR ARCHITECTURE**

**ON
PRELIMINARY ENVIRONMENTAL SITE
ASSESSMENT**

**FOR
PROPOSED REFURBISHMENTS TO SUTHERLAND
ENTERTAINMENT CENTRE AND PEACE PARK**

**AT
30 ETON STREET, SUTHERLAND, NSW**

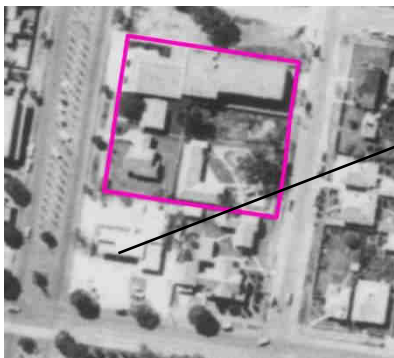
<div data-bbox="1114 1783 1353 1839">Service Station</div> </div>

1965	<p>The site generally appeared similar to the previous photograph.</p> <p>Former residential type buildings located immediately to the north of the site had been demolished. A large rectangular commercial building had been constructed to the north of the site. Paved areas associated with the commercial building was visible to the north of the site. A former residential building to the south of the site (at the corner of Eton and Flora Streets) had been demolished and a service station/motor garage occupied this area. The service station/motor garage appeared to have been in operation at this time based on the parked vehicles visible at the property shown on the image below.</p> <div data-bbox="667 1686 1353 2042">

2000	<p>The site and surrounding features appeared generally similar to the previous photograph.</p> <p>The service station located to the south of the site (at the corner of Eton and Flora Streets) had been demolished and a large square shaped commercial building occupied the area. The building was generally similar in footprint to the existing Centrelink and Medicare building observed to the south of the site.</p>
2007	<p>The site and immediate surroundings generally appeared similar to the previous photograph.</p>
2014	<p>The site and surrounding features appeared generally similar to the previous photograph, with the exception of further commercial buildings located to the north-east of the site.</p>
2018	<p>The site and surrounding features appeared generally similar to the previous photograph.</p>
2019	<p>The site and surrounding features appeared generally similar to the previous photograph and present (2020) layout.</p>

<p><u>Off-site area 1</u> – Former service station at 36 Eton Street (at the corner of Eton and Flora Streets) observed in the historical aerial photograph. The use and storage of fuel could have resulted in potential leaks impacting the groundwater.</p>	<p>Heavy metals (lead), TRH, BTEX, naphthalene and volatile organic compounds (VOCs)</p>
